National Transportation Safety Board

Safety Recommendation

In reply refer to: A-02-06 and A-02-07

On March 17, 2001, about 0708 eastern standard time, an Airbus Industrie A320-200, N357NW, manufacturer serial number 830, being operated by Northwest Airlines as flight 985, ran off the runway and onto terrain during a rejected takeoff at the Detroit Metropolitan Wayne County Airport, Detroit, Michigan. An emergency evacuation was performed. The captain, first officer, 4 flight attendants, and 145 passengers were not injured. Three passengers reported minor injuries that occurred during the emergency evacuation. The airplane sustained substantial damage. The 14 *Code of Federal Regulations* Part 121 flight was operating in instrument meteorological conditions, and an instrument flight rules flight plan had been filed. The flight was destined for Miami, Florida.

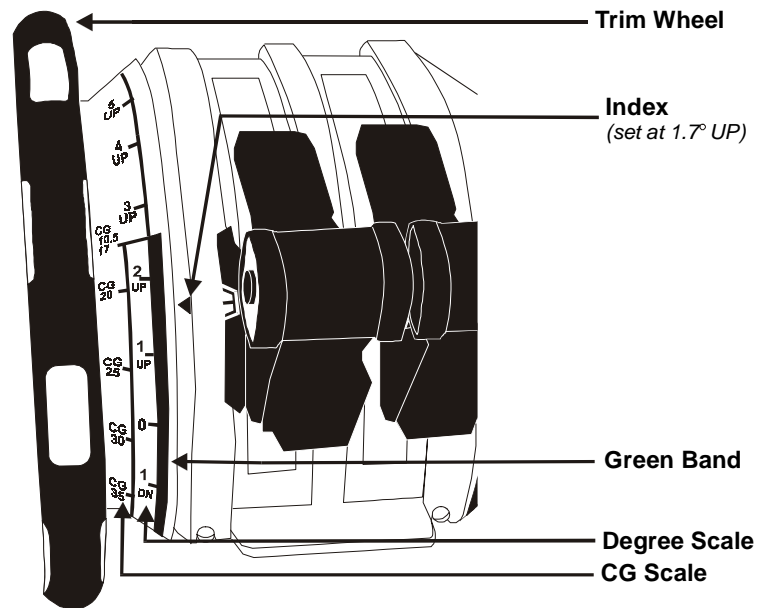
Figure 1. Airbus THS Trim Wheel Indicator Scales.

Airbus Industrie equips its A319, A320, and A321 airplanes with two index scales located adjacent to the THS trim wheel. (See figure 1.) One scale indicates the CG as a percentage of mean aerodynamic chord. In the accident airplane, the CG scale showed the values 10.5, 17, 20, 25, 30, 35, and 41.⁴ The CG scale is not graduated and does not show intermediate values. The other scale indicates the number of degrees of THS deflection above or below zero (neutral), followed by “UP” or “DN” to indicate the corresponding pitch direction of the airplane. These values are 4DN, 3DN, 2DN, 1DN, 0, 1UP, 2UP, 3UP ... 13UP, 13.5UP. Like the CG scale, the degree scale is not graduated and does not show intermediate values. Both the CG scale and the degree scale are fixed in relation to each other and move together when the trim is set.

The Safety Board is concerned that the procedure of using degrees to set and cross-check the THS trim setting has resulted in flight crews improperly setting the trim by using a minus (or UP) value when a plus (or DN) value should have been used. The Safety Board considers pilots of the two carriers who currently follow this procedure to be at risk for incorrectly setting the trim as did the pilots on Northwest flight 985 and the April 2000 Lufthansa flight. This confusion is possible because the degree scale shows some values twice: once to denote pitch up ("UP") and once to denote pitch down ("DN"). The CG scale, however, uses a consecutive series of unique, positive values, which eliminate the opportunity for such confusion.

In addition, the Safety Board is concerned about the inconsistent formats in which trim unit information is presented to Northwest flight crews and the possibility that other operators may also use inconsistent formats. As already noted, the degrees scale located next to the THS trim wheel shows trim values without a "+" or "-" sign, followed by "UP" or "DN" to indicate the corresponding pitch direction of the airplane. The ECAM also displays trim values to Northwest flight crews as "UP" or "DN" but also precedes trim values resulting in a nose-up pitch direction with a "-" sign. Finally, Northwest's ACARS load data sheet, which is the crew's initial source of trim unit information, precedes the trim value with a "-" sign for any setting that results in a nose-up pitch direction but does not display the corresponding "UP" or "DN" designations as appear on the trim wheel scale and ECAM display. The Board recognizes that a

Require operators of Airbus Industrie A319, A320, and A321 airplanes to set and cross-check the trim using center of gravity trim values only. (A-02-06)

Require operators of Airbus Industrie A319, A320, and A321 airplanes to ensure that the electronic centralized aircraft monitoring display and the aircraft communication addressing and reporting system load data sheet are configured so that they display trimmable horizontal stabilizer trim unit information in a manner that is consistent with the display on the degree scale of the trim wheel indicator. (A-02-07)
