National Transportation Safety Board

Safety Recommendation

Date: September 17, 2002

In reply refer to: A-02-26 through -32

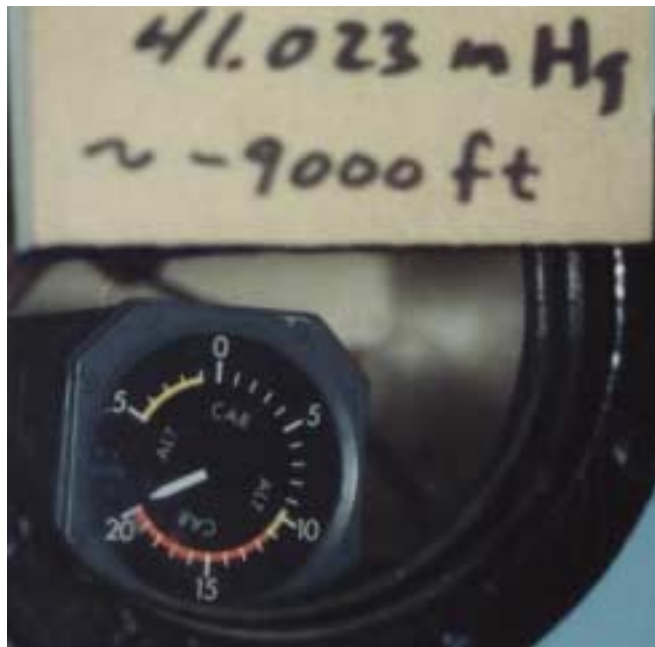
The cabin altimeter is located on the cockpit overhead panel and is marked with values from 20,000 to -5,000 feet. (Figure 1 shows a cabin altimeter from an Airbus A300 airplane.) Unmarked space separates the -5,000-foot mark and the 20,000-foot mark on the gauge. The needle on the gauge moves clockwise into the positive range to indicate higher cabin altitudes as the cabin pressure decreases and moves counterclockwise to indicate lower cabin altitudes as the cabin pressure increases. The investigation determined that when cabin pressure increases such that the cabin altitude is less than -5,000 feet, the cabin altimeter needle moves counterclockwise through the negative altitude range, including past the -5,000 mark, through the unmarked area, and into the highest end of the positive altitude range. There are no mechanical stops on the cabin altimeter that restrict the needle to the marked areas of the gauge and prevent the needle from traveling to the positive altitude range when the cabin altitude is actually beyond -5,000 in the negative range.

Figure 1. Cabin altimeter from an Airbus A300 airplane.

lavatory A smoke detector,¹⁶ its alarm was triggered with no smoke present¹⁷ at a pressure level of 22.28 pounds per square inch absolute (psia),¹⁸ which corresponds to a cabin altitude of -12,100 feet. However, because the cabin altimeter's negative range stops at -5,000 feet, the -12,100-foot cabin altitude would have registered on the cabin altimeter in the high end of the positive range, indicating a cabin altitude of approximately 19,000 feet. This would have presented the flight crew with a misleading indication of a high cabin altitude (indicating low cabin pressure) when, in fact, the cabin was pressurized well above ambient pressure. This high cabin altitude indication would likely have confused the flight crew because it would have appeared that the actions that they had taken to manually pressurize the airplane after recognizing the malfunctioning pressurization system were not being properly reflected in the cabin altimeter reading.¹⁹

The Safety Board is concerned that the cabin altimeter gauges on all A300 airplanes may present flight crews with misleading information about the airplane's cabin altitude and pressure, particularly when the pressurization system is malfunctioning and is being operated in the manual mode. The Board notes that if the cabin altitude were displayed in a digital display as opposed to a mechanical gauge, the display would likely have indicated the accurate cabin altitude of -12,100 feet. The Board further notes that a broader range of values on the cabin altimeter gauge (from -20,000 to 20,000 feet, as opposed to -5,000 to 20,000 feet) would also likely have resulted in an accurate indication of cabin altitude to the flight crew. Therefore, the Safety Board believes that the FAA should require that the cabin altimeter gauges on all Airbus Industrie A300 airplanes be modified to ensure that they will not give flight crews misleading indications about cabin altitude and pressure, particularly when the pressurization system is being operated in the manual mode. This could be accomplished either by the replacement of the gauge with a digital display, by the expansion of the values on the existing gauge design, or by other means.

Require that the cabin altimeter gauges on all Airbus Industrie A300 airplanes be modified to ensure that they will not give flight crews misleading indications about cabin altitude and pressure, particularly when the pressurization system is being operated in the manual mode. This could be accomplished either by the replacement of the gauge with a digital display, by the expansion of the values on the existing gauge design, or by other means. (A-02-26)
