Aerial Damage Survey of the Central Texas Tornadoes of May 27, 1997

Brian E. Peters
Warning Coordination Meteorologist
National Weather Service, Birmingham, Alabama

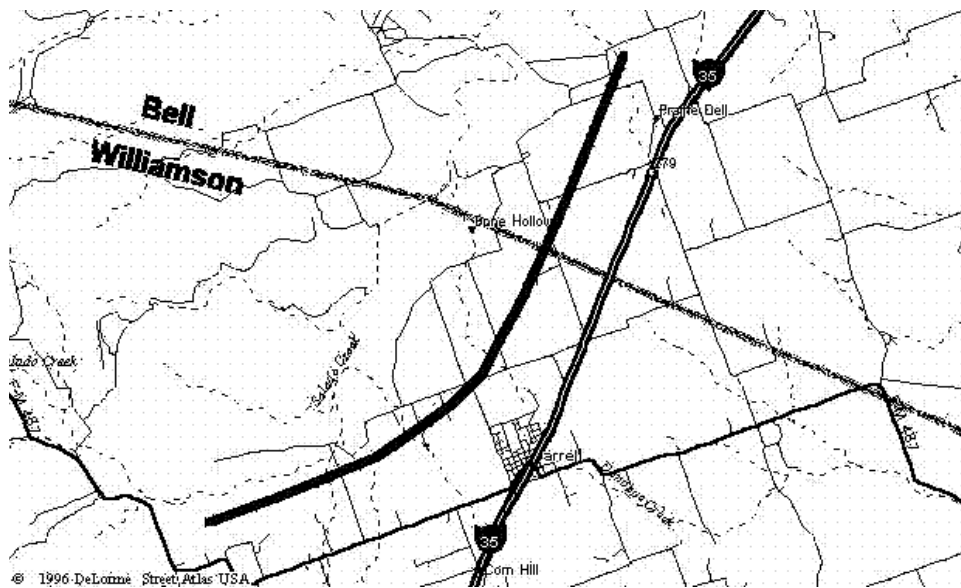
Ground Track of the Jarrell Tornado

Maximum F-scale: F5

Path Length = 7.6 miles Path Width = 3/4 miles

As the tornado crossed the intersection of CR 305 and 307, a business on the corner was destroyed. The tornado moved into the Double Creek Estates subdivision at this point with total destruction. F5 destruction begins shortly after the tornado moved into Williamson County and continued until very close to the end of the damage path.

Moving through the Double Creek Estates subdivision and the surrounding area, the tornado widened to the maximum width of three-quarters of a mile. From the air, the ground appearance changed abruptly in the vicinity of CR 308 and continued until very near the end of the path. No definitive circulation patterns or suction spots were evident, but there was the noted obvious change in the appearance of the ground.

In the Double Creek area, approximately 40 structures were totally destroyed. One of the most striking signs in approaching this area was the distinct lack of debris of any size. Closer inspection showed lots of little debris, but no sign of large items. At least half a dozen cars were identified from the air lying in the open areas, most of them flattened and encrusted with mud and grass. Later, a ground survey revealed that most of the debris that was left in the area was extremely small, indicating the power of the tornadic winds. All 27 deaths associated with the Jarrell tornado occurred in the Double Creek area.

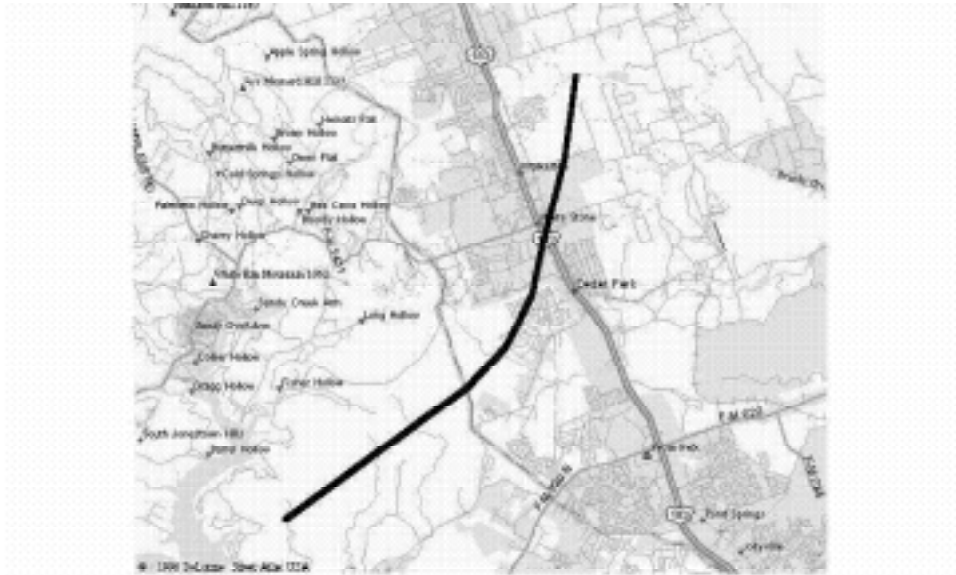
Ground Track of the Cedar Park Tornado

Maximum F-scale: F3

Path Length = 9.2 miles Path Width = 250 yds

The tornado moved south-southwestward, skirting a residential area before it crossed CR 180 immediately east of US 183. It was at this intersection that an Albertsons grocery store was severely damaged. The tornado crossed US 183, causing additional damage to a number of businesses. One business on the west side of US 183 lost nearly the entire roof. Most damage to other businesses was believed to be minor.

A historic train located on the north side of CR 180, just to the east of US 183, was in the direct path of the tornado. While the engine remained on the track, a coal tender converted to hold diesel fuel and weighing approximately 65,000 pounds, including the 1,000 gallons of diesel fuel, was flipped over and thrown a short distance.

From North Park Circle, the tornado moved into the northwestern portion of Buttercup Creek, a subdivision of well constructed homes. Damage to homes was irregular, with one house losing a roof but the house next door losing only shingles. Damage ranged from F0 to F2. At this point, the tornado track was taking a gentle right turn and became more southwesterly. The tornado moved into a wooded area crossing into Travis County before ending 1.1 miles from Lake Travis. Damage in the wooded area was irregular, ranging from near total destruction of all trees to sections with about 10 percent of the trees down.

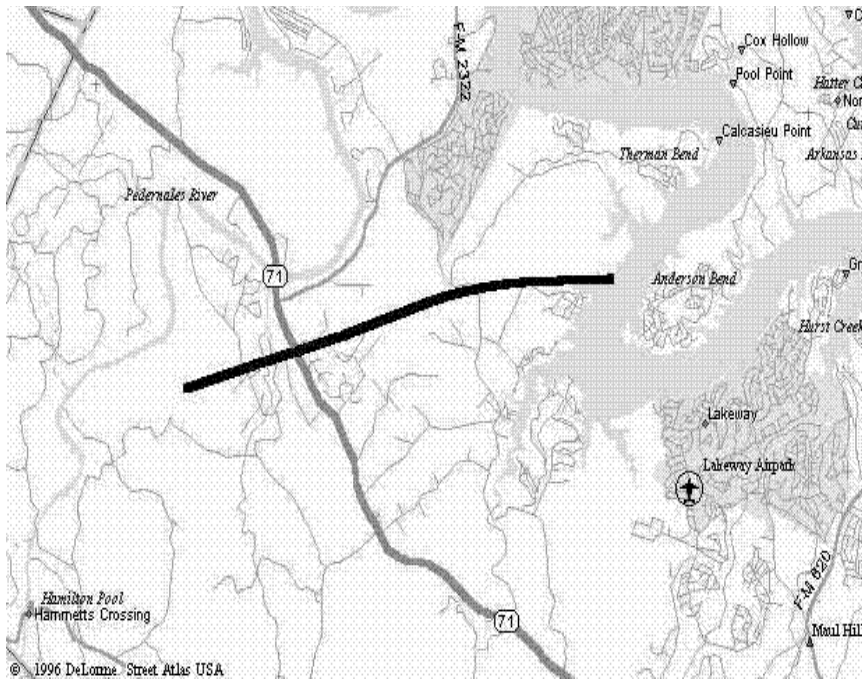
Ground Track of the Pedernales Valley Tornado

Maximum F-scale: F4

Path Length = 5.6 miles Path Width = 440 yds

The tornado was initially on a heading of 265 degrees as it moved into rough terrain. A number of structures sustained varying damage until the tornado reached Bee Creek Road. At that location, a Southwest Bell building housing telephone switching equipment was destroyed. The building was well-constructed and was one of several buildings which indicated at F4 rating for this tornado. Bee Creek Road takes a bend close to the telephone building, and across the street a house was destroyed with walls knocked down.

After the turn, the tornado assumed a heading of 250 degrees and crossed a major power distribution line. One steel tower was destroyed, bringing all lines to the ground. The tornado remained on the 250 degree heading, moving through the area described as the Hazy Hills subdivision. Numerous houses and several mobile homes were totally destroyed. Several houses survived but sustained major damage that made them totally uninhabitable.
