NOAA -14 September 28, 2006(DOY271) Tumble Anomaly

Milton C. Phenneger;
Principal Engineer, ASRC Aerospace Corporation

1. This work is supported by NOAA and performed under the direction of the NOAA Office of Space Operations (OSO) on the Engineering and Mission Operations Support Services Contract (EMOSS), in the NOAA Spacecraft Operations Facility (NSOF) in Suitland MD.

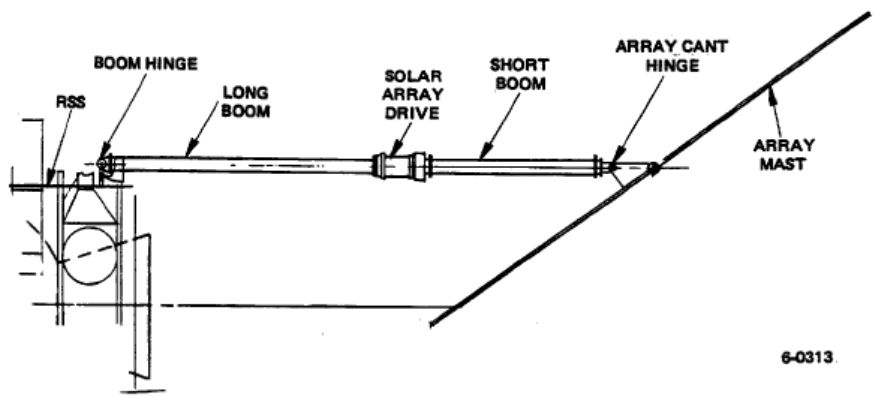
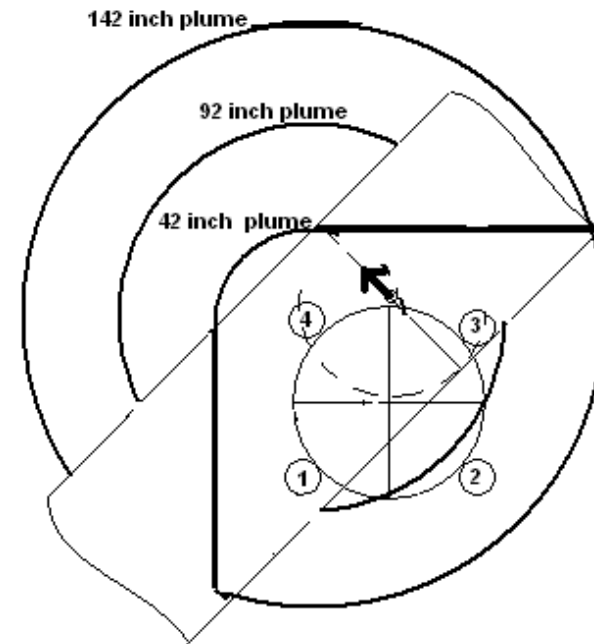
NOAA 14 Spacecraft Solar Array Assembly Side View and Plume Geometry for Thruster 4

- The large angular momentum impulse and solar array spin back of 140 degrees in 45 seconds was caused by the release and ignition of hydrazine propellant from the REA # 2 and deflection of the plume from the canted solar array causing a windmill torque.

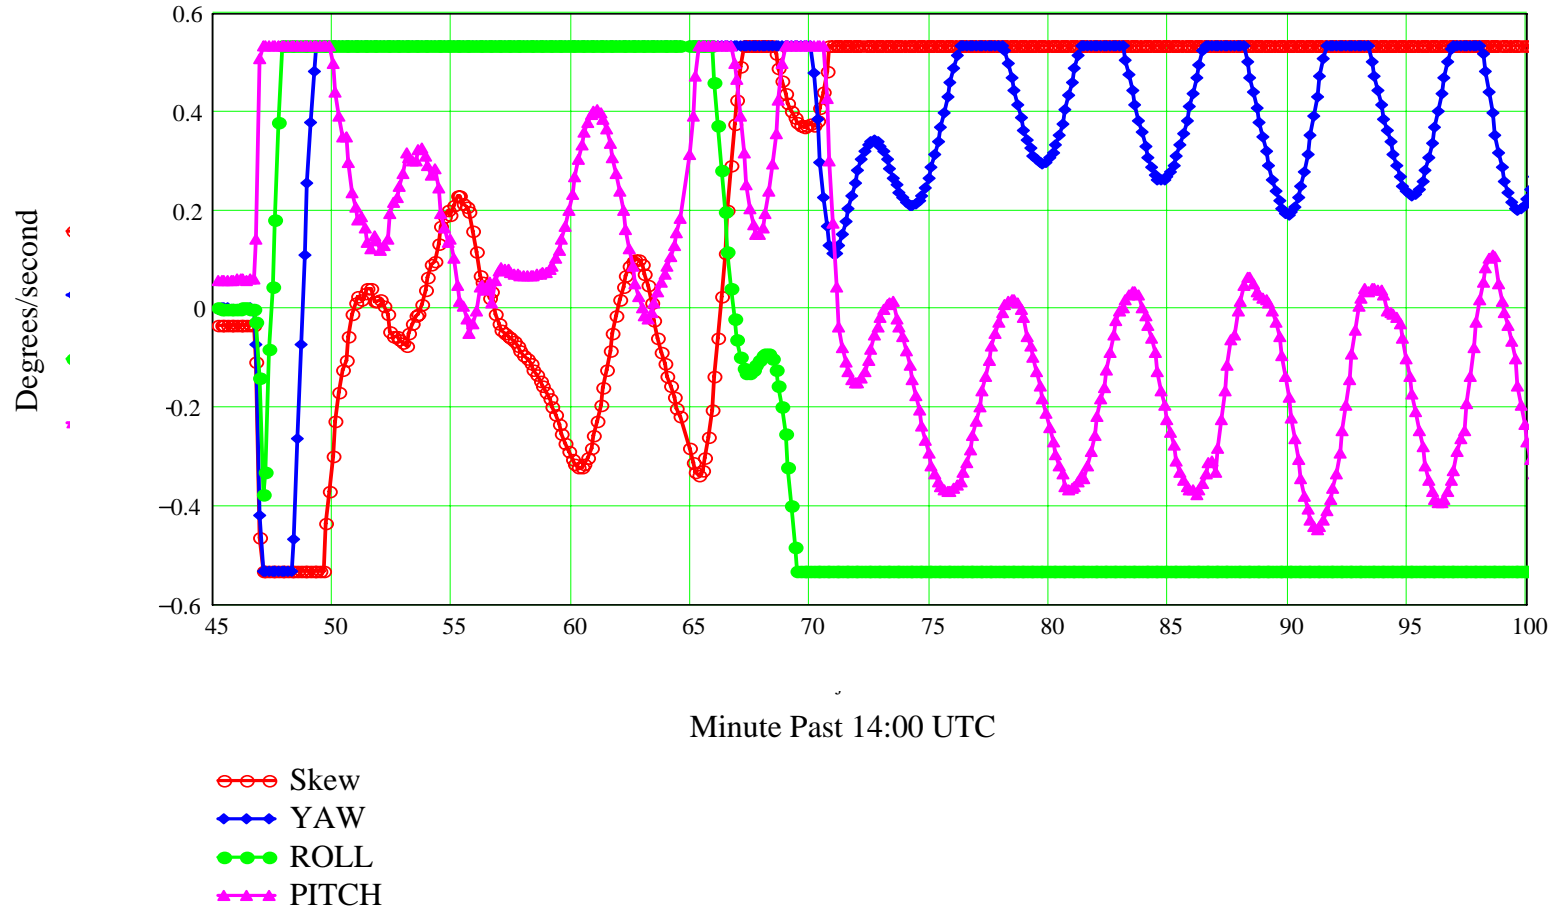
NOAA 14 Body Rates DOY 271

- Attitude Dynamics is dominated by the high angular momentum impulse which saturated the Roll Reaction Wheel Assemblies (RWA) and initiated a body spin rate of about 13 Revolutions per hour.
- Additional motion due to the recovery of angular momentum stored in the deflected solar array and in the switching of the Yaw RWA “off” and the Skew RWA “on” is visible in the rate data but not a dominate feature of it.
- The degenerate Body Moments of Inertia results in a rapid rotation of the body spin vector across the separatrix from the +roll axis to –roll axis correlated with the replacement of the Yaw RWA with the Skew RWA

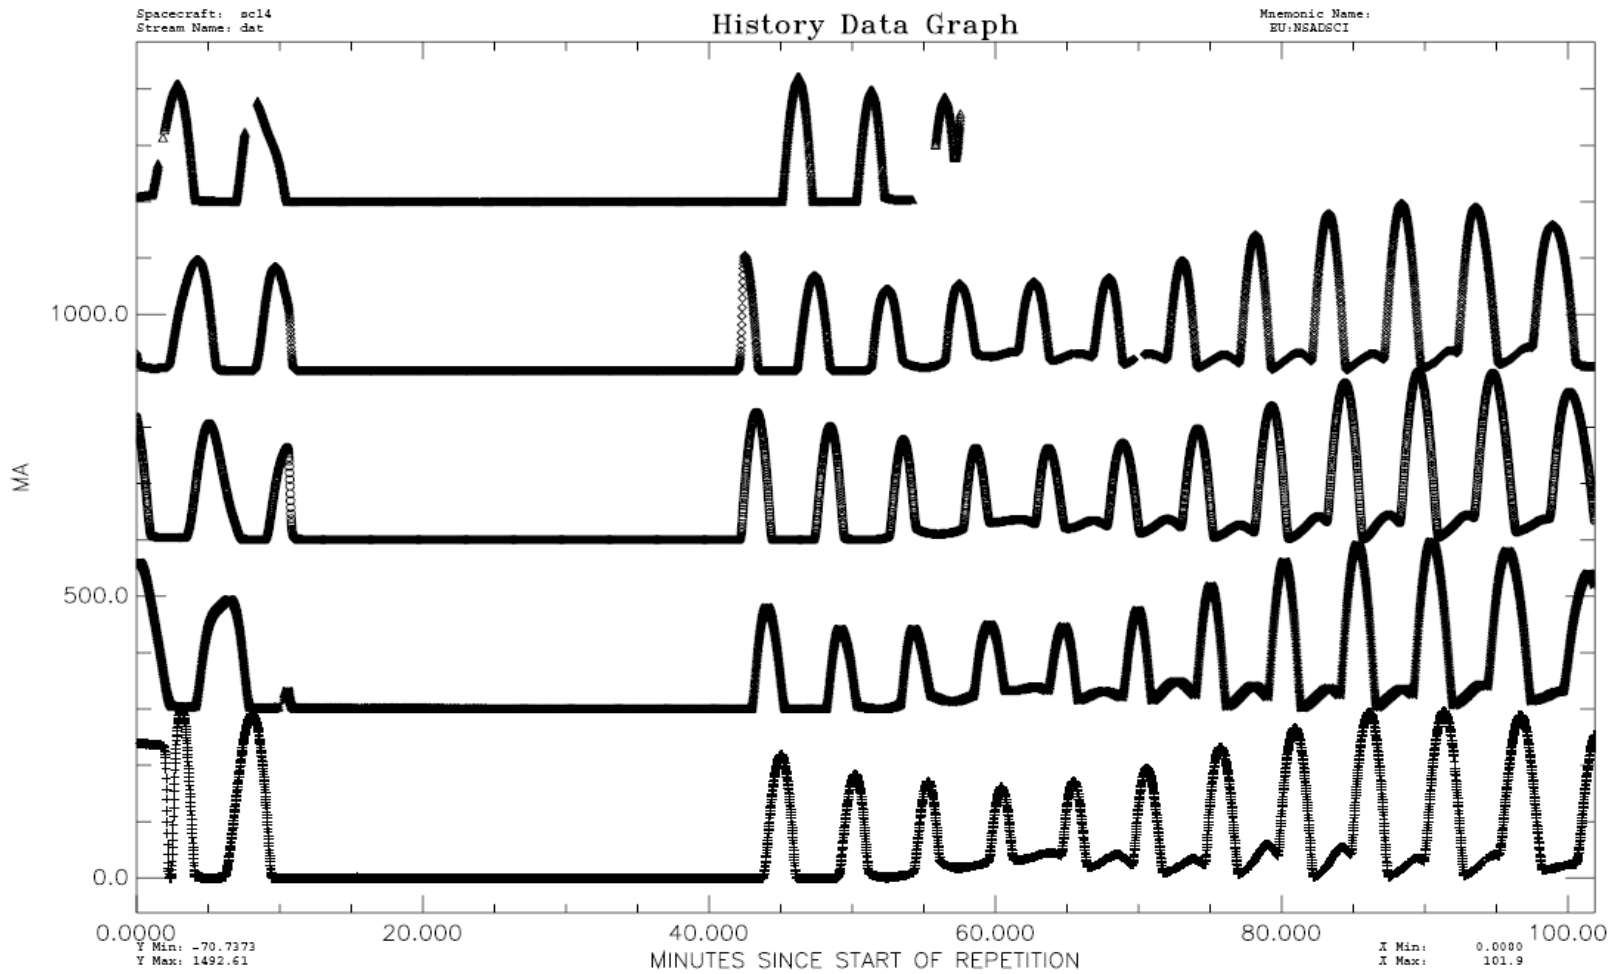
Solar Array Current Determines Spin Rate

- Total angular momentum could not be determined from RWA spin rate and gyro rate data because the roll gyro rate was saturated.
- The body roll rate was computed approximately using solar array current sensor data.
- A crude reconstruction of all saturated gyro rate data was performed to reconstruct the body rate vector.
- Using the reconstructed body rate, the total angular momentum vector is traced in the body frame.
- The inverse of this is the motion of the body in the inertial frame

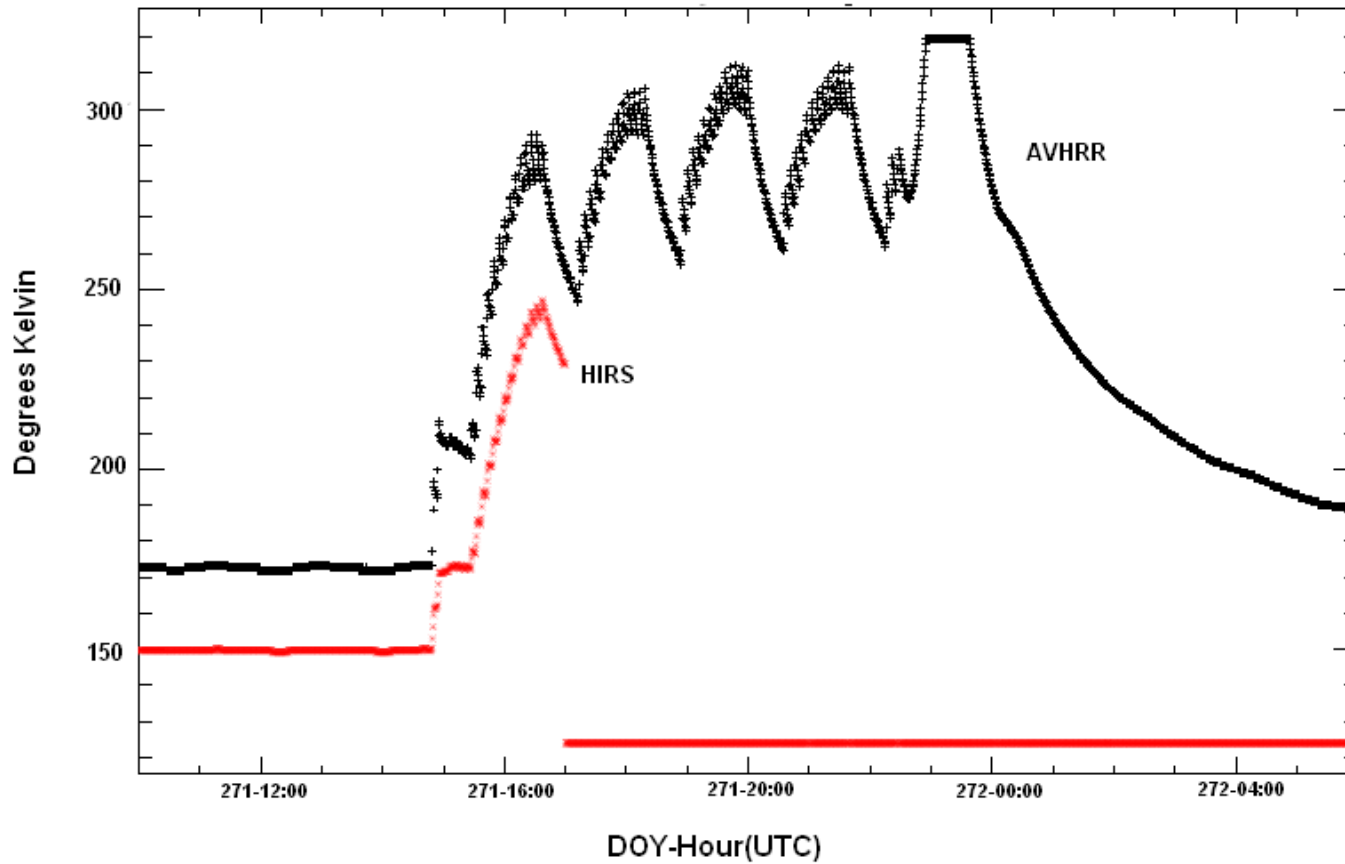
NOAA -14 AVHRR and HIRS Radiator Temperatures

- The NOAA 14 has remote sensing payloads susceptible to damage from extended periods of exposure to the Sun:
 - The High Resolution Infrared Sounder (HIRS) with radiative cooling of IR sensor
 - The Advanced Visual High Resolution Radiometer (AVHRR) with similar radiative cooling for fewer IR channel detectors.
- Data shows:
 - The HIRS was immediately “safed” to assure no IR detector damage from sunlight in the cooler radiator causing the early loss off telemetry.
 - The AVHRR remained “ON” to illustrate that extreme temperature were not reached until the de-spin recovery achieved Earth lock.
- Computed Battery Depth of discharge indicated the batteries reached negative DOD (a calibration error that probably means the actual capacity was over estimated) *No data for this is available*

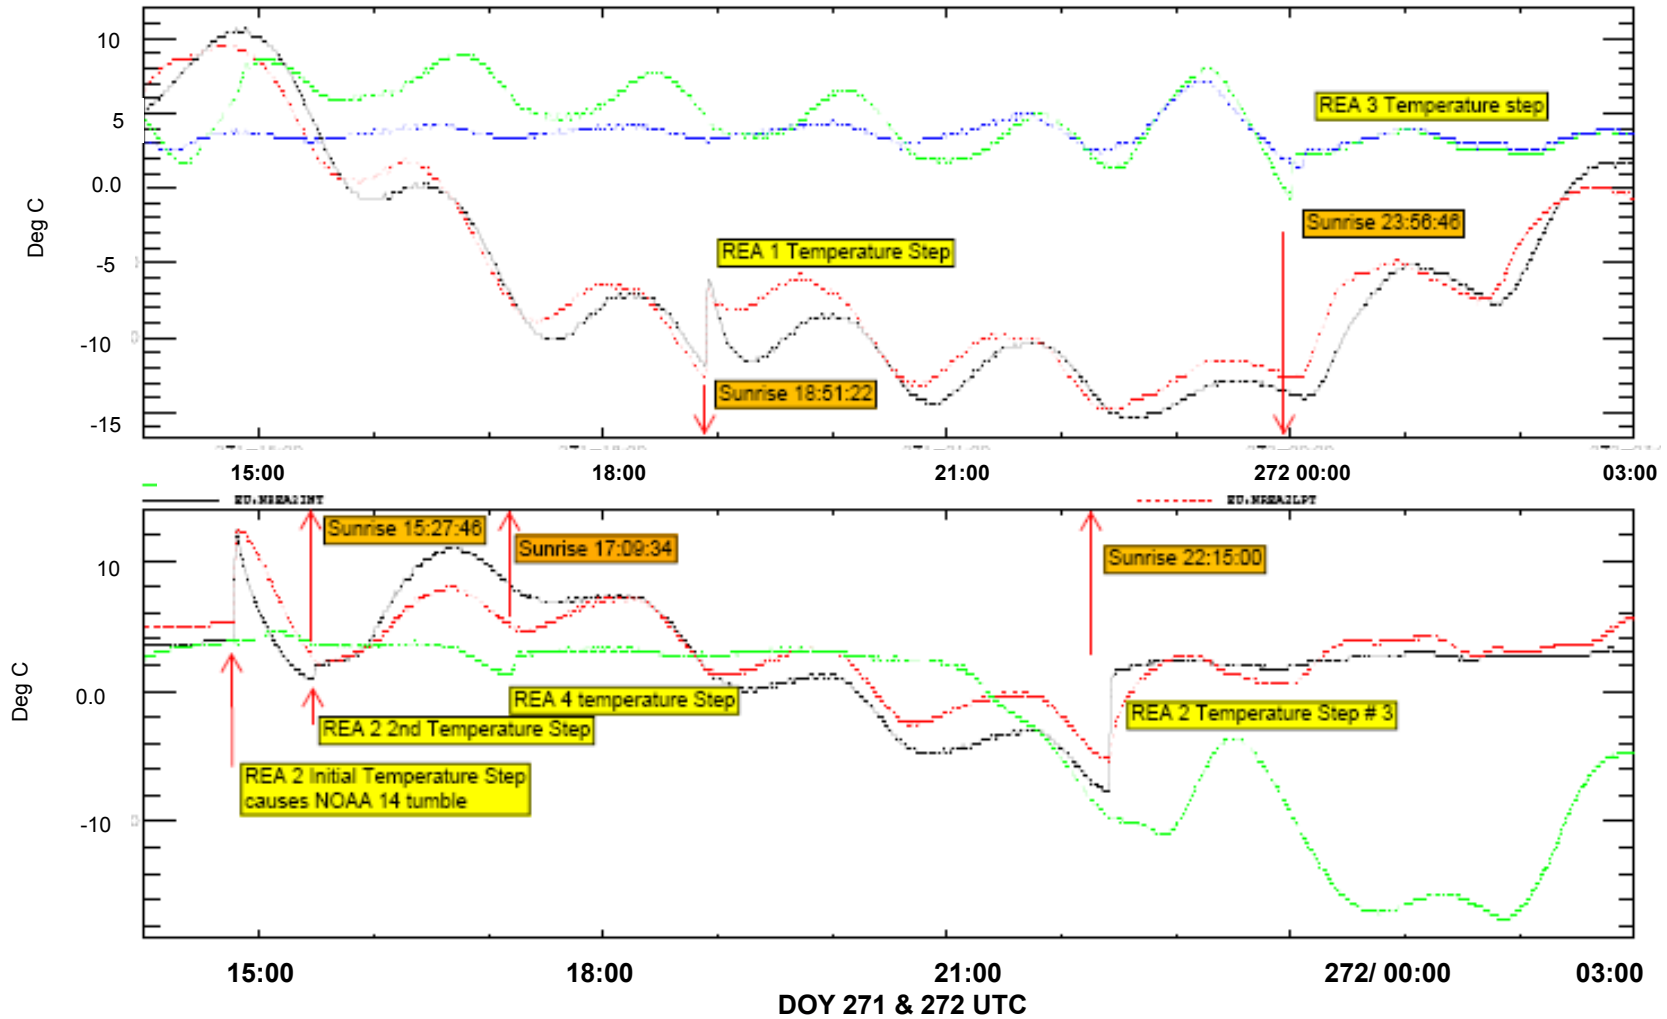
The Propellant System Response to the Hydrazine Leak Ignition **Honeywell**

- This root cause points to another much earlier source of the problem. That is hydrazine venting and isolation procedures just after orbit insertion at the beginning of the mission were insufficient.

- Propellant venting was incomplete or did not occur.
 - Subsequent thermal management of isolated hydrazine remnant was not planned
 - Thermal modulation of this propellant by Day/Night transitions and solar array occultation may have contributed to the failure of the thruster valve seals.
