**Investigation of Shell Offshore Inc,
Hobbit Pipeline Leak,
Ship Shoal Block 281,
November 16, 1994,
Gulf of Mexico,
Off the Louisiana Coast**

Alex Alvarado
William C. Bertges
George M. Conner
Frank Pausina
Pasquale Roscigno

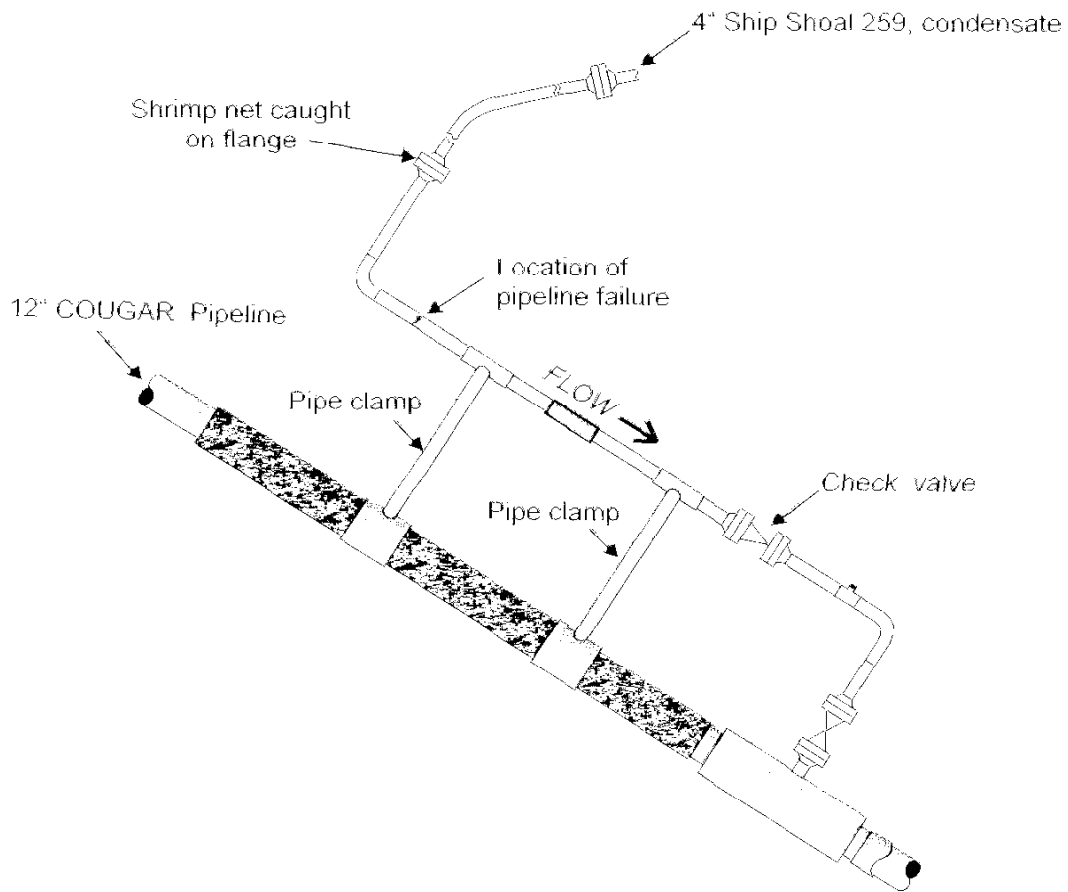
Note: Hatched area shows location of sandbags placed in Jan. 1990 at the time of installation. These sandbags were verified by divers to be in place.

The leak occurred on the 4-inch Hobbit pipeline where it connects subsea with the 12-inch Cougar pipeline in SS Block 281. (The ROW for the Hobbit pipeline had been granted to SOI on June 3, 1988, under 30 CFR 250 regulations; the pipeline was constructed shortly thereafter.) The flange referenced in the divers' report section was not provided with cover after this accident of January 1990 (see Attachment 3).

The trawl net getting caught was the result of an exposed spool piece flange that was left uncovered after repairs of the previous incident were completed in January 1990. As for the spill from the pipeline not being detected immediately, this was primarily the result of (low) pressure sensor pilots not being reliable for this type of operation and, secondarily, because of the meter problem confusion at SS Block 208 Platform F.

The MMS should issue regulatory clarification, in the form of an NTL, or a Safety Alert, of the requirements of 30 CFR 250.153(a)(2), which specify that valves, taps, tie-ins, and repaired sections of pipe that could be an obstruction should be provided with cover.

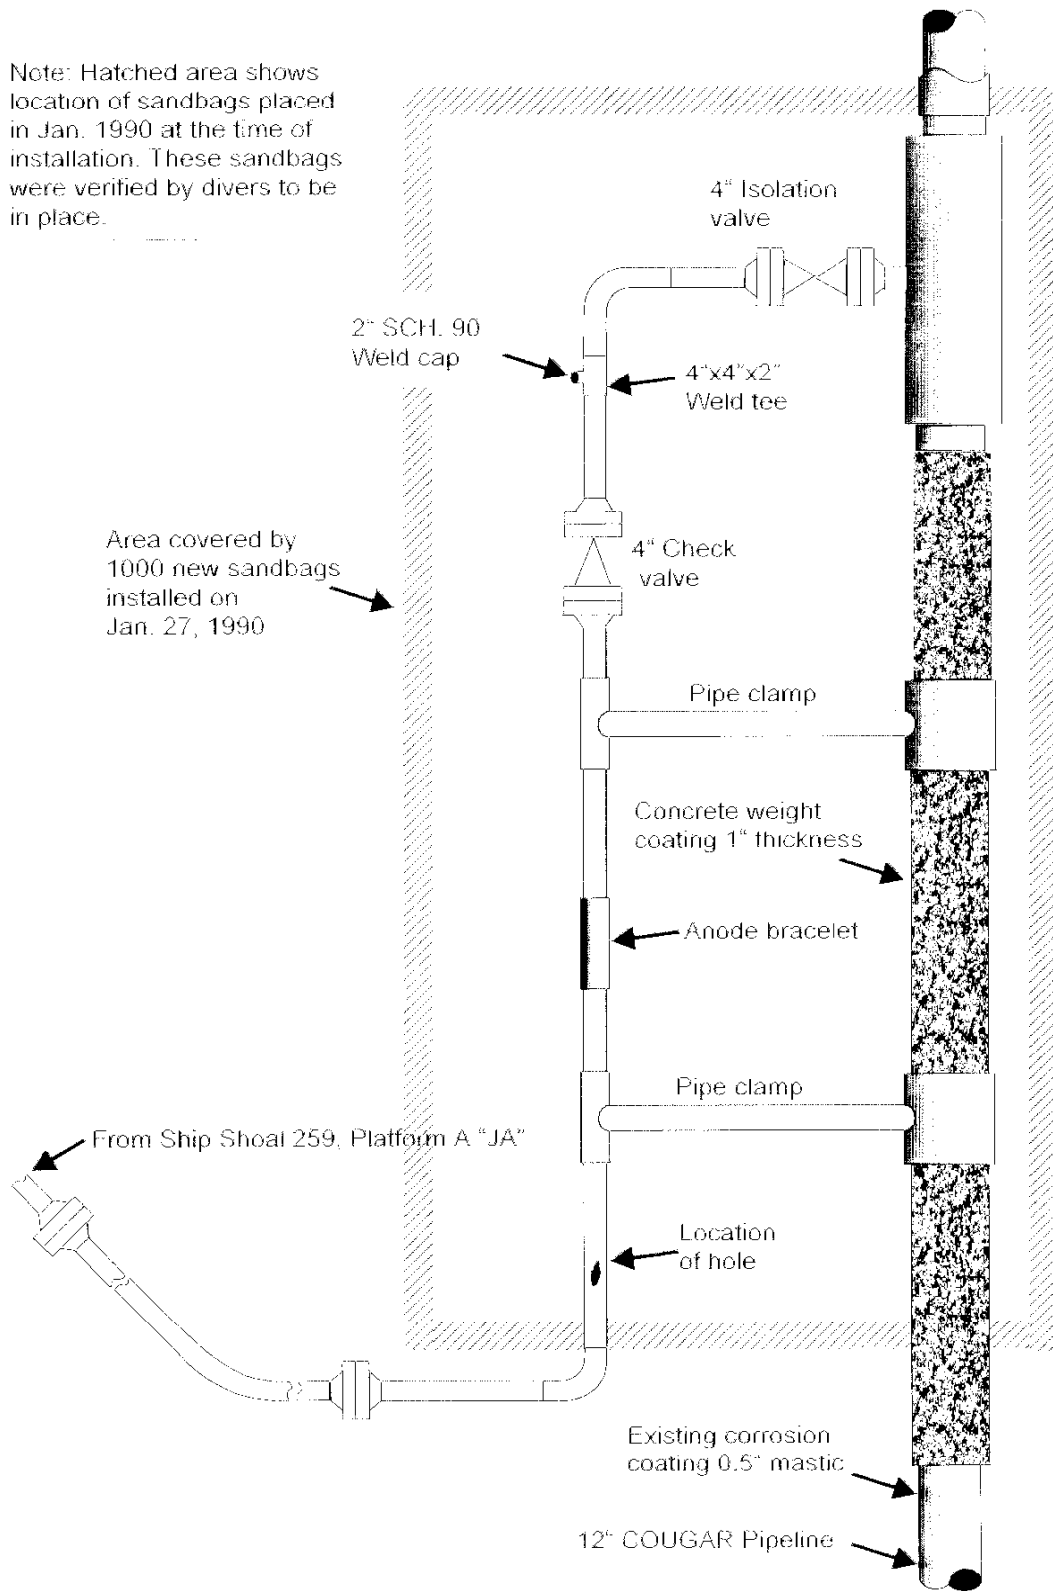
1. The 90° elbow in view A was flattened.
2. The spool piece preceding (in terms of the flow) the 90° elbow was straightened and located 7 feet off bottom.
3. The bolts on the connecting flanges of this spool piece were bent and pieces of a trawl net were found on some of the bolts.
4. A section of 4½-inch pipe was split (see Attachment 4).
5. The diver shut in the block valve, and production was allowed to proceed *on the Cougar 12-inch pipeline.*

By letter dated January 18, 1995, Shell Development Company submitted to SOI a failure analysis of the damaged pipe. The failure appears to have initiated from a 2- to 3 in.-long crack that formed within a dent in the pipe, and propagated circumferentially in a shear mode. The failure was described as a common ductile shear fracture, with no indication of fatigue or other time-dependent crack growth. The fracture initiated as a result of a high transverse impact load that dented and ovalized the pipe. The crack initiated during subsequent straightening and reverse bending of the pipe.

The most probable scenario for the cause of the damage to the pipe is that a shrimp boat was trawling north in the vicinity of this SSTI and snagged the bolts on the previously referenced unprotected flange. While attempting to free the net from the hangup, the vessel bent the pipeline several times and partially severed the 4½-inch pipe. Any product that was pumped into this pipeline probably never entered the 12-inch pipeline and was subsequently lost.
