**Investigation of Top Drive Accident and Fatality
East Cameron Block 332,
Gulf of Mexico,
Off the Louisiana Coast
June 4, 1996**

Frank Pausina
Michael Hebert
Johnny Serrette

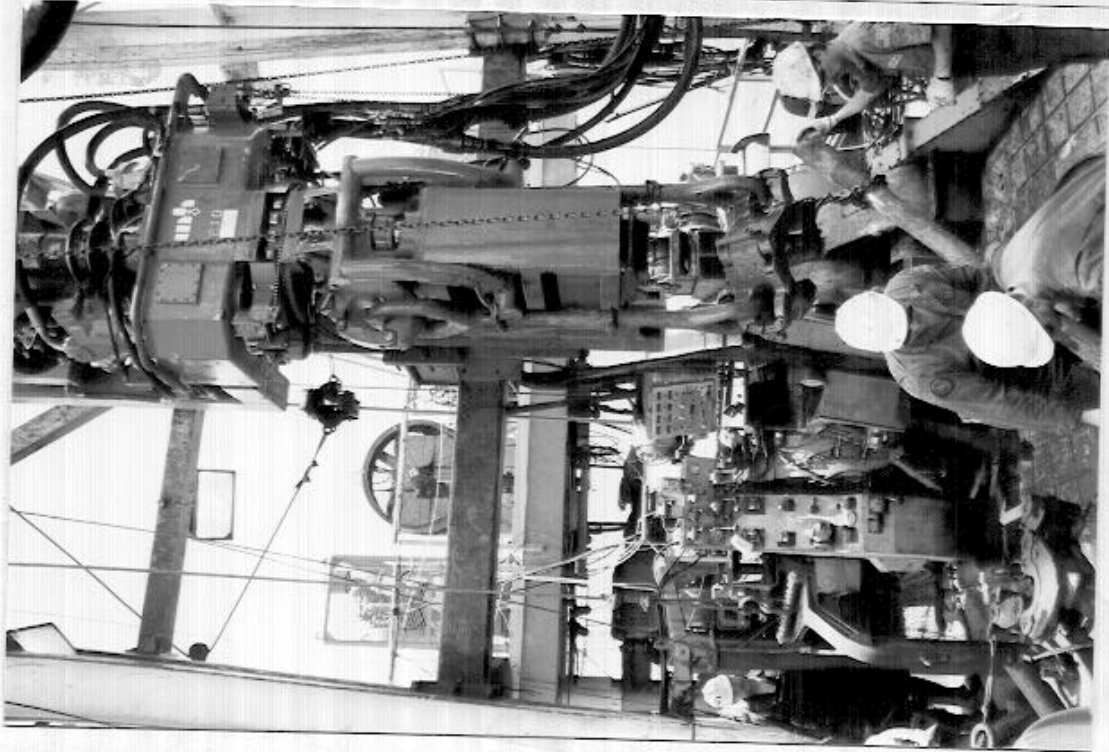
Top Drive at Accident Scene

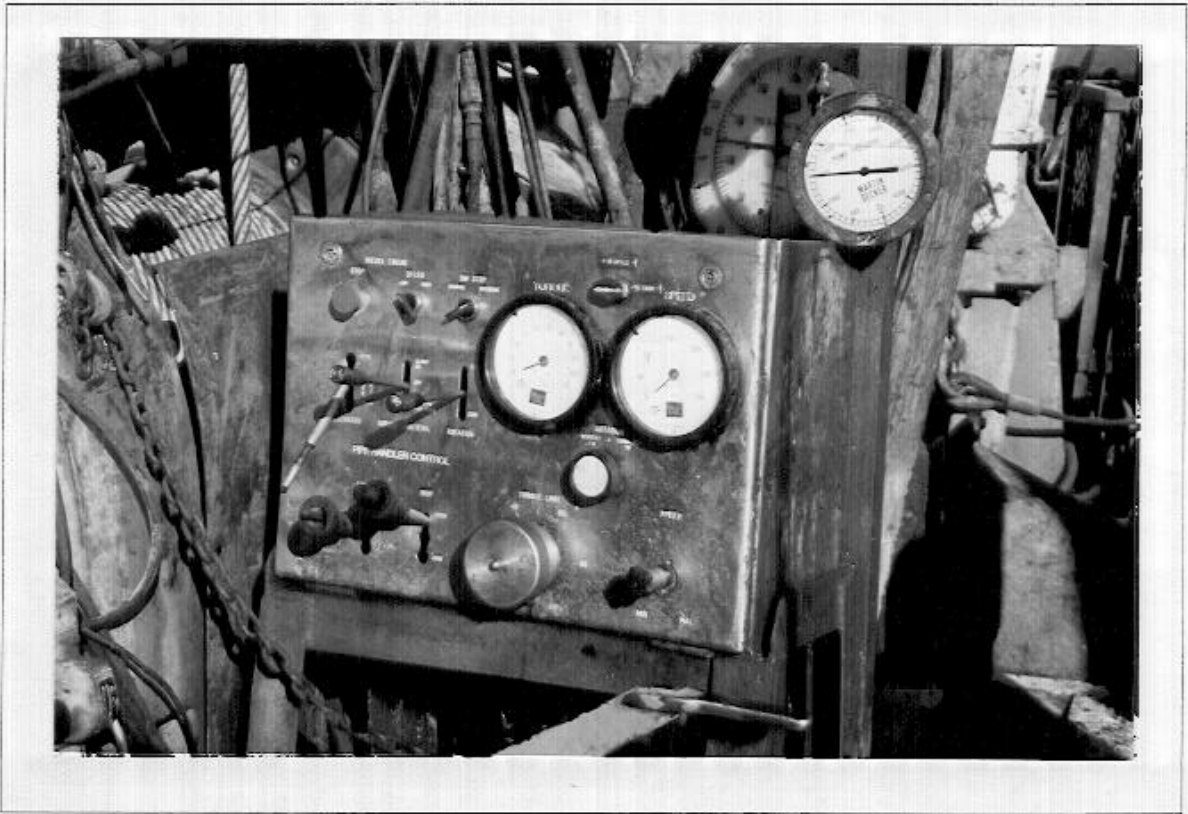
The Pride employee, referred to in this report as Operator 2, in attempting to stop the counterclockwise rotation of the tilted links and elevator, accidentally turned the rotation knob past neutral to the clockwise position, thereby causing the links and elevator to suddenly reverse direction and fatally pin Operator 2 as well as the control panel against the draw works.

3. The driller's control panel was located within the sweep area of the tilted elevator links when the top drive was positioned near the rig floor.
4. There was no protective shield to prevent the tilted links and attached elevator *from coming into contact with the driller's control panel.*
5. The links and elevator are capable of rotating when the torque arrestor is activated, the top drive motors are engaged, and the hydraulic pin is not engaged in the toothed lower flange of the pipehandler assembly.

Driller's Control Panel After Accident

1. Operations personnel be made aware of the ability of the elevator links to rotate when the hydraulic pin is not engaged, the torque arrestor is activated, and torque is applied;
2. A safe procedure for stopping the rotation of tilted elevator links, should such a rotation be undesirable and/or unintentional, be incorporated into a prescribed operational procedures statement and be made incumbent upon operations personnel;
3. Every practical precaution be taken to shield the drilling control panel from tilted rotating elevator links; and
4. Consideration be given to the redesigning of the driller's control panel to accommodate an indicator that would conspicuously signal the disengagement of the hydraulic pin.

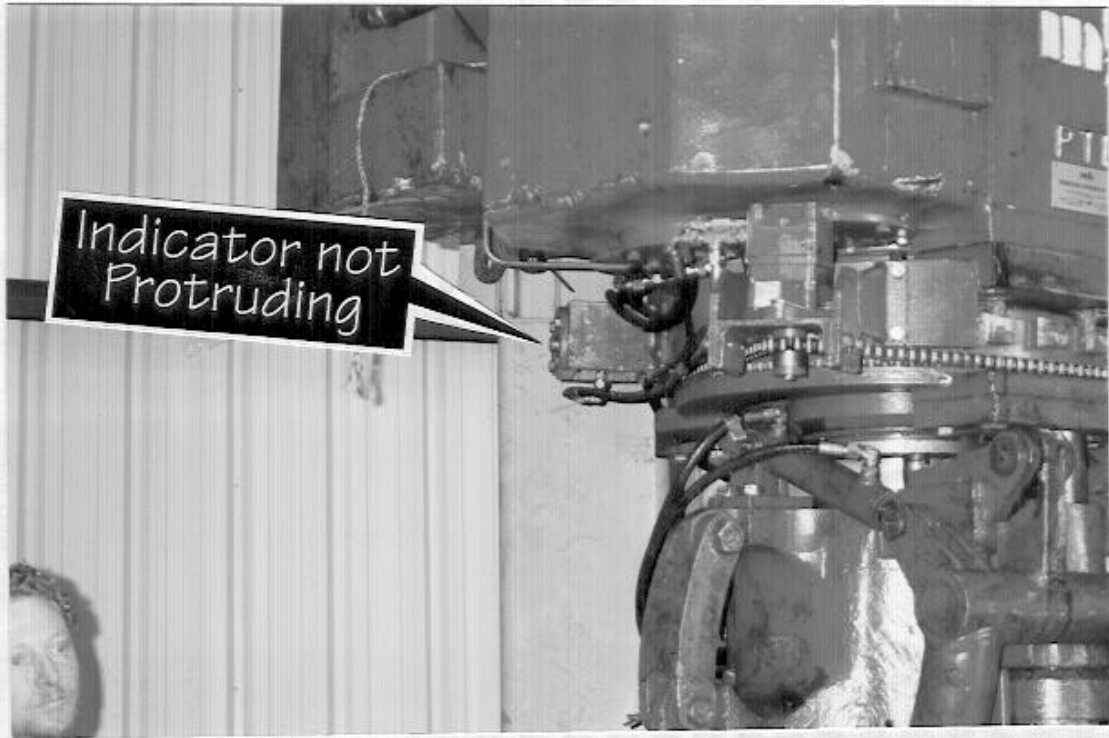
Photo 1

When the hydraulic pin is not engaged, an indicator protrudes from the housing of the pin’s controlling mechanism. (For pictures of the hydraulic pin housing with and without the protruding indicator, see Attachment 9.) The appearance of the indicator is the sole means by which a determination can be made as to whether or not the pin is engaged. If the torque arrestor is activated and visual confirmation of the hydraulic pin indicator cannot be confirmed, uncertainty exists as to whether or not the elevator links will rotate when the top drive motors are engaged for makeup or breakout purposes.

PIN ENGAGED — INDICATOR NOT PROTRUDING

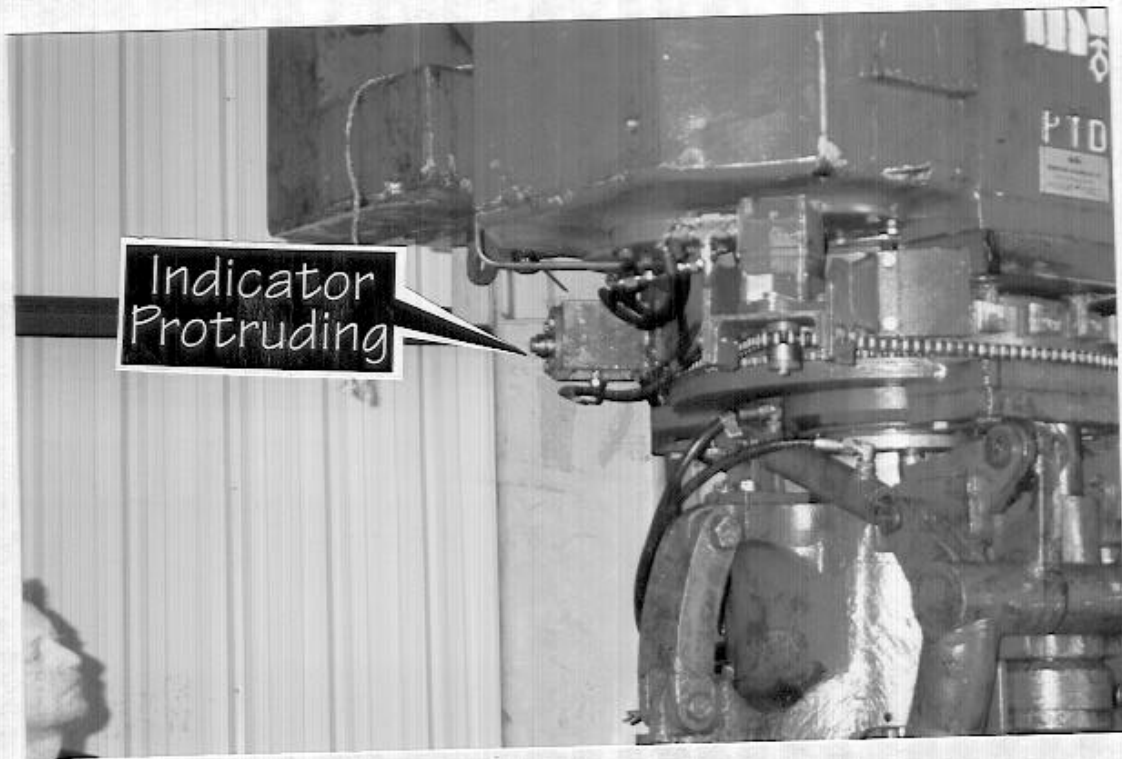
Photo 2

2. At some point during the reaming operation, the links were rotated toward the V-door and then tilted to allow the top drive to go farther down. The rotation lever, which is used to rotate the links, initially disengaged the pin and then rotated the links. After the rotation of the links, the pin did not successively reengage. Since the torque arrestors were not activated from the time of the previous makeup until the application of torque in the final breakout sequence attempt, there would have been no rotation of the links. Therefore, in addition to the indicator protruding from the pin housing, there was no other indication prior to the final breakout attempt that the pin was not engaged.

PIN DISENGAGED — INDICATOR PROTRUDING

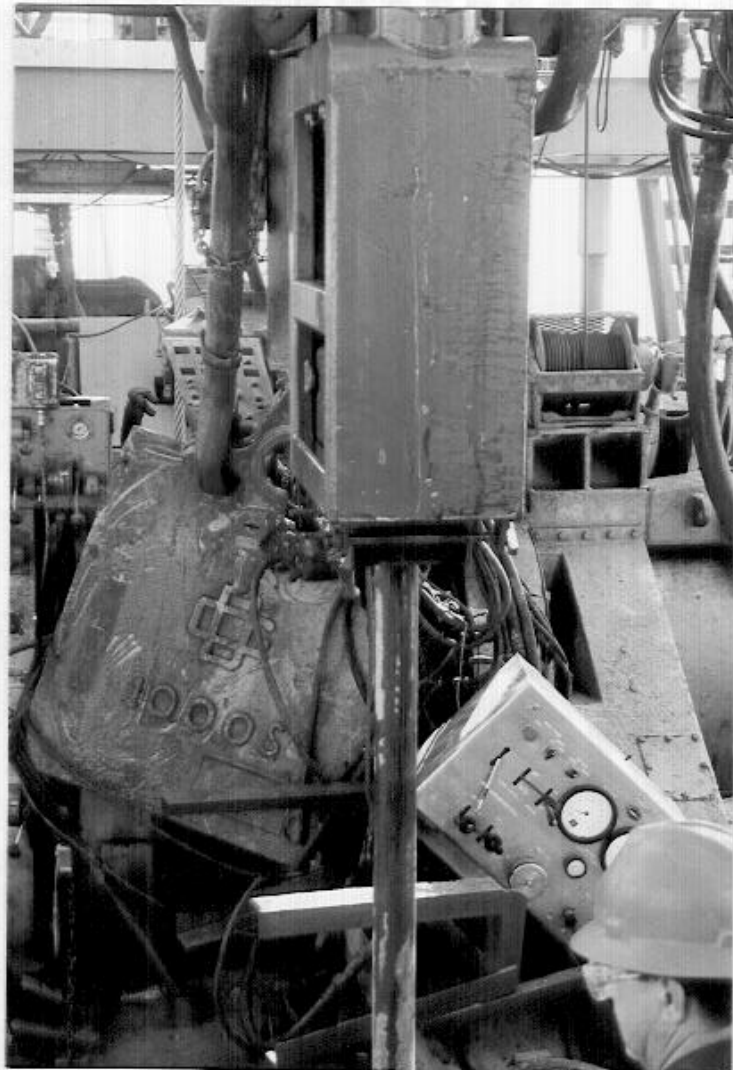
The company representative, who was on the rig floor at the time of the accident, said that immediately prior to the accident he heard a “very fast” clicking noise coming from the top drive during the time that the elevator links were rotating. He stated that he believed the noise was the result of the disengaged hydraulic pin striking the rotating teeth of the lower flange. He further stated that the noise was very loud and that he believed everyone on the rig floor heard the noise. Operator 1 said that he heard no unusual noise at the time of the accident. (For a picture of the accident scene, see Attachment 11; for a simplified schematic depicting the sequential rotation of the elevator links, see Attachment 12.)

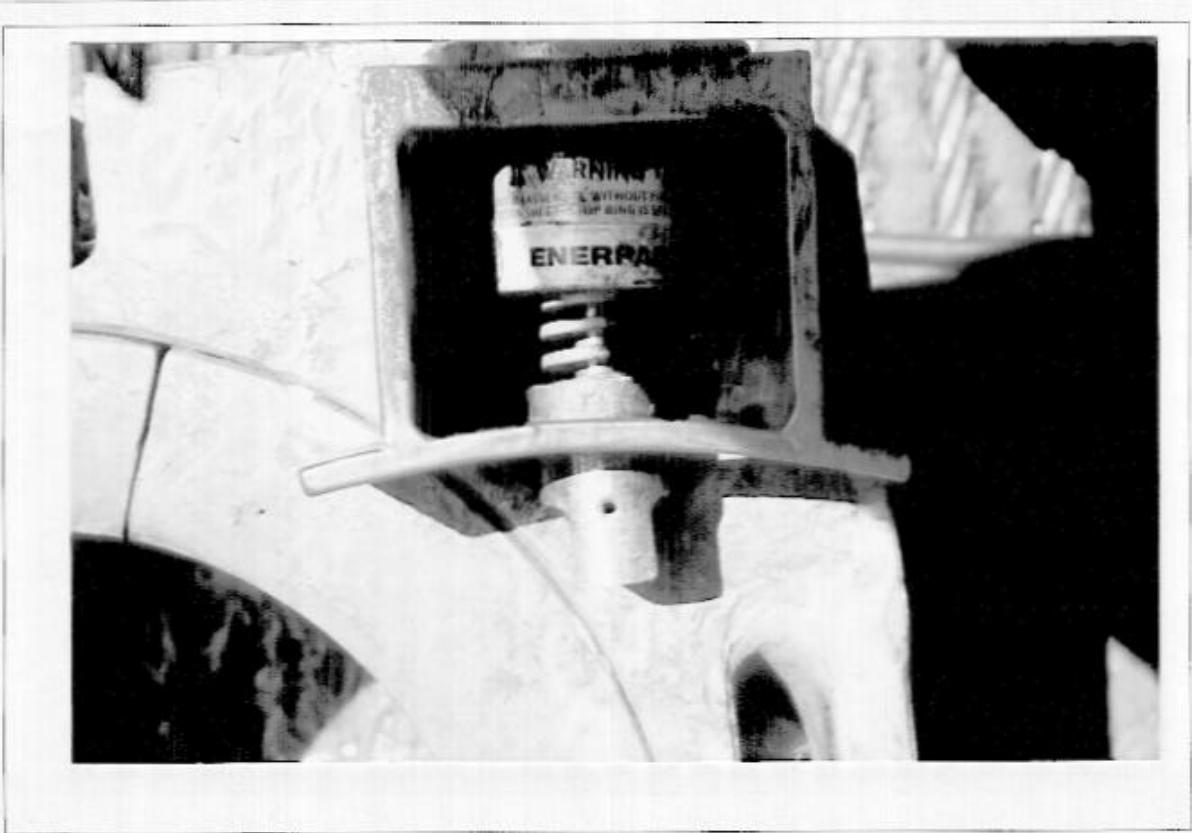
Top Drive Function Test, Disassembling, and Observations The test and the disassembling of the top drive did not reveal any significant operational problems. However, during an examination of the top drive it was discovered that the hydraulic pin was slightly bent and the edges of the lower flange teeth were worn. (For pictures of the bent hydraulic pin and worn teeth, see Attachment 13.)

Slightly Bent Hydraulic Pin

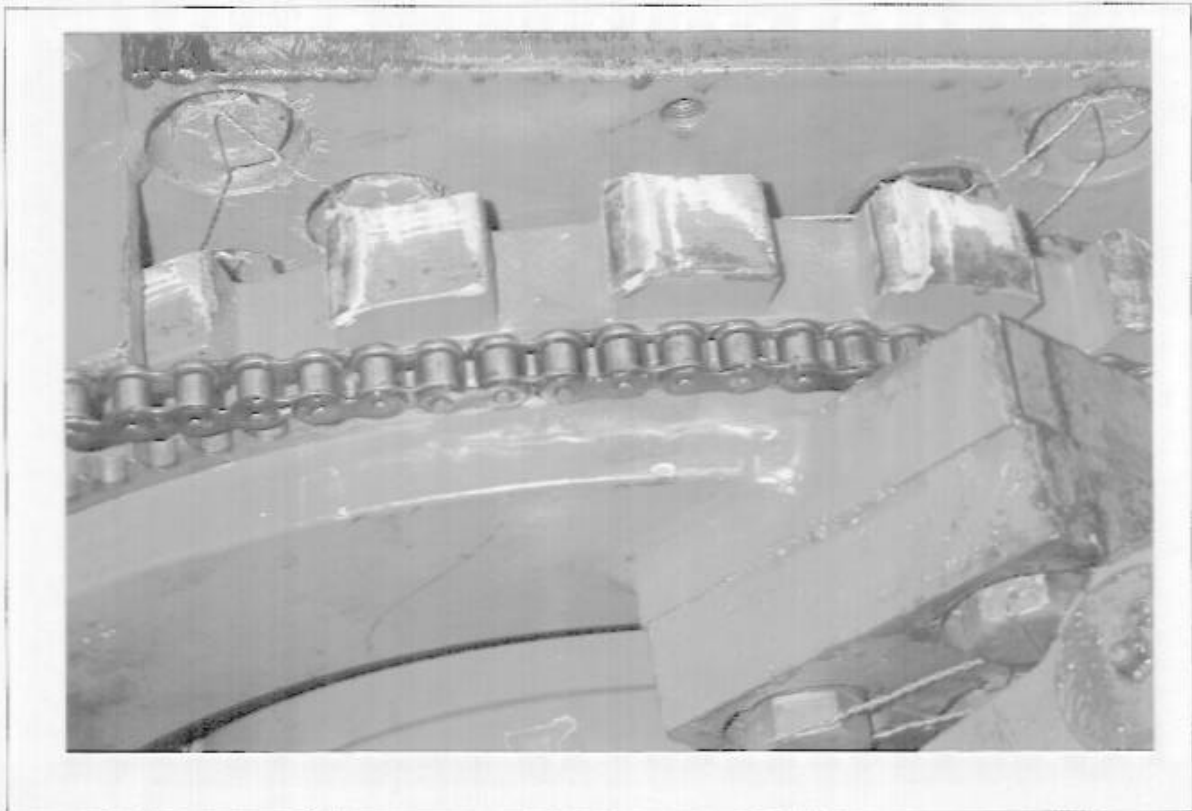
Worn Teeth on Lower Flange
