**Investigation of Blowout and Fire
East Cameron Block 328
Gulf of Mexico
Off the Louisiana Coast
April 1, 1997**

U.S. Department of the Interior
Minerals Management Service
Gulf of Mexico OCS Regional Office

**New Orleans
March 1999**

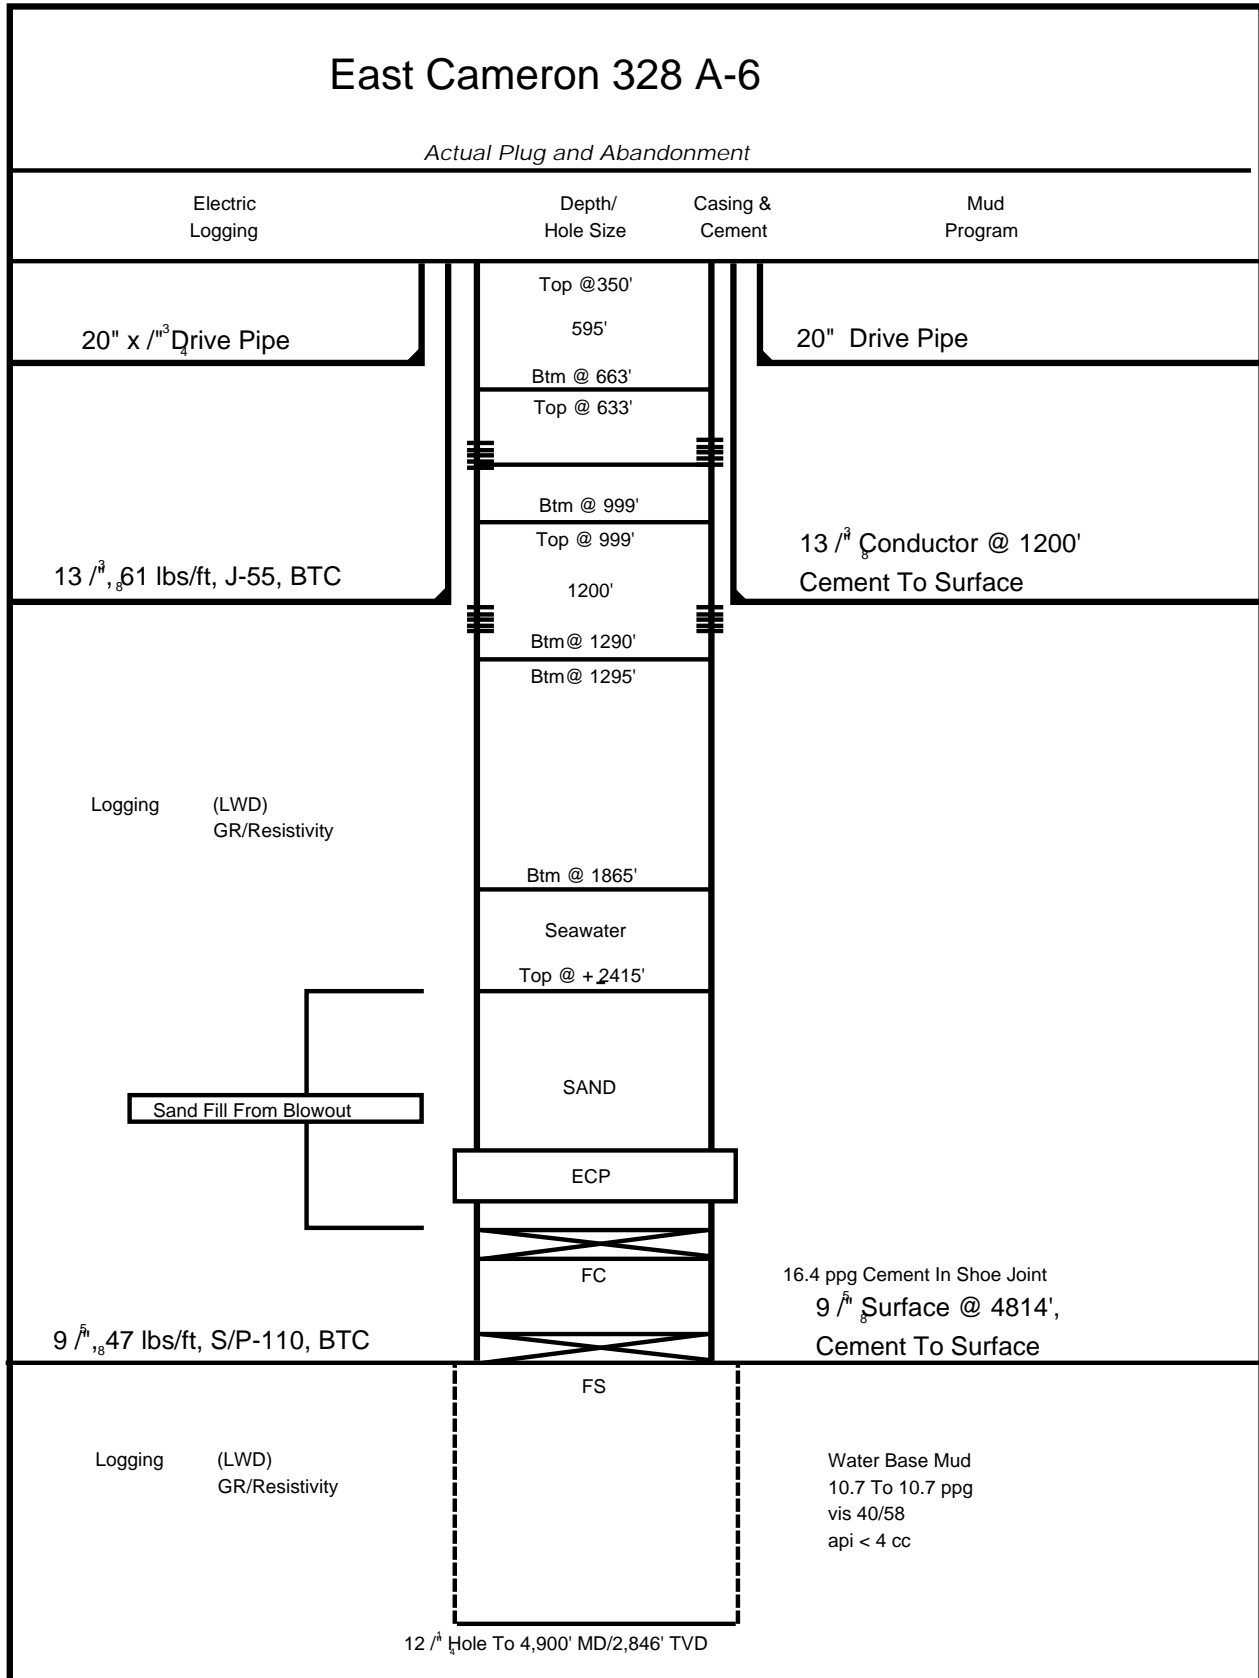
Well Bore Schematic

Formation gas migrated through the cement between the 9 $\frac{3}{8}$ -inch casing and the 13 $\frac{3}{8}$ -inch casing.

1. Temporarily losing returns, as well as noting that the first rubber cement bumped 40 barrels late, may have indicated problems with the cement job.
2. Because of the well being drilled horizontally, the casing may not have been properly centralized, resulting in a nonuniform cement job.
3. The effect, if any, of the ECP not behaving as expected, and presumably rupturing, is unclear.
