**Investigation of
Chevron Pipe Line Company
Pipeline Leak
South Pass Block 38
September 29, 1998**

**Gulf of Mexico
Off the Louisiana Coast**

**U.S. Department of the Interior
Minerals Management Service
Gulf of Mexico OCS Regional Office**

David M. Moore - MMS
Frank Torres - MMS
Mike Joseph - MMS
Buddy Sheets - USDOT
LCDR George Butler - USCG

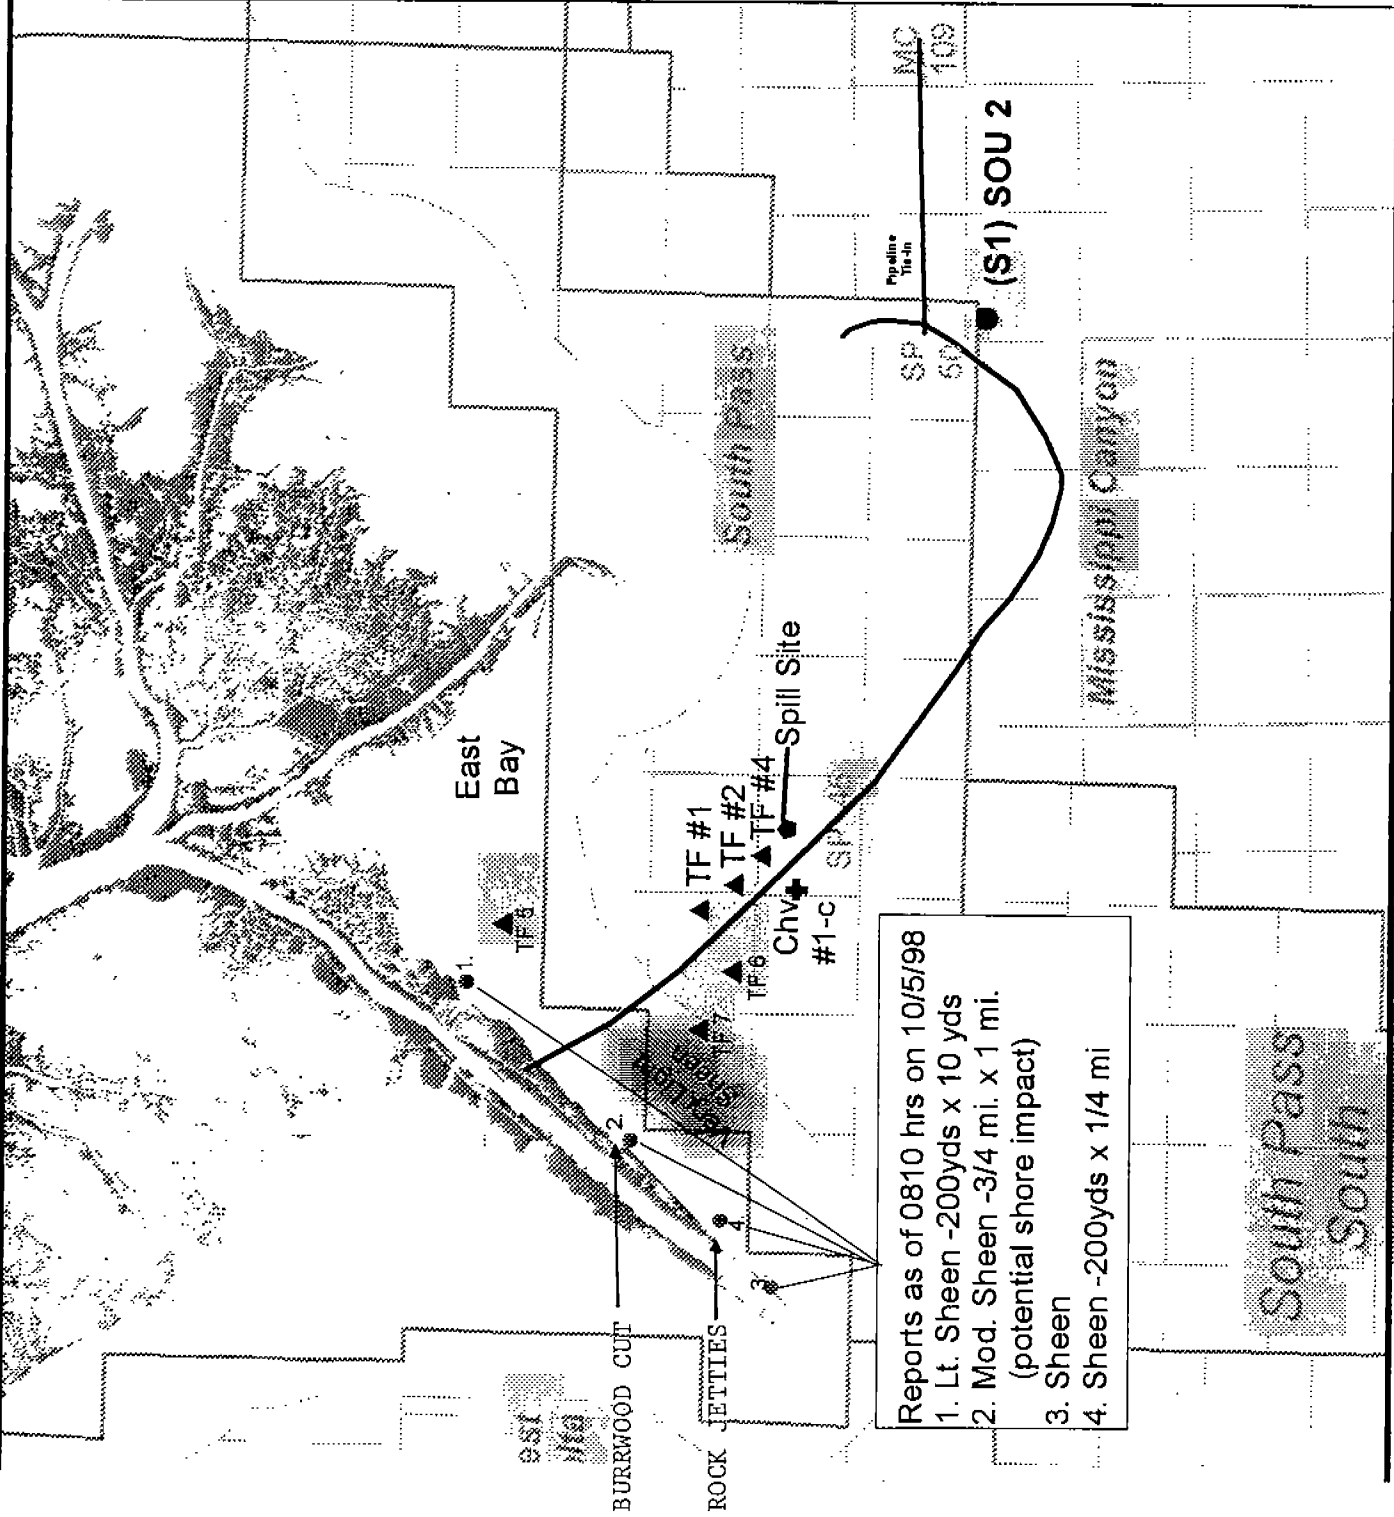
Reports as of 0810 hrs on 10/5/98

1. Lt. Sheen -200yds x 10 yds
2. Mod. Sheen -3/4 mi. x 1 mi. (potential shore impact)
3. Sheen
4. Sheen -200yds x 1/4 mi

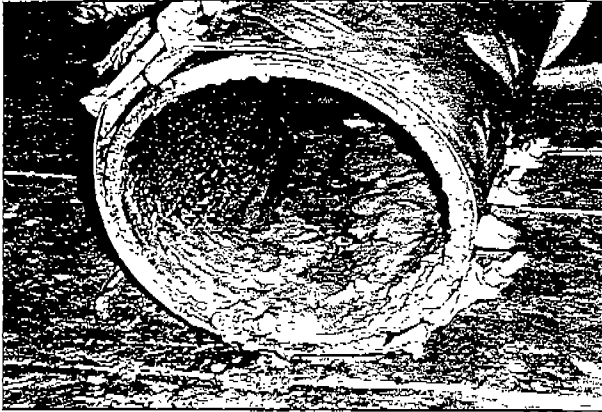
OIL SEPARATING IN SOUTH END

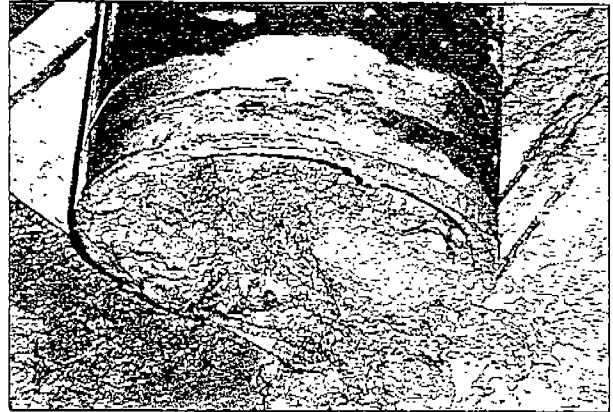
NORTH END (NO OIL)

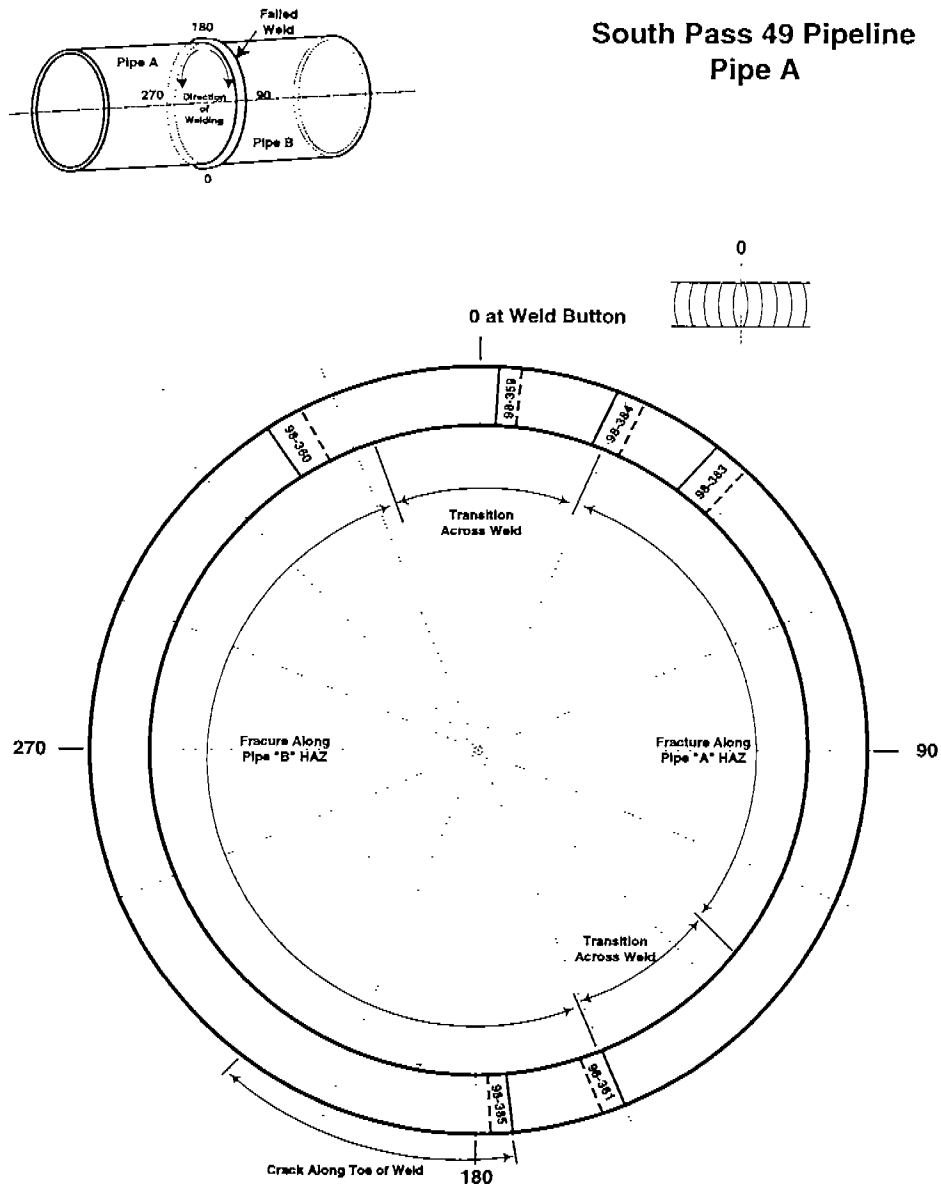
Figure 1 Schematic of pipe "A" side of fracture surface indicating location of fracture, secondary cracks, and metallographic samples.

Both ends of the failed pipeline section contained a primary fracture along their HAZ that transitioned through the weld to the HAZ of the adjoining

pipe. The failure propagated circumferentially along the weld as this area has a lower fracture toughness than the pipe. Neither of the primary fractures began or ended at the weld buttons, which are oriented 180° from each other. Inspections indicated that there was “no obvious initiation site or evidence of a preexisting flaw . . .” in the pipe or weld.

Two additional secondary cracks were also found on the pipeline. The cracks were approximately ¾ inches in length and oriented 180° from each other, possibly a result of “cyclic bending stress.” The cracks “did not follow the HAZs but propagated into the base metal. The crack faces were covered with corrosion products and one of the cracks had grown thru-wall.” The cracks were determined to be “a result of corrosion-fatigue.”

The fracture occurred primarily along the weld heat affected zones (HAZ). Approximately 50% of the fracture surface propagated along the pipe "B" HAZ, transitioned across the weld, and then followed the pipe "A" HAZ (Figures 1 & 2). The surfaces were covered with rust in the as-received condition. Upon light chemical cleaning to remove the corrosion products, no obvious initiation site or evidence of a preexisting flaw was apparent. Diameter measurements at the fracture revealed a 0.125 in. difference between major and minor dimensions. Appreciable plastic deformation at the failure was not apparent. Metallographic cross sections indicated that crack propagation
