Investigation of Blowout and Fire
Eugene Island Block 284
OCS-G 0991 Well A-13
March 1, 2001

Gulf of Mexico
Off the Louisiana Coast

U.S. Department of the Interior
Minerals Management Service
Gulf of Mexico OCS Regional Office

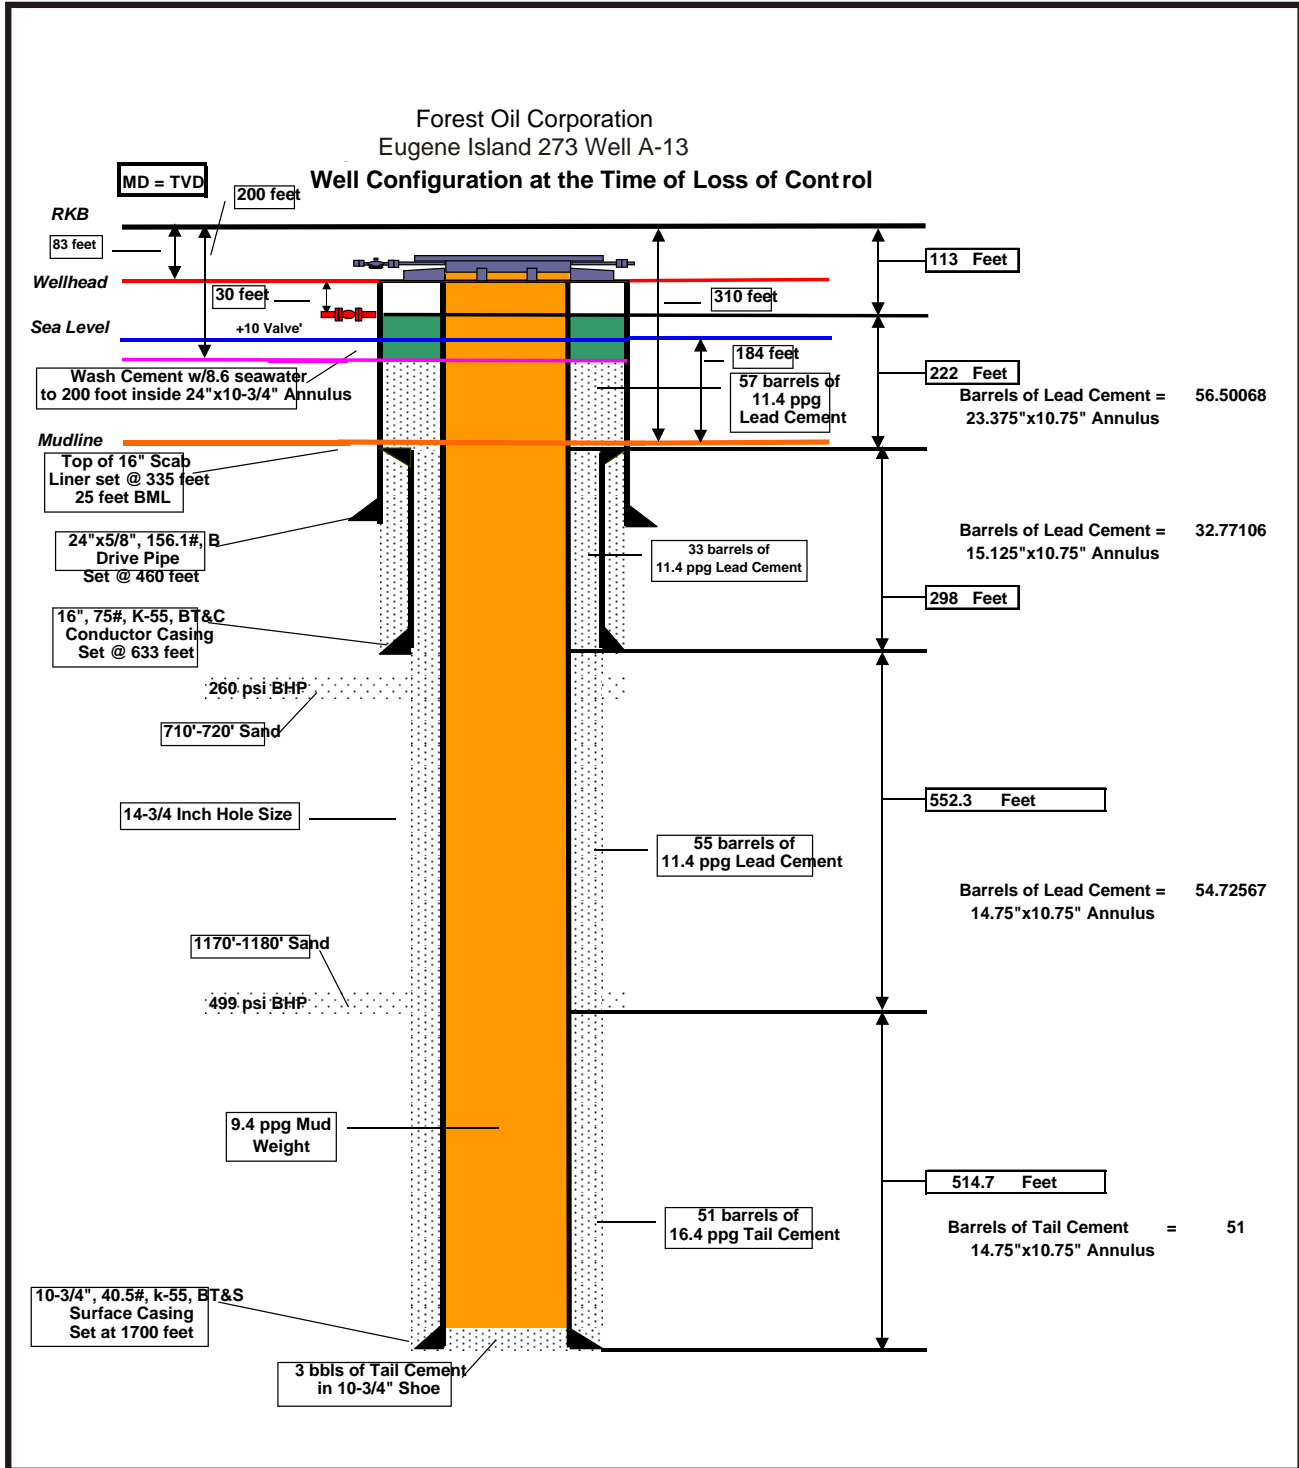
Eugene Island Block 273, Well A-13, wellbore schematic

February 24, 2001 – A 22-inch hole was drilled to 670 feet MD/TVD. The hole was circulated clean and a 16-inch scab liner was run to 633 feet MD/TVD and cemented with full returns taken at the +10 valve (*see Attachment 2, for well schematic*).

Formation gas migrated from the 700-ft sand and/or the 1,200-ft sand through the cement between the 24-inch drive pipe and the 10³/₄-inch surface casing, because of the above mentioned loss of hydrostatic pressure.

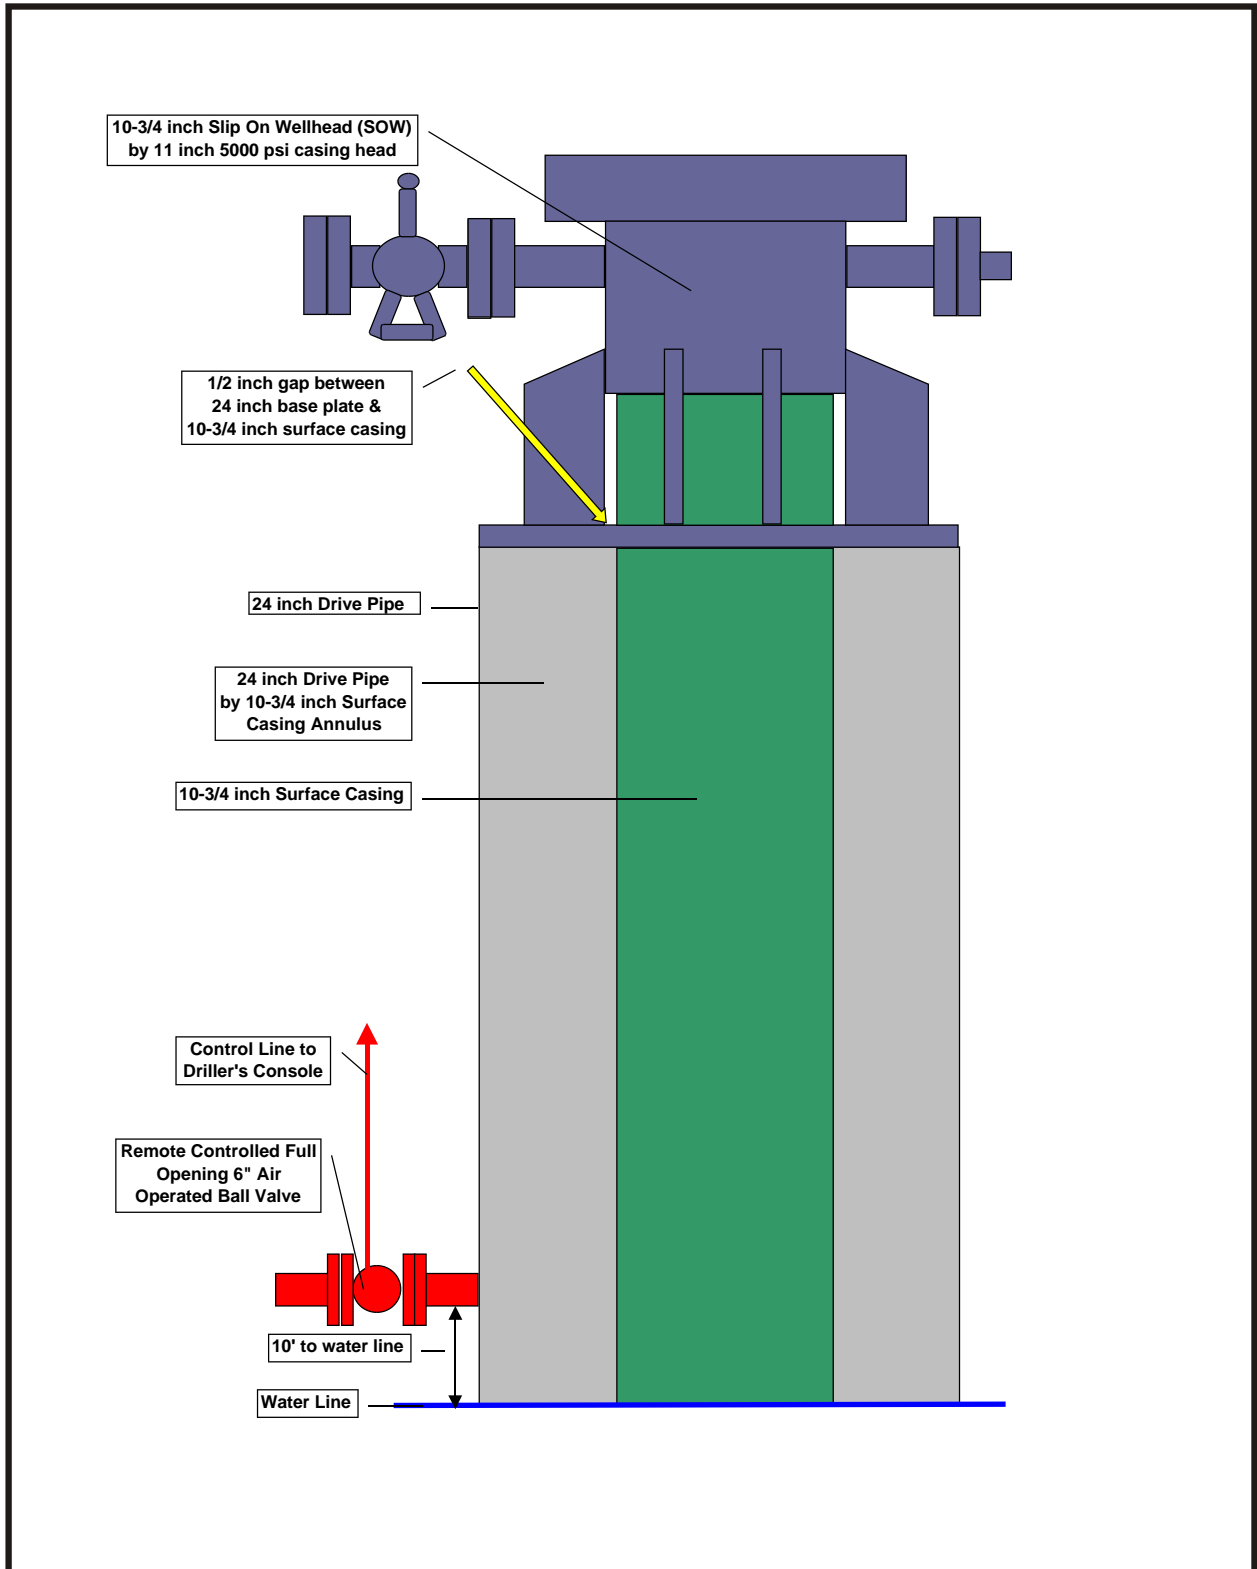
Slip-on wellhead schematic and +10 valve schematic

March 01, 2001 - The onsite Forest Company representative was alerted and was informed that gas and fluid were escaping from the +10 valve. The Forest Company representative immediately instructed the crew to close the +10 valve to establish additional hydrostatic head by using 8.6-ppg seawater. An attempt was made to add seawater to the annulus through a ½ -inch gap located between the base plate and 10¾-inch surface casing (*see Attachment #3*). Because of the size of the opening on the base plate and the

4. Opening of the +10 valve allowed the fluid level in the 24-inch drive pipe by 10³/₄-inch surface casing annulus to fall, reducing the hydrostatic pressure on the cement, which could have contributed to gas migrating into the wellbore.

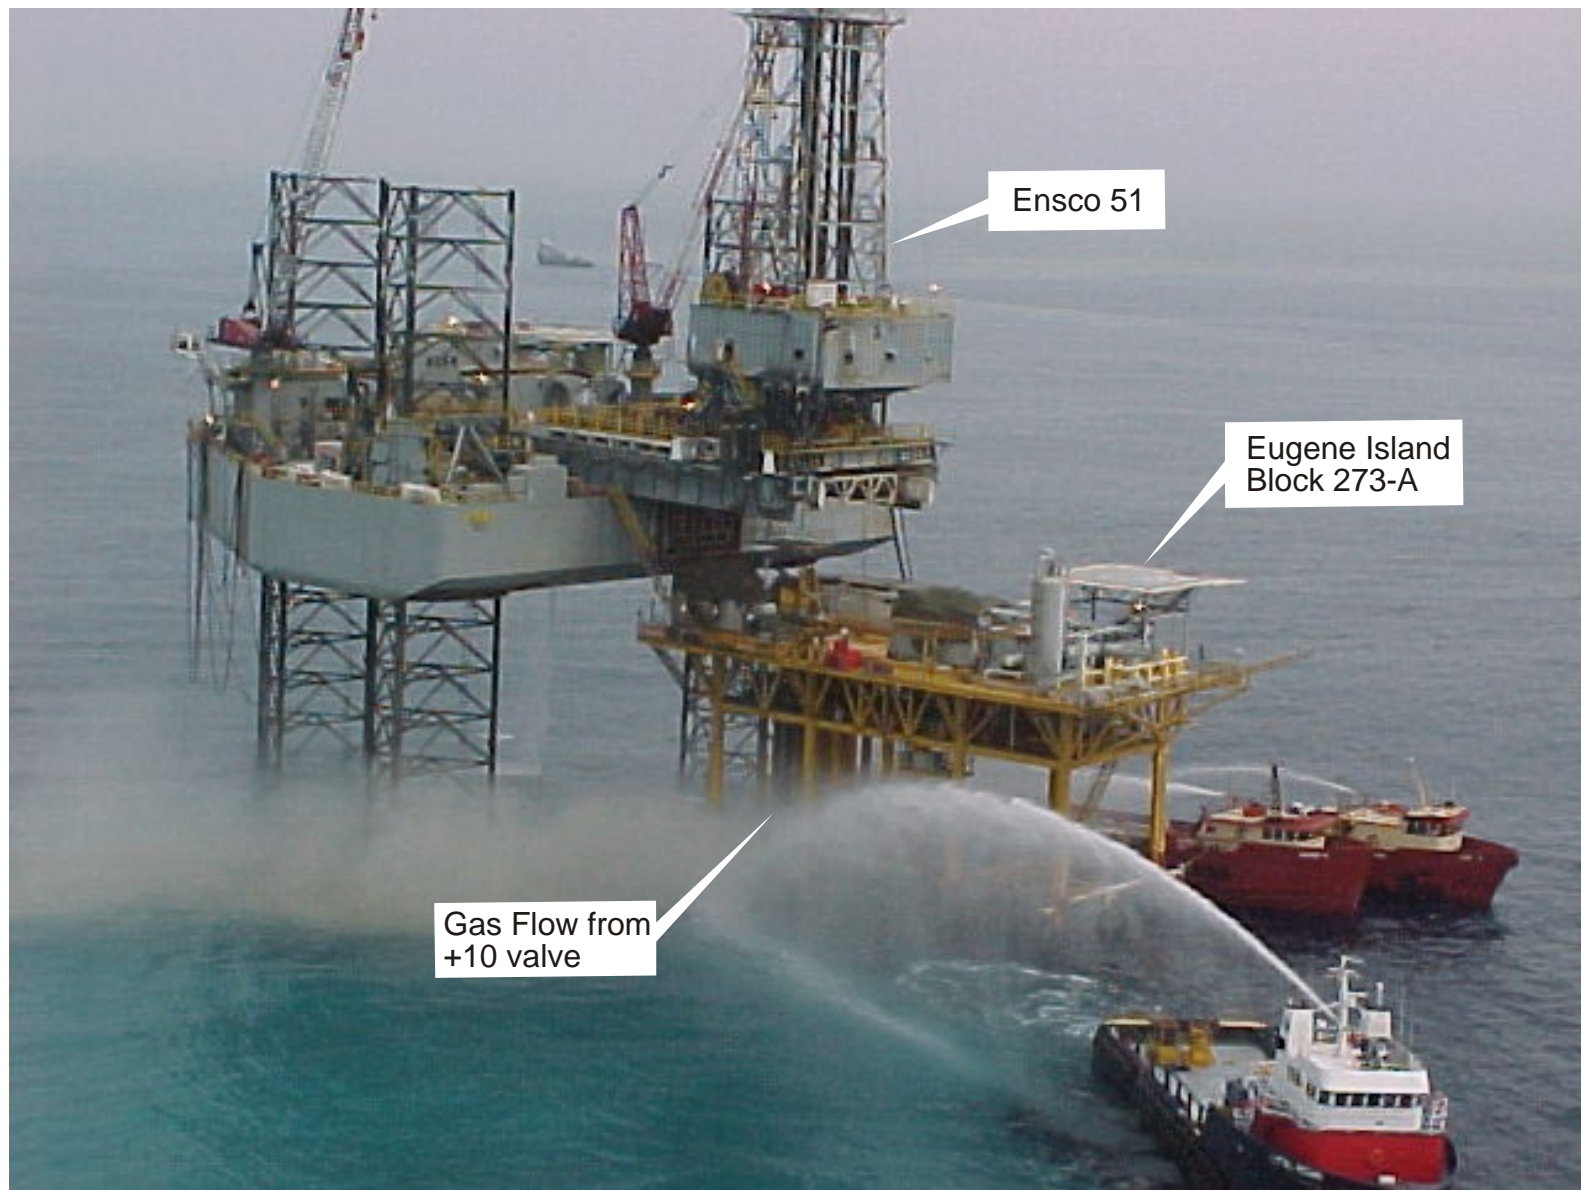
rate of 8.6-ppg water being added, sufficient volume could not be added to slow down the current well flow. At this point, rig personnel attempted to install another hose to add 9.2-ppg mud to the 24-inch drive pipe by 10¾-inch surface casing annulus. The flow of the well continued at an increasing rate. An attempt to increase the mud weight to 17.0 ppg was planned. Because of the rapid increase in flow, it was decided to add what was being mixed in the slug pit, which at that time was 16.0 ppg mud. It became difficult for the mud to flow at a steady rate because of the density and the size of the opening between the 24-inch base plate and 10¾-inch casing. As a last attempt to control the well, the Forest Company representative decided to open the +10 valve to allow the 16.0-ppg mud to displace the lighter fluid present inside the 24-inch drive pipe by 10¾-inch surface casing annulus. With the flow of the well increasing and all attempts of adding mud to the 24-inch drive pipe by 10¾-inch surface casing annulus failing, the +10 valve was closed. At approximately 0300 hours, a decision was made to evacuate the rig, and the +10 valve was opened in an attempt to divert flow away from the platform and rig (*see Attachment 4 & 5*). The rig/platform was then abandoned.

Flow at +10 valve and fire monitors on location

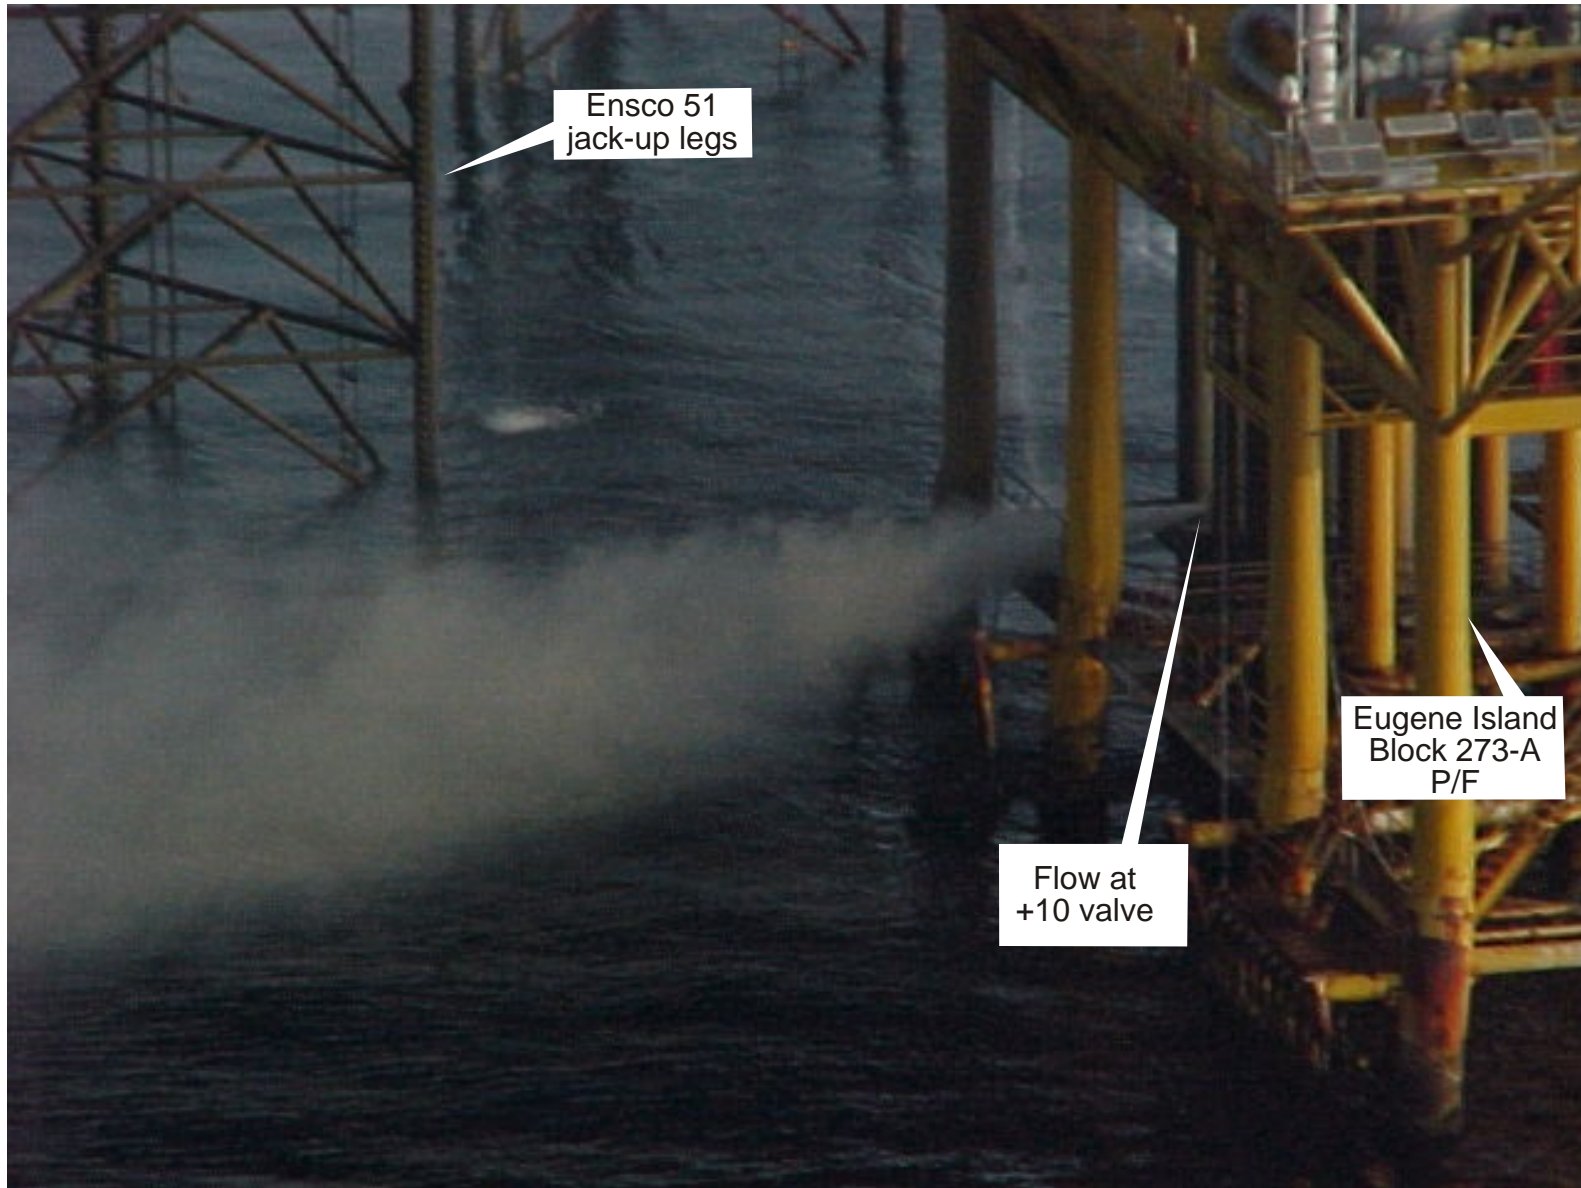
Flow at +10 valve

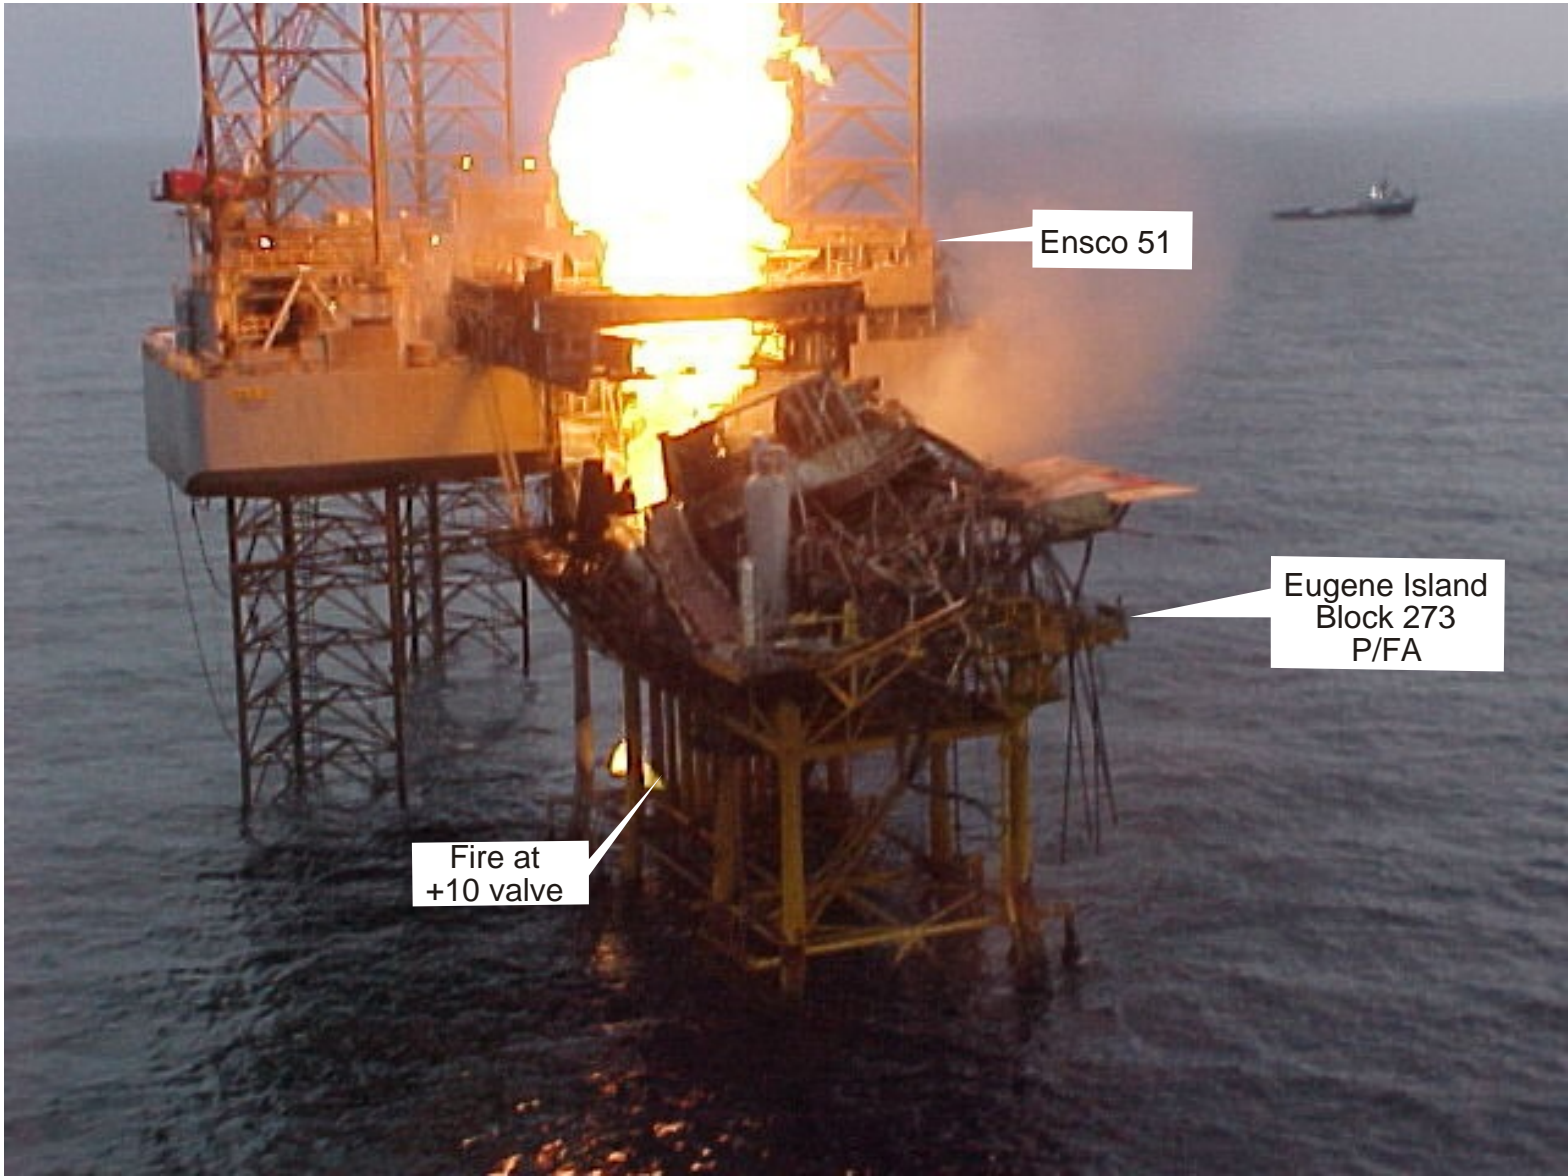
On March 2, 2001, 0330 hours, fire erupted on the Eugene Island 273-A Platform; source of ignition is unknown (see Attachment 6). *Ensco 51's* derrick collapsed on the Eugene Island 273 A platform at 0345 hours (see Attachment 7). Because of the excessive heat, boats were unable to spray the platform continuously. Because the hydrocarbon flow was dry gas, dispersant application was not initiated and recovery action was not attempted.

Platform/rig on fire

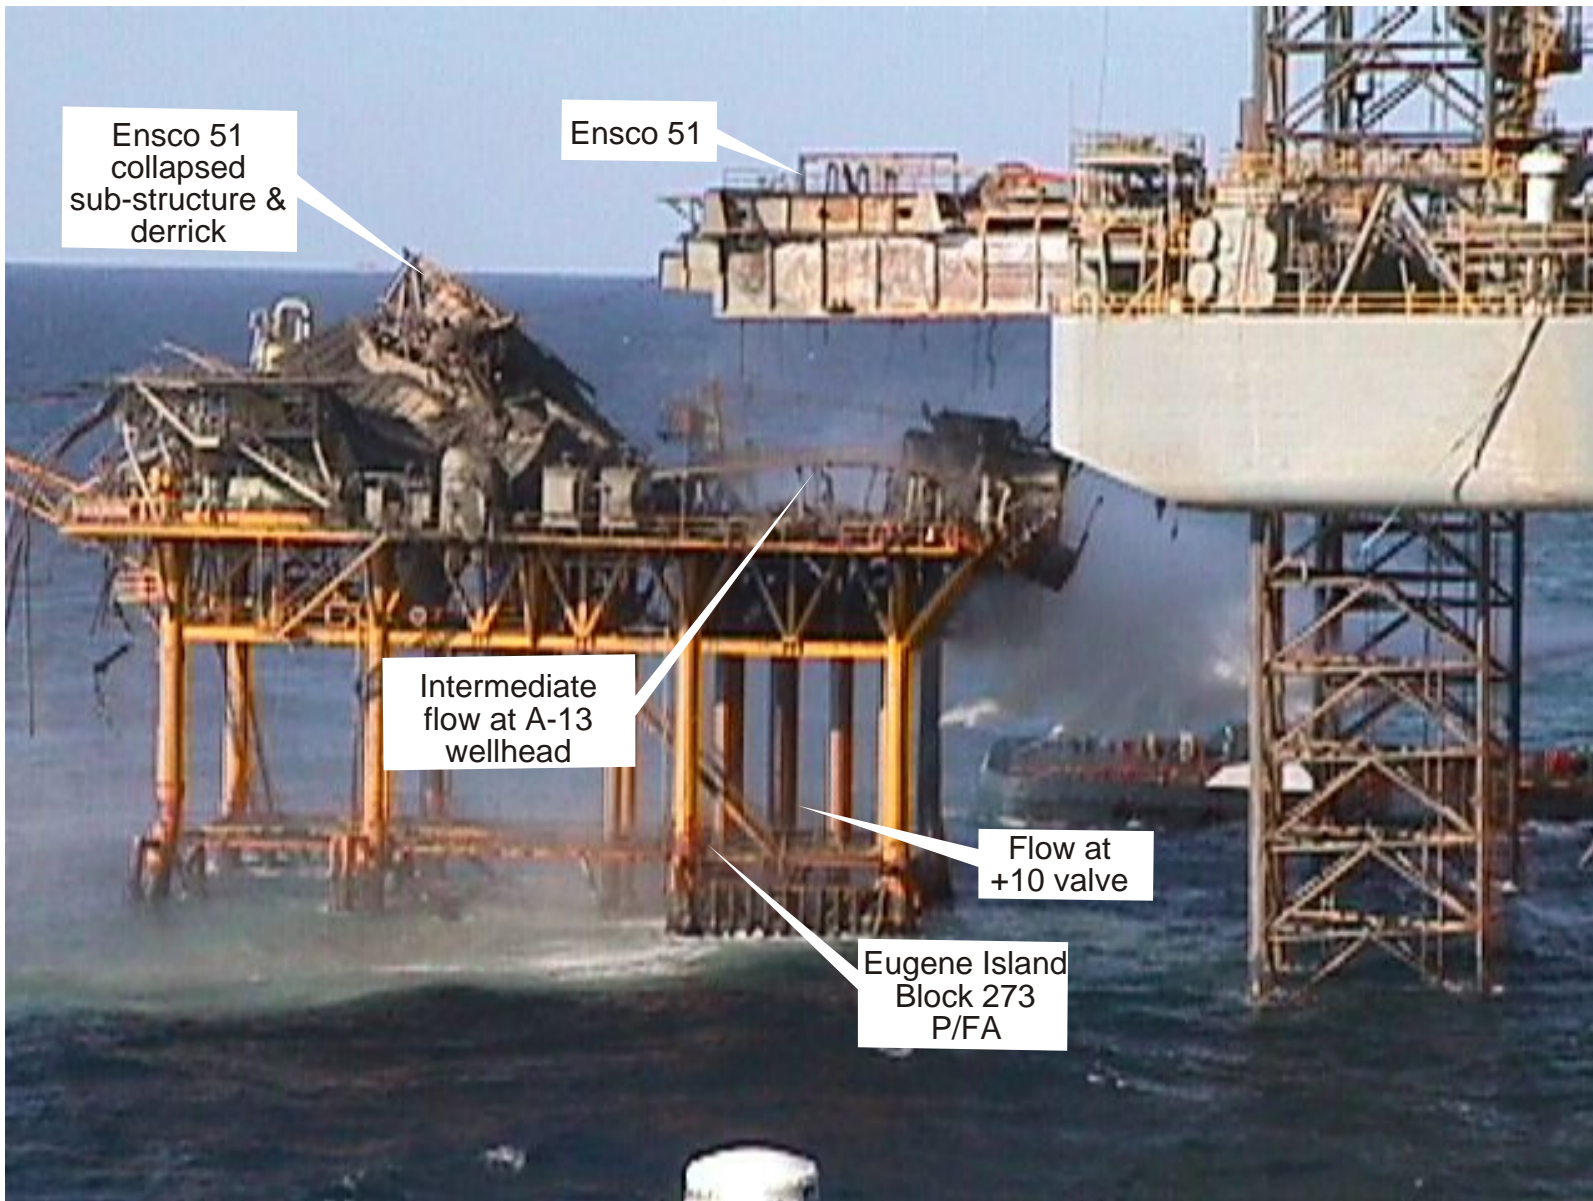
The *Ensco 51* substructure and derrick were completely destroyed in the blowout and subsequent fire. There was severe damage to the production platform and associated production equipment.

Damage to platform and rig resulting from fire
