METAL AND NONMETAL MINE SAFETY AND HEALTH
REPORT OF INVESTIGATION

Surface Nonmetal Mine
(Sand & Gravel)

Fatal Machinery Accident
February 25, 2008

Illinois Mining Corporation
Contractor I.D. SRE
at
Wash Plant
Park View Sand & Gravel, LLC
Rochester, Racine County, Wisconsin
Mine I.D. 47-03001

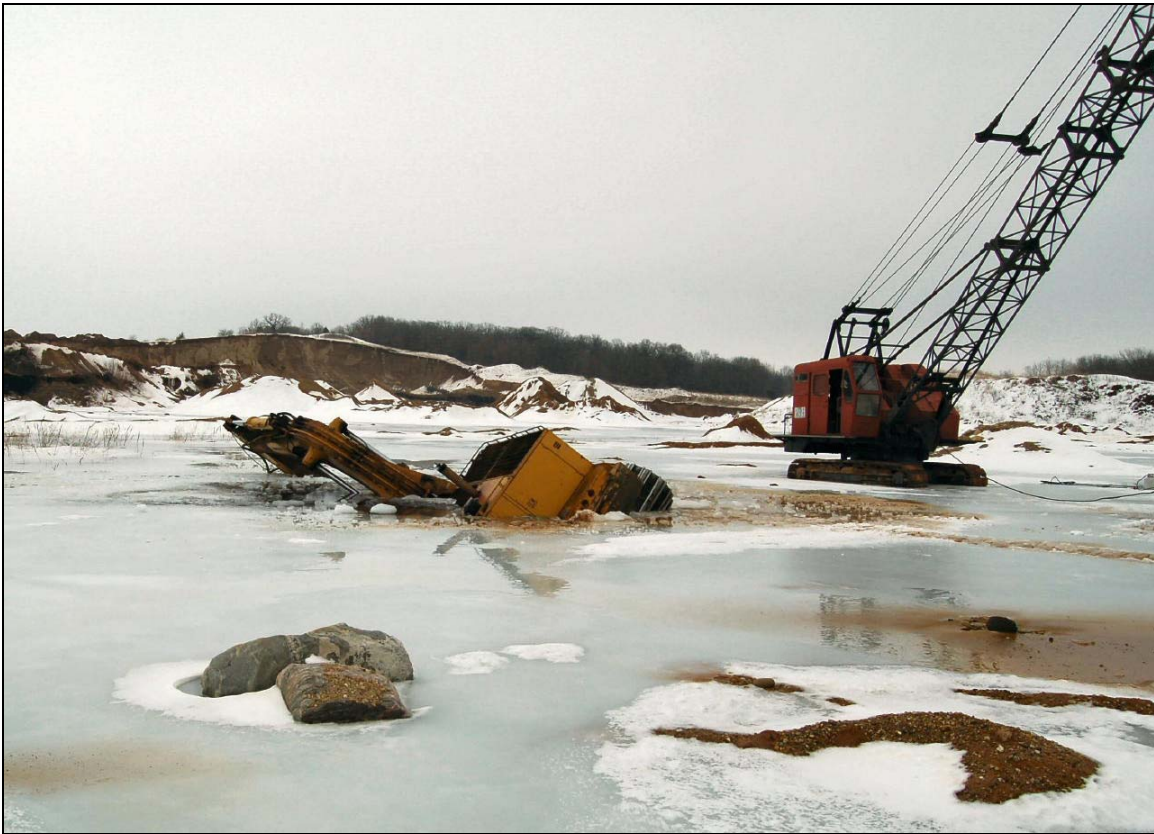
Photo of Accident Scene

Charles S. Nemetz, general superintendent, age 62, was fatally injured on February 25, 2008, when the track-mounted excavator he was operating broke through ice covering a water-filled ditch. Nemetz was using the excavator to free a dragline frozen to the ice-covered pit floor.

The accident occurred because management policies and procedures failed to address the hazard created by an ice-covered, water-filled ditch. All hazards associated with the task were not identified and appropriate controls were not in place to ensure that persons could safely perform the task. Barricades or warning signs, visible from all approaches, were not erected to warn persons of a hazard that was not immediately obvious.

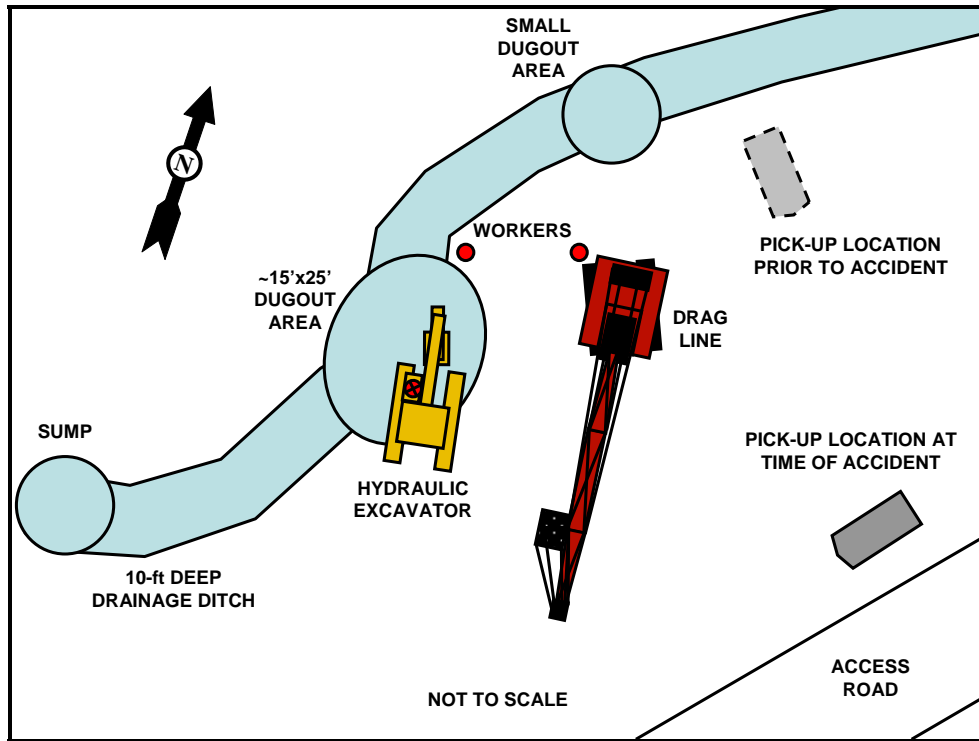
Diagram of Accident Scene (not to scale)

The drainage ditch was located along the west side of the north pit, oriented generally in the north-south direction (Appendix B). Mine personnel reported that the ditch was dug in the spring of 2007 to alleviate wet conditions caused by excessive precipitation and an elevated ground water level in the pit. The drainage ditch was approximately 10 feet wide at the top, 3 feet wide at the bottom, and about 10 feet deep, with two exceptions created by the dragline. A pump had been installed at the south end of the ditch but was removed in September 2007. The pump typically maintained the water level about 2 to 3 feet below the top of the ditch. When the pump was removed, the water level in the pit rose above the ditch banks and spilled water approximately 4 inches deep across the surrounding pit floor. During the winter the water froze in the pit. The uniform layer of ice covering the area prevented persons from distinguishing the exact location of the ditch. No berms, barricades, or warning signs were posted to identify the location of the ditch.

The dragline was located approximately 25 feet from the east side of the drainage ditch (Appendix B). The dragline was assembled and test operated at this location in the summer of 2007. Two areas were excavated, a small area north of the machine and a larger area to its west. The larger area was the location where the excavator tipped over. This excavated area was estimated to be approximately 15 feet wide, 25 feet long, and 12 feet deep.

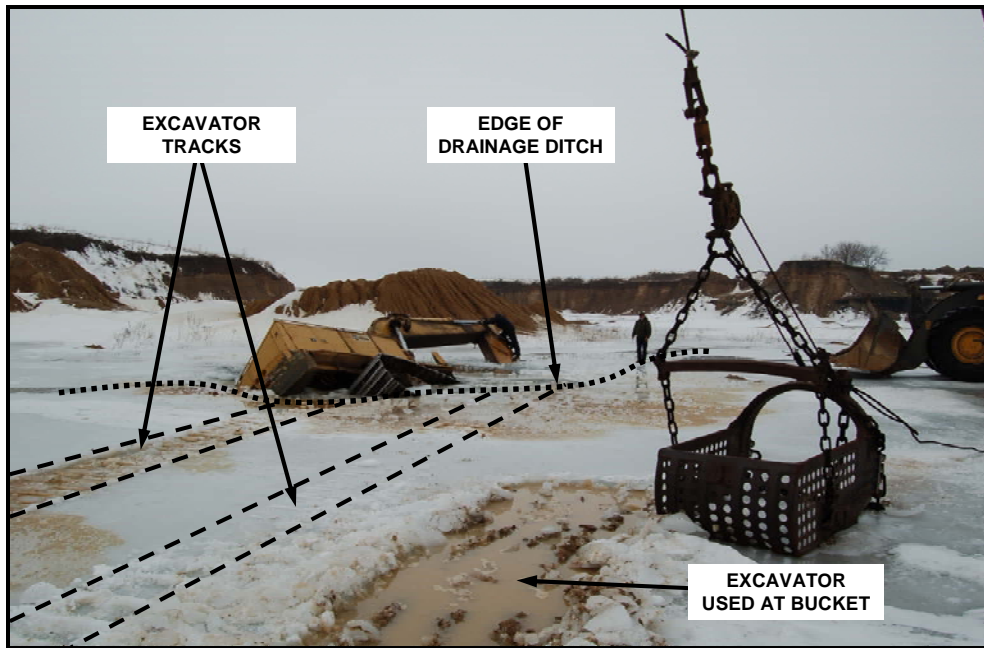
View of Accident Scene

The excavator fell through the ice and tipped on its side, submerging the cab and a major portion of the excavator (Appendix C). Epright used his cell phone to call for emergency assistance. Ignatowski and Epright then attempted to rescue Nemetz from the water but were unsuccessful. The Racine County Sheriff's Department arrived at 10:24 a.m. and located Nemetz at approximately 4 p.m. Nemetz was transported to a local hospital where he was pronounced dead by the Racine County medical examiner. The cause of death was attributed to drowning.

The thickness of the ice at the accident scene varied from approximately 9 inches to 12 inches. The ice consisted of layers of clear and white ice, with the clear ice beneath the white ice. Clear ice at the drainage ditch varied from approximately 4 inches to 6½ inches thick. The white ice was the result of an accumulation of melted snow and rain that froze on top of the clear ice and varied from approximately 4½ inches to 5½ inches thick. Ice strength guidelines (Ice Engineering Information Bulletin No. 13, "Safe Loads on Ice Sheets", U.S. Army Corps of Engineers, Cold Regions Research and Engineering Laboratory, Hanover, NH, Jan. 1996) estimate that white ice exhibits half of the strength of clear ice, therefore only one-half of white ice thickness could be considered as contributing to ice strength. Consequently, for strength estimation, ice thickness at the accident scene was considered to vary from 6½ inches to 9¼ inches, with an average thickness of about 8 inches.

Jan. 1996; "Engineering and Design – Ice Engineering," U.S. Army Corps of Engineers, EM1110-2-1612, October 2002; and "Use of Ice Covers for Transportation," 23rd Canadian Geotechnical Conference, Banff Alberta, Canada, L.W. Gould, Nov. 19-20, 1970), it is estimated that an ice thickness of 8½ inches to 10 inches was necessary to support the victim's pickup truck given the estimated vehicle weight and temperature conditions leading up to the accident. Using these same methods, the ice thickness required to support the approximately 71-ton CAT 245 excavator was estimated to be between 32 inches and 44 inches. These calculations show that the estimated actual equivalent ice thickness of 8 inches was significantly inadequate to support the excavator.

Corrective Action: Management should establish policies, procedures, and controls to ensure that persons can safely perform their tasks when working on ice on the pit floor. Ice conditions should be evaluated for safety and barricaded or posted with warning signs visible from all approaches if unsafe on which to work or travel.
