UNITED STATES  
DEPARTMENT OF LABOR  
MINE SAFETY AND HEALTH ADMINISTRATION  
COAL MINE SAFETY AND HEALTH

REPORT OF INVESTIGATION  
Fatal Underground Coal Mine Explosion  
May 20, 2006

Darby Mine No. 1  
Kentucky Darby LLC  
Holmes Mill, Harlan County, Kentucky  
ID No. 15-18185

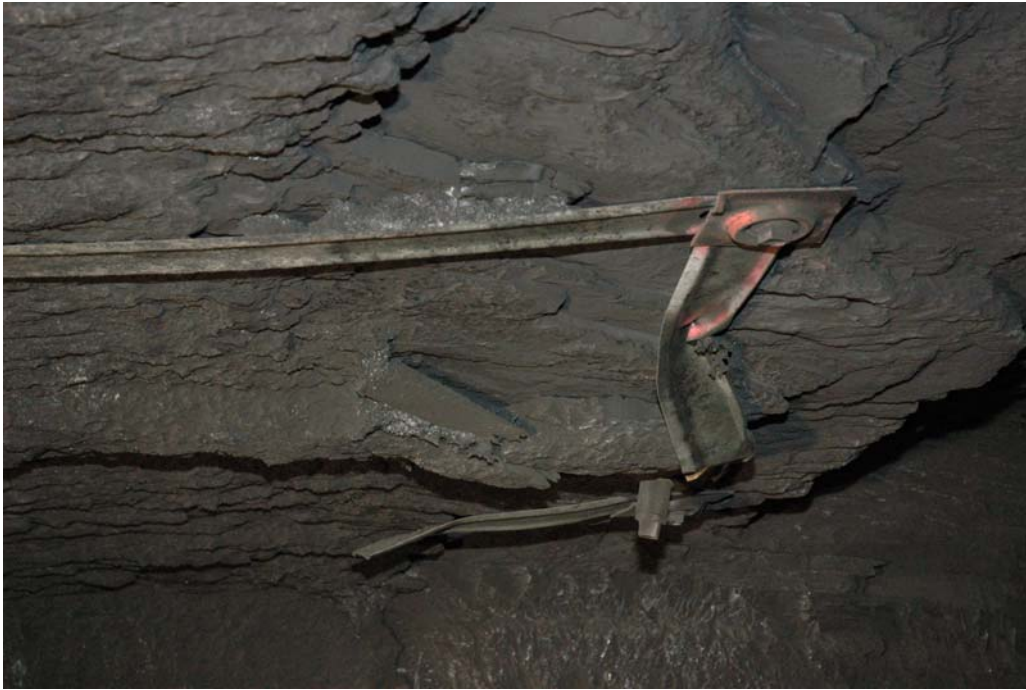
**Figure 2 - Roof Straps at the No. 3 Seal Location for A Left**

The physical evidence suggests that Brock and Lee arrived at the area of the return seals and commenced to cut metal roof straps (see Figure 2) that had been placed in the area as roof support but which had not been removed when the seals had been built. The acetylene cylinder and cutting torch were found in the area as was a piece of roof strap that gave indications that it had been cut with a torch. Brock had a methane detector with him but it is clear that it was not being used to check continuously for methane given that it was found in his pocket after the explosion. The detector was functional since it was giving off an alarm when the body was found. There is no indication that any test for methane was made behind the seals before the cutting commenced. There was no means available to sample the atmosphere behind the No. 3 Seal. Therefore, a cutting torch should not have been used in the vicinity of the seals.

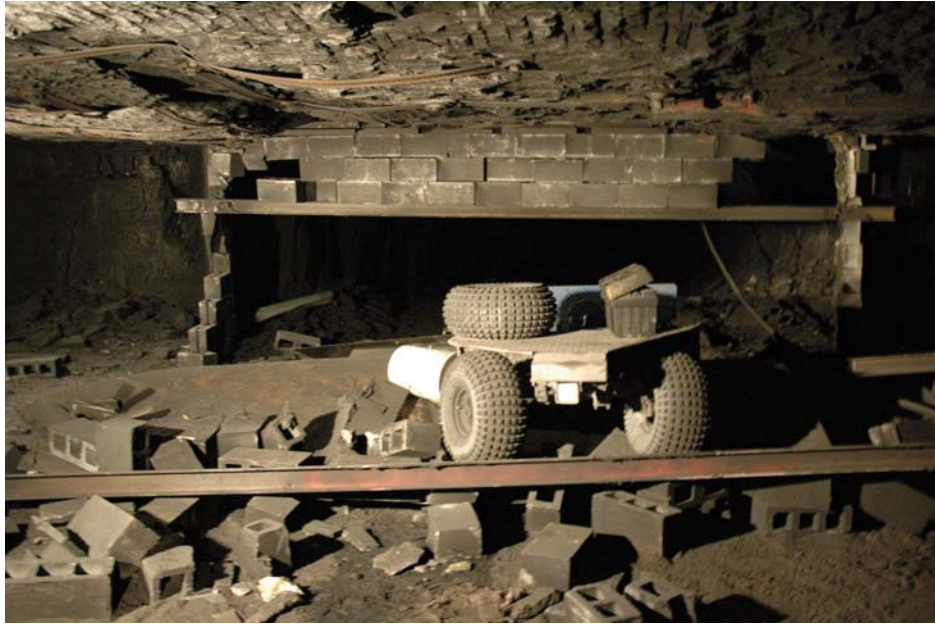
**Figure 3 - Personnel Carrier Lodged on Overcast Debris**

After traveling approximately 300 feet, the personnel carrier became lodged on debris from an overcast that had been extensively damaged by the force of the explosion (see Figure 3). The crew got off of the vehicle and proceeded on foot until they reached the power center located one crosscut inby the No. 4 Belt Drive. Somewhere near this point, Ledford and Middleton removed their SCSR mouthpieces and discussed how they should exit the mine. Ledford informed Middleton that he had located the high-voltage power cable and that he intended

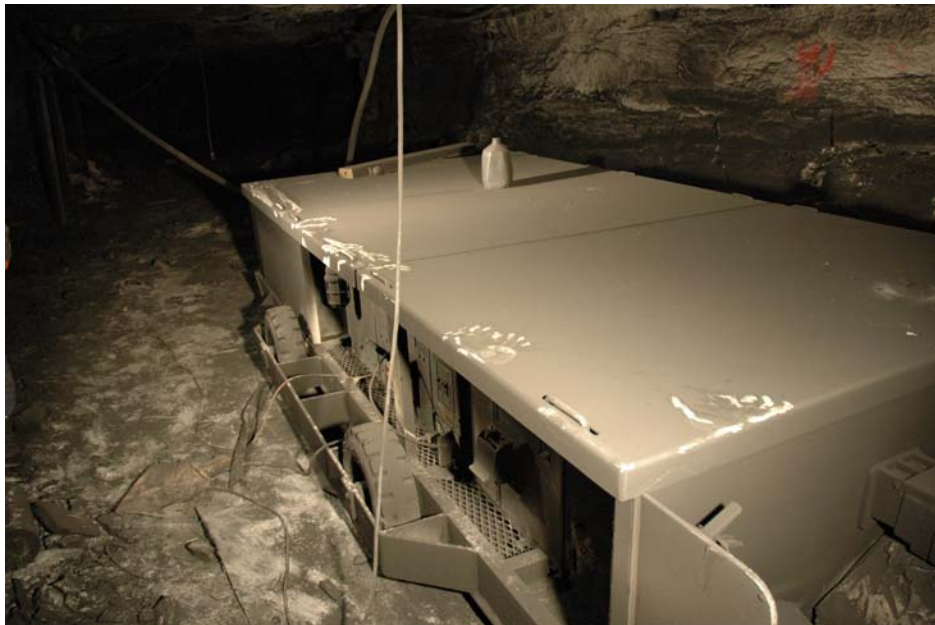
**Figure 4 - Power Center at No. 4 Belt Drive**

to follow it to the surface. Middleton told Ledford that he was going back to find the power center (see Figure 4). After another short discussion, Ledford began walking outby in the No. 5 Entry, using the high-voltage power cable as a guide. Ledford had no further contact with the other miners.

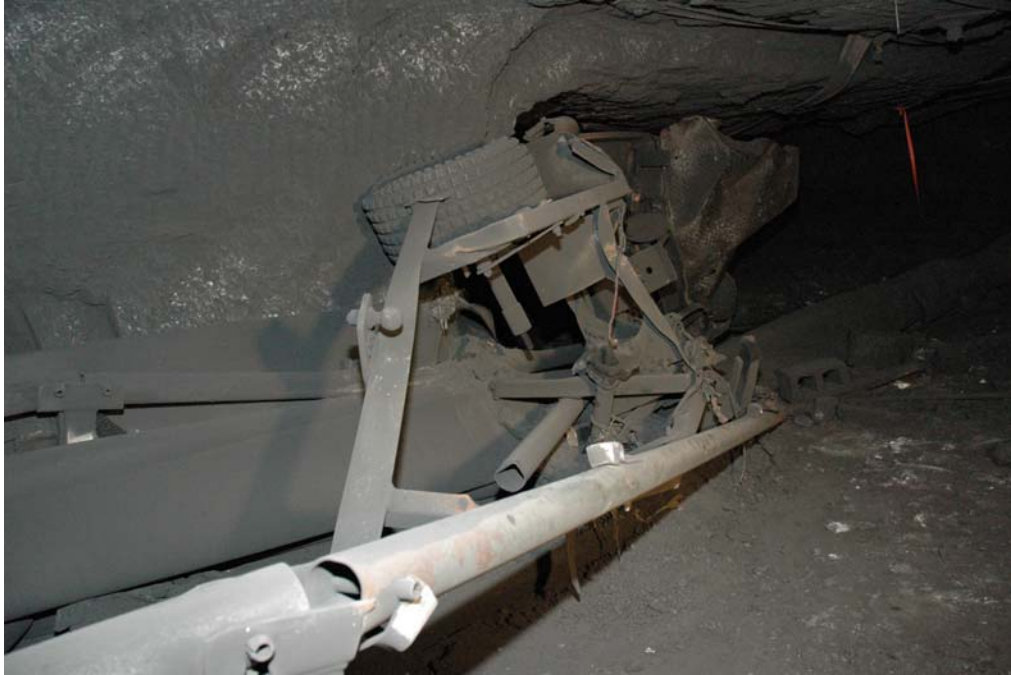
**Figure 6 - Damaged Personnel Carrier on top of Conveyor Belt Debris**

was found on top of the debris from the destroyed intake overcast. A search was made around the personnel carrier and no persons were found. End caps from two SCSRs were found on the personnel carrier. Footprints indicated someone may have traveled inby in the Mains toward the old works.

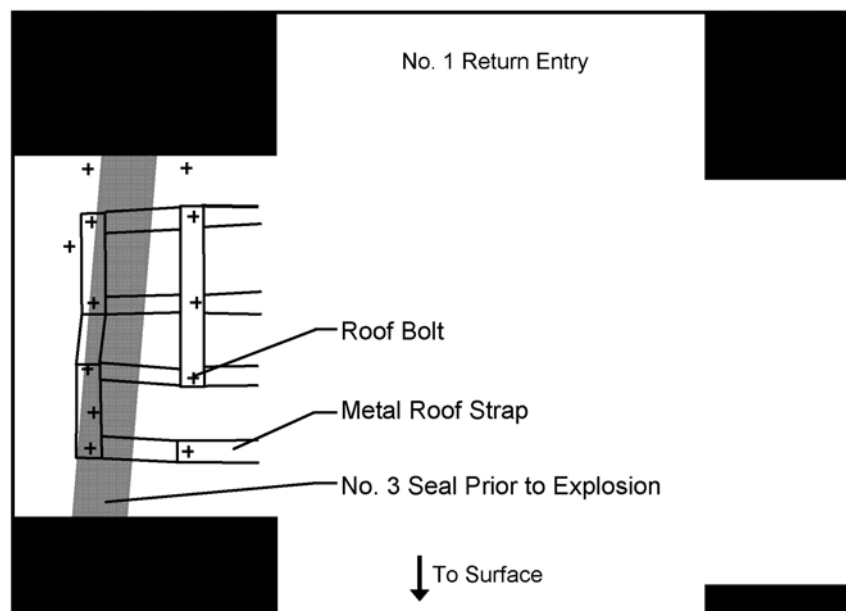
**Figure 8 - Sketch of Metal Roof Straps at the No. 3 Seal**

- f. The No. 3 Seal was located 6 to 7 feet from the outby rib corner whereas the plan requires a minimum distance of 10 feet.
- g. One metal roof strap extended through the No. 1 Seal and four metal roof straps extended through the No. 3 Seal. The use of Omega 384 block for seal construction was tested and approved by MSHA without any metal straps passing through the seal. The metal straps interfered with the installation of wood planking on the top of the seal. The wood planking could not be positioned flush with the mine roof. Figure 8 is a sketch of the metal roof straps at the No. 3 Seal.

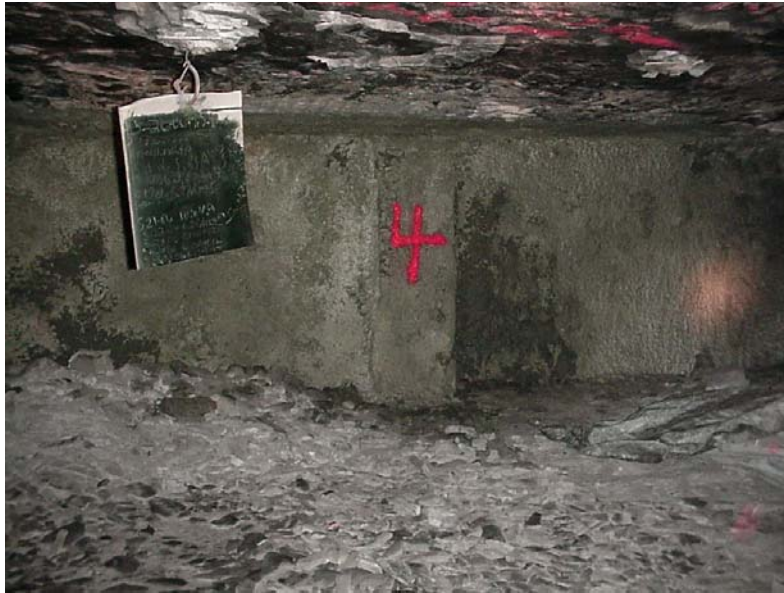
**Figure 9 - No. 4 Intake Seal**

After the explosion, seven solid concrete block seals were constructed which complied with 75.335(a)(1) to replace the Omega seals at the intake seals. The plan approved by the District Manager for the construction of the new seals required that the existing No. 4 Seal (Omega) be breached prior to completing the solid concrete block seal that would replace it. Figure 9 is a picture of the No. 4 Intake Seal prior to being breached.

On June 7, 2006, team members of the MSHA's Mine Emergency Unit, while under apparatus, breached this seal. The team observed the following deficiencies:

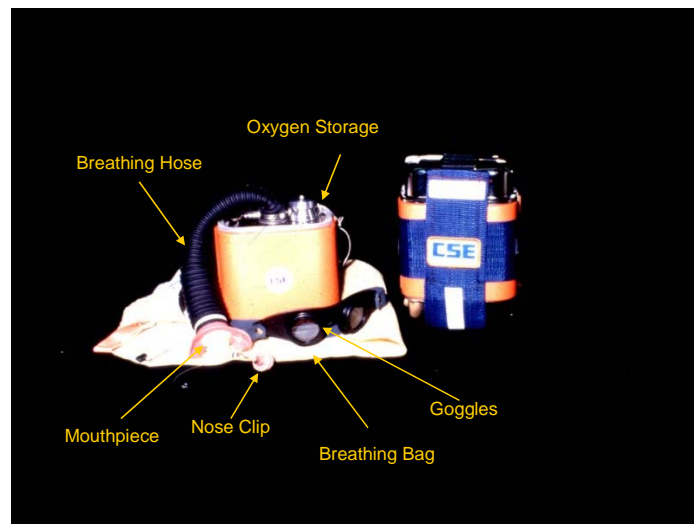
**Figure 10 - SCSR Deployed**

Of the four miners who donned SCSRs, only one miner survived. Accident survivor Paul Ledford donned CSE SR-100 serial number 93609. Accident victims Roy Middleton, Paris Thomas and Bill Petra, donned CSE SR-100 serial numbers 84784, 89692, and 105936, respectively.

National Institute for Occupational Safety and Health (NIOSH) collaborated with MSHA in the post-incident evaluation of the five SCSRs recovered from the Darby Mine No. 1. NIOSH generated a report (“Investigation of Self-Contained Self-Rescuers (SCSRs) Recovered from the Darby Mine Disaster”, NIOSH Report to MSHA, January 2007) summarizing the SCSR evaluation. Four of these five SCSRs were used by miners during evacuation of the mine. These four SCSRs exhibited conditions consistent with partial use. The single intact SCSR failed visual inspection. A dent in the bottom case lid crossed the location of the moisture indicator. The indicator was dislodged and the case open to the external atmosphere, a condition that causes it to fail visual inspection. However, it is not possible to know that the SCSR would have failed the visual inspection prior to the explosion, or if the damage observed occurred as a result

of the explosion. In either event, it is in a condition that makes it unsuitable for use.
