## **Fire Origin Investigation Involving a DOT 3AL Cylinder Failure in Luraville, FL**

WHA Report 05H010

Date: September 29, 2006

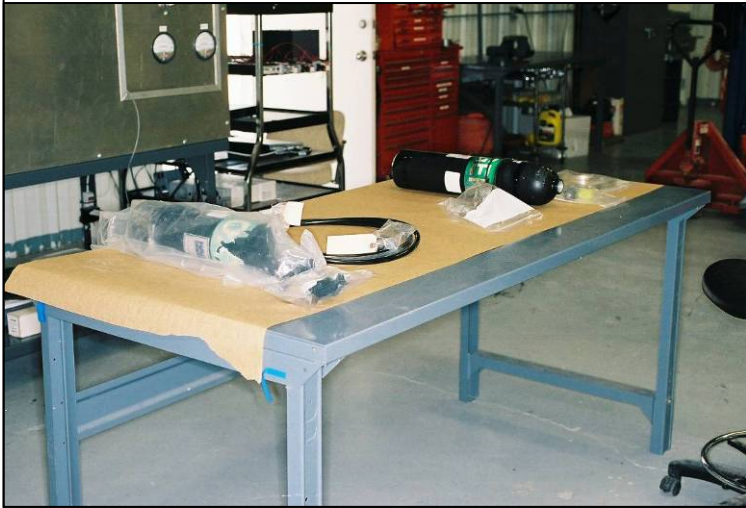
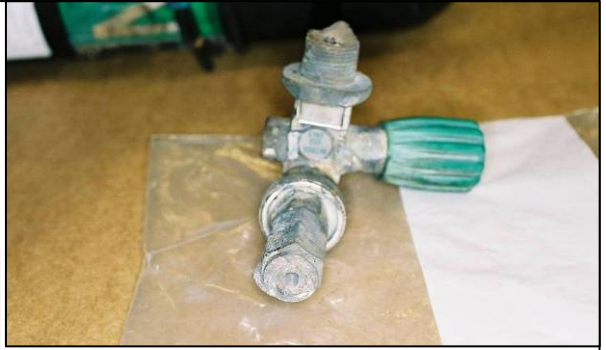
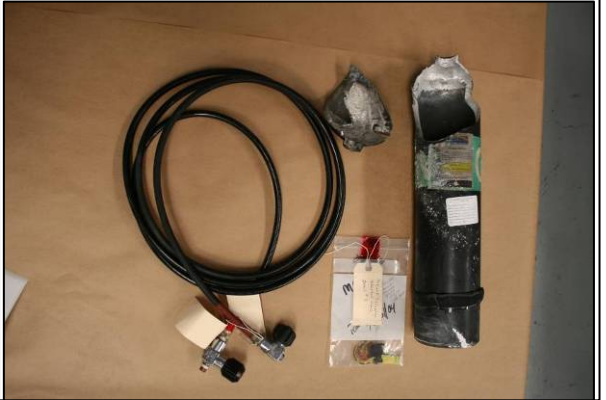
Figure 1: As-Received Condition of Components

The materials that were analyzed by WHA are depicted in Figures 1 and 2 in their “as-received” condition. The following provides a summary list of the components submitted to WHA for analysis:

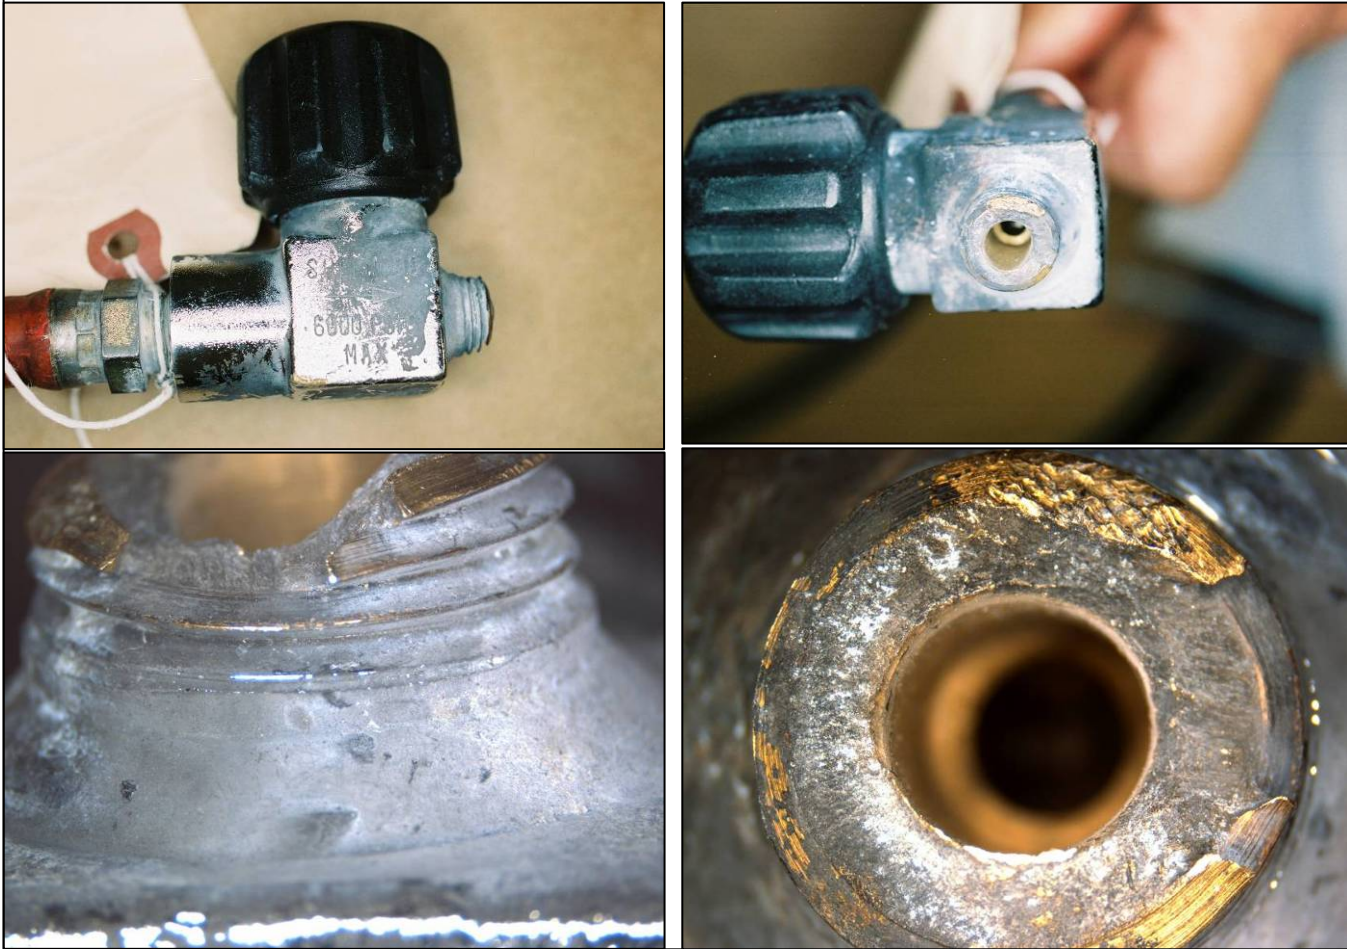
Figure 3: Downstream Fill Valve  
(Sherwood Date Code 0503)

The WHA inspection revealed that the isolation/fill valve, attached to the downstream end of the fill hose (or fill whip), exhibited a fracture pattern on its downstream threads, shown in Figure 3, consistent with a bending overload failure. The exterior body of the valve as well as the fracture surface exhibited a surface residue condition consistent with combustion products, also shown in Figure 3.

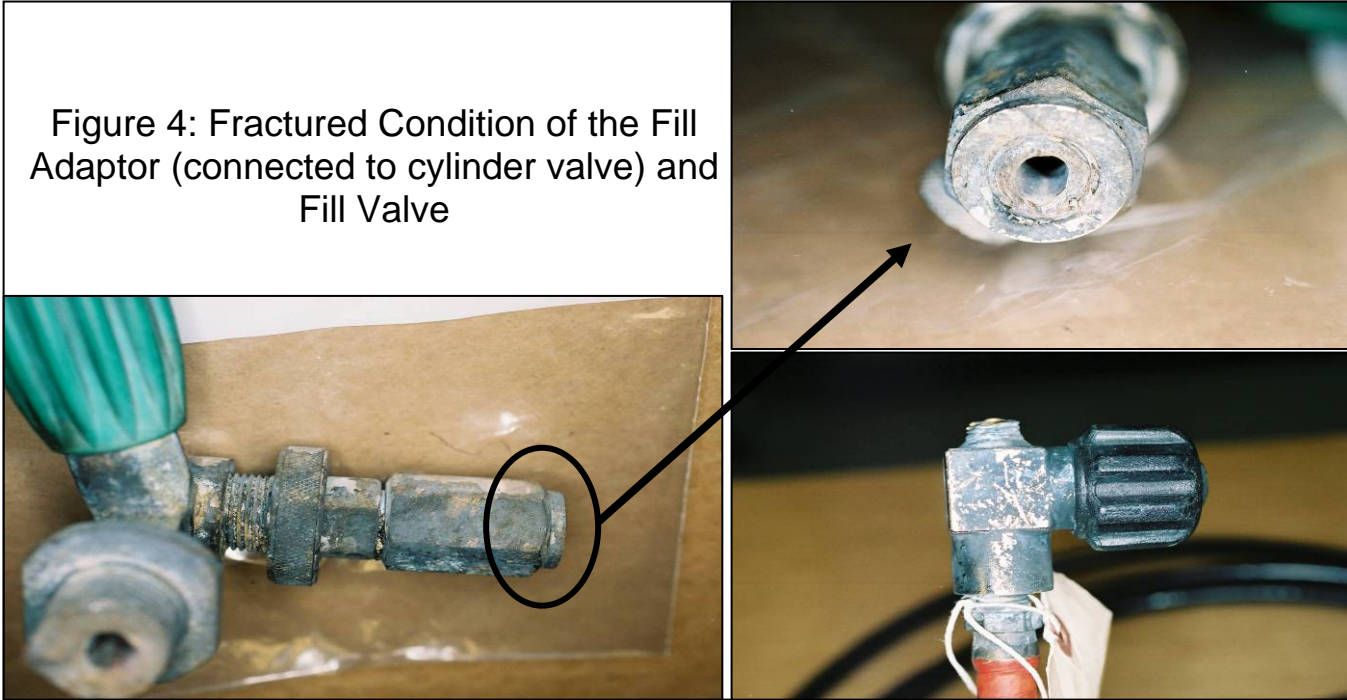
Figure 4: Fractured Condition of the Fill Adaptor (connected to cylinder valve) and Fill Valve

It was noteworthy that the THERMO cylinder valve, found after the initial scene investigation, also exhibited a fracture on the end of the valve adaptor fitting that was attached to the cylinder valve inlet, where an isolation valve would have been originally attached, as shown in Figure 4. The adaptor fitting fracture included a threaded end that

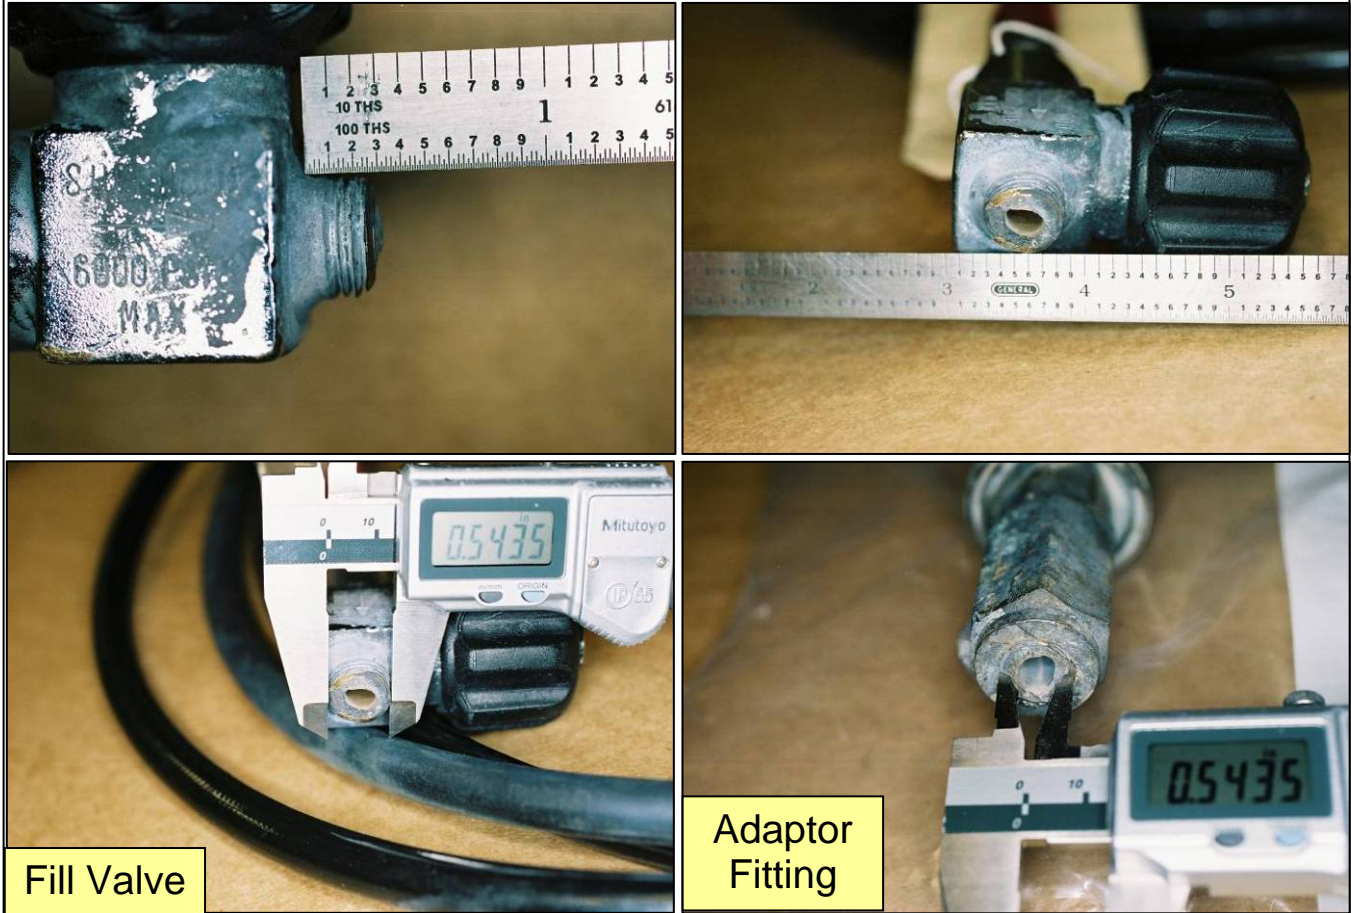
Figure 5: Downstream Fill Valve and CV Adaptor Fitting  
(Dimension Comparison of Fracture Surfaces)

was dimensionally the same OD and ID as the fractured end of the downstream valve. The dimensional measurements are documented in Figure 5 and the notes of Attachment 5 comparing the dimensions of the fracture on the adaptor fitting to the downstream fill valve.

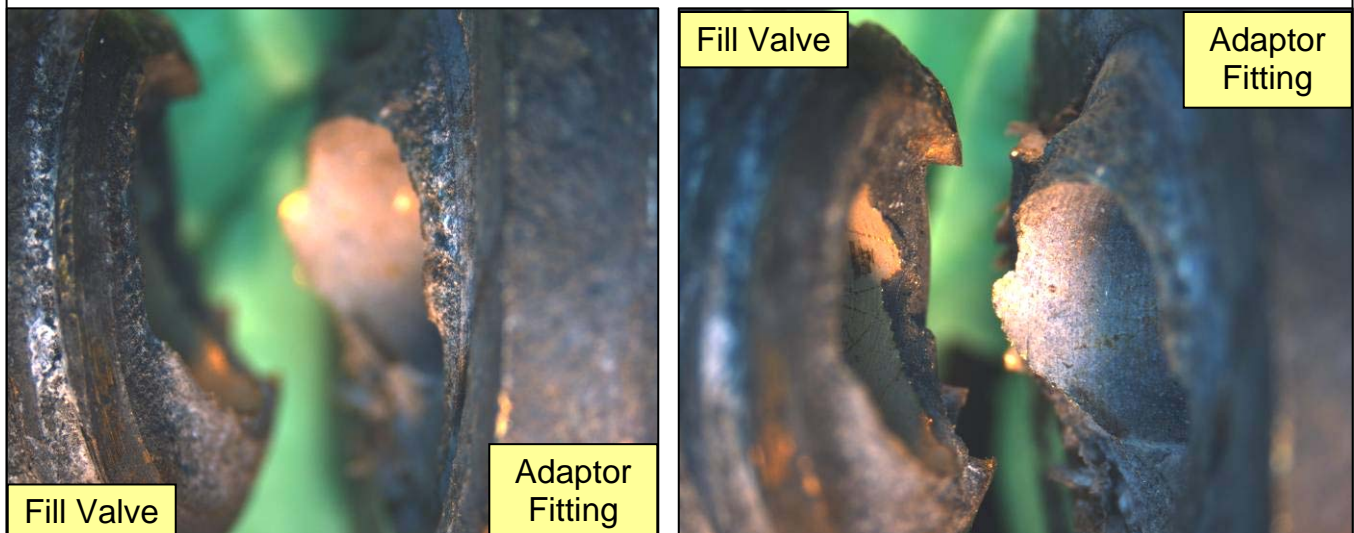
Figure 6 – Fracture Surface Comparison between Downstream Fill Valve  
Fracture and Cylinder Valve Adaptor Fitting  
(left – top focus; right – bottom focus)

It was also considered significant that the fracture patterns for the two surfaces (i.e., adaptor and fill valve) were very similar in appearance and surface morphology as shown in Figure 6 and both fractures developed at the thread root under a bending overload. As is illustrated in Figure 6, the fracture pattern and surface morphology extending from the inside diameter of the two pieces through the thread form (*see right side photograph of Figure 6 showing the inside diameter pattern*) match very closely. The fracture discontinuity on the inside diameter of the adaptor fitting is mirrored on the fracture of the downstream fill valve. Further, the sharp discontinuity on the thread of the fill valve is mirrored on the thread fracture of the adaptor fitting.

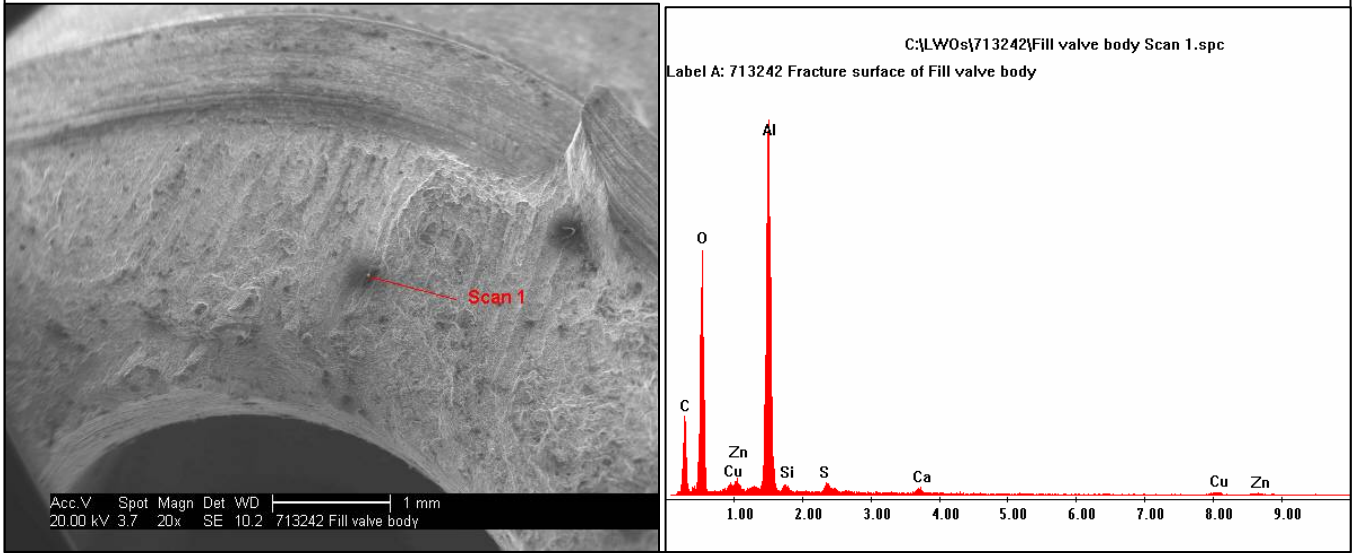
# Figure 7 - Downstream Fill Valve Thread Fracture

Figures 7-12 show microscope and SEM photographs obtained of each fracture surface and the EDS analysis for the major elemental constituents that are dominant in the locations where the scans were obtained. The locations of the individual scans are indicated in each figure. The elemental analysis indicated that the base material was consistent with brass (copper/zinc alloy), as would be expected for these components. This analysis confirmed that both fragments/remnants were probably comprised of the same base alloy. It was further significant that the EDS analysis also indicated that both surfaces contained aluminum-oxide deposits. This result was considered significant since the fracture probably developed during the combustion event and would have included burning aluminum from the SCUBA cylinder, which would have deposited on the surfaces during the venting of combustion gases while the fitting was failing.

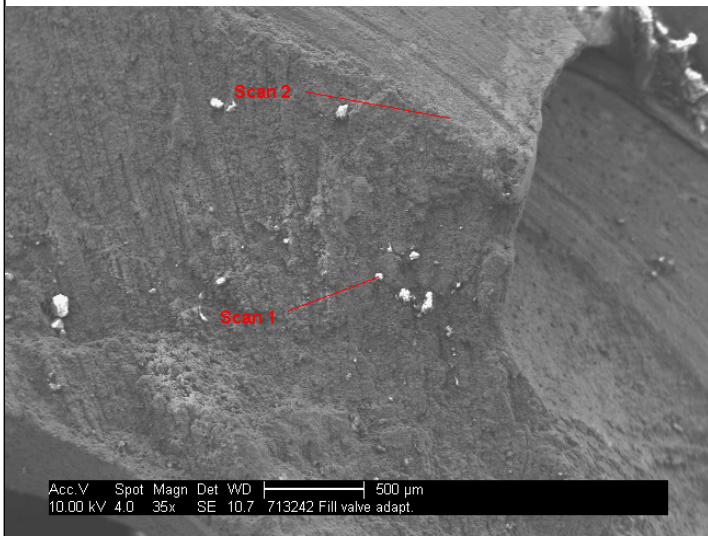
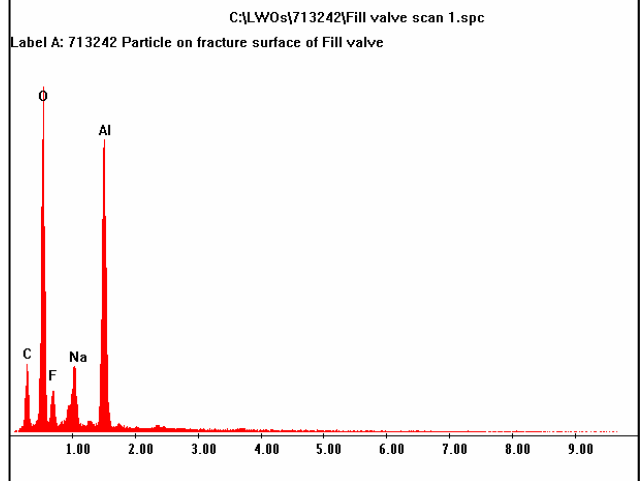
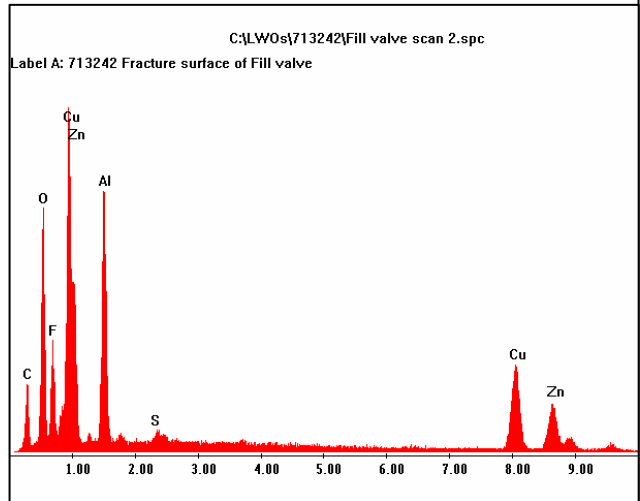
Figure 10: Adaptor Fitting Fracture Surface

One noteworthy difference was the presence of fluorine detected on the EDS scans for the adaptor fitting. Fluorine was not detected on the surface of the downstream fill valve. However, since the adaptor fitting still contained obvious residues from PTFE – Teflon<sup>®</sup> tape, which is a fluorocarbon-based material, this difference was considered to be insignificant. The remaining PTFE tape remnants on the adaptor fitting would have been expected to slough off onto the fracture surface during handling.

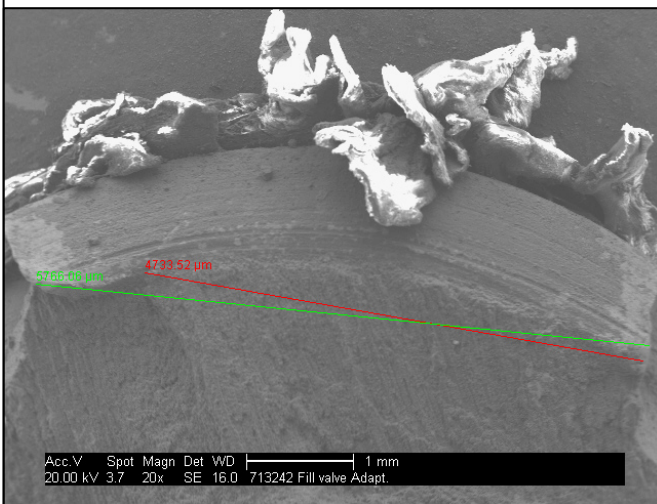
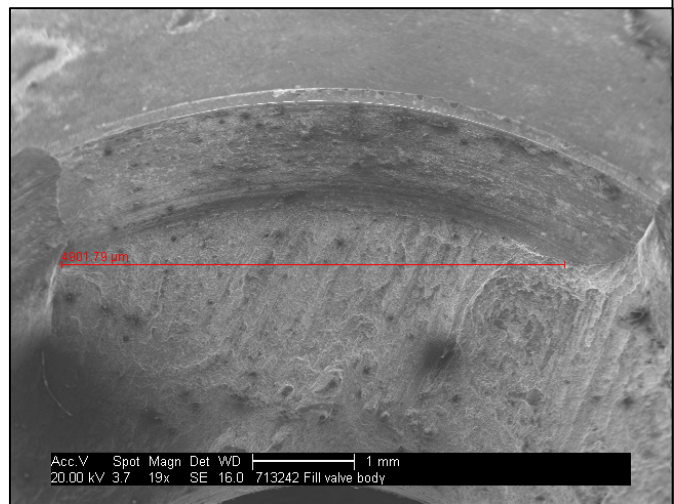
# Figure 12 - Thread Root Comparison

Figure 12 provides side by side comparisons at the thread root of a fracture pattern on both the adaptor fitting and the fill valve. This comparison shows that the estimated distance between similar features measured on each remnant was highly similar and varied by less than 200 microns. Since the measurement locations for the comparable features were selected arbitrarily, and since the morphologies of the two features were visually highly similar (Figure 6), ***the two fractures were confirmed to be highly consistent and represented two mating surfaces of the same fracture.***

**Adaptor Fitting Fracture**  
(4733.5 & 5766.1 microns = 4.7 & 5.8 mm)

**Fill Valve Thread Fracture**  
(4901.79 microns = 4.9 mm)

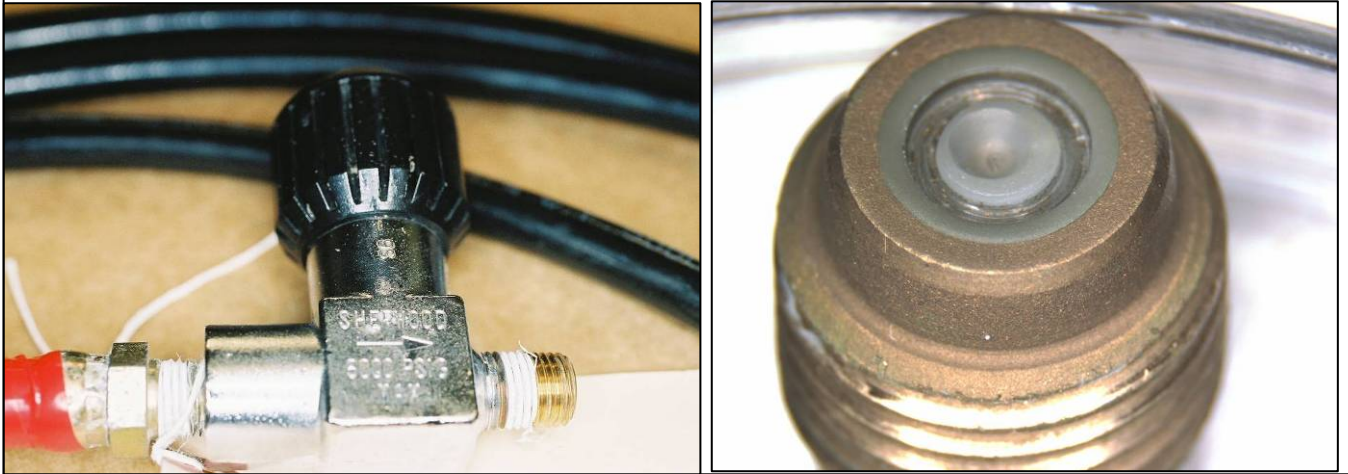
Figure 13: Upstream Fill Valve Condition  
(Sherwood Date Code 4302)

The upstream fill valve (Figure 13) did not exhibit evidence of internal combustion and the main seat of this valve was intact. The seat did exhibit evidence of extrusion where the plastic seat interacts with the valve body nozzle; but, no combustion was observed. A discoloration was noted on the compressed section of the seat (i.e., where the seat seals against the nozzle) but experience indicates this condition is common and consistent with abrasion and brass transfer to the plastic. In order to evaluate the potential presence of contaminants within the gas supply components, the internal surfaces of this valve were washed with a solvent (AK225)<sup>3</sup>. The results of this analysis will be discussed later in this report.

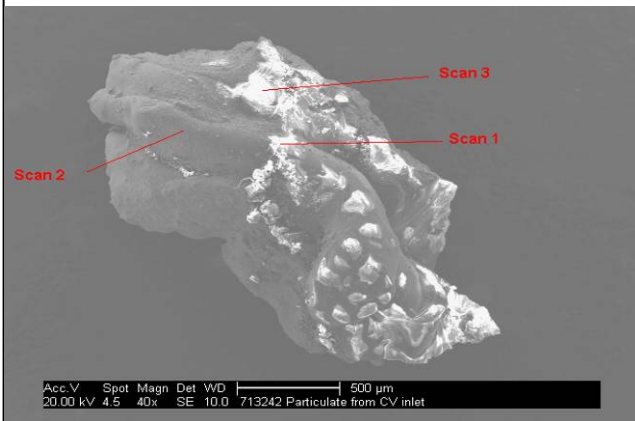
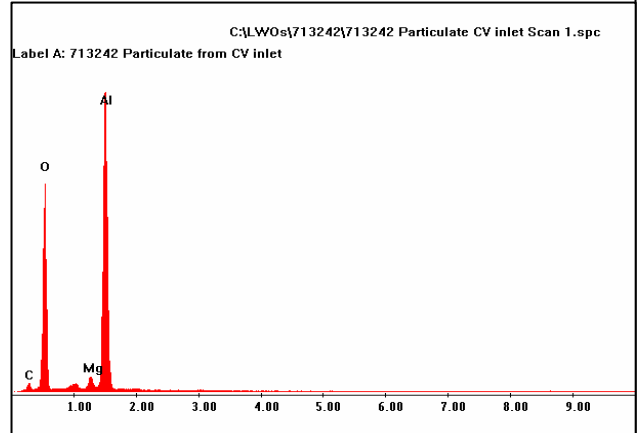
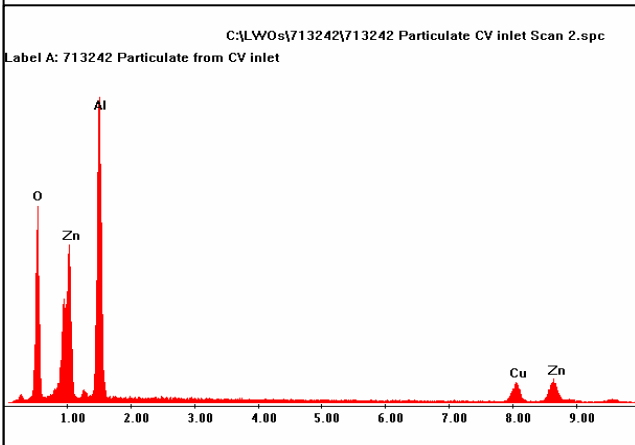
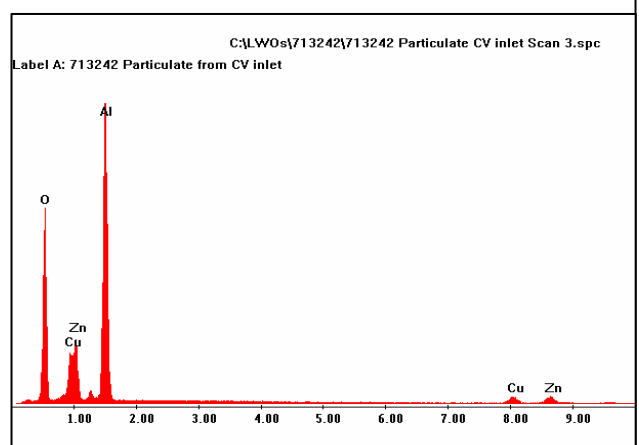
Figure 20 - Particulate Residue Removed From Cylinder Valve Inlet Bore

pressure oxygen at the pressures understood to have existed. However, if provided with sufficiently strong ignition mechanisms<sup>5</sup>, the aluminum can be ignited and would be expected to self-support combustion. Therefore, the melt flow character observed at the inlet to the cylinder valve and the resolidified melt mass that comprised a mixture of brass and aluminum oxide further supported the conclusion that the THERMO valve had been attached to the cylinder at the time of the fire. This residue mass was considered consistent with combustion residue from the cylinder back-flowing through the valve prior to the valve being energetically ejected from the cylinder during the event.

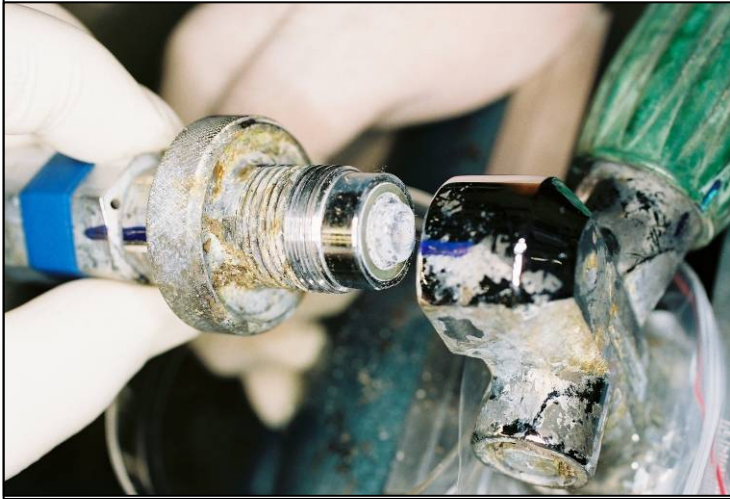
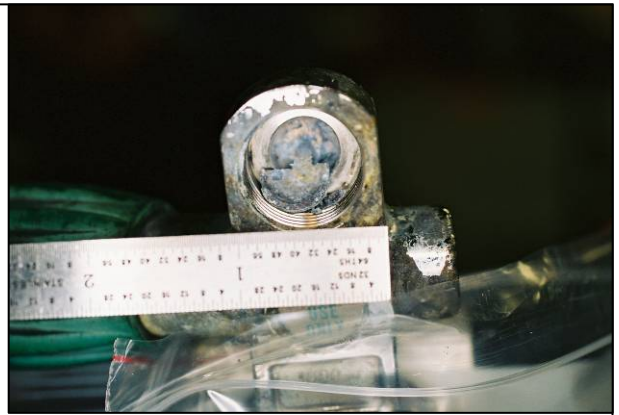
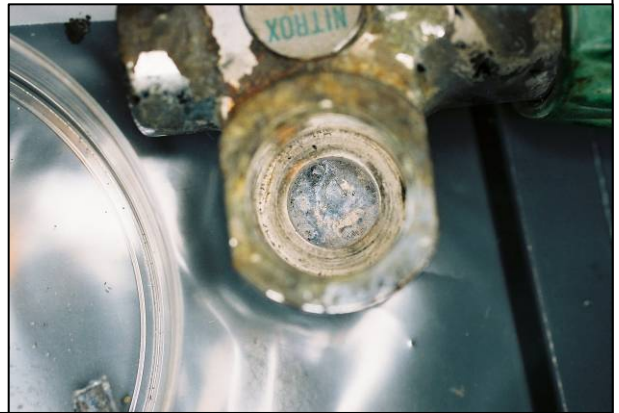
Figure 21 – Cylinder Valve Outlet Condition (Debris Collection)

Figures 21 and 22 depict the disassembly of the fill adaptor from the cylinder valve outlet. A very significant amount of combustion residue, also comprised of a resolidified mass of brass and aluminum-oxide (see Figures 23-25), was observed in the outlet port of the cylinder valve where the adaptor fitting would hinder free gas flow due to the change in flow direction. The adaptor fitting interface was also heavily deposited with brass and aluminum-oxide combustion residue (Figure 22). This resolidified mass was consistent with combustion product back-flow from the cylinder after combustion of the aluminum had developed. Based on the significant degree of combustion observed with the neck and upper crown of the aluminum cylinder (Figure 2), especially at the threaded connection, this mass was consistent with the melting of the base of the brass valve while exposed to the significant thermal energy release of aluminum combustion in oxygen<sup>6</sup>.

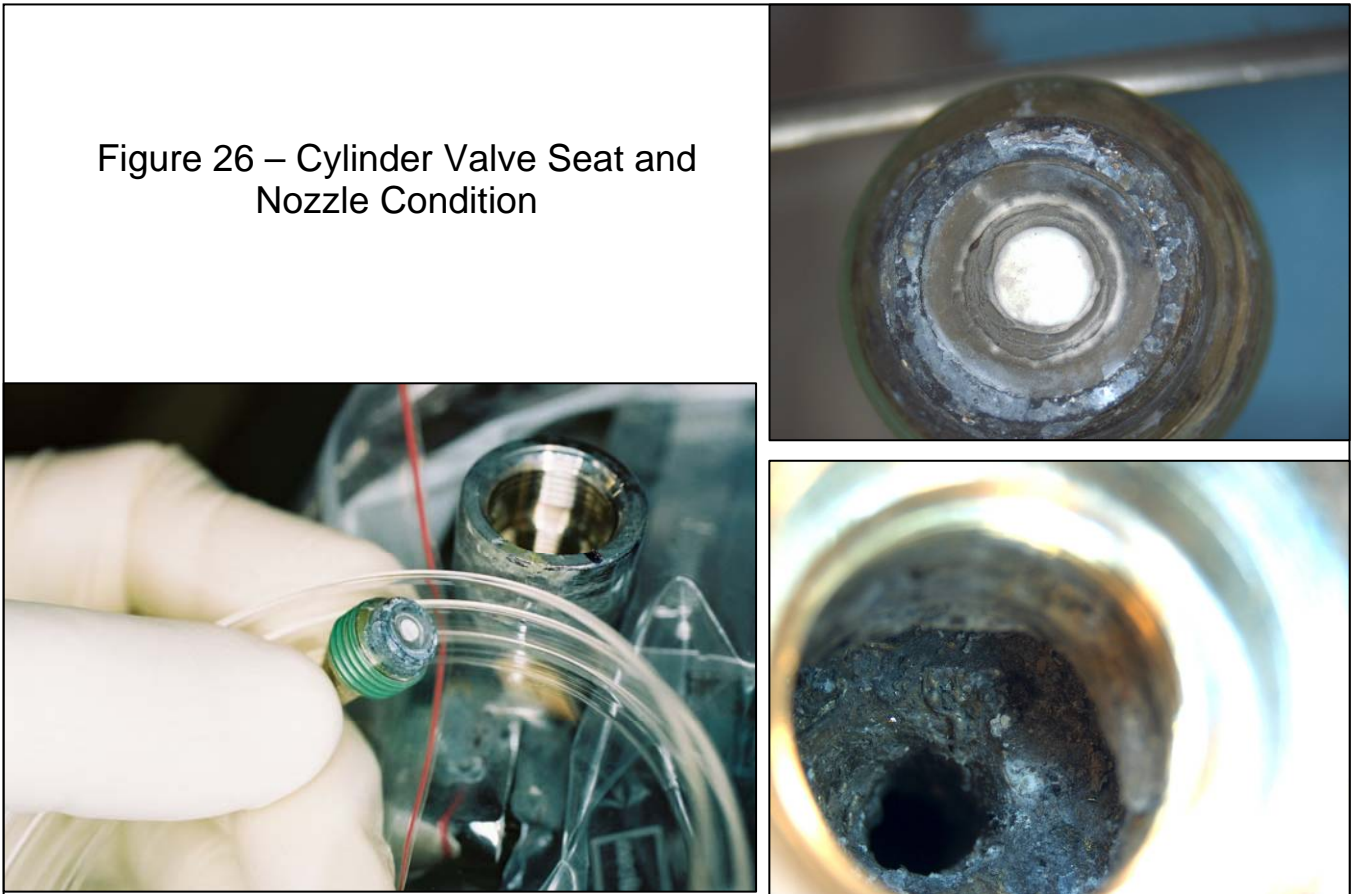
Figure 26 – Cylinder Valve Seat and Nozzle Condition

Figure 26 depicts the condition of the cylinder valve's plastic seat as well as the condition of the seat interface (or nozzle) within the valve. Based on the amount of combustion product that was ingested by the valve during the fire it was considered unusual that the plastic seat was not consumed. While the seat was heavily damaged and exhibited extensive thermal trauma, it was intact and not consumed. This was probably a result of the valve being open during the fire's initiation which helped to redirect the short duration of the combustion backflow<sup>7</sup> around the valve seat and into the valve outlet prior to the cylinder's rupture. WHA experience indicates that aluminum alloys burn very rapidly in high-pressure oxygen. Therefore, it is considered likely that the valve was ejected and the cylinder ruptured very shortly after ignition developed. The short duration of the plastic seat's exposure to the combustion products and the redirection of the backflow toward the valve outlet was believed to have protected the seat from ignition. In any event, it was clear that the cylinder valve was exposed to combustion backflow from the cylinder during the fire and that one possible ignition origin (i.e., the cylinder valve seat) could be ruled out.

- a. The intact condition of the cylinder valve seat, albeit deteriorated, rules out an origin at this location. WHA experience indicates that the plastic seat of a cylinder valve of this design can ignite due to flow dynamics; however, had this occurred in the accident in question, the seat would have been consumed.

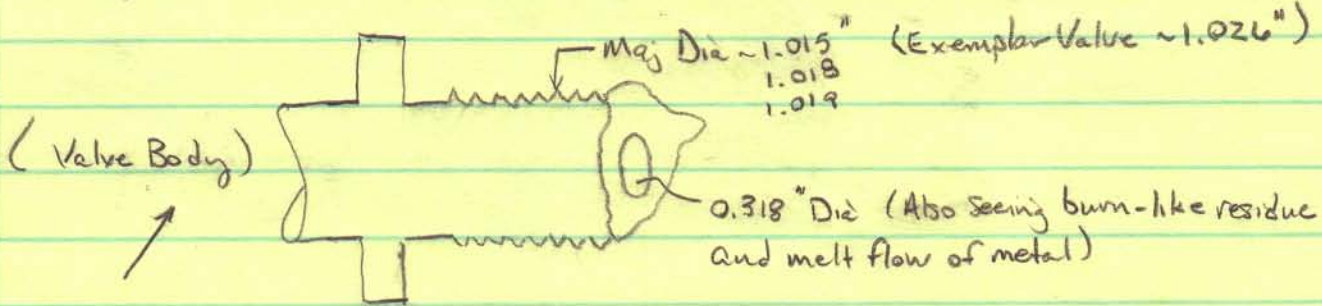
\* Some Teflon tape protruding  
Aluminium comb-like residue

"Nitrox Use Only" "Thermo" Stamped onto body  
Noting aluminium-like combustion residue on valve exterior surfaces  
Noting dirt in burst disc and on surfaces  
Understand valve found in mud puddle "days" after incident
