**METALLURGICAL EVALUATION  
OF A DOT-3AL2015 CYLINDER**  
FaAA Project No.: DC17916.000

U.S. Department of Transportation  
400 Seventh Street S.W.  
Washington, D.C. 20590

Timothy R. Smith, Ph.D., P.E.  
Failure Analysis Associates, Inc.  
310 Montgomery Street  
Alexandria, VA 22314

September 1997

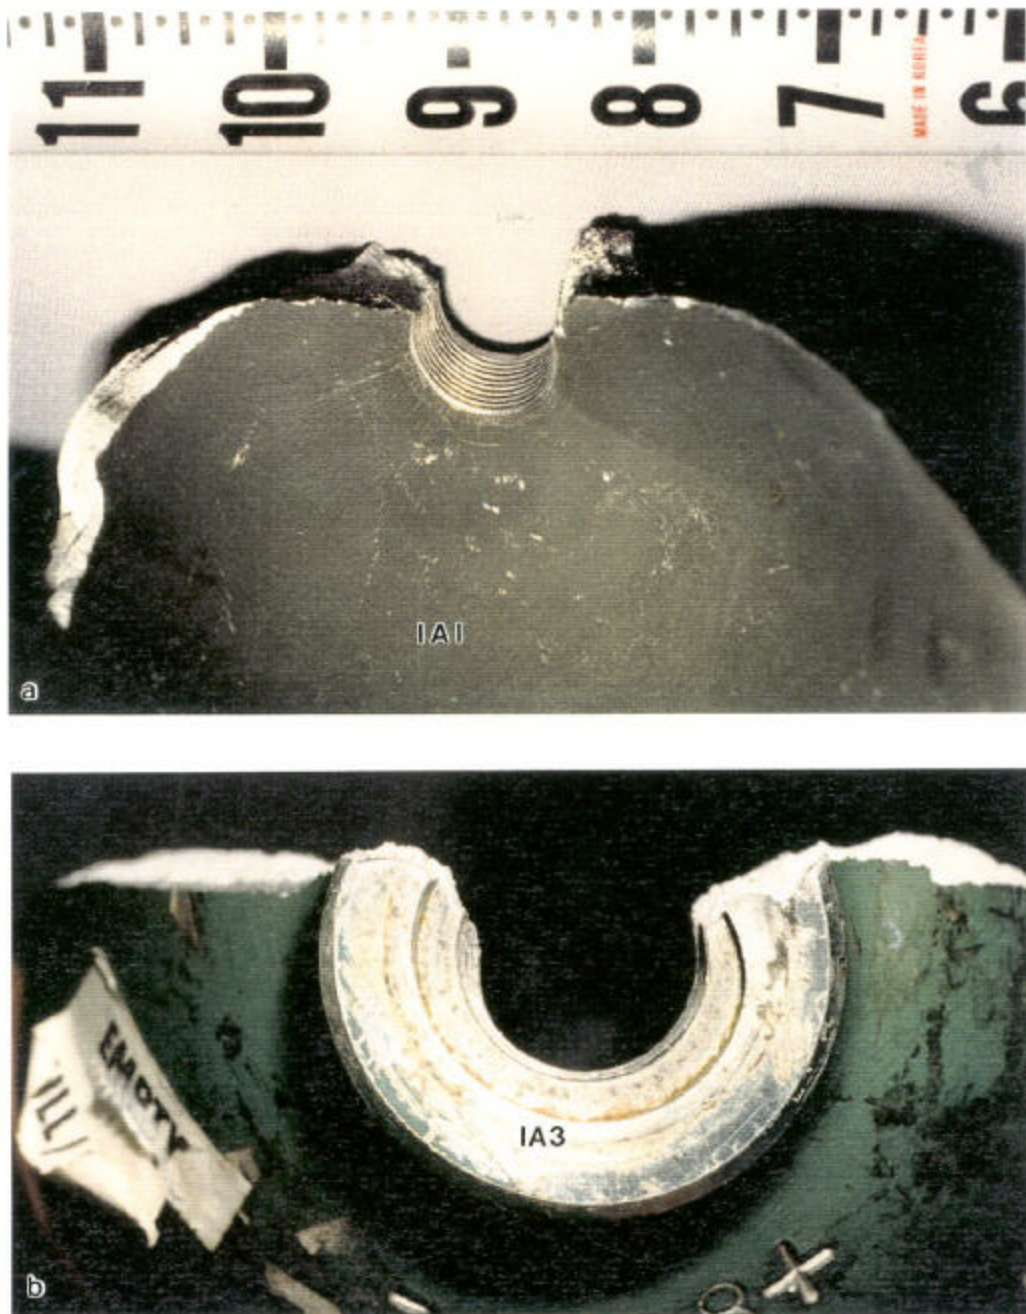
**Figure 2. Neck region of failed cylinder.**

The fracture surfaces of the cylinder were inclined (i.e., non-radial with respect to the cylinder axis) shear-type, except for a portion of the sidewall where the fracture surfaces were flat and radial with respect to the axis of the cylinder. In the neck region, the fracture did not pass through a diameter of the inlet hole.

(a) View inside looking out. Photo ID: DC17916-R2E12.

(b) View looking down on the inlet hole. Photo ID: DC17916-R2E20.

*Note that the fracture surface in the neck region is not parallel to the cylinder axis and the fracture path does not pass through a diameter of the inlet hole.*

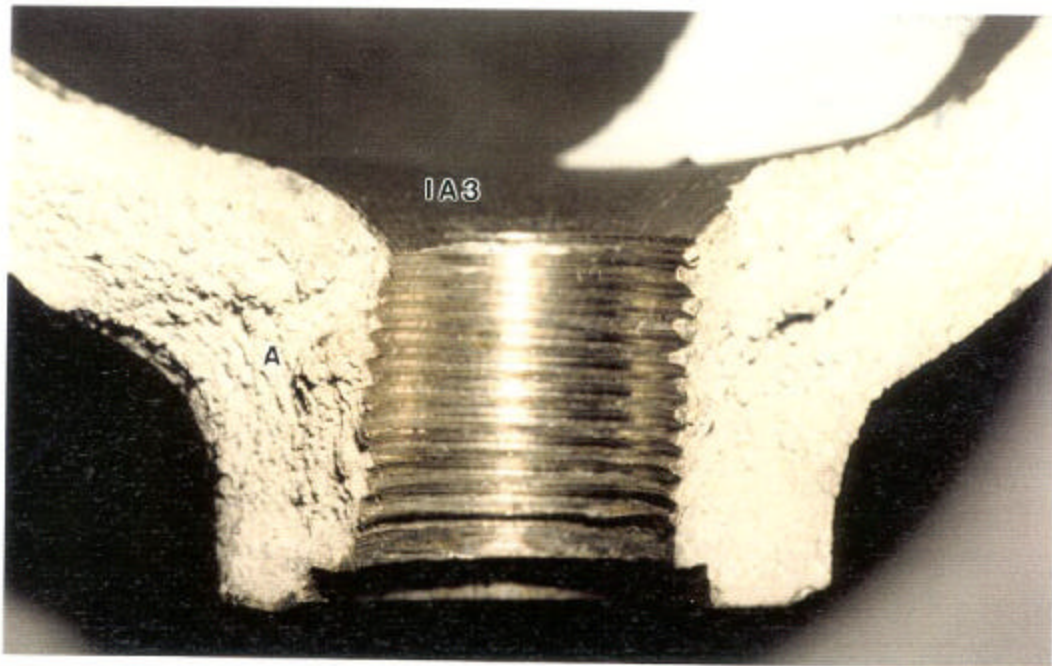
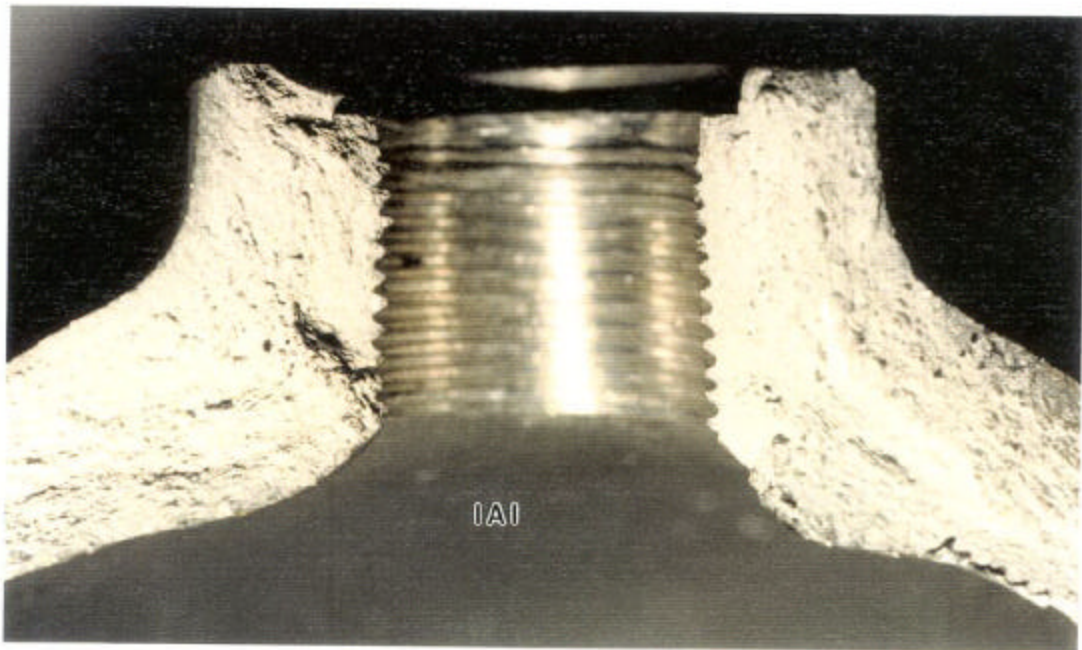
**Figure 3. Mating fracture surfaces at the inlet hole.**  
Fracture surface marked "A" was selected for further study.  
Photo ID: DC17916-R3E1 and -R2E15.

The fracture surface in the neck region on one side of the inlet hole (marked "A" in Figure 3) was sliced on a plane that was approximately parallel to the fracture surface. This portion was chosen for detailed fractographic examination (see below) as it appeared to be representative of the fracture surface in the neck region.

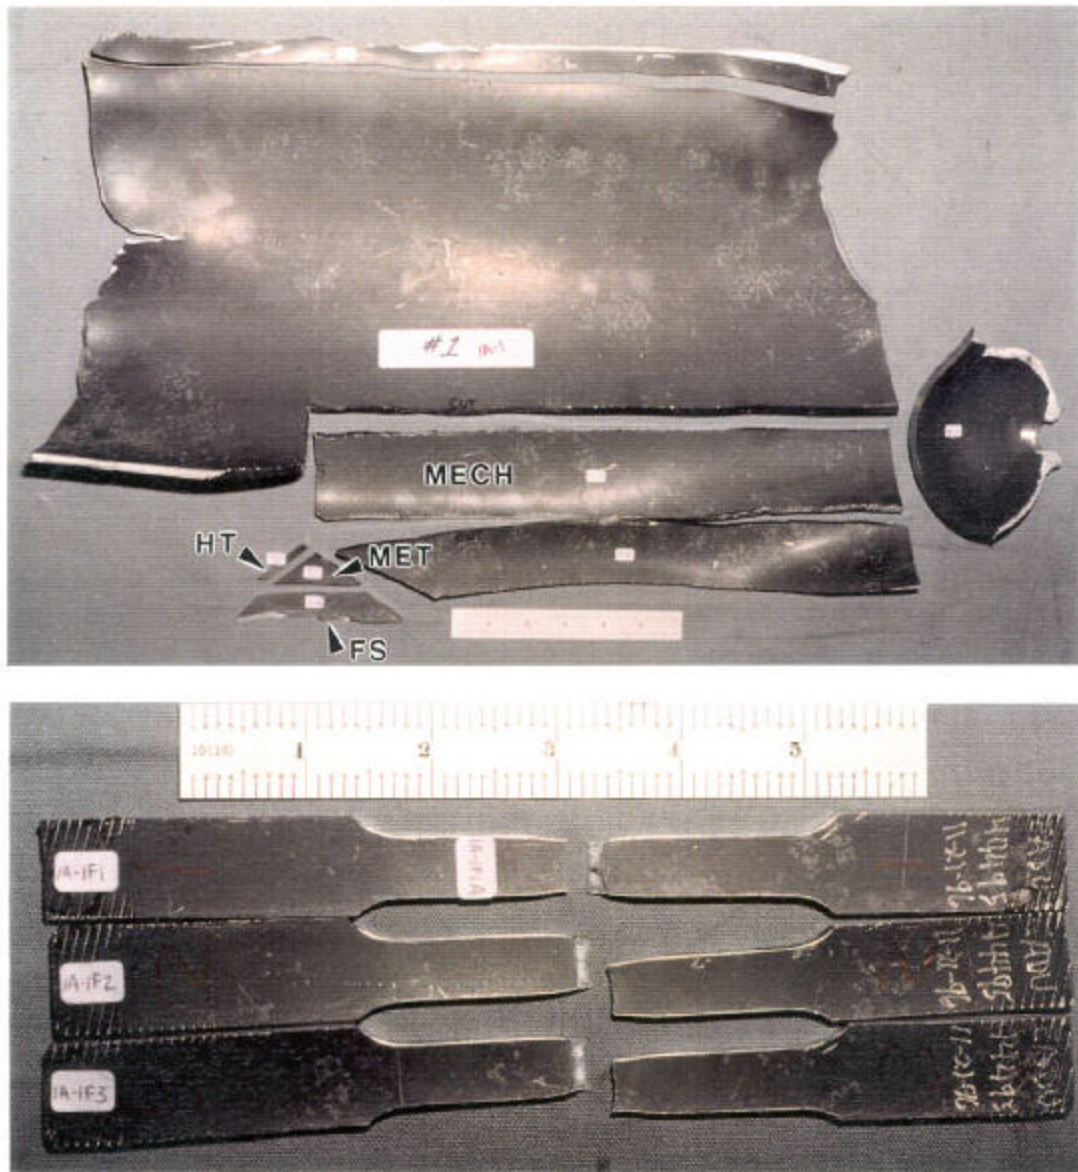
**Figure 4. Cylinder fragment 1A-1.**

Tensile tests were performed at room temperature on standard size ASTM A370 tensile test coupons from the cylinder wall, aligned along the cylinder axis. Sectioning was performed on fragment 1A-1, Figure 4. Component 1A-1F was used for the tensile test coupons, as it contained material minimally deformed by the cylinder rupture. Three full-thickness coupons were machined and Figure 4b shows them in the post-tested configuration. The test data are shown in Table 3.

(a) Sections cut. Photo ID: DC17916-R11E19.

*Note "MECH" denotes the piece used for machining tensile test coupons, "MET" denotes the section used for metallographic examination, "HT" denotes the section used for Rockwell hardness measurements, and "FS" denotes the fracture surface from the region marked with the arrow in Figure 1.*

(b) Tensile test coupons in the post-test condition.

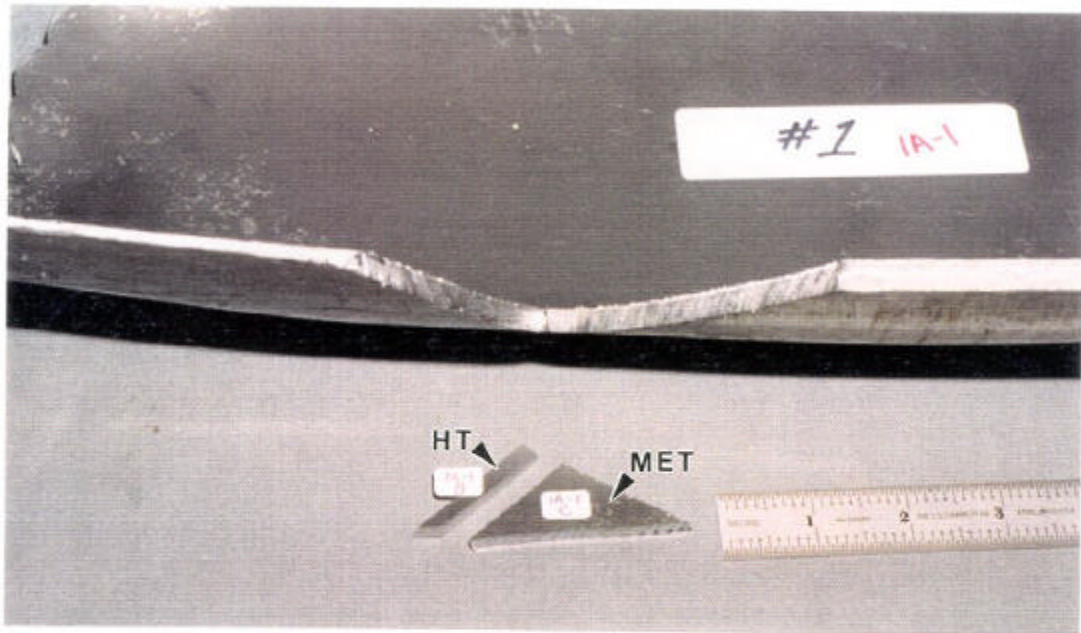
**Figure 5.** Close up of sidewall region showing "HT" and "MET" sections from Figure 4.  
Photo ID: DC17916-R11E7.

Sections were cut from the sidewall region, Figure 5, for metallography, hardness testing, and to remove a portion of the fracture surface (see Figure 1) for further detailed examination. The section for metallography (MET) was polished and etched using standard techniques and photographed under polarized light to reveal the grain structure, Figure 6. Note that, in these micrographs, the grain boundaries are lighter than the matrix. The microstructure observed appears to be typical for AA6351-T6 [2].

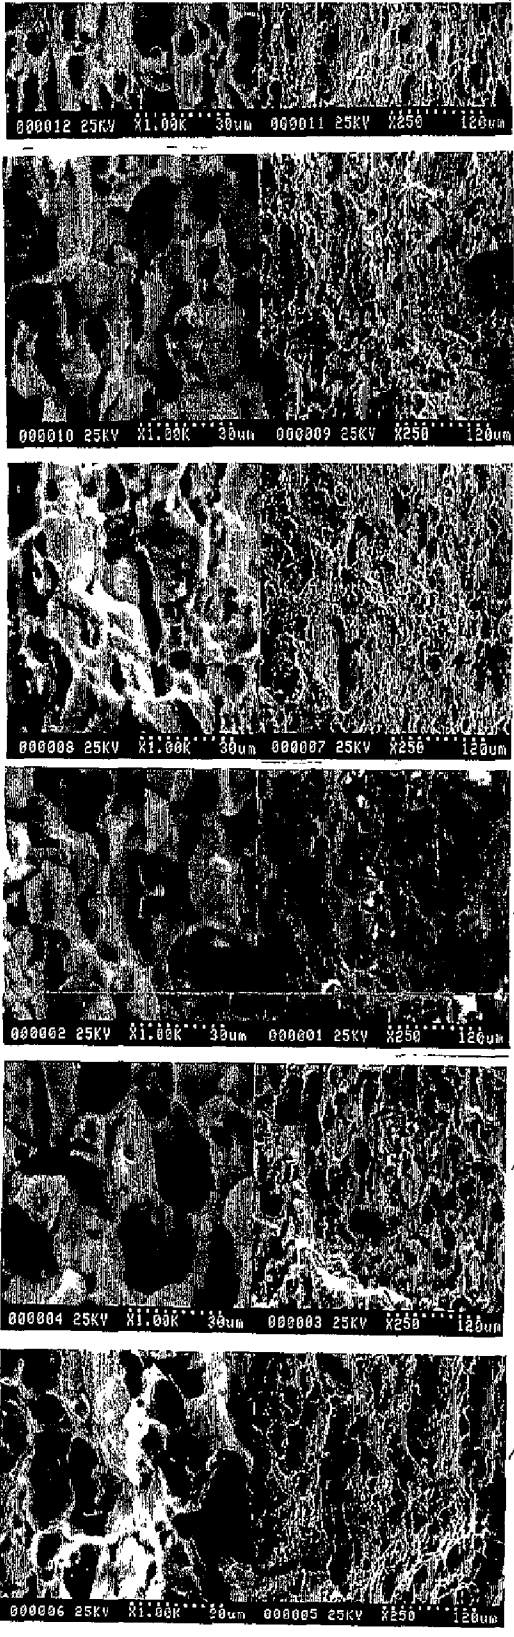
Figure 10. SEM fractography of fracture surface

Figure 10 shows an scanning electron image montage of the sidewall fracture shown in Figure 9. The flat, discolored regions correspond to regions of intergranular fracture. Some of these regions show microdimpling on the grain facets. Varying degrees of oxidation/corrosion are also seen on these facets. The intergranular facets should be compared with the microstructure of the sidewall region shown in Figure 6. The intergranular flat regions form a feature of approximately 2 inches in length axially, and penetrating about 90% of the wall thickness from the exterior. The thin band (i.e., approximately 10% of the wall thickness) near to the inside surface is characterized by ductile dimpled rupture. The slant-type regions at both ends of the flat area are characterized by ductile dimpled rupture, with some faceting.

- The cylinder failure initiated from the sidewall near to a series of surface indentation marks attributable to mechanical damage. Multiple sites of intergranular corrosive attack beneath these indentation marks (pre-dating the cylinder's rupture) apparently linked to form a crack approximately 2 inches in length and penetrating about 90% of the wall thickness from the exterior. This crack then propagated unstably to failure.
