**METALLURGICAL
EVALUATION
OF DOT-3AL-2015
CYLINDER T-57003**

Prepared for

U.S. Department of Transportation
400 Seventh Street S.W.
Washington, DC 20590

November 1998

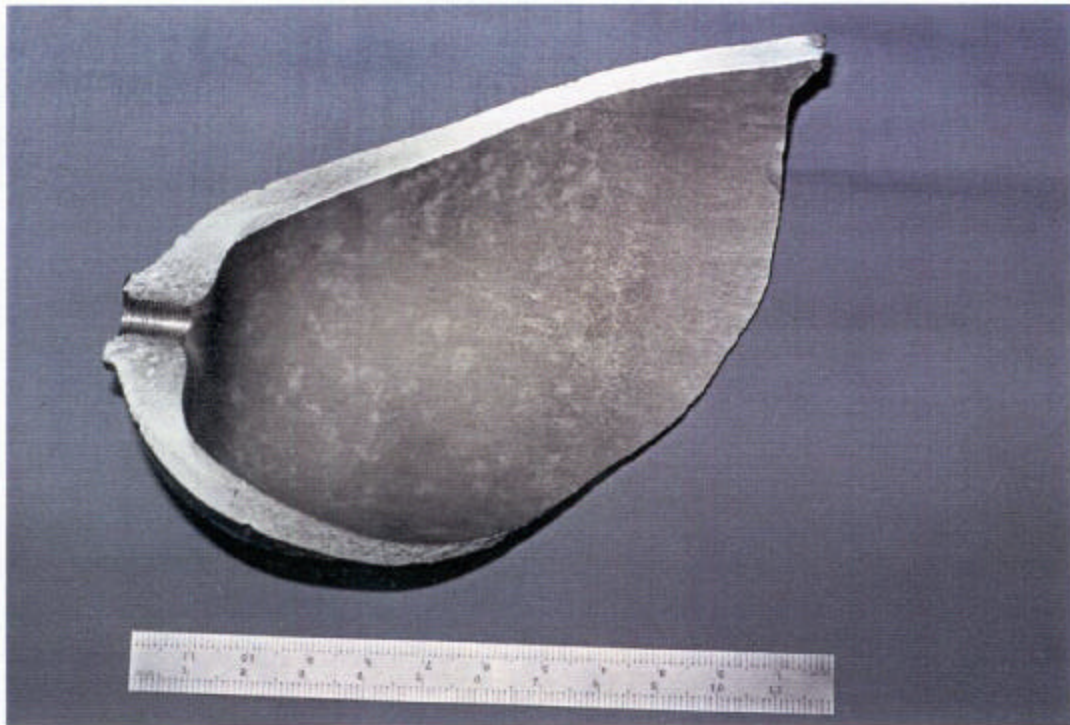
A visual examination of the cylinder remains was performed. The remains are shown in Figures 1 and 2 in the as-received condition. The cylinder broke apart into two large pieces. The bottom of the cylinder erupted as seen in Figure 2.

Figure 1: Cylinder remains, as-received
Fragment 2A-1. Photo ID: DC18128-R1E17

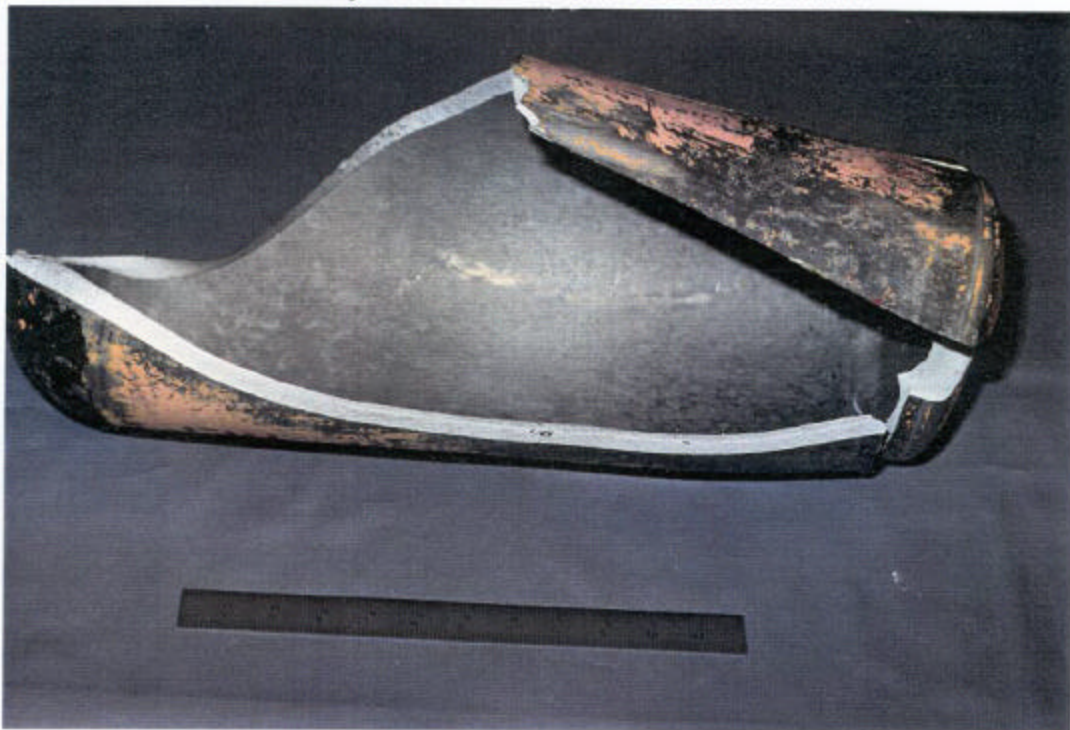
Figure 2: Cylinder remains, as-received
Fragment 1A-1. Photo ID: DC18128-R1E20

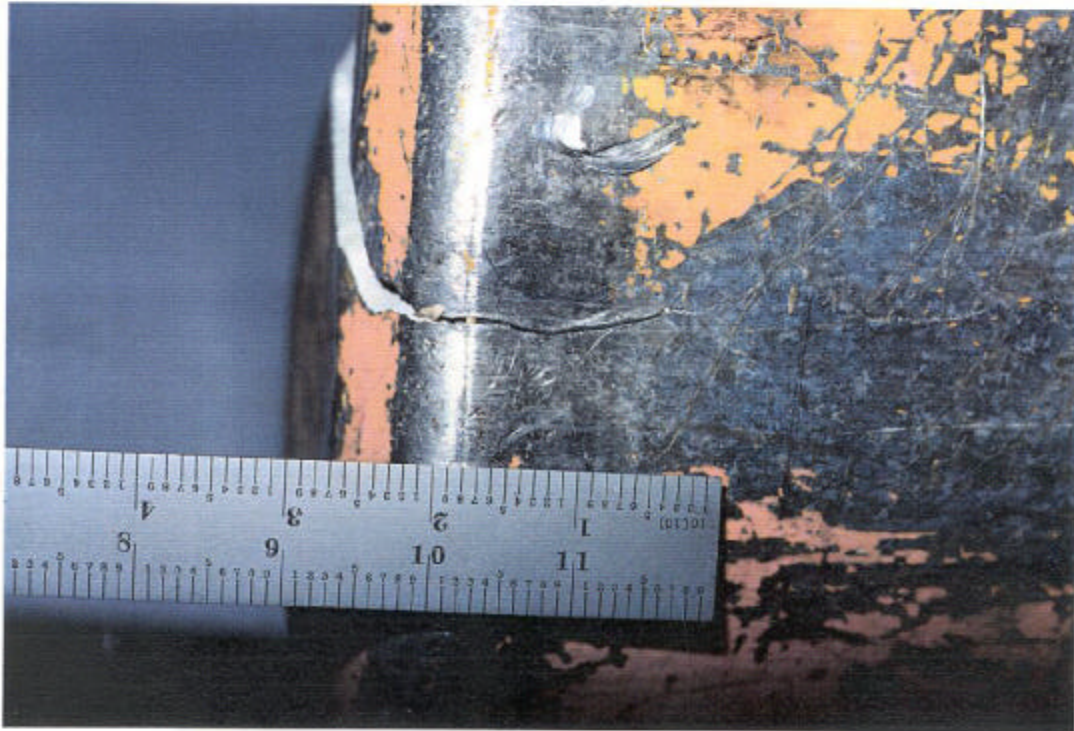
Figure 3: Cylinder remains, as-received
Fragment 1A-1. Photo ID: DC18128-R1E24

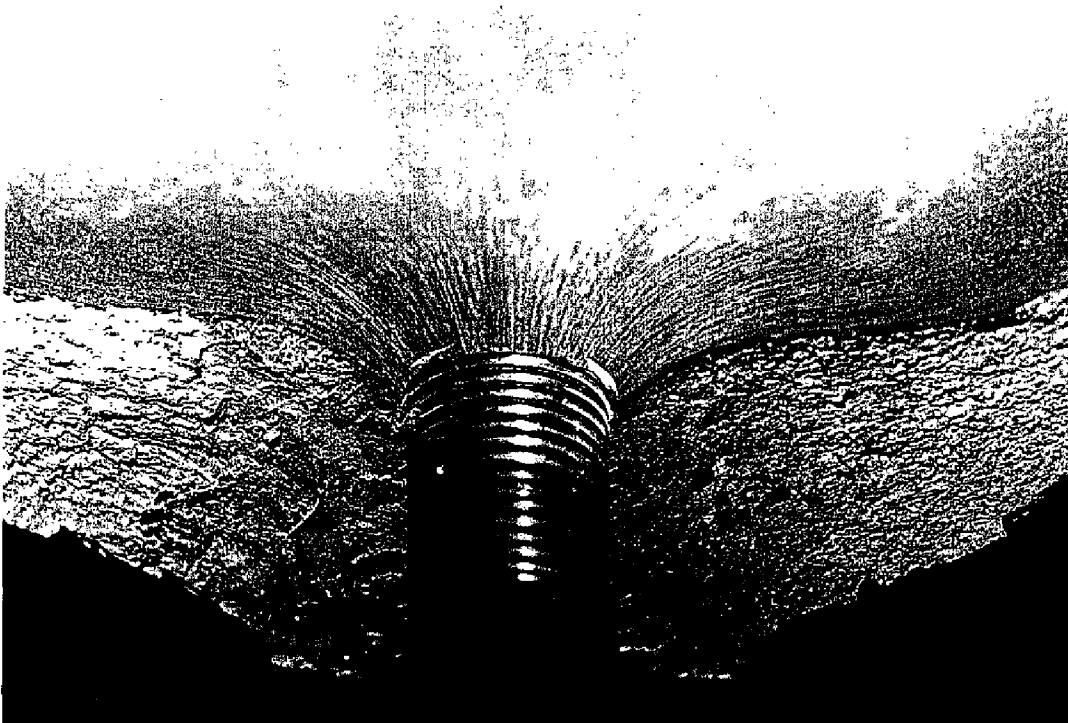
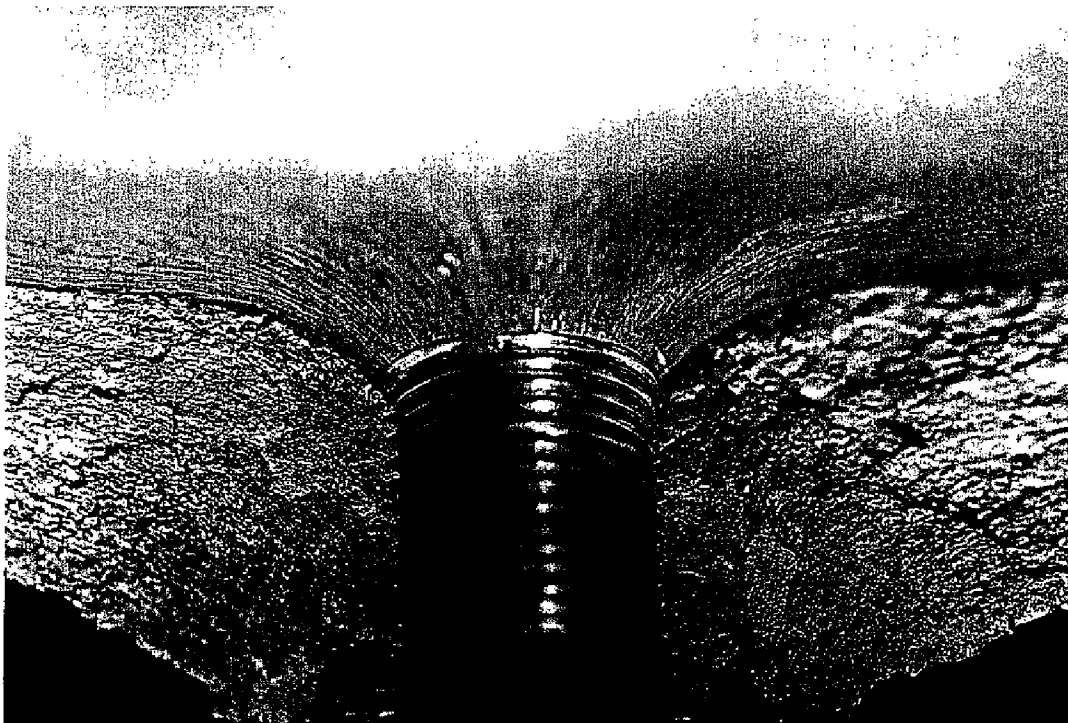
The fracture surfaces of the cylinder were inclined (i.e., non-radial with respect to the cylinder axis) shear-type except for a portion of the neck where the fracture surfaces were flat and radial with respect to the axis of the cylinder. In the neck region, the fracture appears to pass through a diameter of the inlet. Figure 3 shows the erupted bottom. Regions of the bottom separated from the sidewall with a crack extending into the side parallel to the axis of the cylinder. In the neck region, the inside wall of the cylinder in this region shows multiple folds (or cusps) from the original manufacturing process, Figure 4. The fracture surface on both sides of the inlet hole appears to pass through folds of this type. A slight amount of aluminum corrosion product was present on the threaded region.

Figure 4: Fracture surface at the inlet hole.
Photo ID: DC18128-R1E9, R2E7

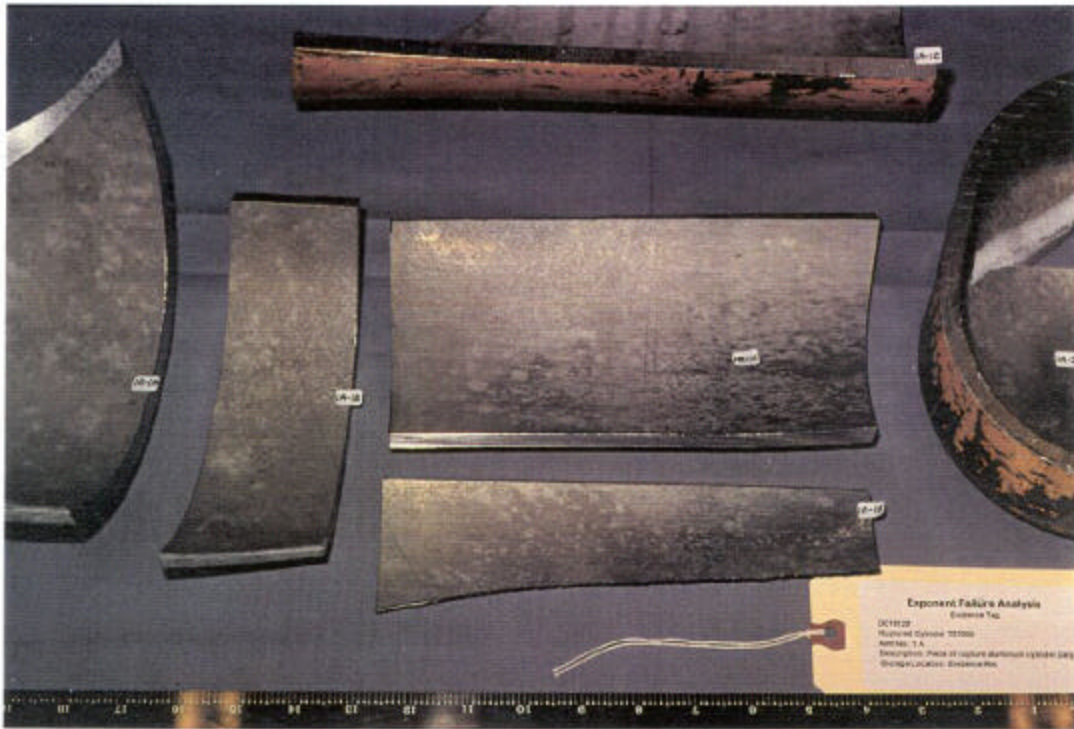
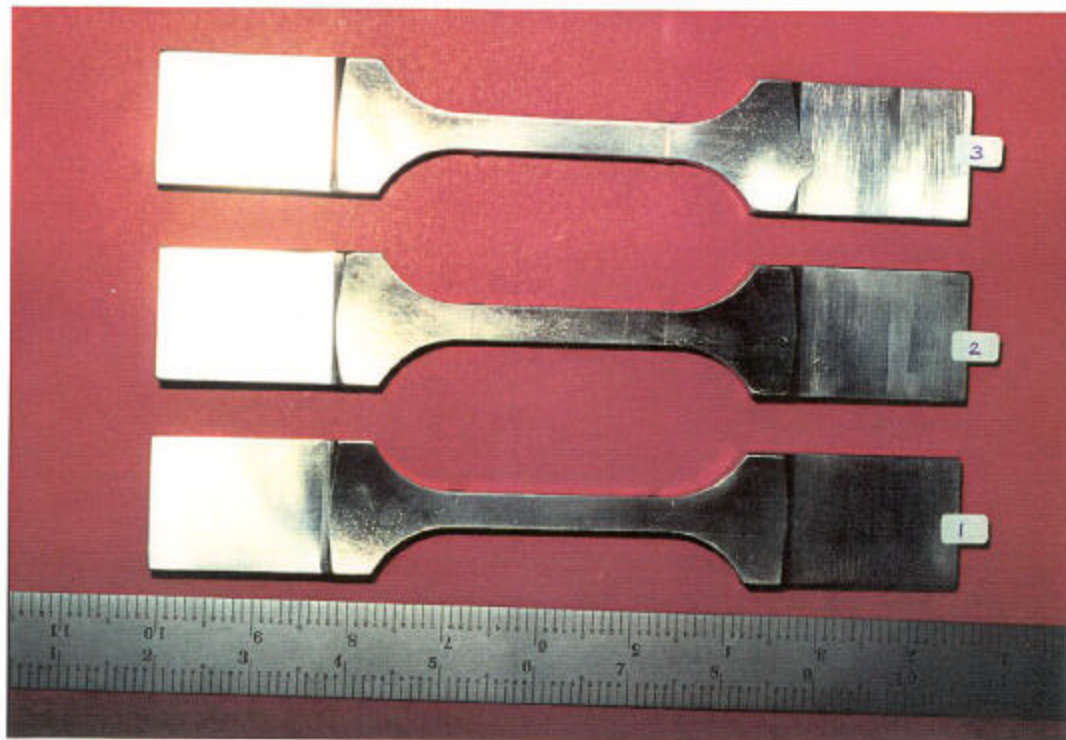
Figure 5: Cylinder fragments 1A-1.

Full thickness tensile test coupons from the cylinder wall, aligned along the cylinder axis, were tested at room temperature in accordance with ASTM B557 and following the procedure given by 49 CFR 178.46-13. The samples were machined from the segment marked "Mech" in Figure 5. The results of these tests are shown in Table 2.

(a) Sections cut. Photo ID: DC18128-R4E5.

Note "MECH" denotes the piece used for machining tensile test coupon.

(b) Tensile test coupons, DC18128-R5E11.

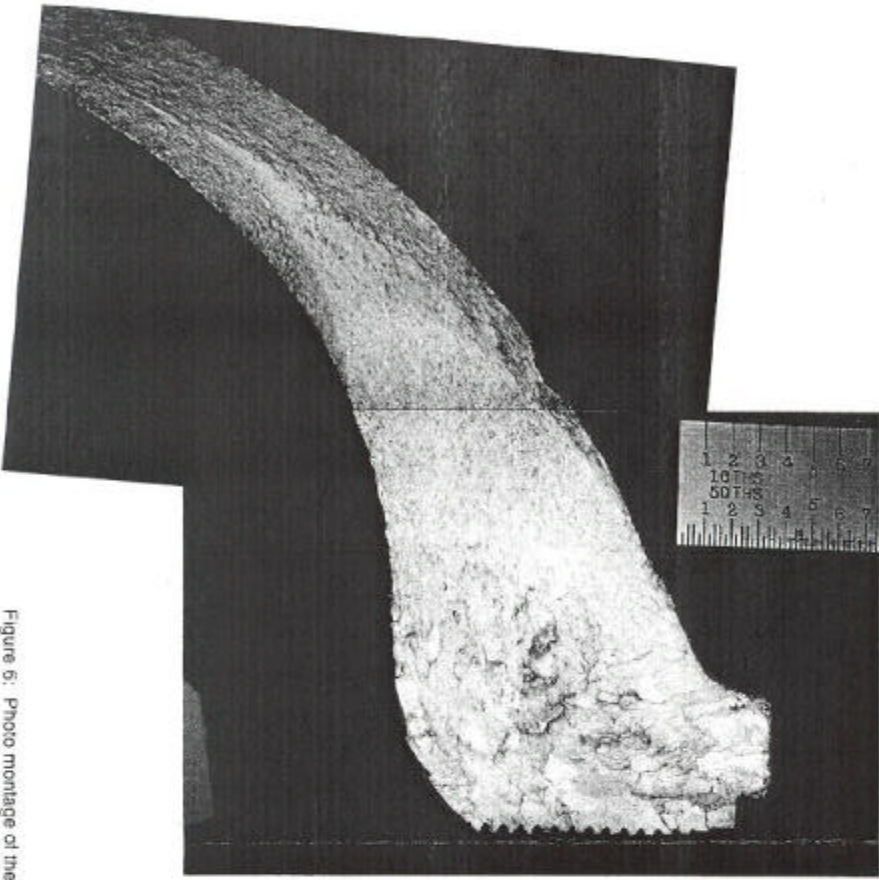
The wafer (samples 2A-1 and 2A-2) containing the flat-face fracture surface is shown in Figure 6. Optical examination revealed that the flat-face region of the fracture surface shows little macroscopic ductility. Just outside of this region, the fracture surface transitioned to an inclined shear-type of fracture.

Examination of the fracture surfaces of each cylinder fragment suggests that the failure originated from the neck region of the cylinder near to the inlet hole. The flat-faced (i.e., radial) nature of the fracture surface at the neck region, followed by a transition to an inclined (i.e., non-radial) shear type of fracture on both sides of the cylinder, suggests fast fracture initiating nearly simultaneously on diametrically opposed sides of the inlet hole, prior to final rupture. Based on Figures 9, 10, and 11, subcritical cracking clearly existed to a small extent near to the inlet hole at folds in the inside wall. The origin of the rupture is at two of these small cracks; however, the similarity in the grain sizes (Figure 8) and the failure surfaces in Regions 1-3 suggests a "tearing-out" of the grains during a rapid ductile failure outward from the small cracks. This tearing of grains and the absence of beachmarks along the fracture surface suggests that the crack growth from these initial origin areas occurred during a single event. This event is consistent with an internal pressure well in excess of normal operation (i.e., an overpressurization) of the cylinder.

Figure 6: Photo montage of the fracture surface at the neck from fragment 2A, photo id DC18128-R3E1.2,3,4
Regions 1 through 5 represent areas for further study.

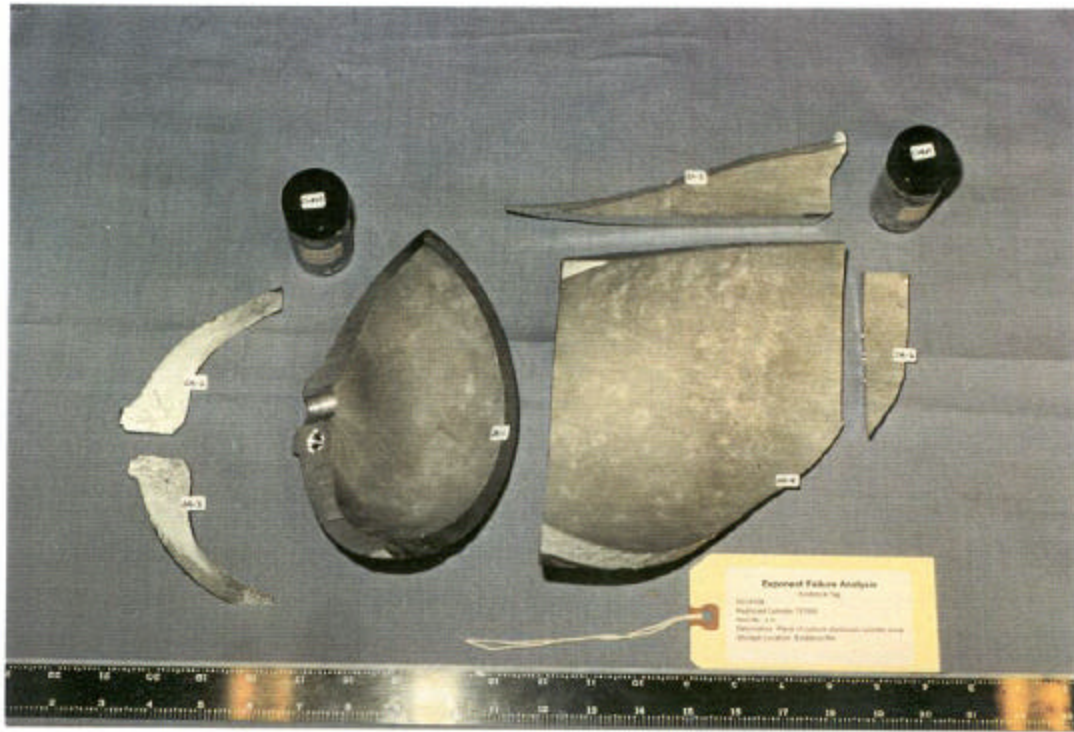
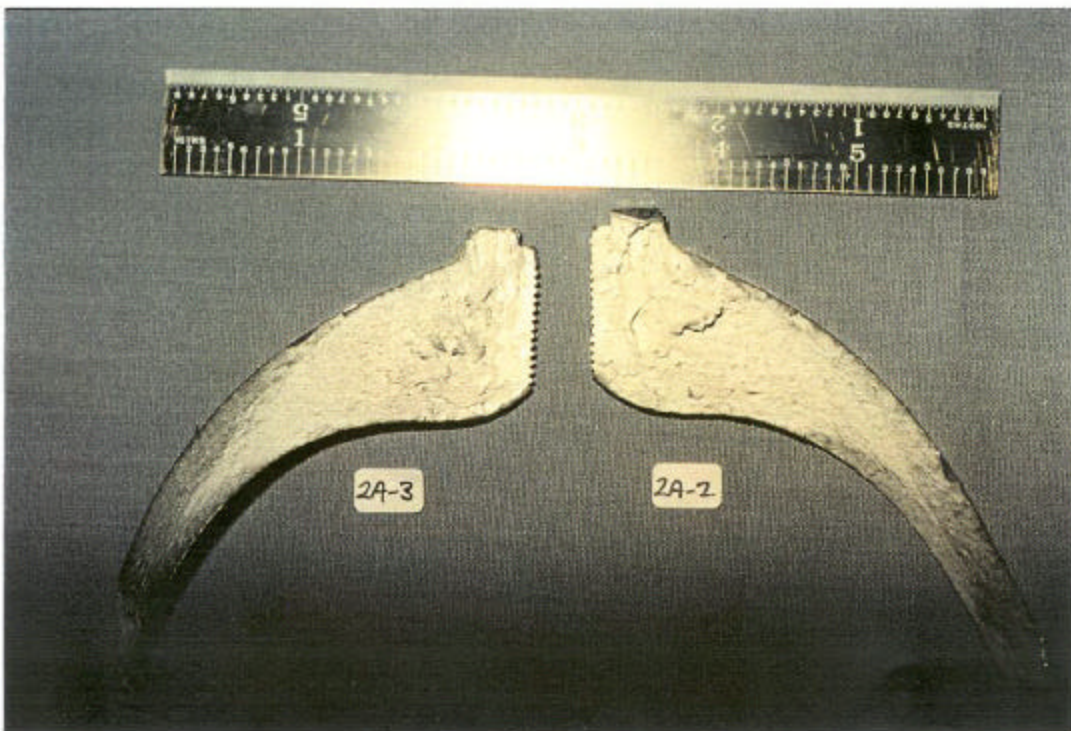
Figure 7: Sectioning of fragment 2A

The sections cut from cylinder fragment 2A-1 are shown in Figure 7. Sections of the fracture surface on both sides of the inlet were cut such that the flat-faced portion of the fracture surface was separated from the fragment. Two wafers were generated in the process.

(a) Overall view. Photo ID: DC18128-R3E2

(b) Close up of neck region. Photo ID: DC18128-R3E11

Note: the fracture surface portions that were removed and the drilling taken to determine chemical composition.

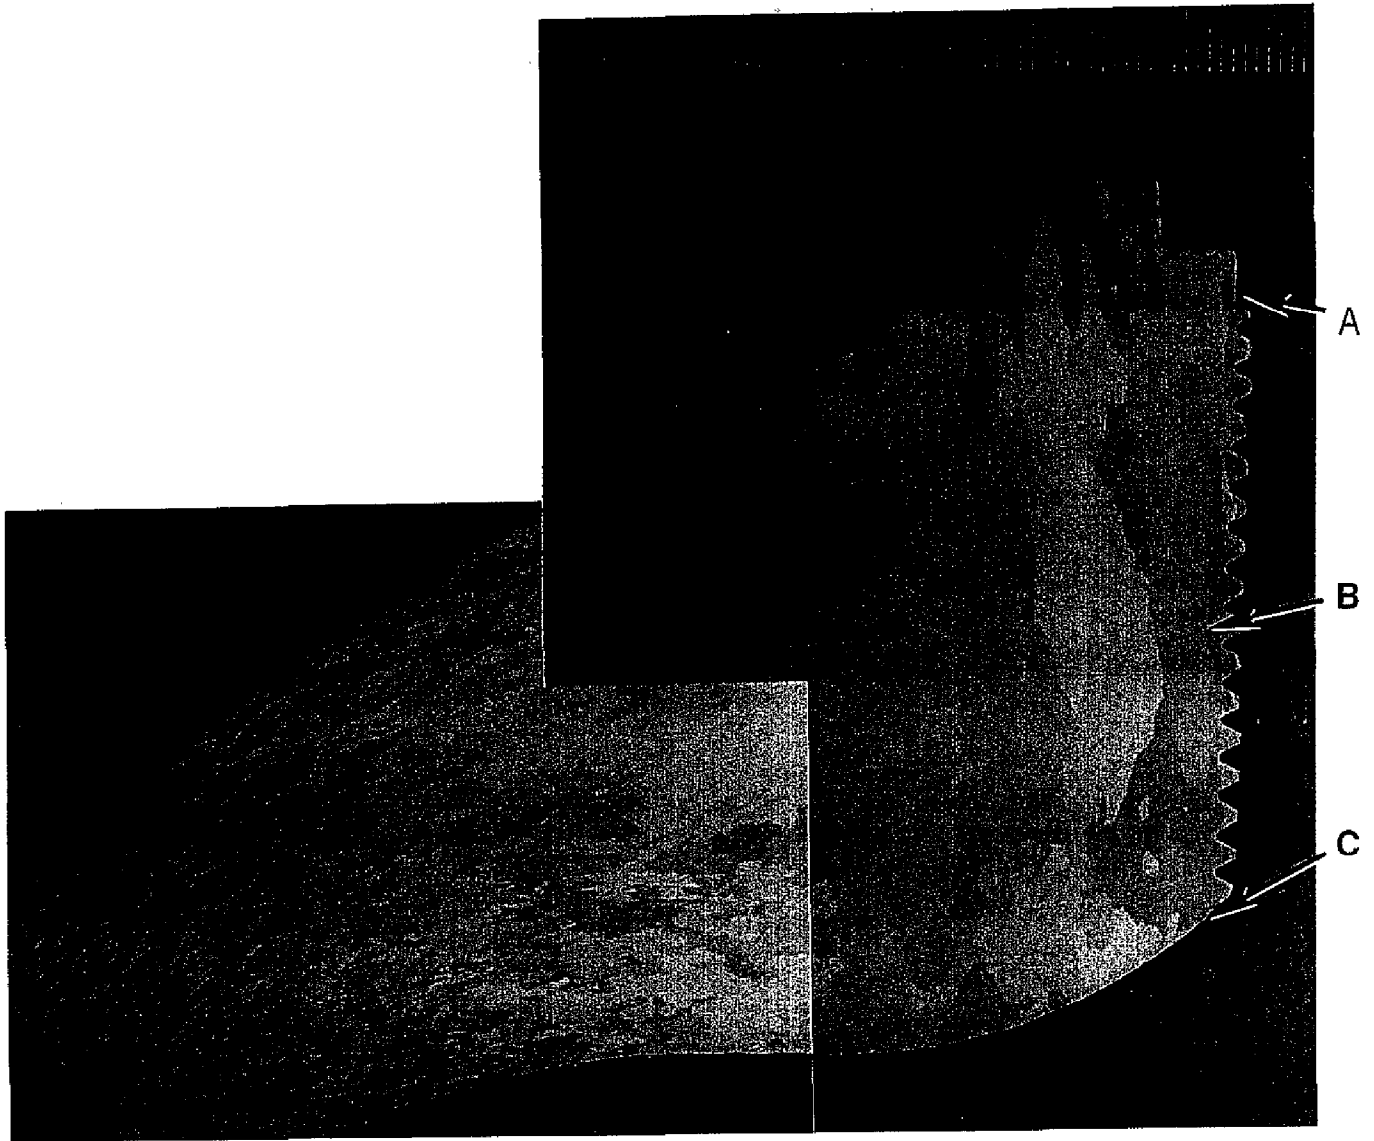
A section in the neck region of sample 2A-1 was sliced (2A-1A) and then polished and etched to reveal its microstructure, Figure 8. Note that the grain size varies from relatively large to small, compared to the thickness at the neck. Also note the directionality of the grains and their relative sizes along the neck and the commencement of the cylinder body. This grain configuration is a consequence of the neck forming process used during manufacturing. Figures 9, 10, and 11 show regions A, B, and C at higher magnifications. Small cracks are seen within these areas. Some of the cracks have origins at the surface while others do not. The cracks show fine-scale branches and appear to be discontinuous.

Figure 8: Section 2A-1A showing the microstructure in the neck region. Note the scale is in 0.05 inch increments. HF-H₂SO₄-H₂O etch. Photo ID: DC18128-PAL-1,2,3 8/5/98. Regions A, B, and C are investigated further in figures 9, 10, and 11.

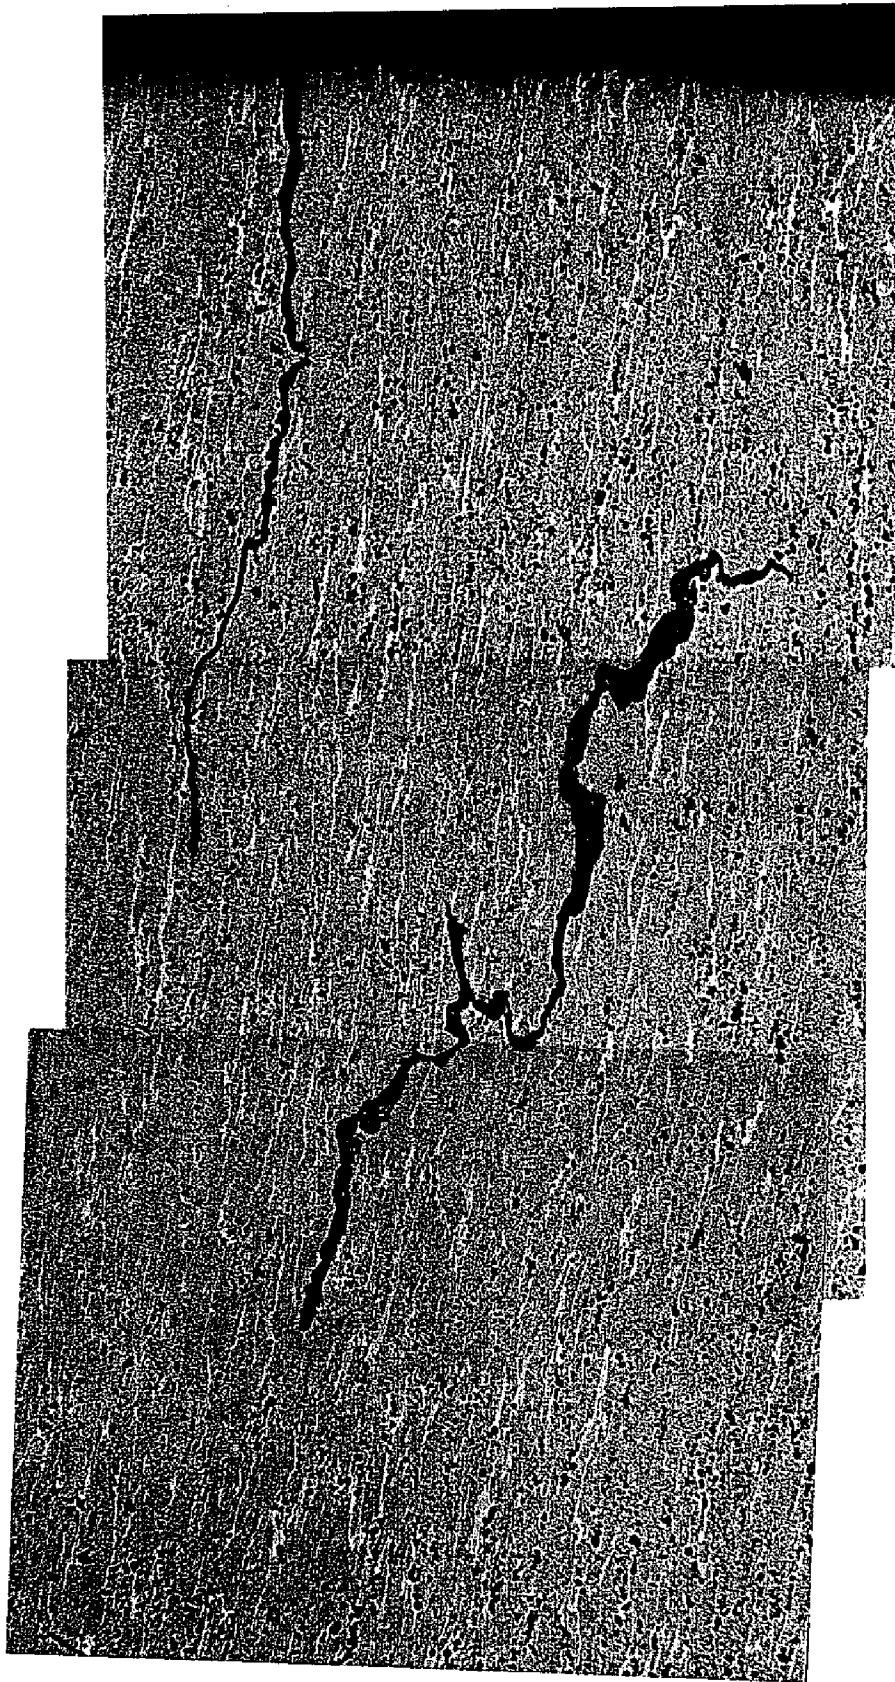
Figure 9: Section 2A-1A region A, photo montage. Photo ID: DC18128-Pa12, 3, 4 8/7/98.

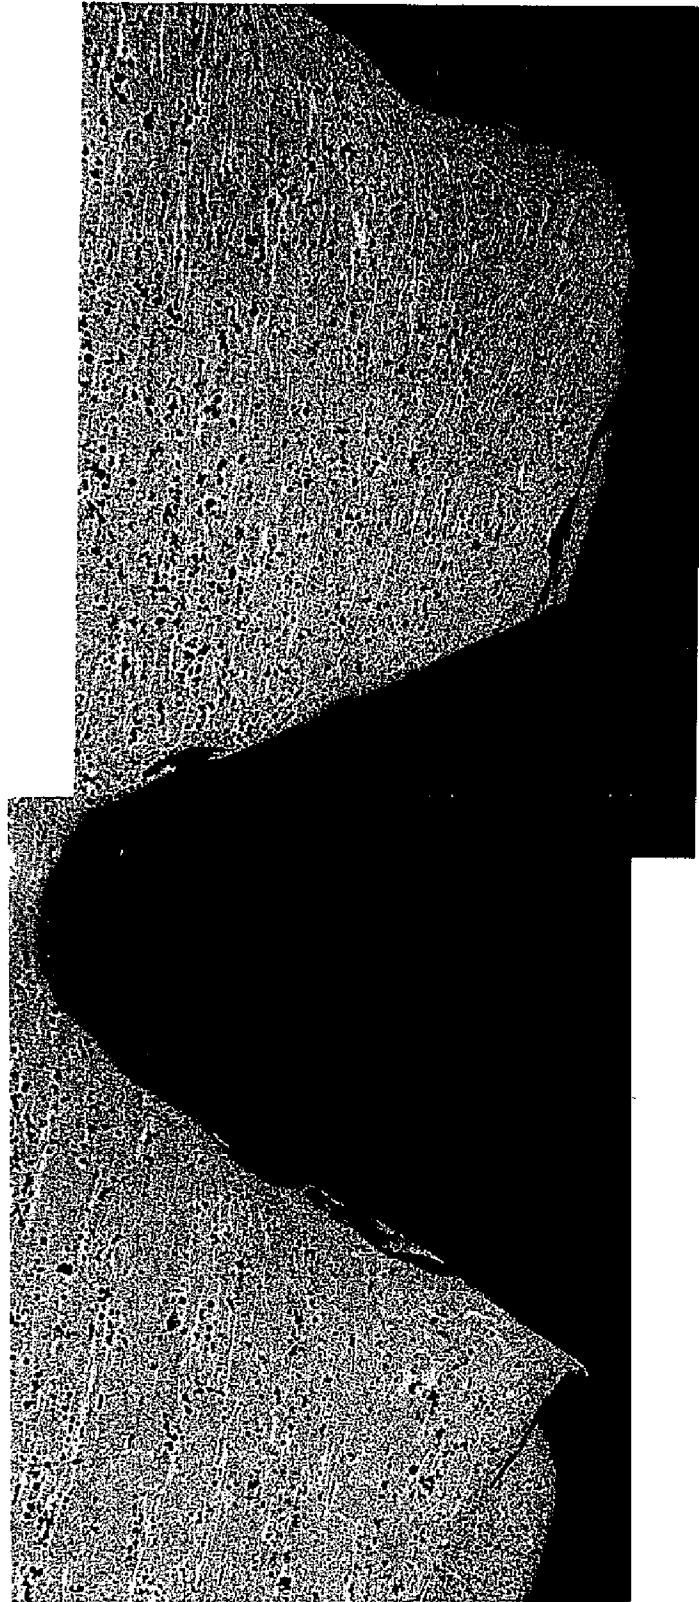
A minor amount of corrosion pitting and smearing or galling of the aluminum , threads is visible in Figure 10. Figure 12 shows energy dispersive spectra (EDS) taken from at or near the corrosion pits of the threaded region of sample 2A-2. Note the O, Ca, Cl, Fe, and Cu peaks, all of which are corrosion product or contaminants. The Cu and Fe are most probably from the treaded end of the regulator assembly that was screwed into the inlet hole during service.

Figure 10: Section 2A-1A region B, photo montage. Photo ID: DC18128-Pal10, 11 8/7/98.

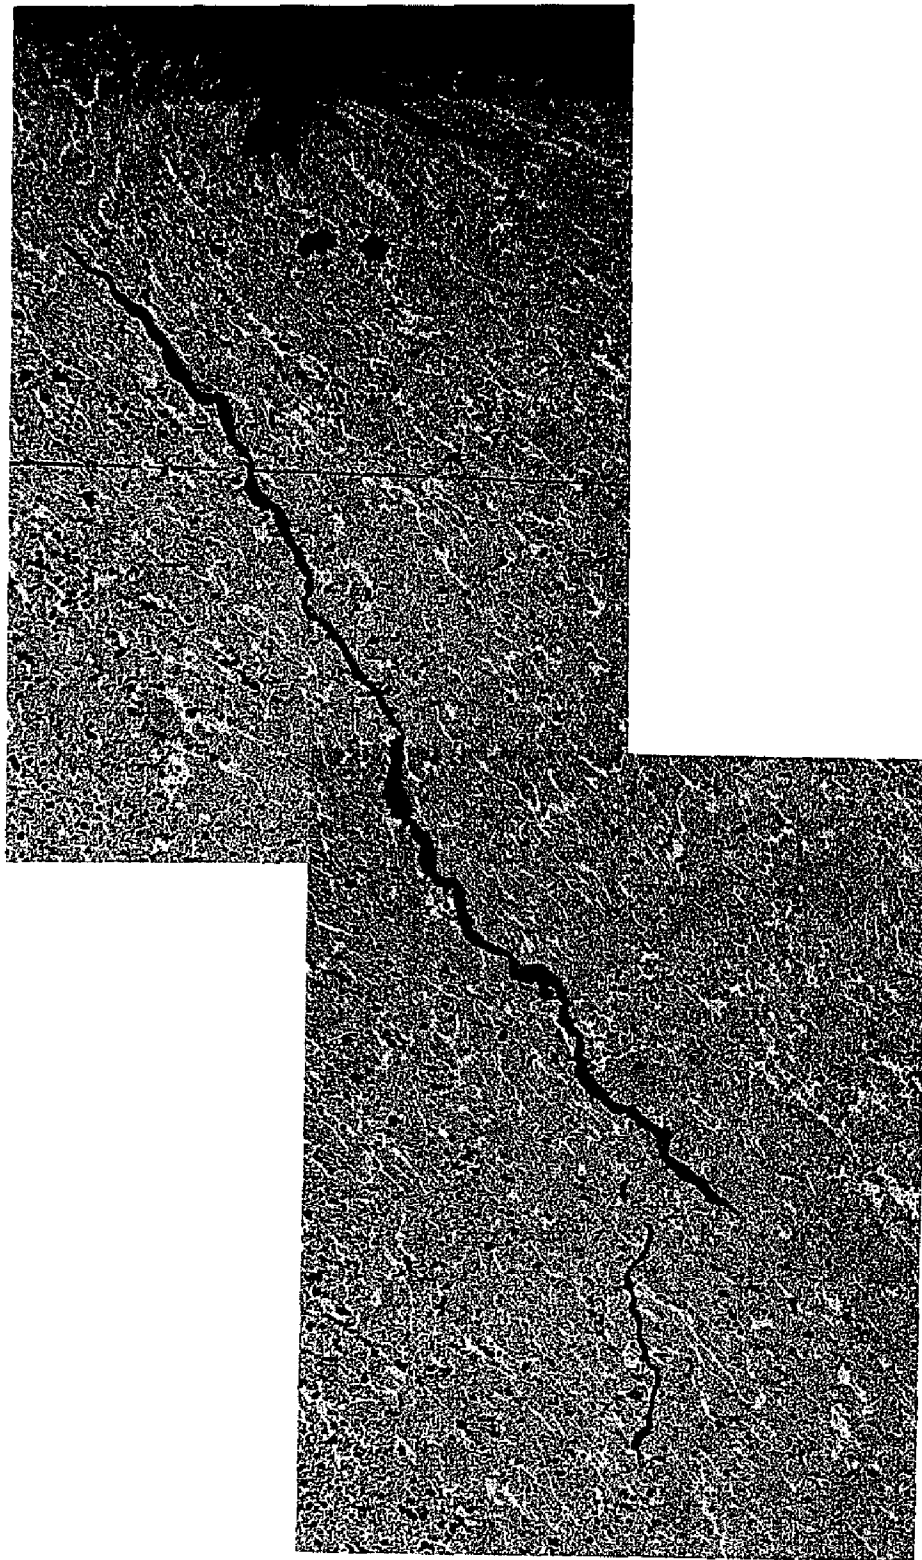
Sectioning of the cylinder wall just below the threads at the inlet hole revealed multiple cracks from multiple origins at folds (or cusps) in the inside wall. These cracks are similar to the small fracture origin cracks noted above. These branched cracks are consistent with cracks found in the neck region of other DOT-6498, DOT-3AL, and DOT-7235 aluminum cylinders [3]. Since no fatigue striations or evidence of another sub-critical crack growth mechanism were found, the observed cracks are more consistent with studies of "sustained-load cracking" reported in the literature for similar Al alloys, [2, 4-8] than fatigue or another sub-critical crack growth mechanism.

Figure 11: Section 2A-1A region C, photo montage. Photo ID: DC18128-Pal6, 7 8/7/98. Note the discontinuities in the crack.

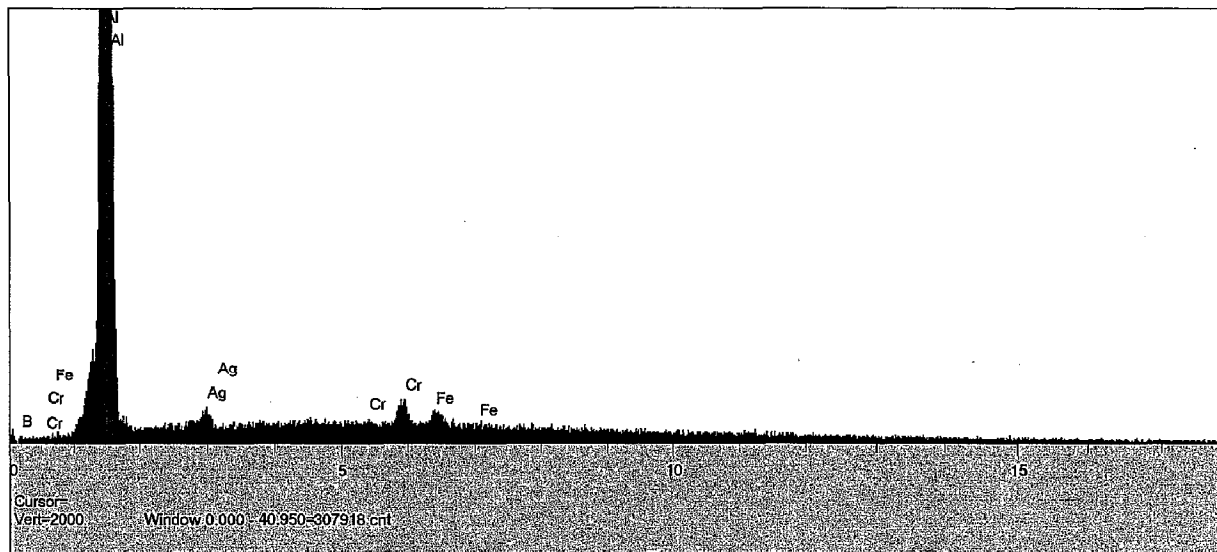
Figure 12: Energy Dispersive Spectrum taken near the corrosion product in the thread region.
Photo ID: DC18128 10/6/98 2:19:43 PM

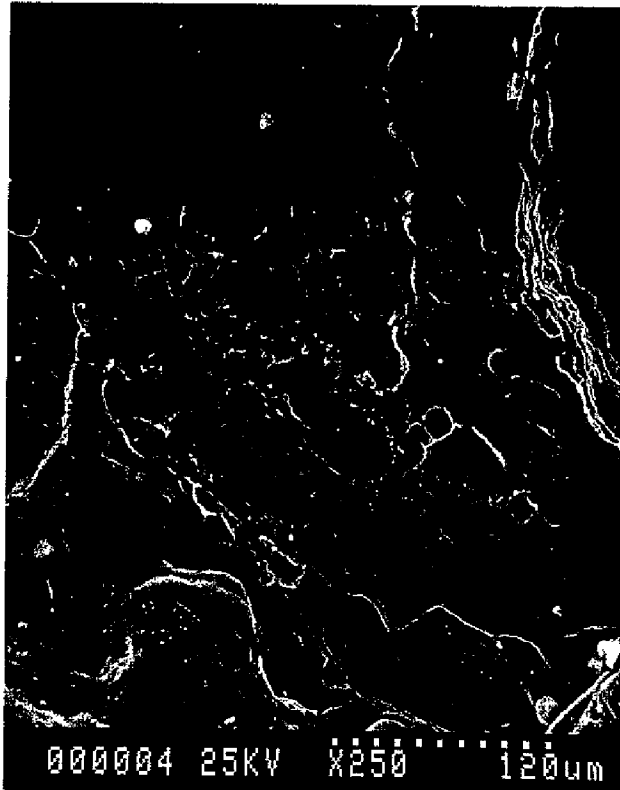
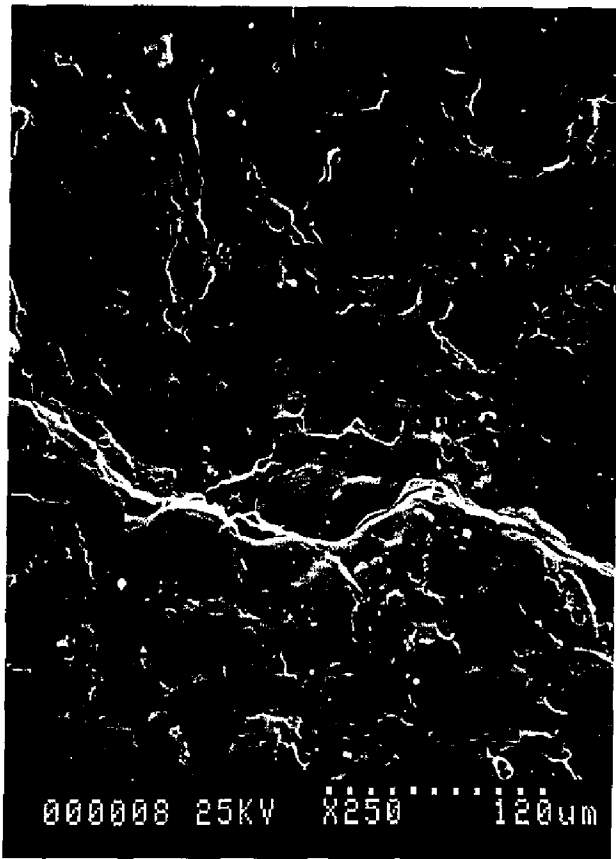
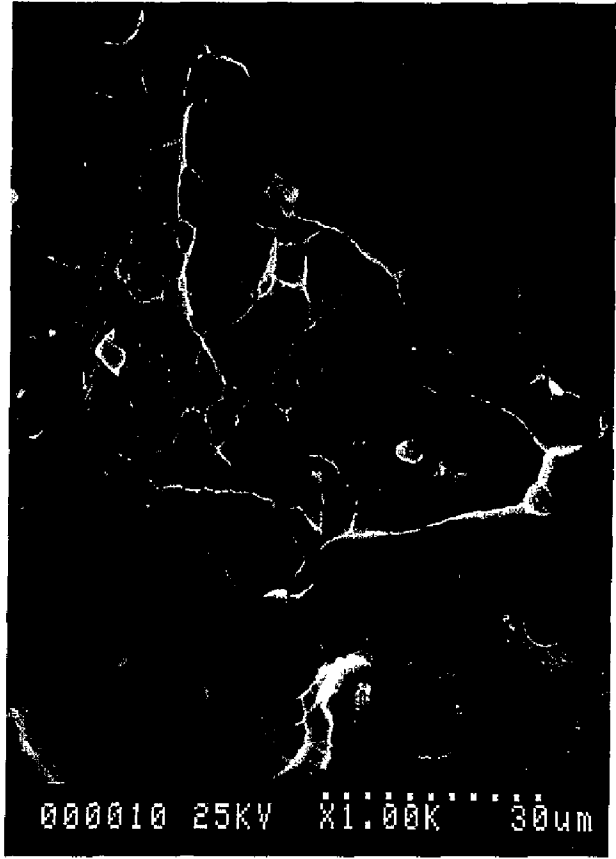
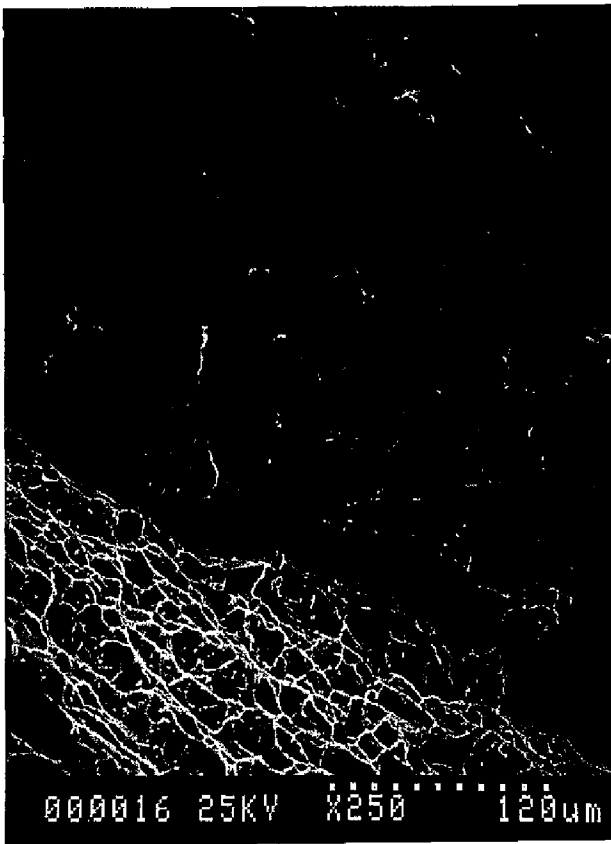
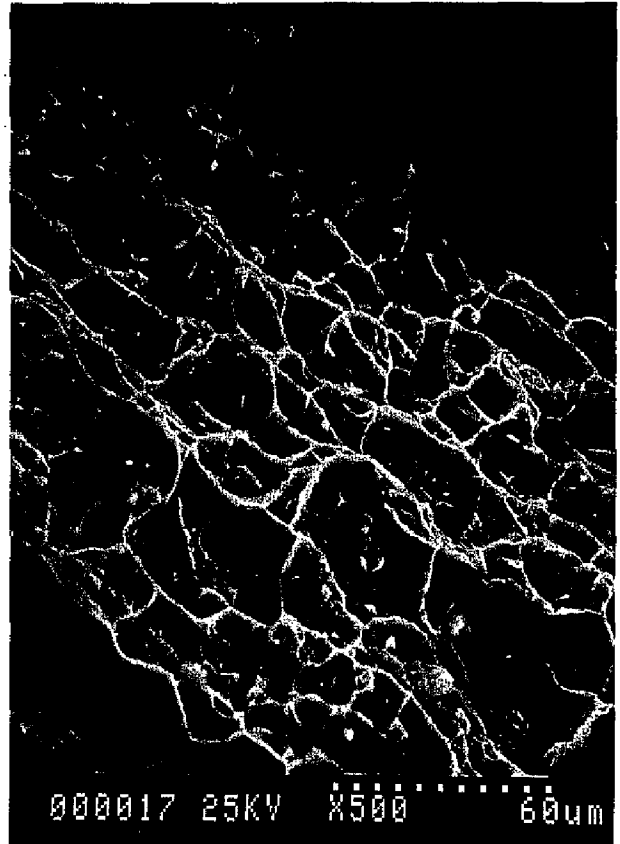
Figure 13: Fractography of section 2A-2. Regions 1 through 5 are delineated in figure 6.

Section 2A-2 was examined optically and in the scanning electron microscope (SEM). The region just below the inlet hole threads and close to the inside of the cylinder contained some coating³ used to line the cylinder, suggesting that a deep fold was present at this location at the time of manufacture. Figure 13 shows a series of SEM fractographs taken from this fracture surface.

Region 1 is at the inside surface close to the inlet hole threads. This region shows intergranular fracture with fine poorly formed dimpling on the grain facets. In the area of the threads, region 2, similar features are seen. Region 3 is similar as well with an increase in the extent of dimpling. Region 4 marks a transition with part of the area showing a mixture of intergranular and transgranular fracture with the remaining area indicative of ductile, dimpled rupture. Region 5 shows predominantly ductile dimpled rupture with a minor amount intergranular faceting (with microdimpling on these facets) as a failure mode. This is the predominant failure mode for the remainder of the neck region.
