**METALLURGICAL
EVALUATION
OF DOT-3AL-2015
CYLINDER T-57003**

U.S. Department of Transportation
400 Seventh Street S.W.
Washington, DC 20590

November 1998

Purchase Order No.: DTRS56-98-70066
Project No.: DC18128.000
Report No.: DC18128.000 A0FD 10/98 .1001

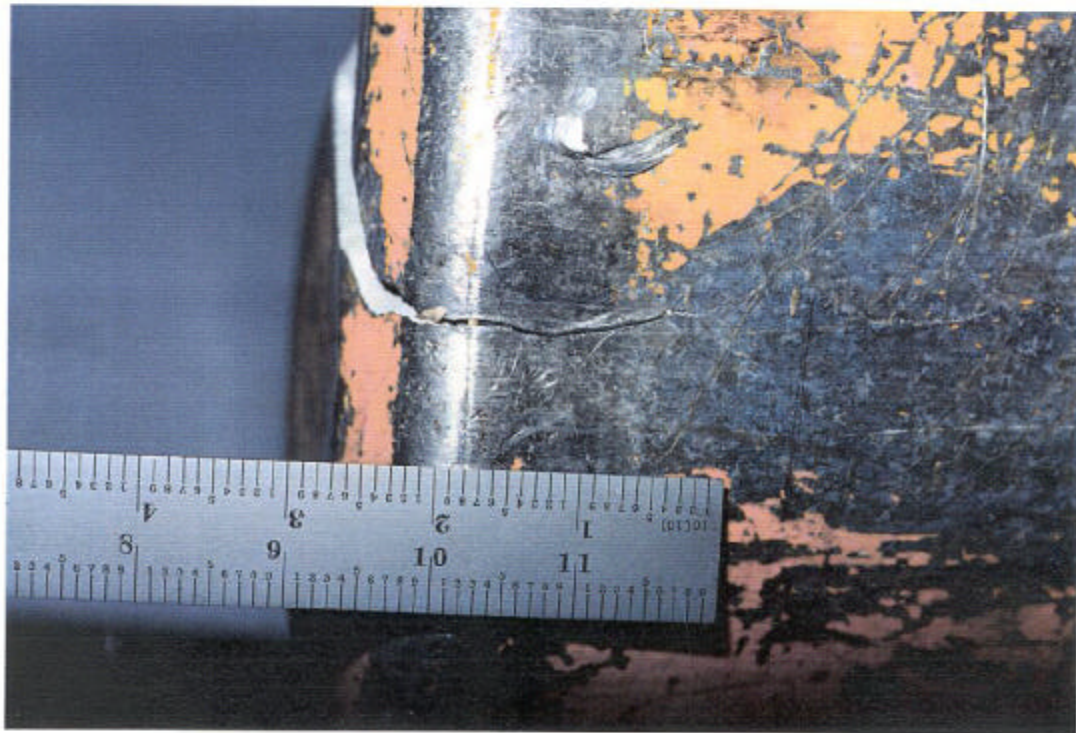
Figure 3: Cylinder remains, as-received
Fragment 1A-1. Photo ID: DC18128-R1E24

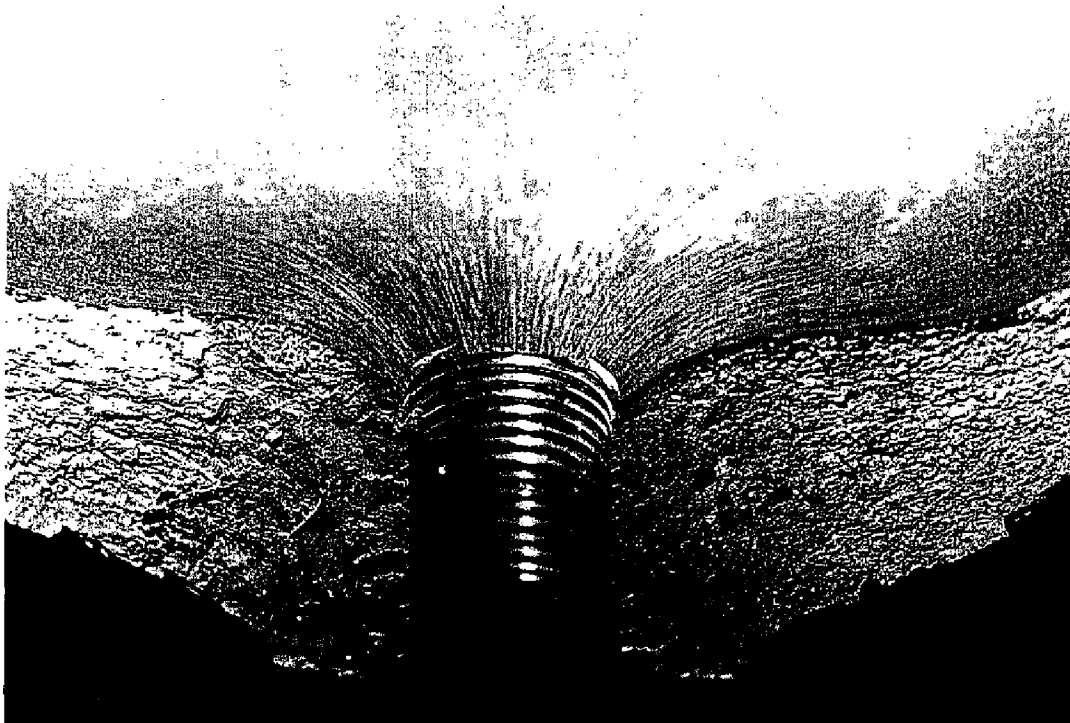
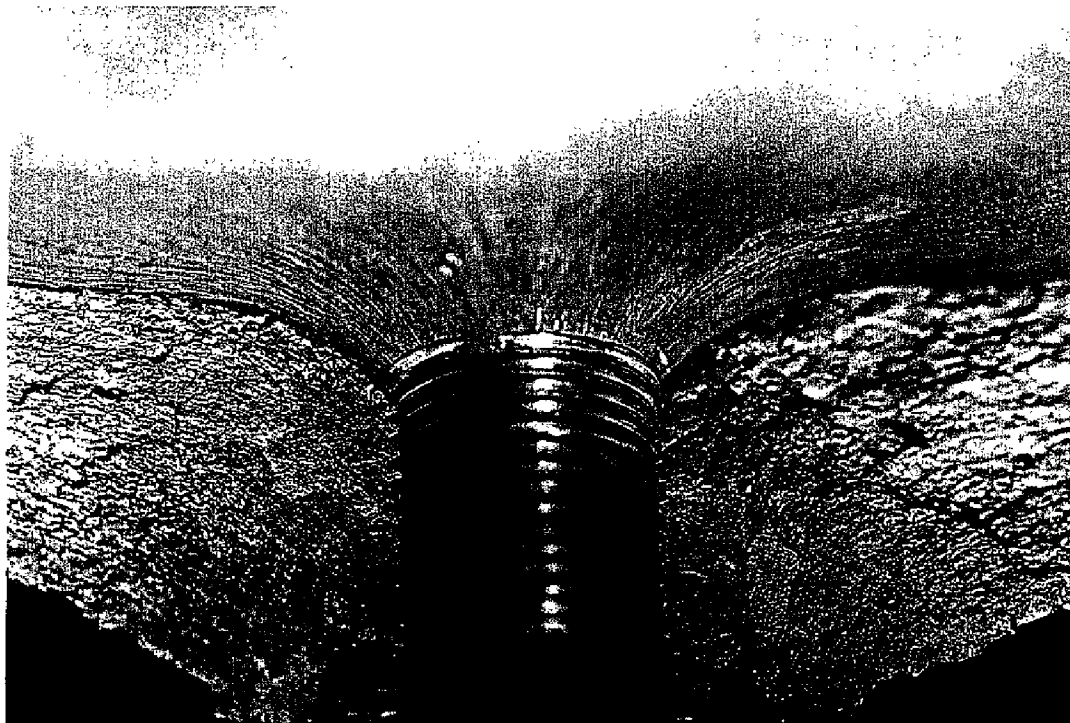
The fracture surfaces of the cylinder were inclined (i.e., non-radial with respect to the cylinder axis) shear-type except for a portion of the neck where the fracture surfaces were flat and radial with respect to the axis of the cylinder. In the neck region, the fracture appears to pass through a diameter of the inlet. Figure 3 shows the erupted bottom. Regions of the bottom separated from the sidewall with a crack extending into the side parallel to the axis of the cylinder. In the neck region, the inside wall of the cylinder in this region shows multiple folds (or cusps) from the original manufacturing process, Figure 4. The fracture surface on both sides of the inlet hole appears to pass through folds of this type. A slight amount of aluminum corrosion product was present on the threaded region.

Examination of the fracture surfaces of each cylinder fragment suggests that the failure originated from the neck region of the cylinder near to the inlet hole. The flat-faced (i.e., radial) nature of the fracture surface at the neck region, followed by a transition to an inclined (i.e., non-radial) shear type of fracture on both sides of the cylinder, suggests fast fracture initiating nearly simultaneously on diametrically opposed sides of the inlet hole, prior to final rupture. Based on Figures 9, 10, and 11, subcritical cracking clearly existed to a small extent near to the inlet hole at folds in the inside wall. The origin of the rupture is at two of these small cracks; however, the similarity in the grain sizes (Figure 8) and the failure surfaces in Regions 1-3 suggests a "tearing-out" of the grains during a rapid ductile failure outward from the small cracks. This tearing of grains and the absence of beachmarks along the fracture surface suggests that the crack growth from these initial origin areas occurred during a single event. This event is consistent with an internal pressure well in excess of normal operation (i.e., an overpressurization) of the cylinder.

Figure 4: Fracture surface at the inlet hole.
Photo ID: DC18128-R1E9, R2E7
