Appendix A: Recommended Scope of Work

Recommended Scope of Work for Metallurgical Evaluation of Aluminum Cylinder

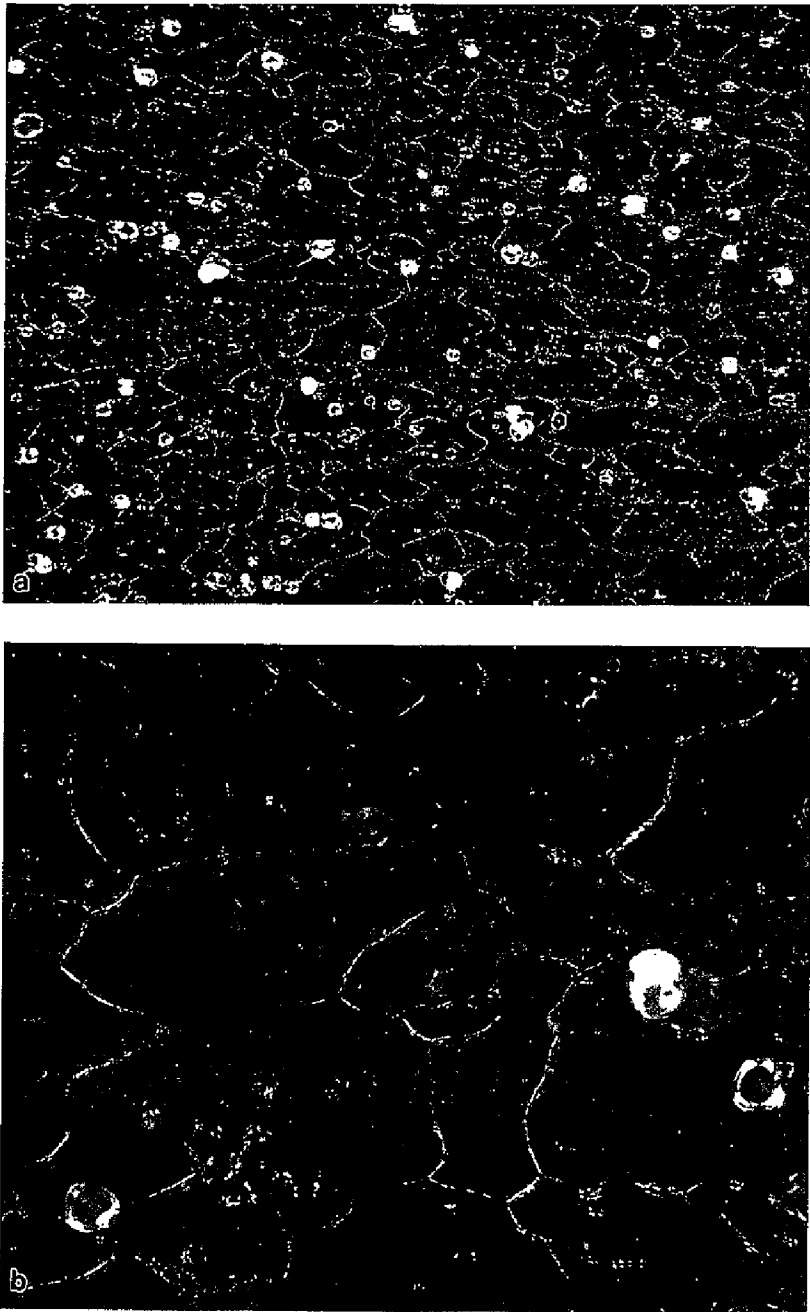
Figure 6. Microstructure of the sidewall region. 10% NaOH, polarized light.
(a) 250X. Photo ID: DC17916-PAL-1-8/22/97.
(b) 1000X. Photo ID: DC17916-PAL-2-8/22/97.

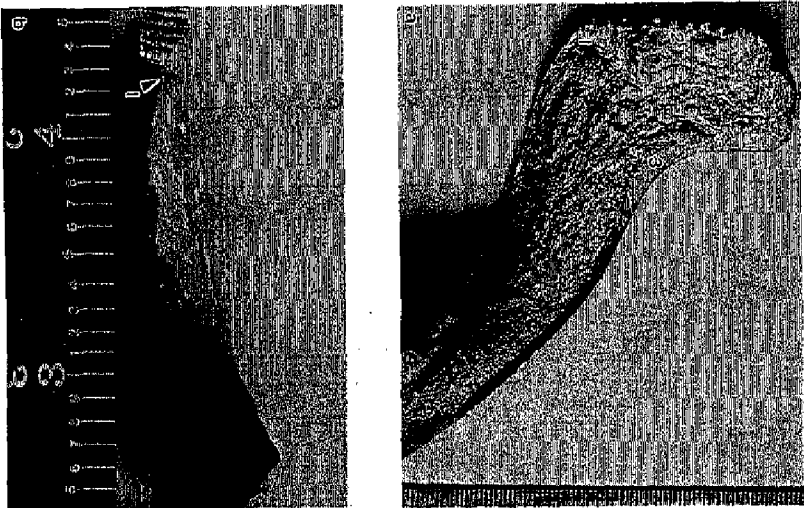
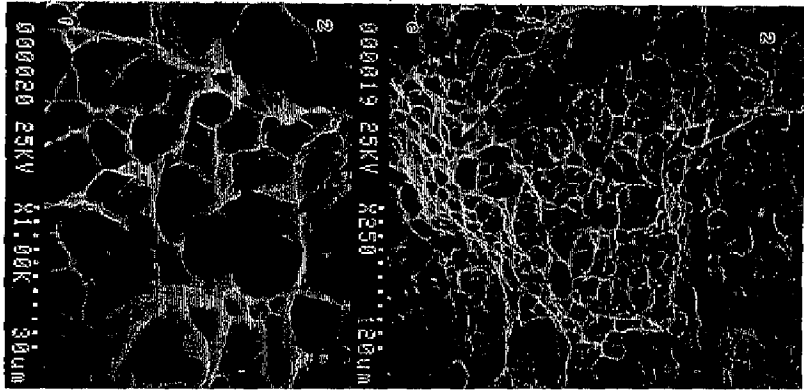
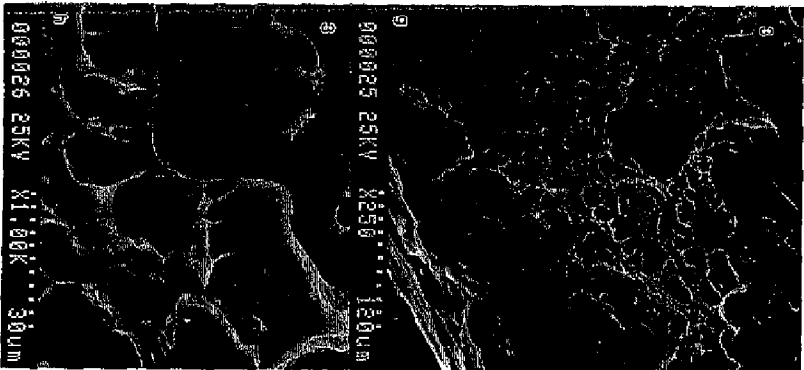
Figure 7. Fractography of fracture surface "A" (Section 1A-3) from the neck region (see Figure 3).

- (a) Optical fractograph depicting neck region.
Photo ID: DCI7916-FAL-21A-17/10/96.
- (b) Side view of fracture surface shown in (a). Note the non-planar character of the fracture surface in this region.
Photo ID: DCI7916-TR5-1-8/22/97.
- (c) SEM fractograph of region 1 from (a). 250X.
Photo ID: DCI7916-FAL-17-12/10/96.
- (d) SEM fractograph of region 1 from (a). 1000X.
Photo ID: DCI7916-FAL-18-12/10/96.
- (e) SEM fractograph of region 2 from (a). 250X.
Photo ID: DCI7916-FAL-19-12/10/96.
- (f) SEM fractograph of region 2 from (a). 1000X.
Photo ID: DCI7916-FAL-20-12/10/96.
- (g) SEM fractograph of region 3 from (a). 250X.
Photo ID: DCI7916-FAL-25-12/10/96.
- (h) SEM fractograph of region 3 from (a). 1000X.
Photo ID: DCI7916-FAL-26-12/10/96.

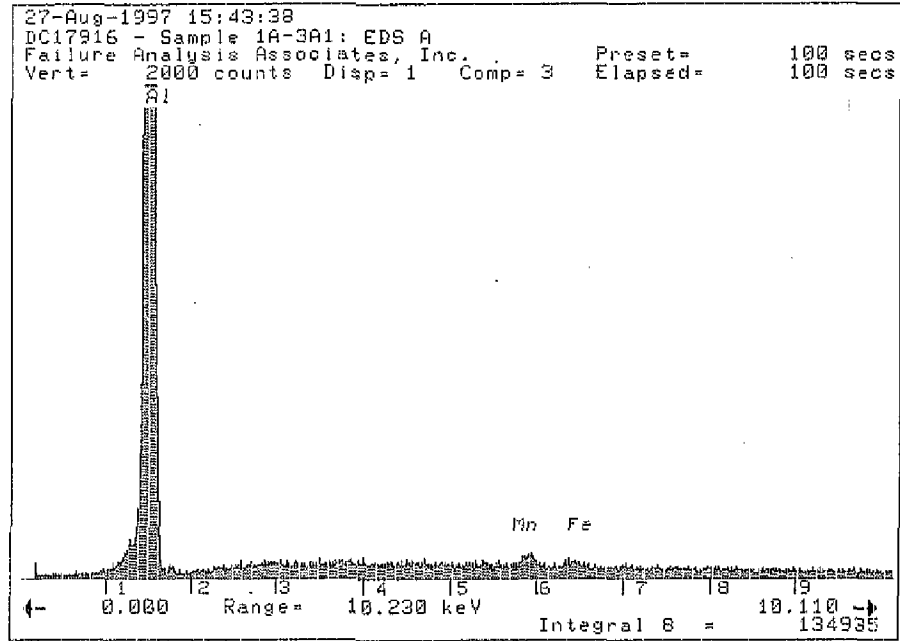
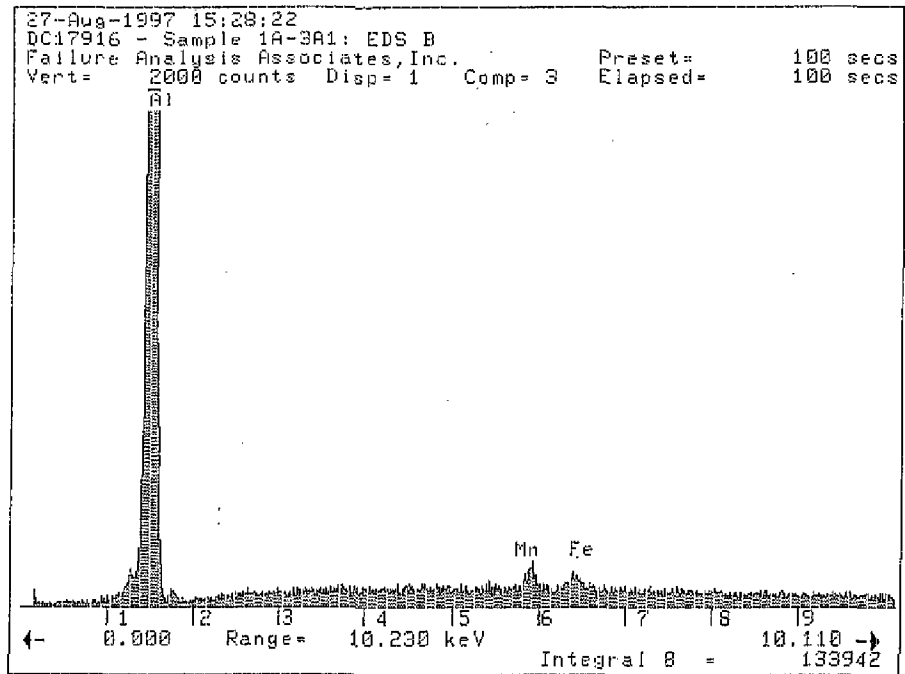
Figure 8. EDS spectra from fracture surface in neck region (see Figure 7).
 (a) Region 1.
 (b) Region 2.

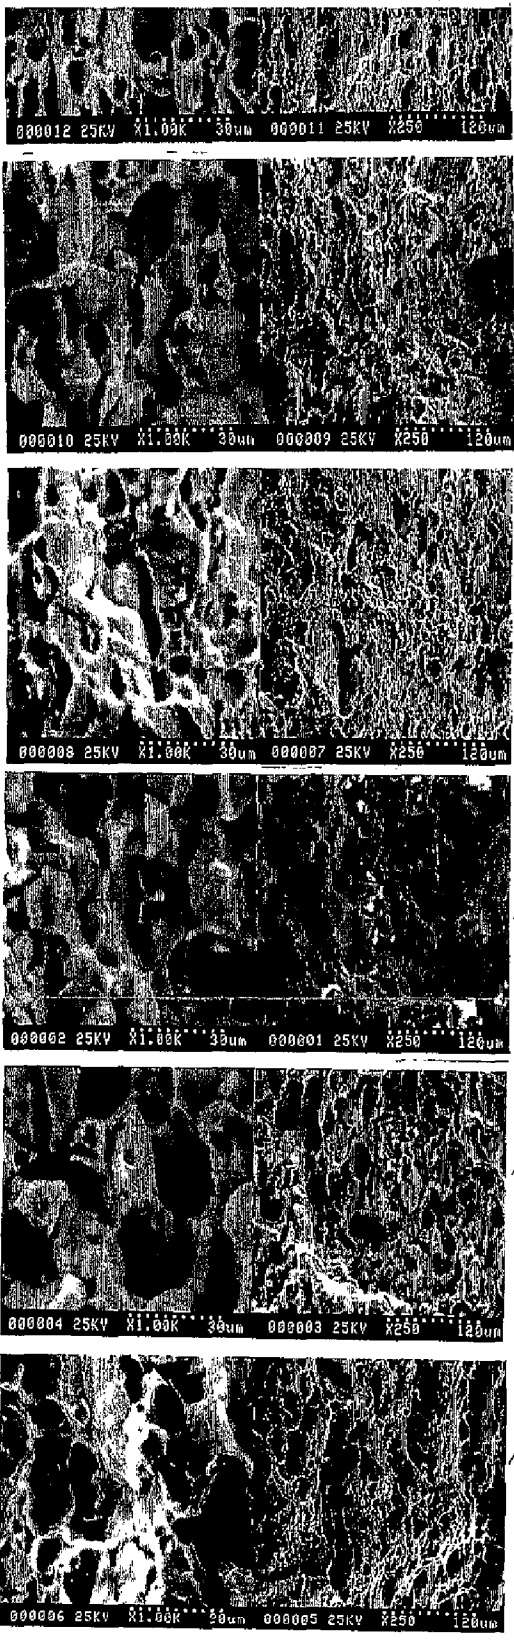
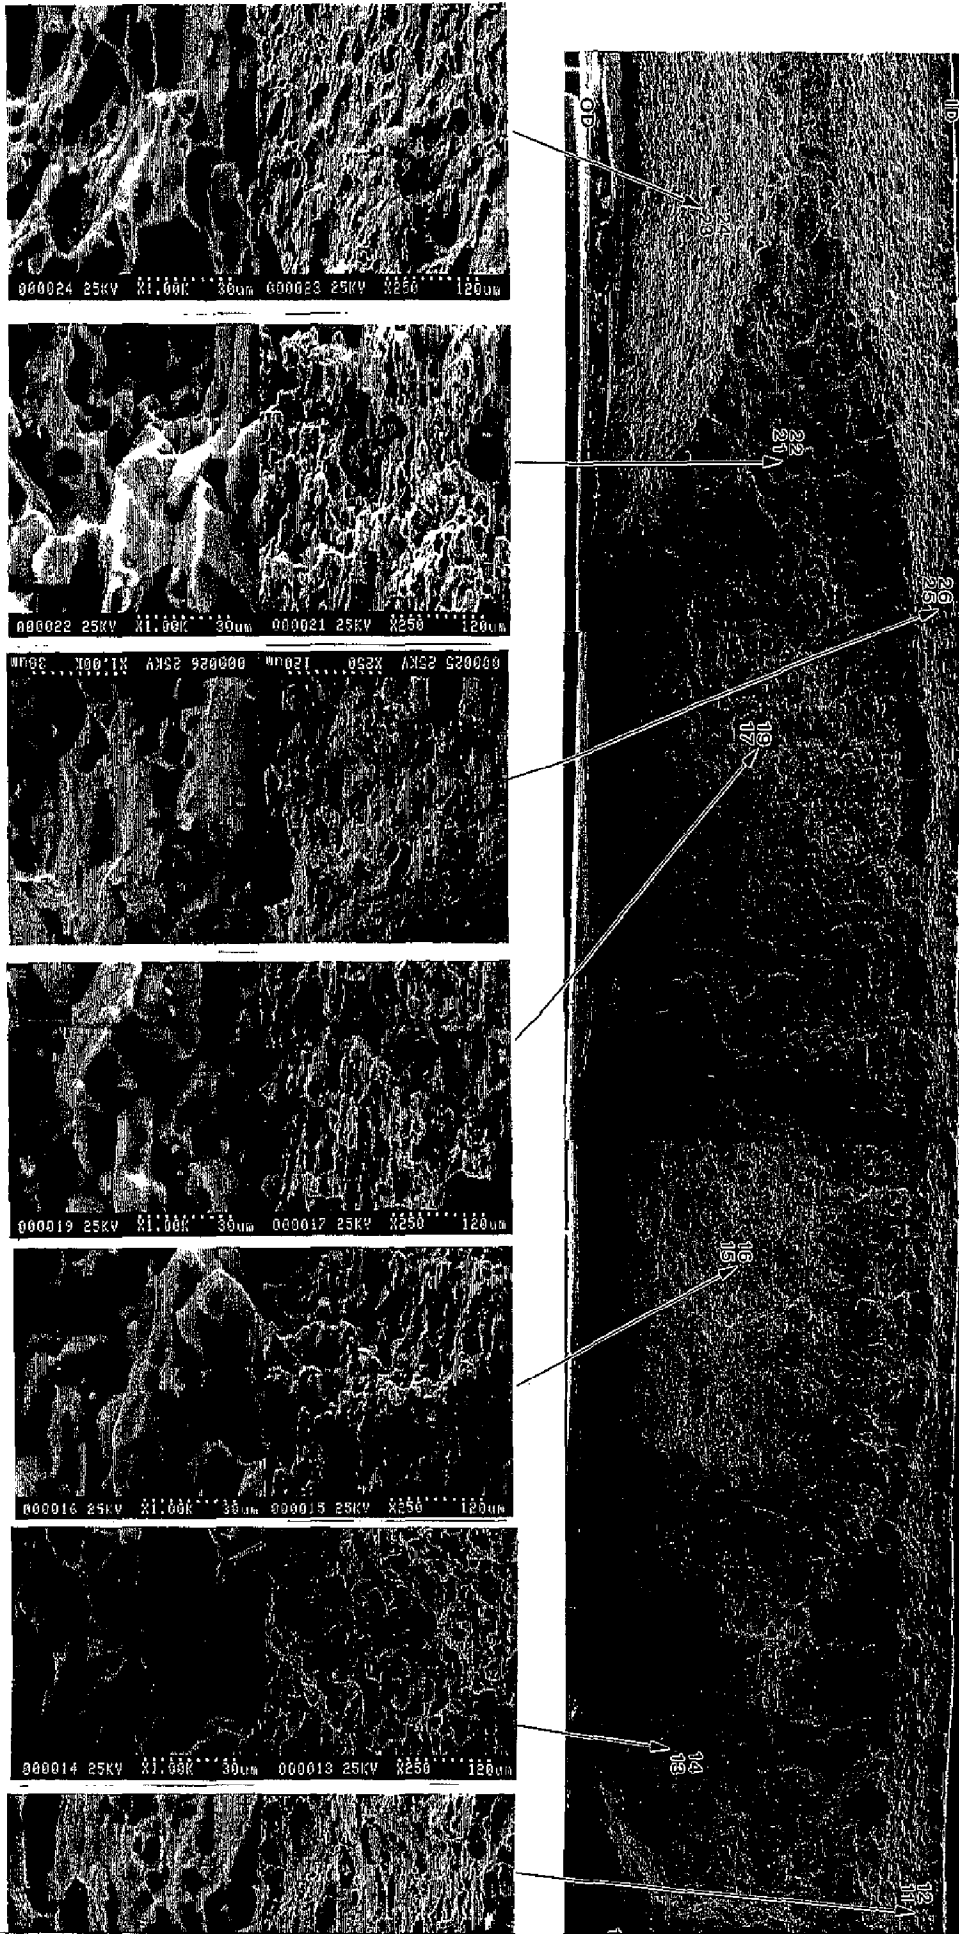
shown in Figure 9.

Figure 10. SEM fractography of fracture surface

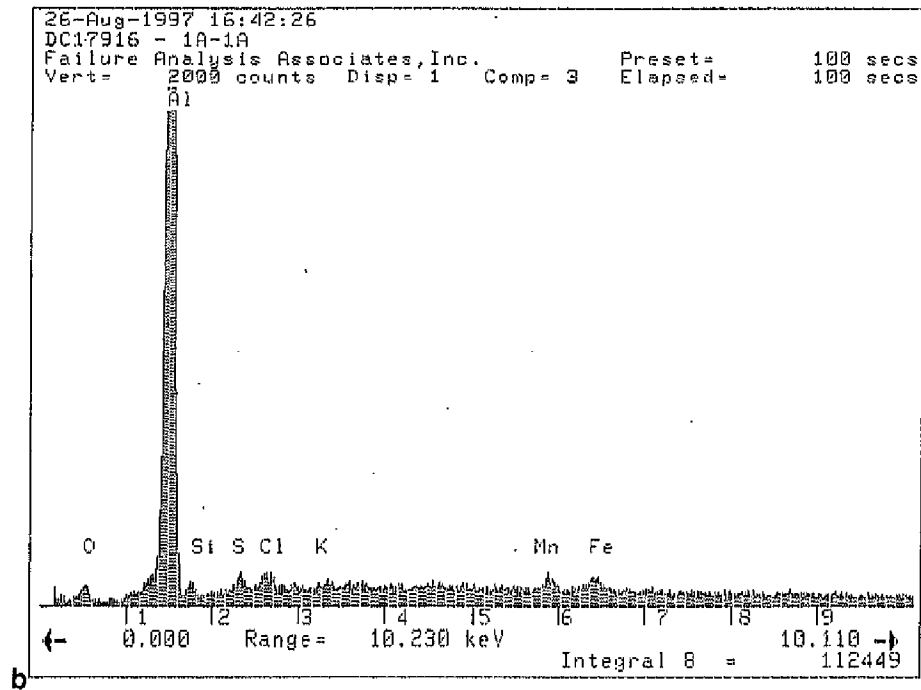
Figure 11. Intergranular region of fracture surface showing oxidation.
 (a) SEM fractograph. 1000X. Photo ID: DC17916-PAL-1-8/27/97.
 (b) EDS spectrum.

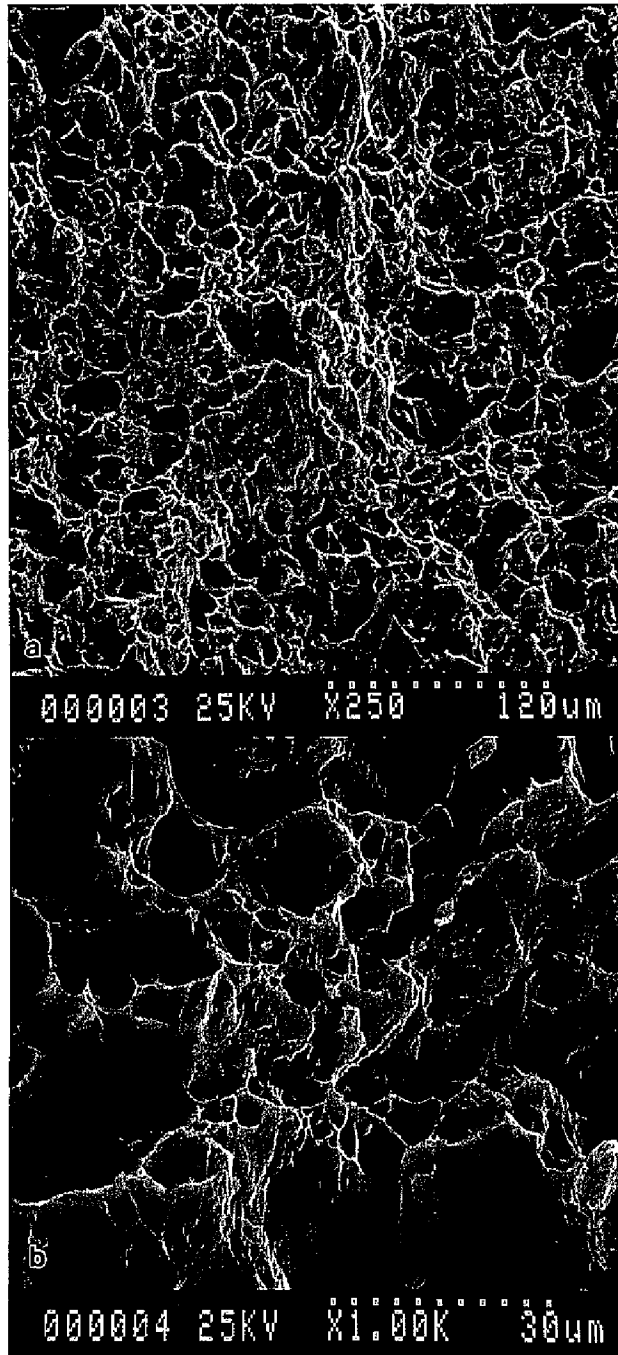
Figure 12. SEM fractographs of a tensile specimen.
(a) 250X. Photo ID: DC17916-PAL-3-12/10/96.
(b) 1000X. Photo ID: DC17916-PAL-4-12/10/96.
