**METALLURGICAL EVALUATION
OF A DOT-3AL2015 CYLINDER**
FaAA Project No.: DC17916.000

U.S. Department of Transportation
400 Seventh Street S.W.
Washington, D.C. 20590

Timothy R. Smith, Ph.D., P.E.
Failure Analysis Associates, Inc.
310 Montgomery Street
Alexandria, VA 22314

September 1997

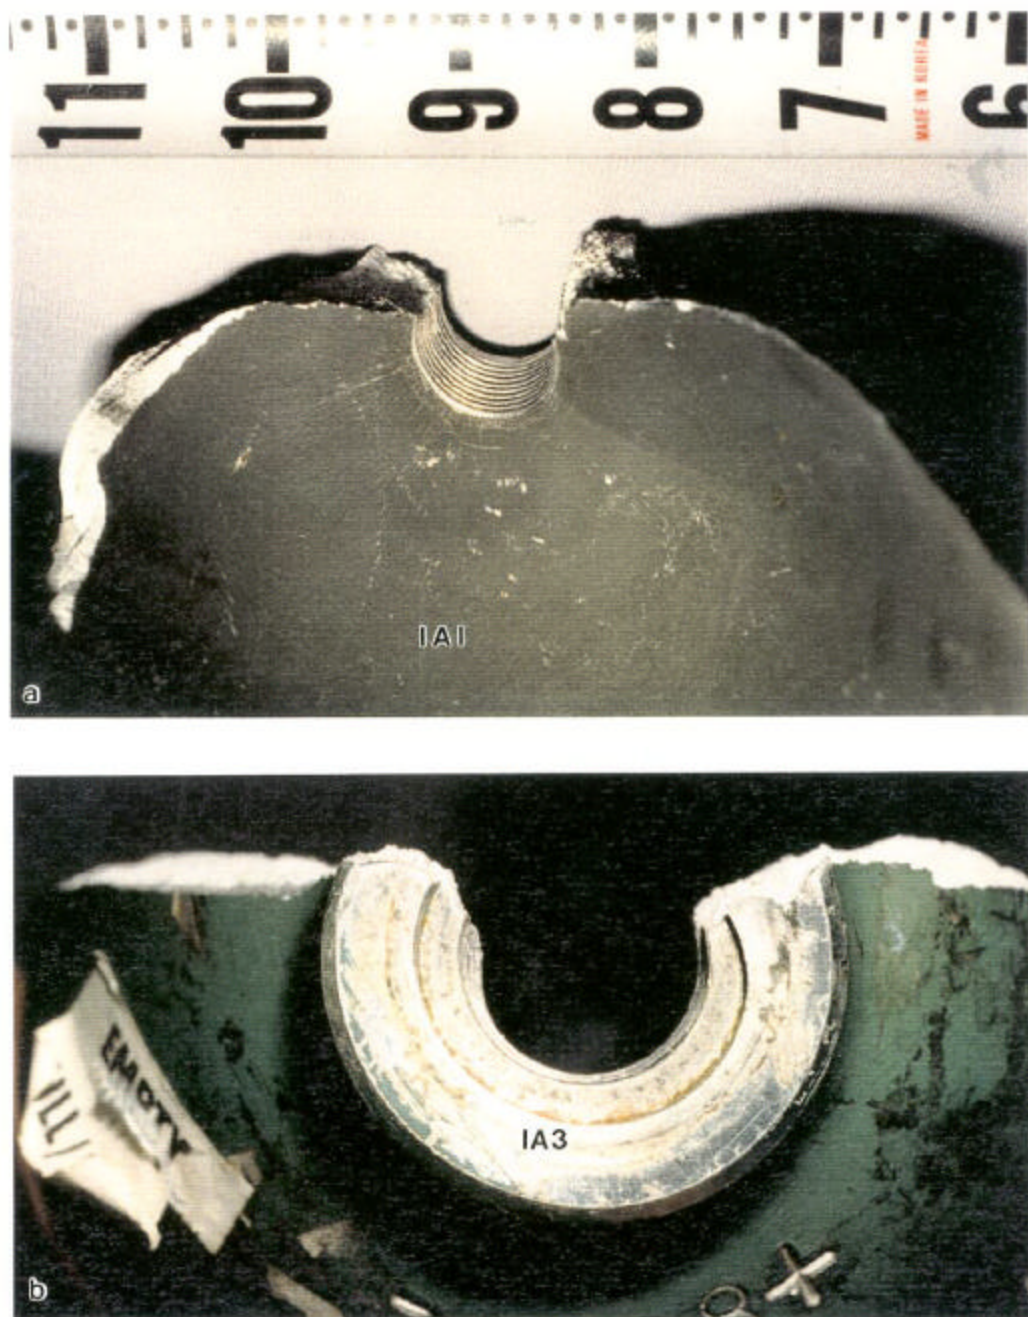
Figure 2. Neck region of failed cylinder.

(a) View inside looking out. Photo ID: DC17916-R2E12.

(b) View looking down on the inlet hole. Photo ID: DC17916-R2E20.

Note that the fracture surface in the neck region is not parallel to the cylinder axis and the fracture path does not pass through a diameter of the inlet hole.
