Exponent
310 Montgomery Street
Alexandria, VA 22314

telephone 703-549-9565
facsimile 703-549-4225
www.exponent.com

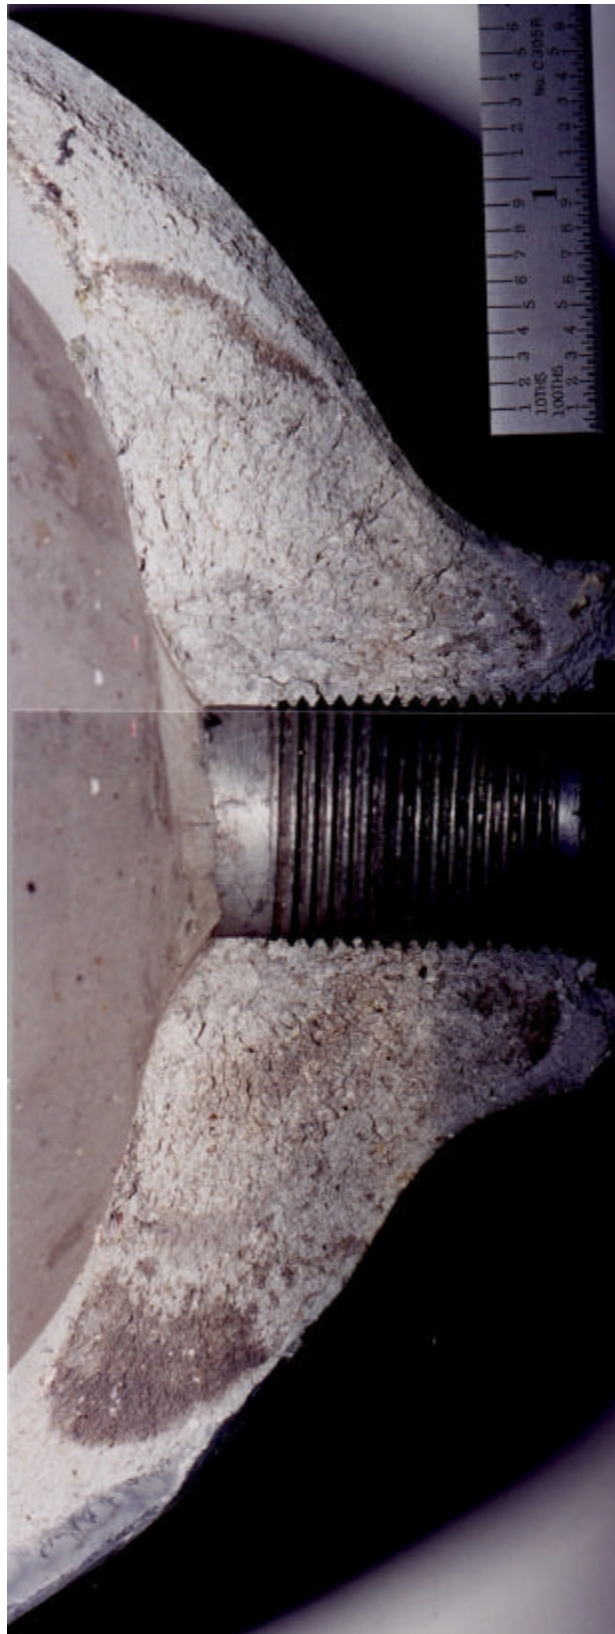
Figure 3. Photomontage of the fracture surface in the neck region.
DC18344-R6E14,15.

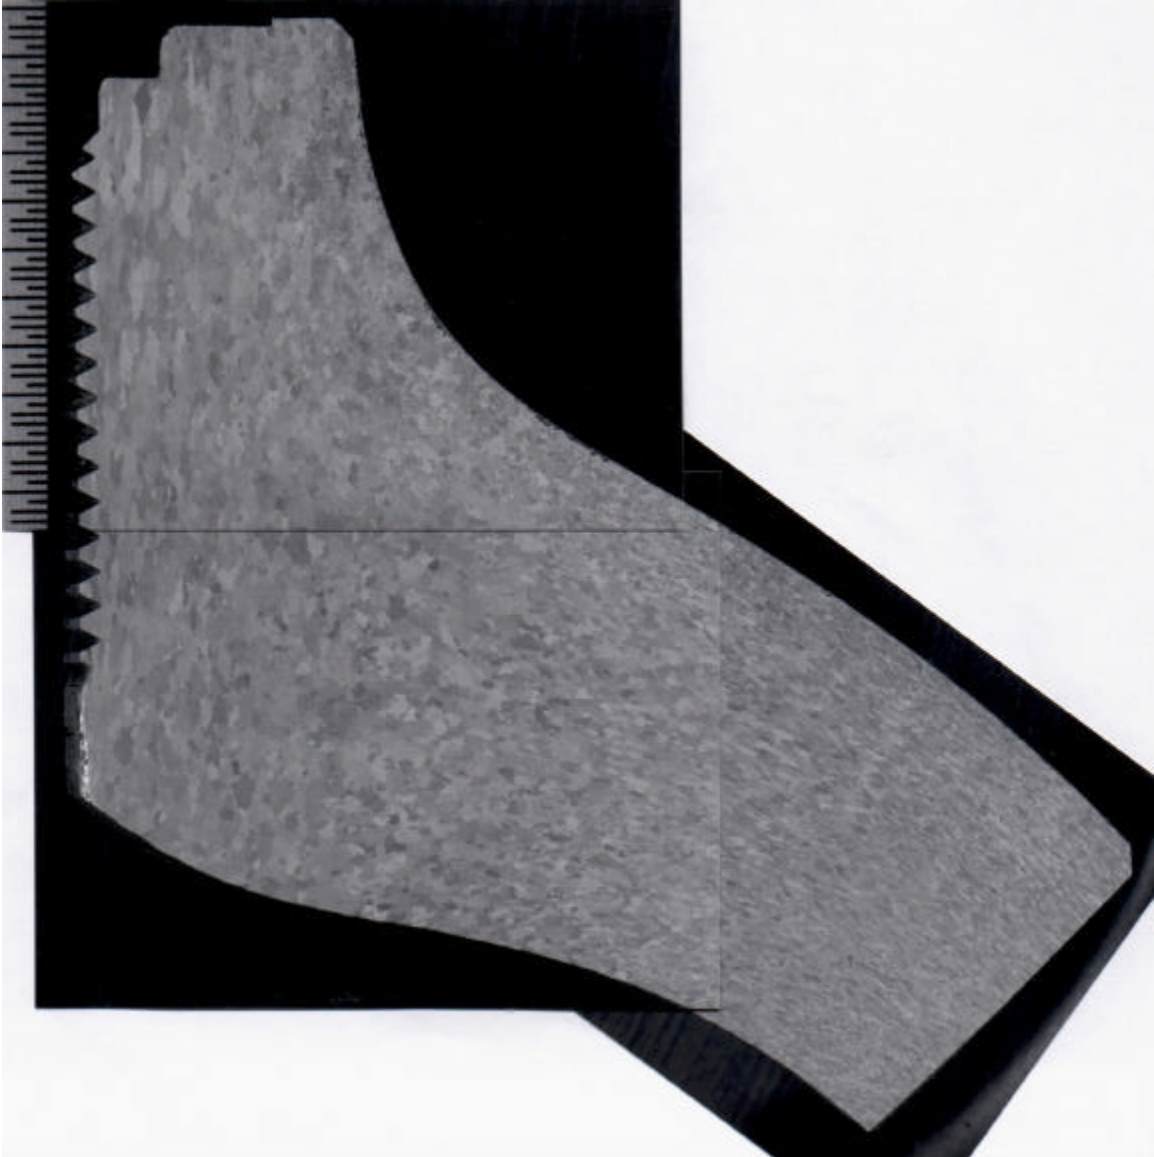
Figure 7. Microstructure of the neck region. Photo ID: DC18344-PAL-4,5,6-8/30/00.

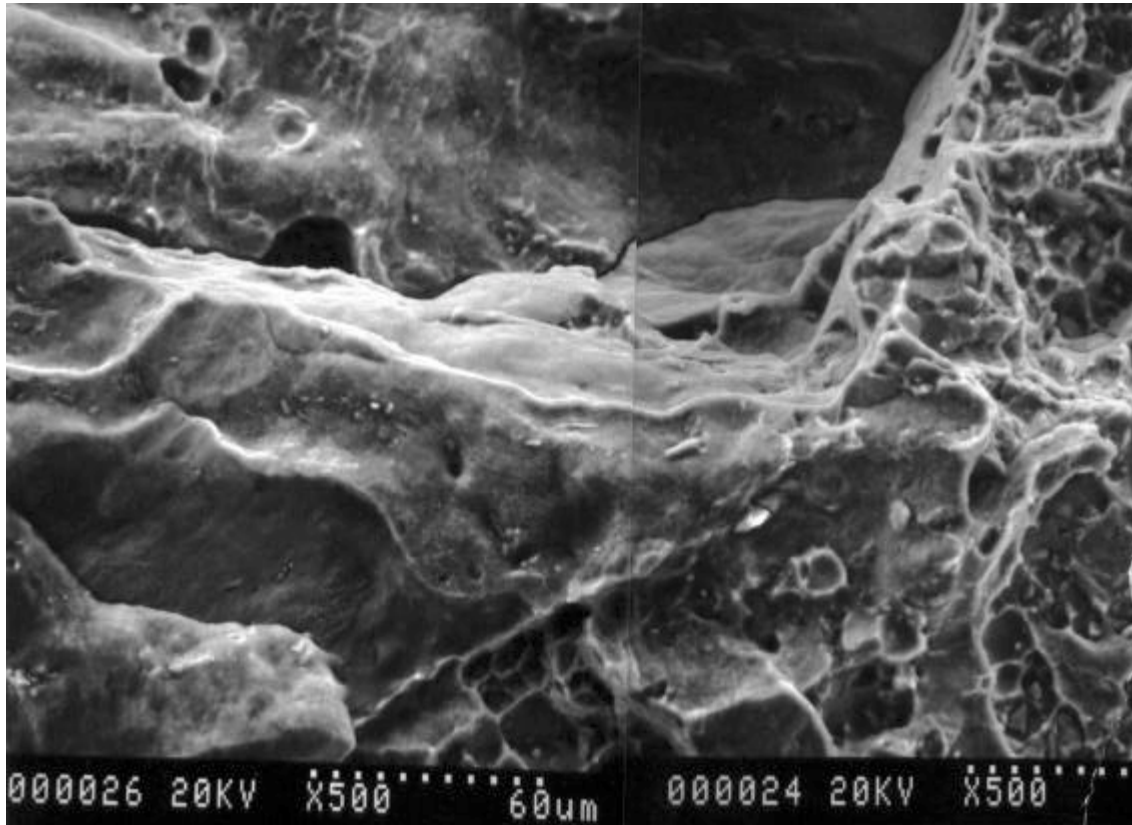
Figure 11. SEM montage from Region D of figure 9. Note the abrupt transition from intergranular fracture with poorly-formed dimples (left) to ductile dimples (right). The fracture progressed from left to right.

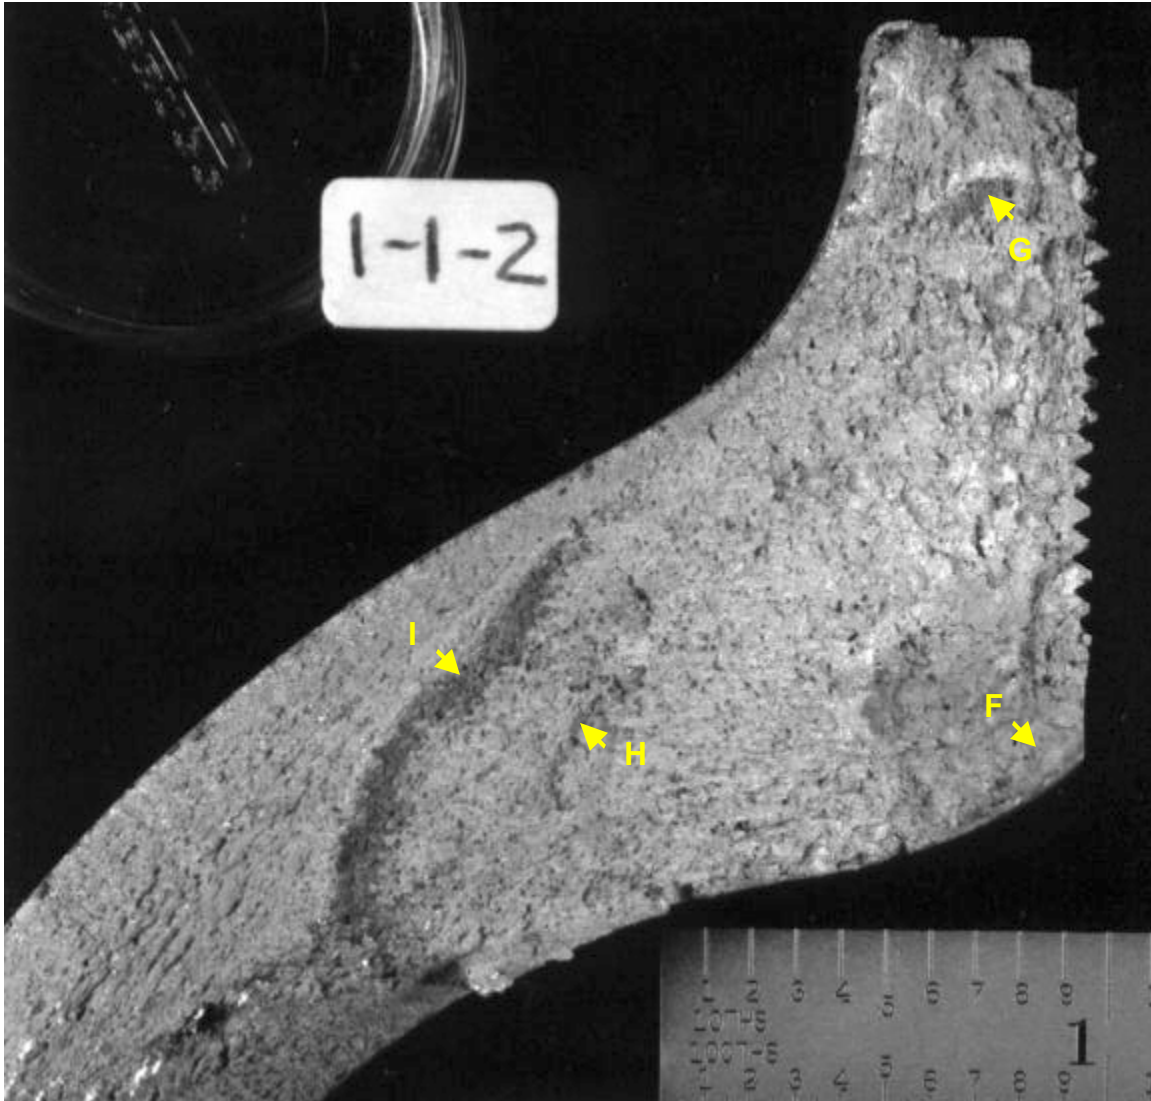
Figure 14. Fractograph of section 1-1-2. Photo ID DC18275-CEM-6-8/28/00

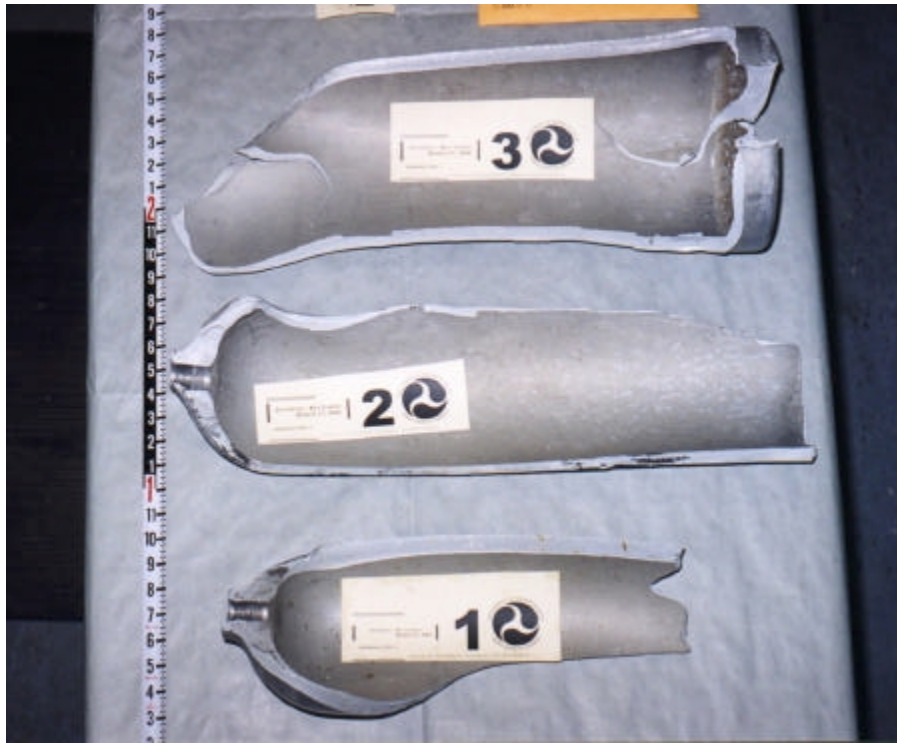
Photo ID: DC18344-R1E8
