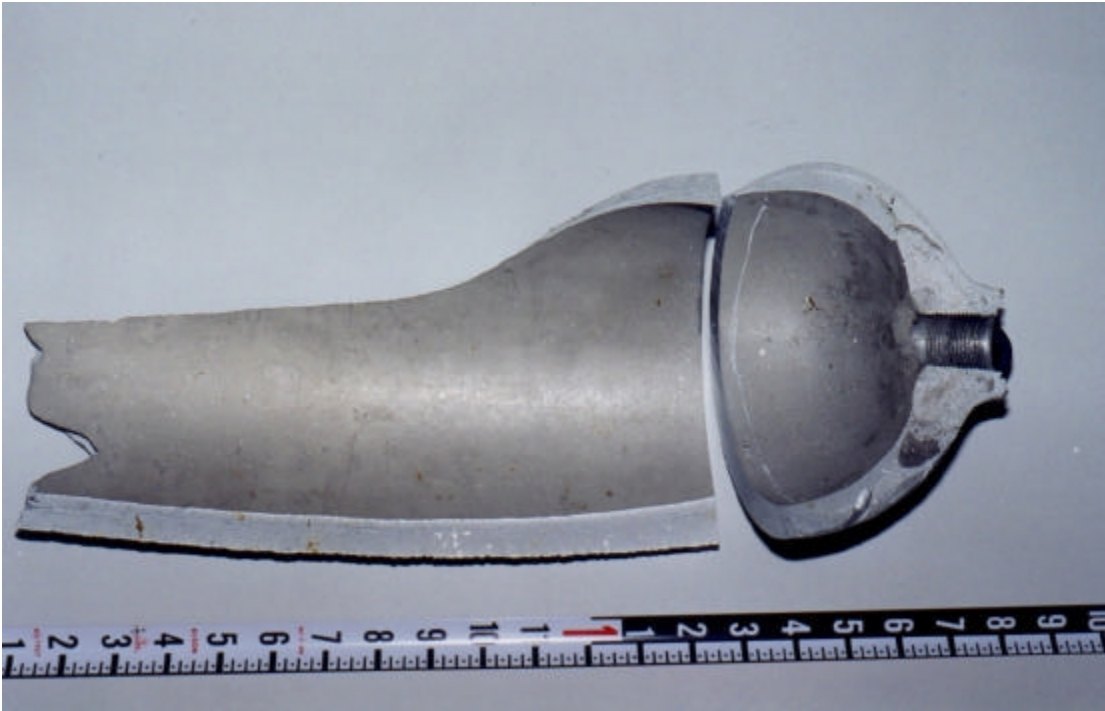
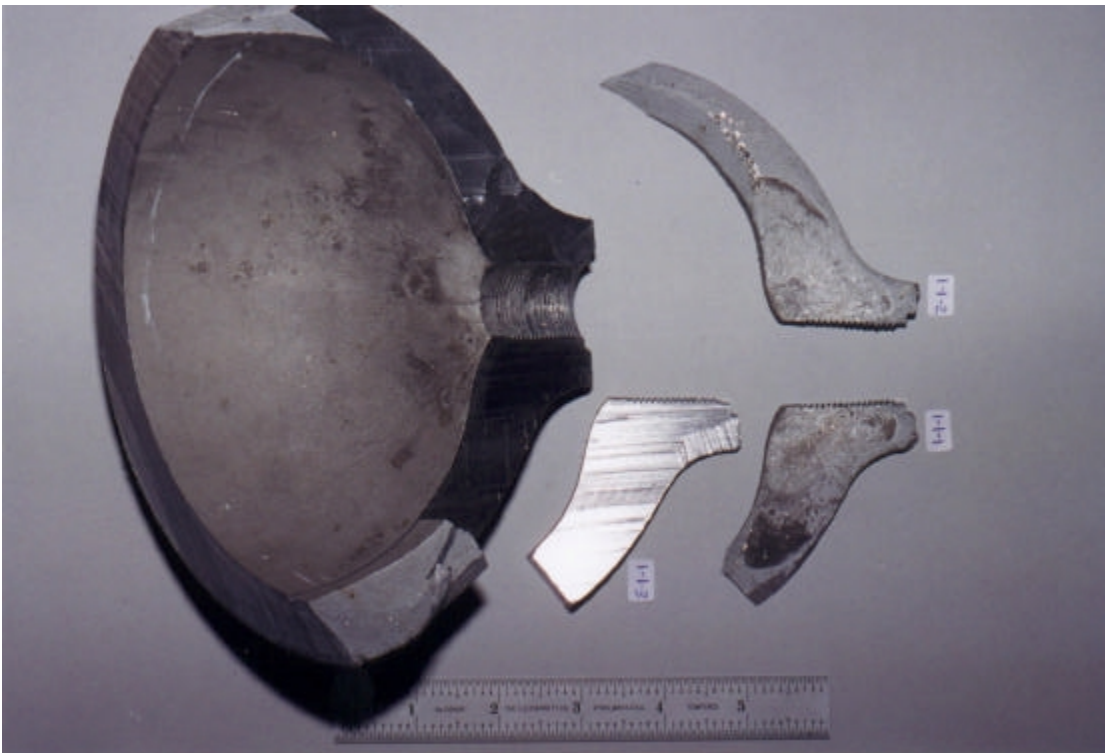
Figure 5. Sectioning of fragment 1.

(a) Cut separating neck region. Photo ID: DC18344-R8E6.

(b) Sectioning of the neck region. Photo ID: DC18344-R10E4.

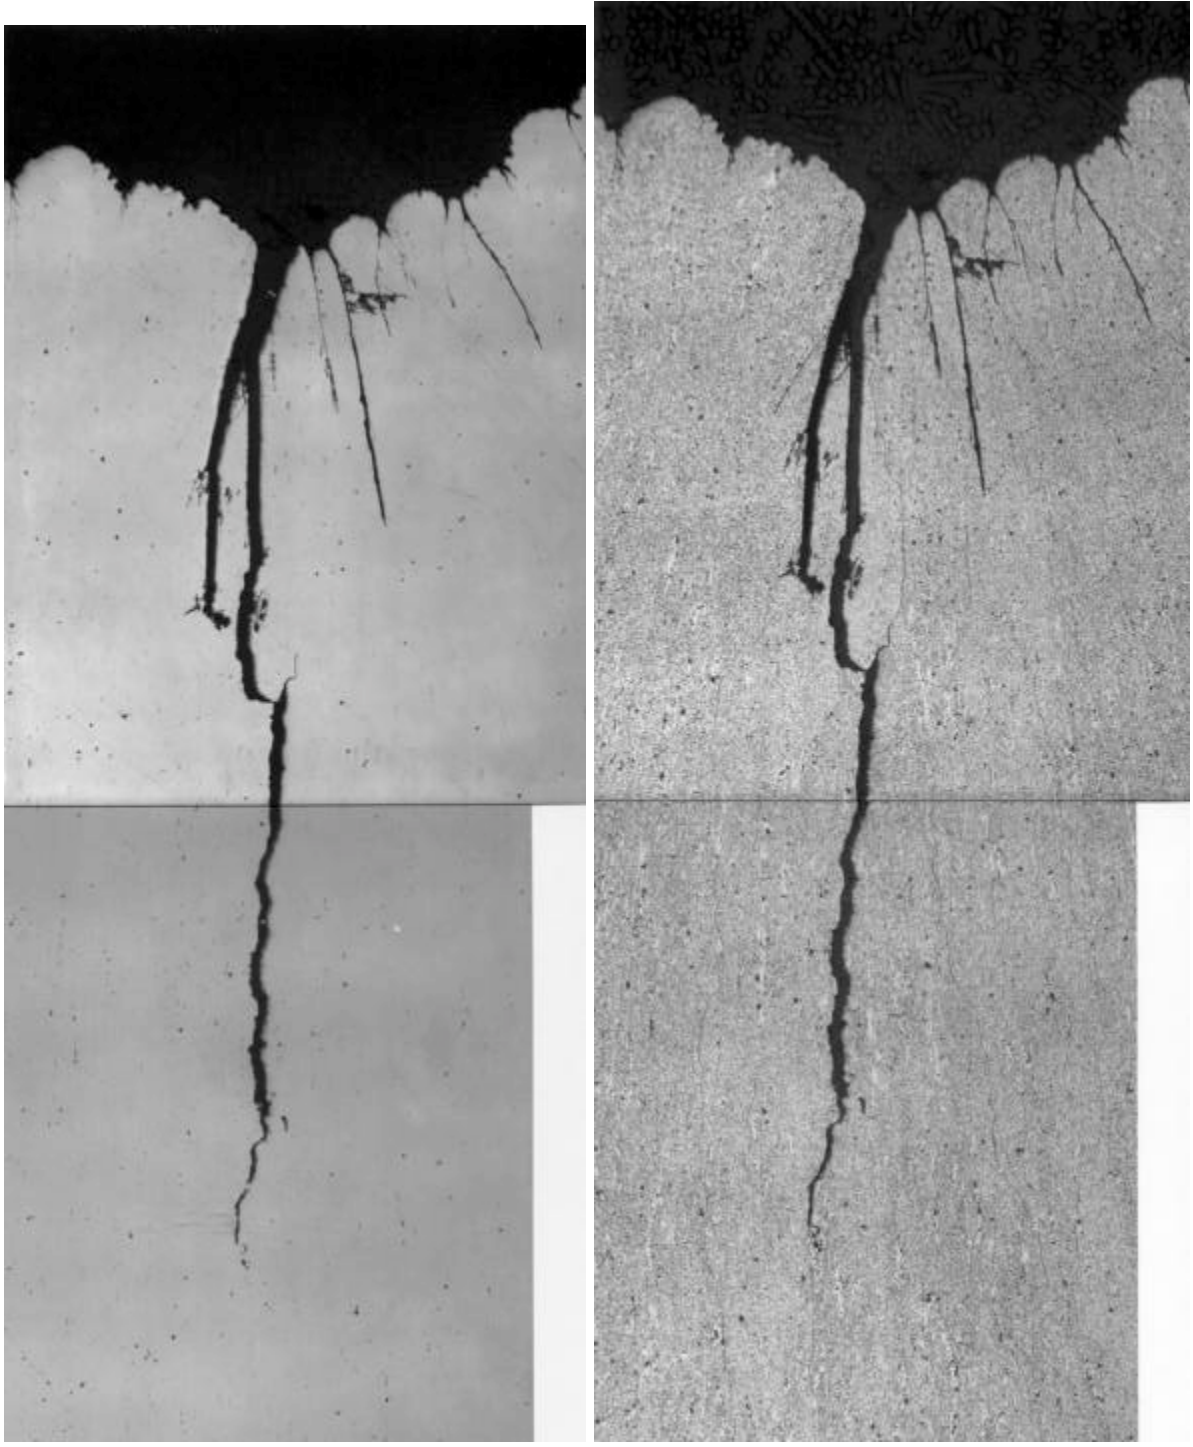
Figure 8. Micrographs of crack C1 in the neck region. 100X.

(a) Unetched. Photo ID: DC18344-PAL-2,3-9/11/00.

(b) Etched 1% HF (aqueous). Photo ID: DC18344-PAL-4,5-9/11/00.

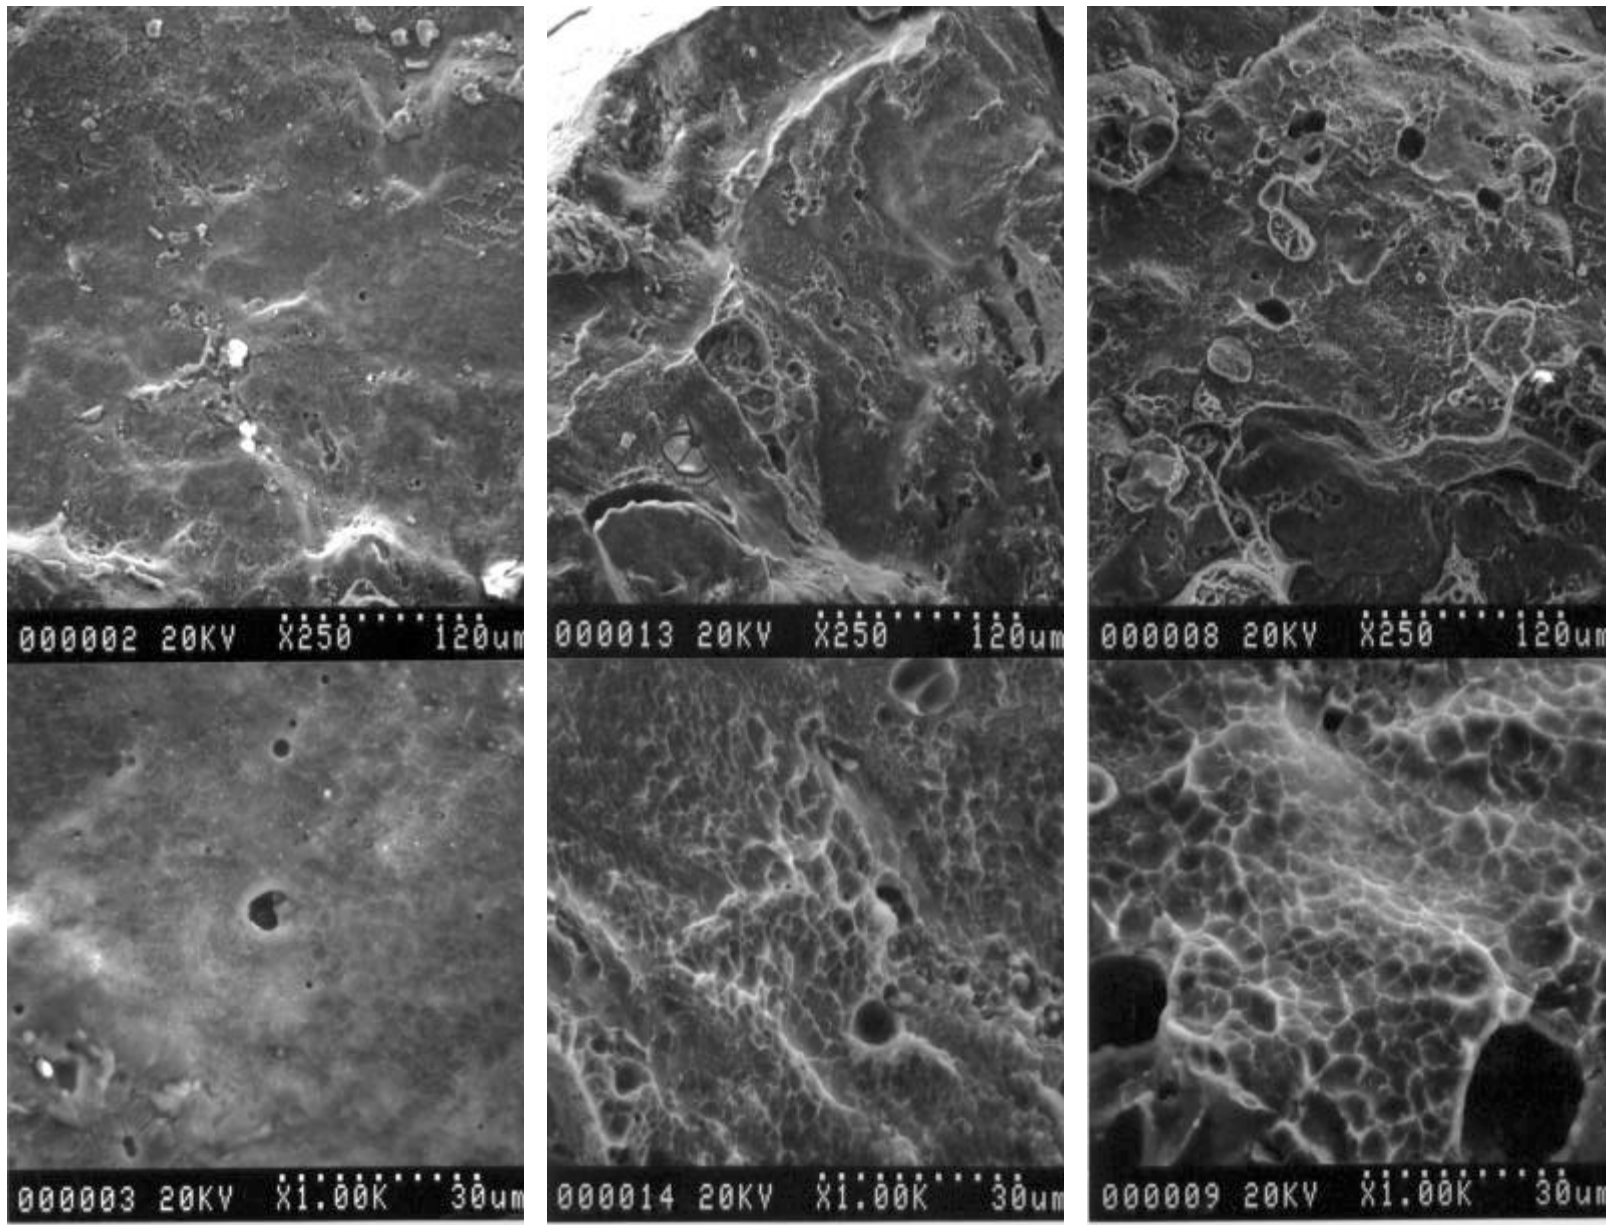
Figure 10. SEM fractographs from regions shown in Figure 9.

(a) Region A

(b) Region B

(c) Region C

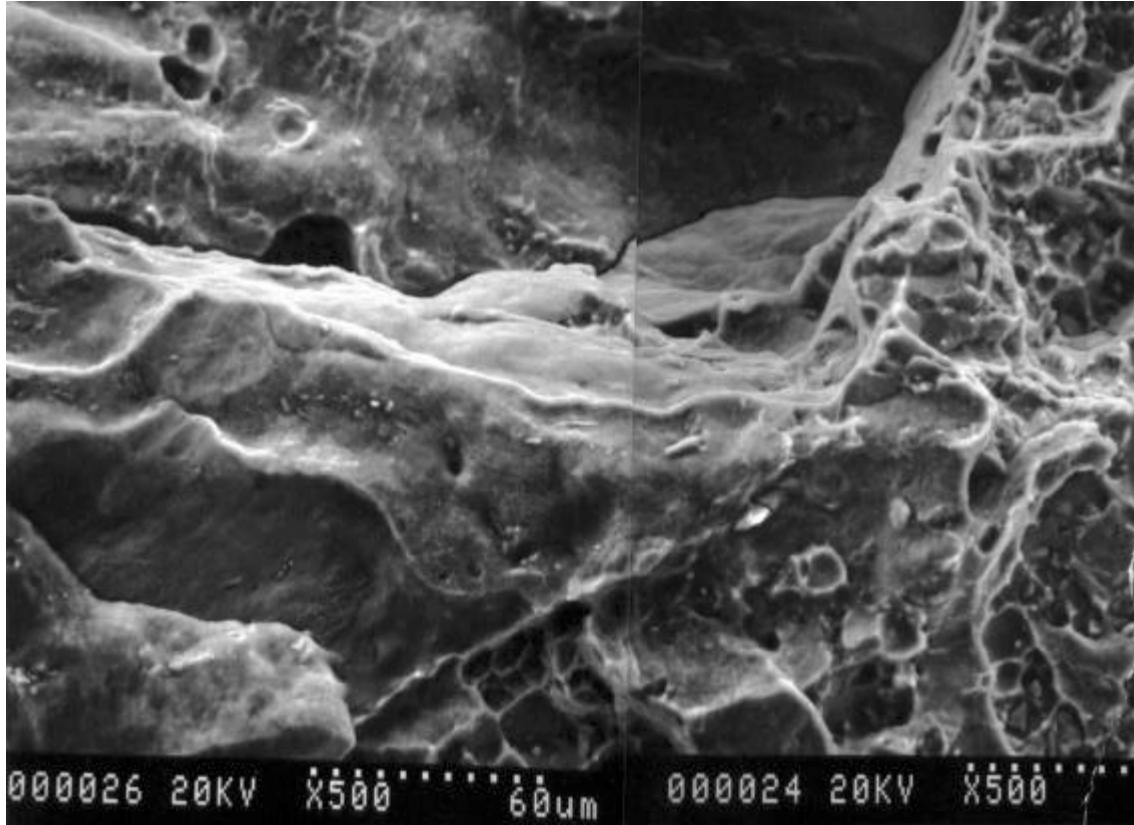
Figure 11. SEM montage from Region D of figure 9. Note the abrupt transition from intergranular fracture with poorly-formed dimples (left) to ductile dimples (right). The fracture progressed from left to right.

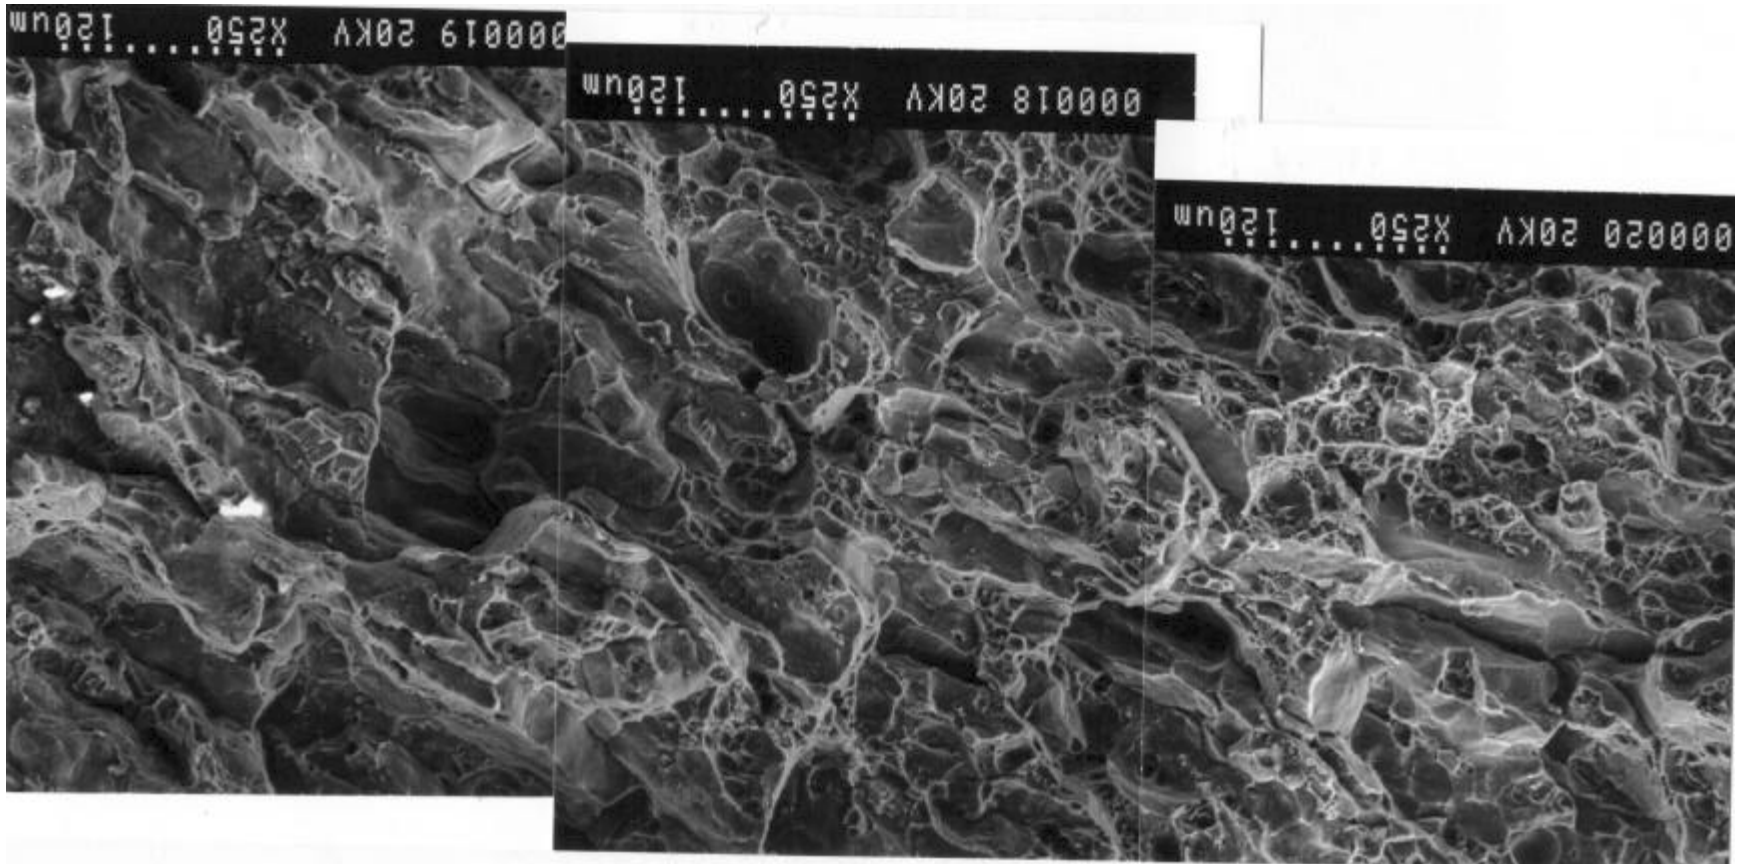
Figure 12. SEM montage from Region E of Figure 9. The fracture progressed from left to right and transitioned in mode from predominantly intergranular fracture with poorly-formed dimples to predominantly ductile rupture.

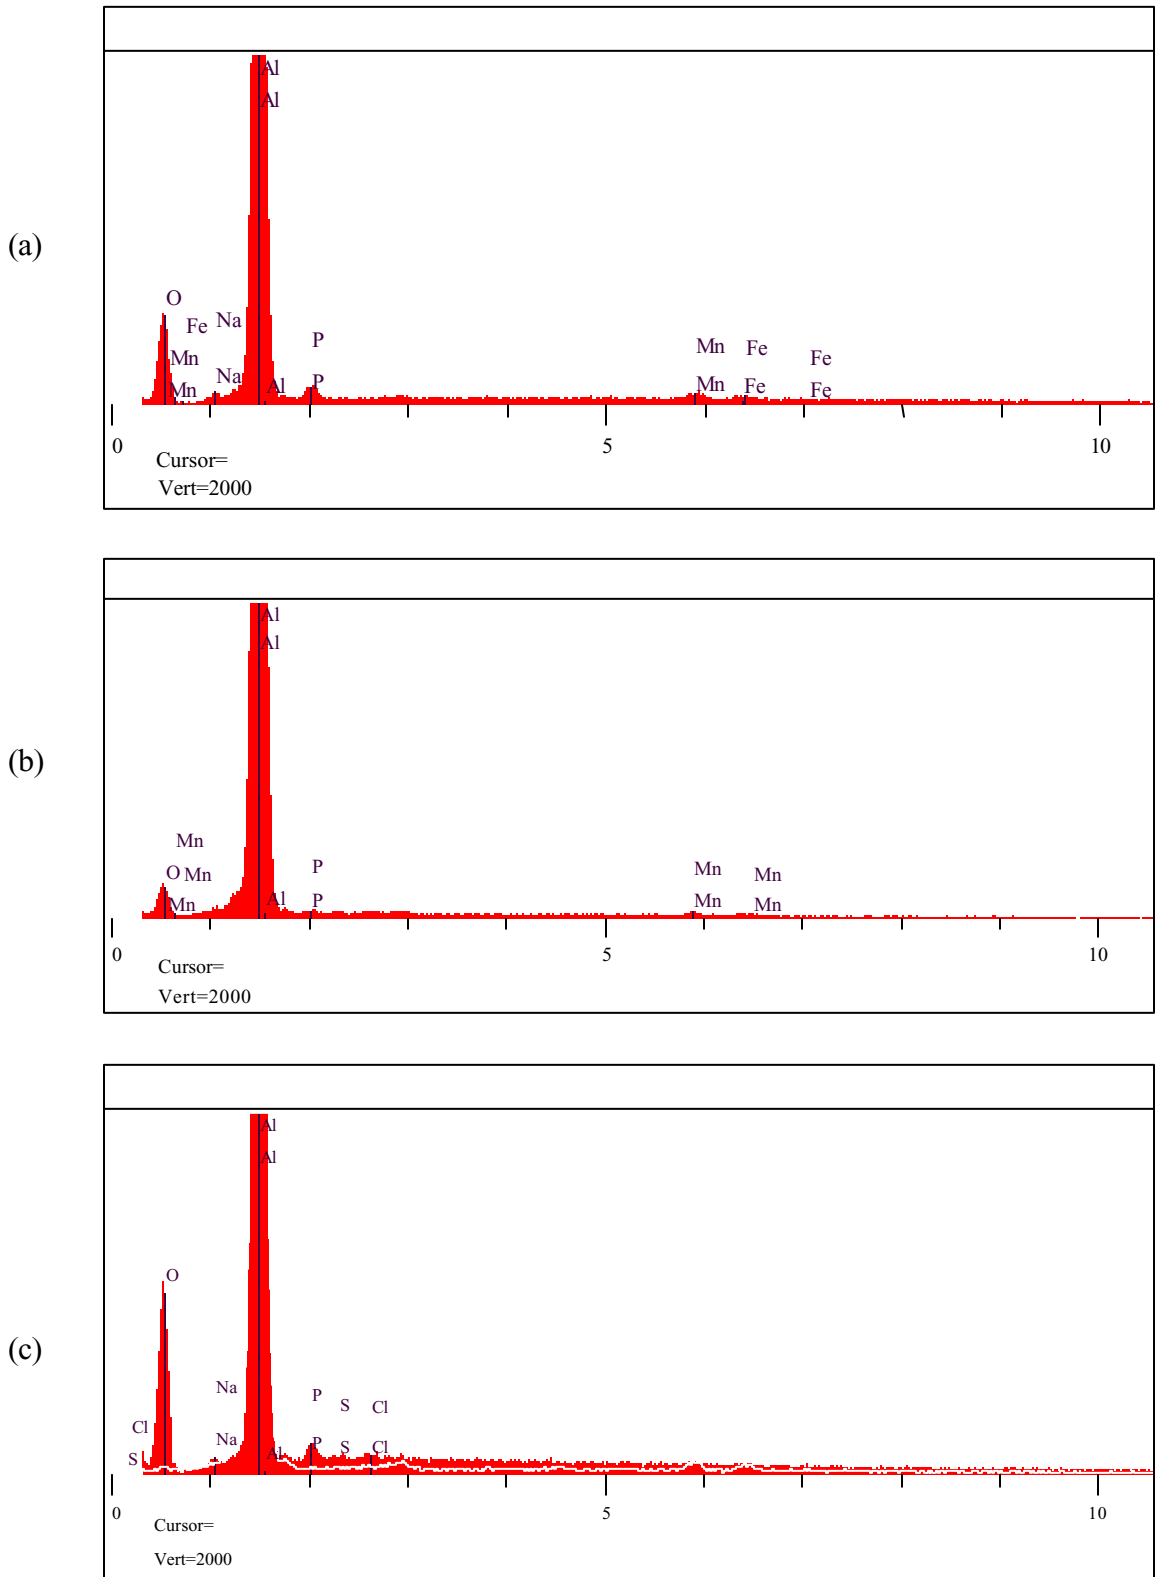
Figure 13. EDS results from 1-1-1 fracture surface.
 (a) Region A (b) Region B (c) Region E
 Plots show the spectra from the dark area (Figure 9) with the spectrum from the area beyond the beach mark superimposed in white. Note the lack of S, O, Na, Cl and P peaks in the superimposed spectrum.
