## **METALLURGICAL EVALUATION OF DOT-3AL-3000 CYLINDER J95119**

Research and Special Programs Administration  
U.S. Department of Transportation  
400 Seventh Street S.W.  
Washington D.C. 20590

Timothy R. Smith, Ph.D., P.E.  
Carol E. Moyer

10/5/00

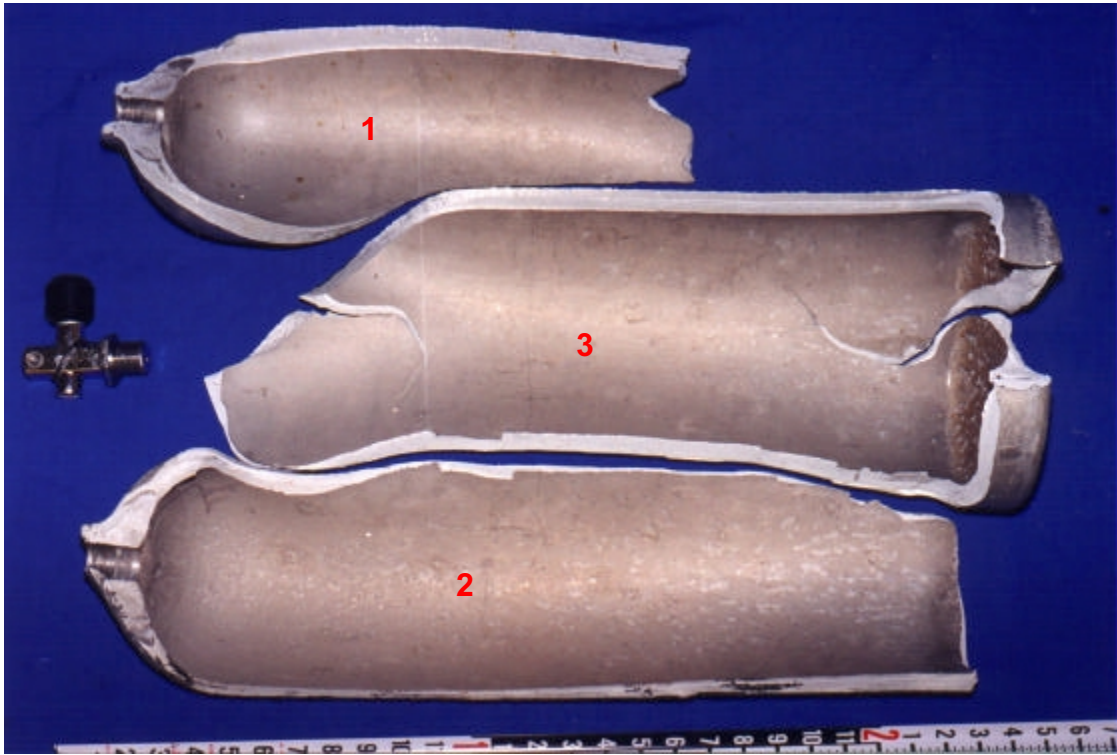
A visual examination of the cylinder remains was performed. The remains are shown in Figures 1 and 2, in the as-received condition. The cylinder broke apart into three large pieces designated 1, 2, and 3 by FaAA, the tank valve, and several small fragments.

Fragment 2, containing one-half of the neck region, sustained impact damage to its fracture surface and cylinder exterior, both likely as a result of the rupture event. Other pieces also showed impact damage and, at certain locations, scuffmarks. These also all appeared to be from the rupture event.

Figure 1. Cylinder remains, as received, showing fracture surfaces. Photo ID: DC18344-R4E4.

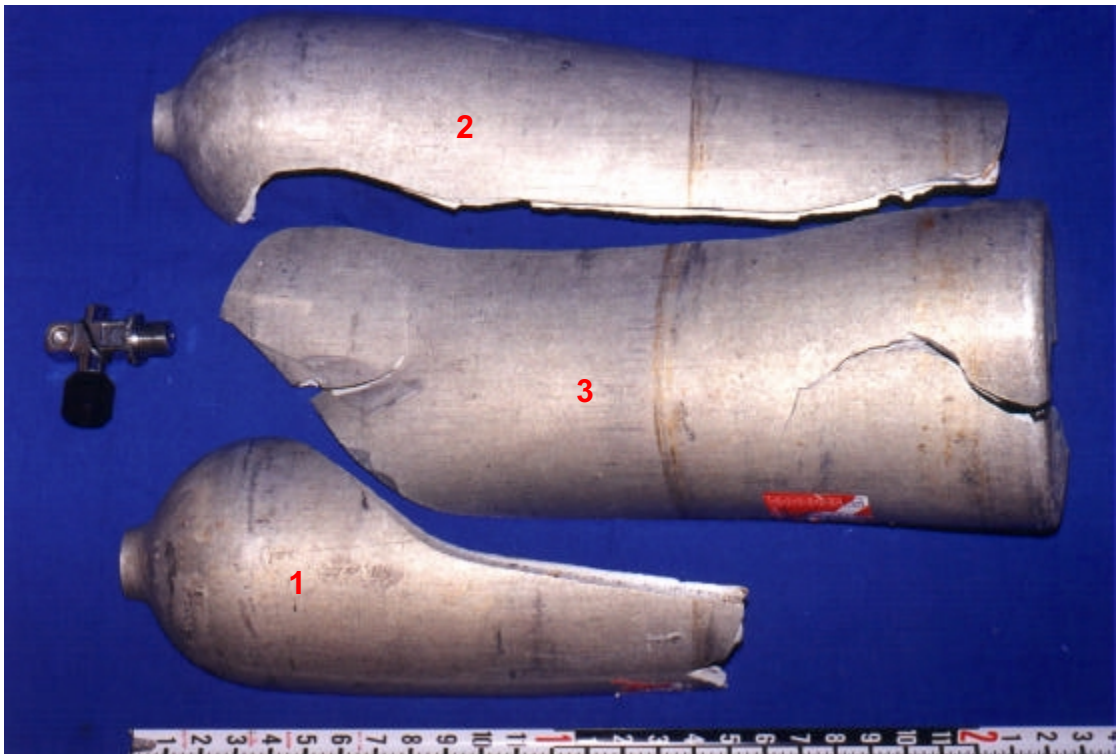
Figure 2. Cylinder remains, as received. Photo ID: DC18344-R4E45.

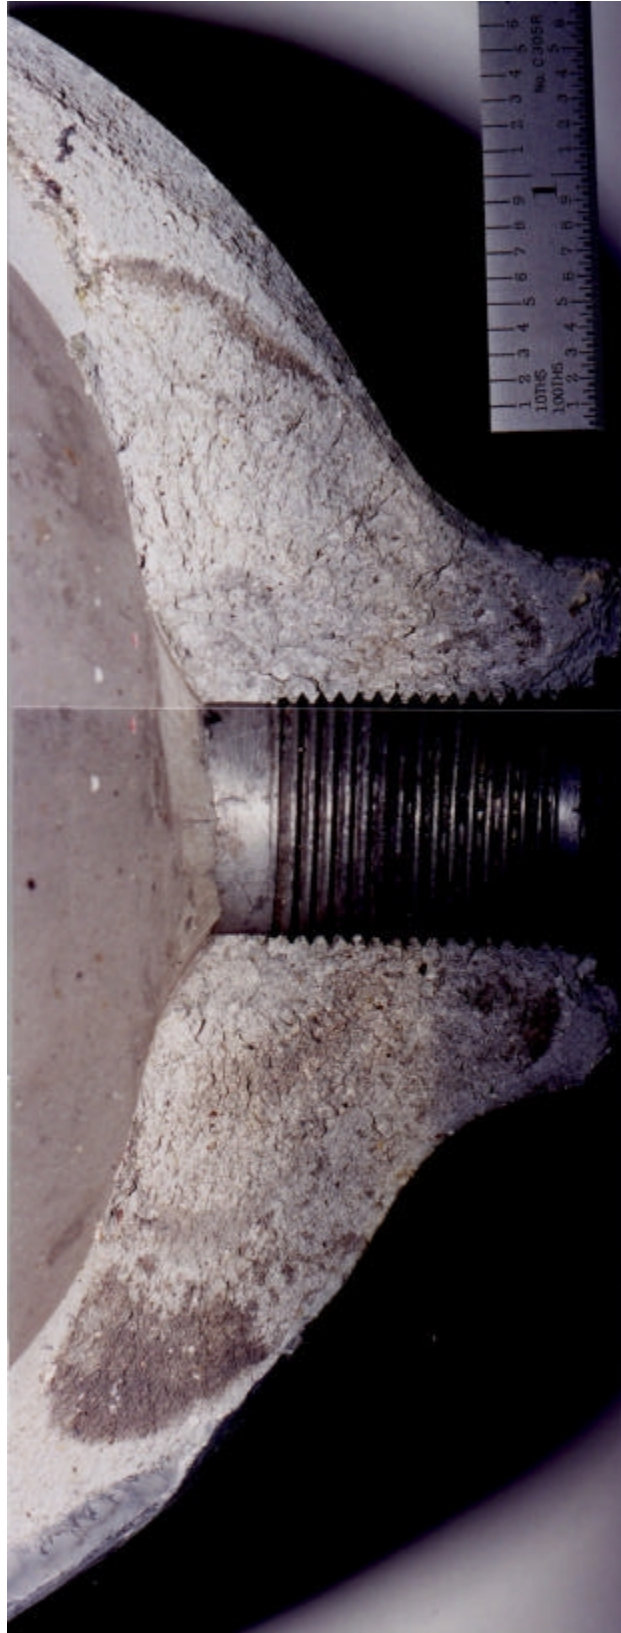
The fracture surfaces of the cylinder present on each of the three major fragments were inclined (i.e., non-radial with respect to the cylinder axis) shear-type, except in the neck region where the fracture surfaces were flat and radial with respect to the axis of the cylinder. The main fracture ran through essentially a full diameter of the inlet hole in the neck region. Figure 3 shows a photomontage of the fracture surface in the neck region.

Figure 3. Photomontage of the fracture surface in the neck region.  
DC18344-R6E14,15.

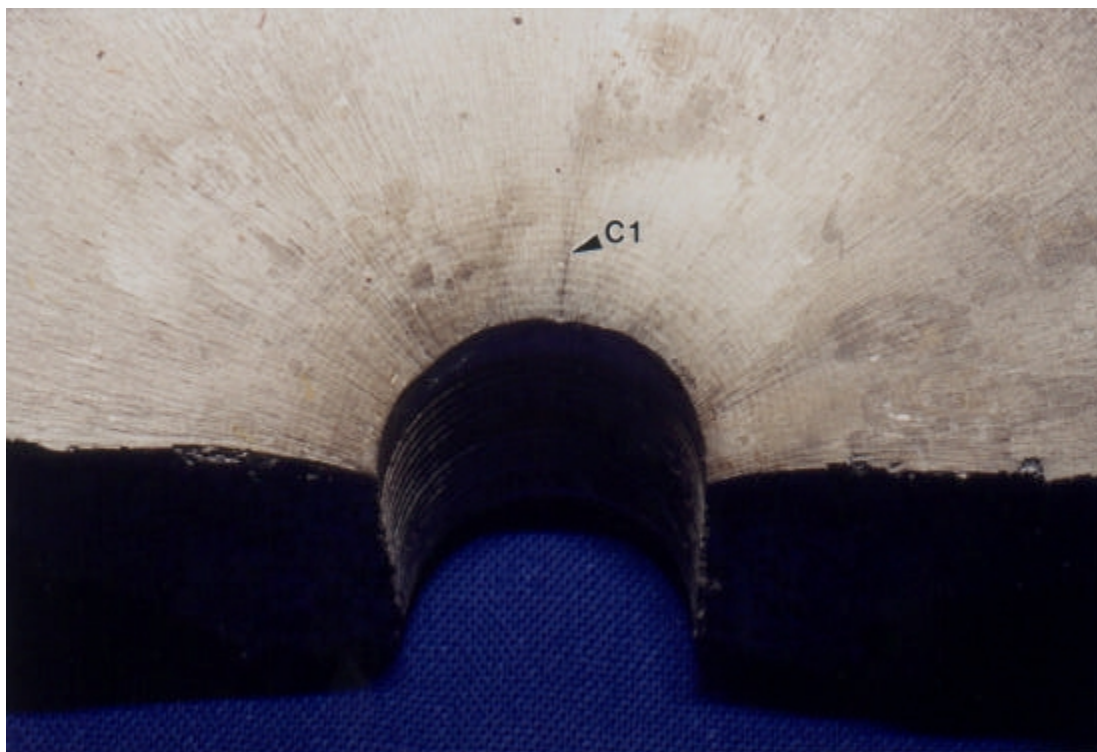
In the neck region, the inside wall of the cylinder showed multiple folds (or cusps) from the original manufacturing process (see Figure 4). The fracture surface on both sides of the inlet hole appeared to pass through folds of this type. On fragment 1 at least one crack, labeled C1 on Figure 4, was found originating from these folds.

The neck crack, C1 (see Figures 4 and 8), showed a mechanical character (i.e., straight and non branched) in the deeper half of its extent. Although this crack was not forced open in the laboratory it is reasonable to assume, based on its extent parallel to the inlet hole, that it was not as deep as the flat regions on either main fracture surface. As such, the force required to extend this crack is expected to be much larger than that required to extend the main fracture. The mechanical character of the C1 crack segment is consistent with the fast fracture event that ruptured the cylinder being the result of a pressurization event.

Figure 4. Close up of inside of the neck. A crack emanating from a neck fold is shown at C1. Photo ID: DC18344-R4E20.
