## **Recommended Scope of Work for Metallurgical Evaluation of Walter Kidde Aluminum SCUBA Cylinder**

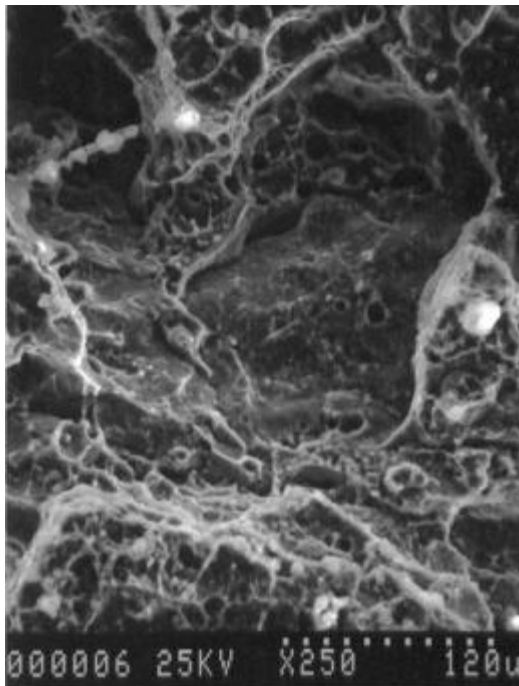
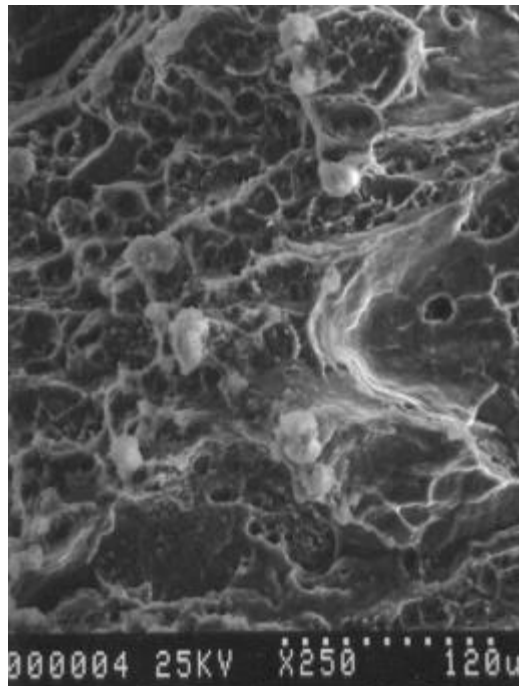
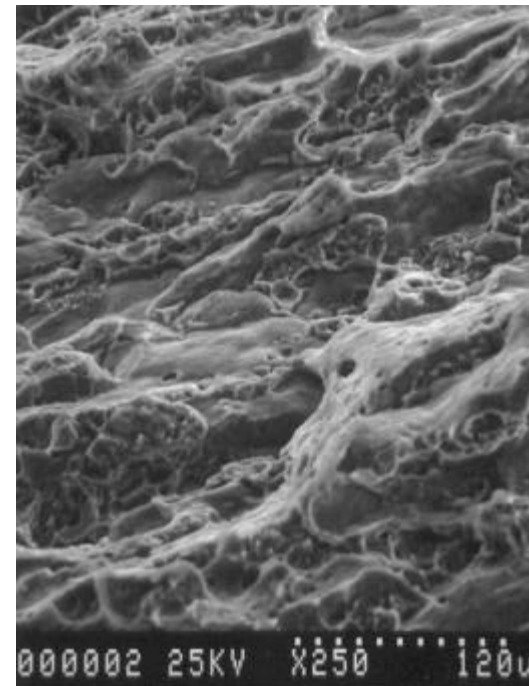
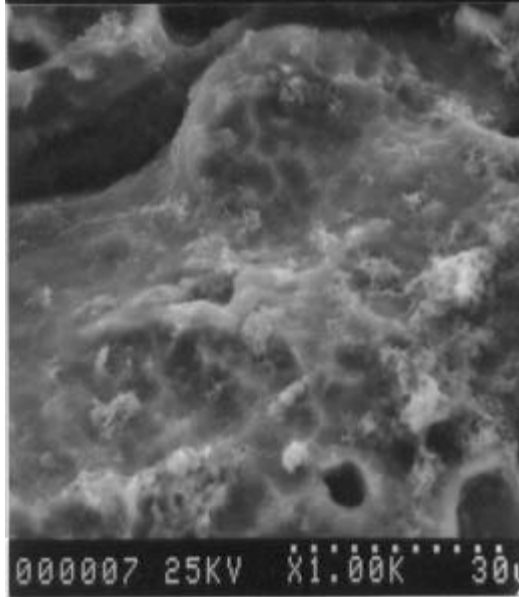
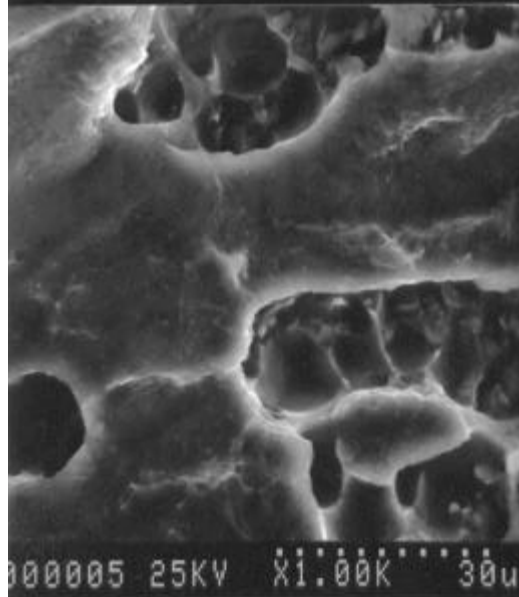
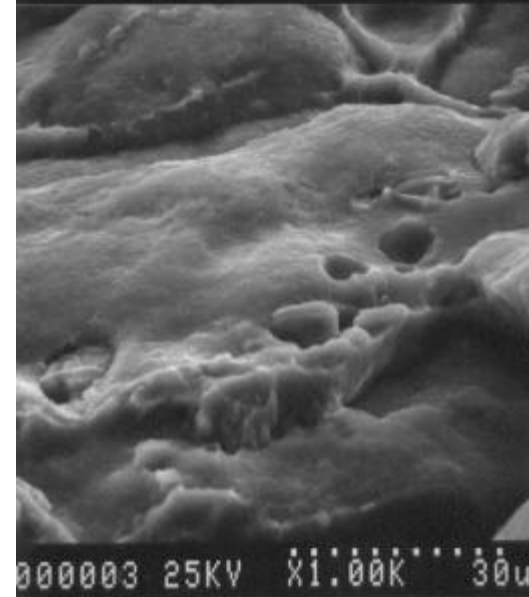
(a) Region I (dark area)

(b) Region I (at transition)

(c) Region I (beyond transition)

Figure 16. SEM fractographs from regions shown in Figure 14.

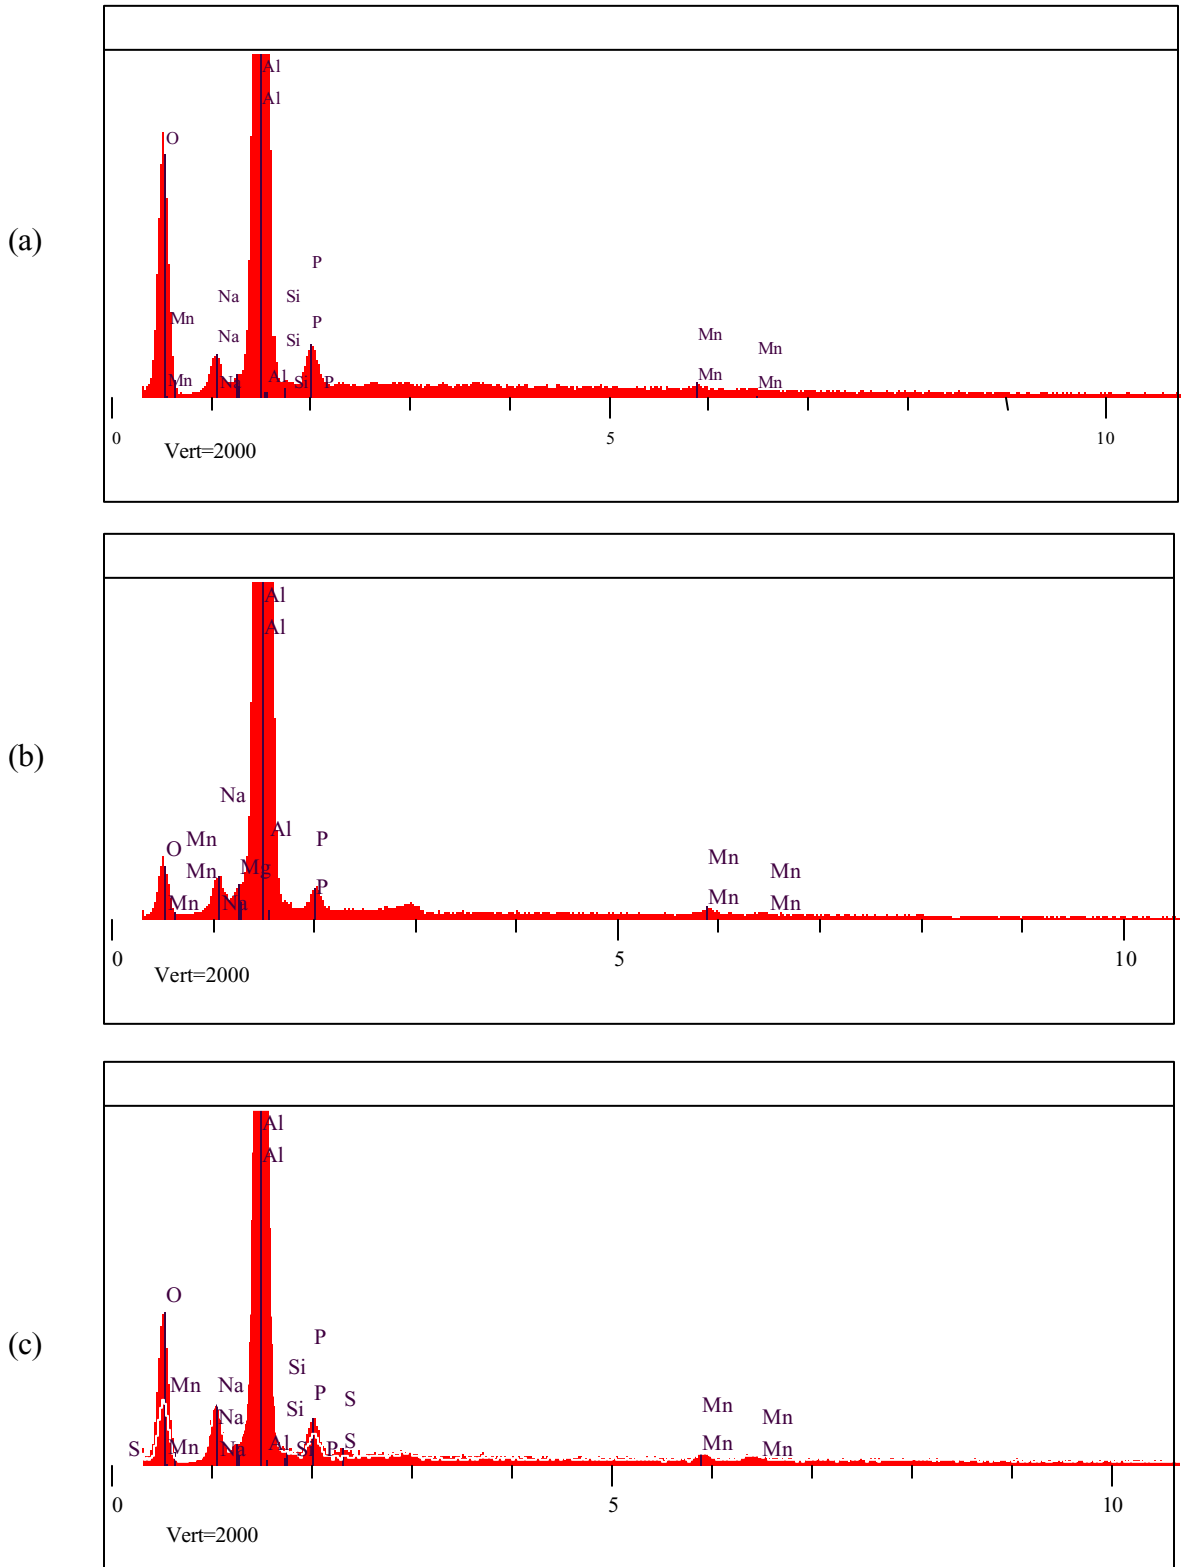
Figure 17: EDS results from 1-1-2 fracture surface.  
 (a) Region F (b) Region G (c) Region I  
 Plots show the spectra from the dark area (Figure 14) with the spectrum from the area beyond the beach mark superimposed in white. Note the lower S, O, and P peaks in the superimposed spectrum.

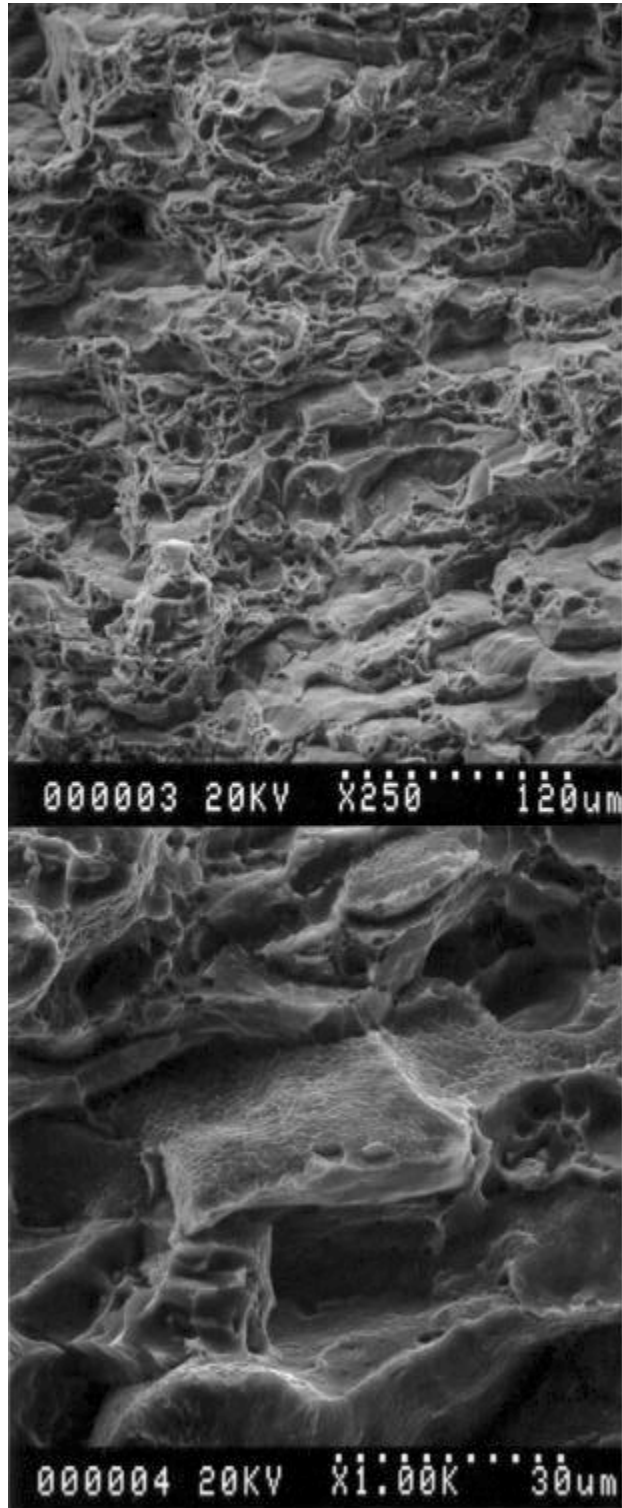
Figure 18. SEM fractographs of tensile specimen 1-2-1.

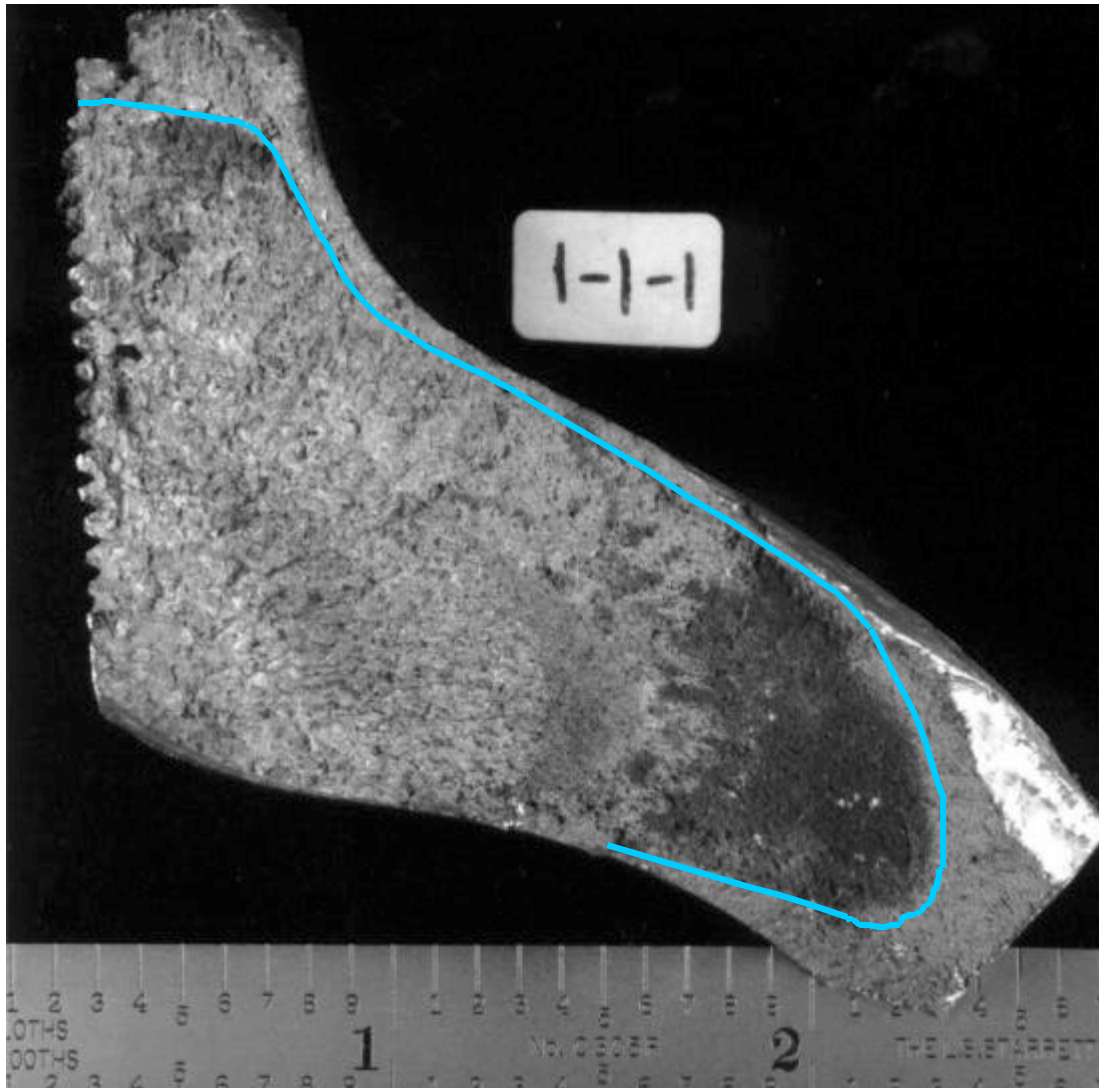
Figure 19: Approximate extent of subcritical crack growth on the 1-1-1 fracture surface.

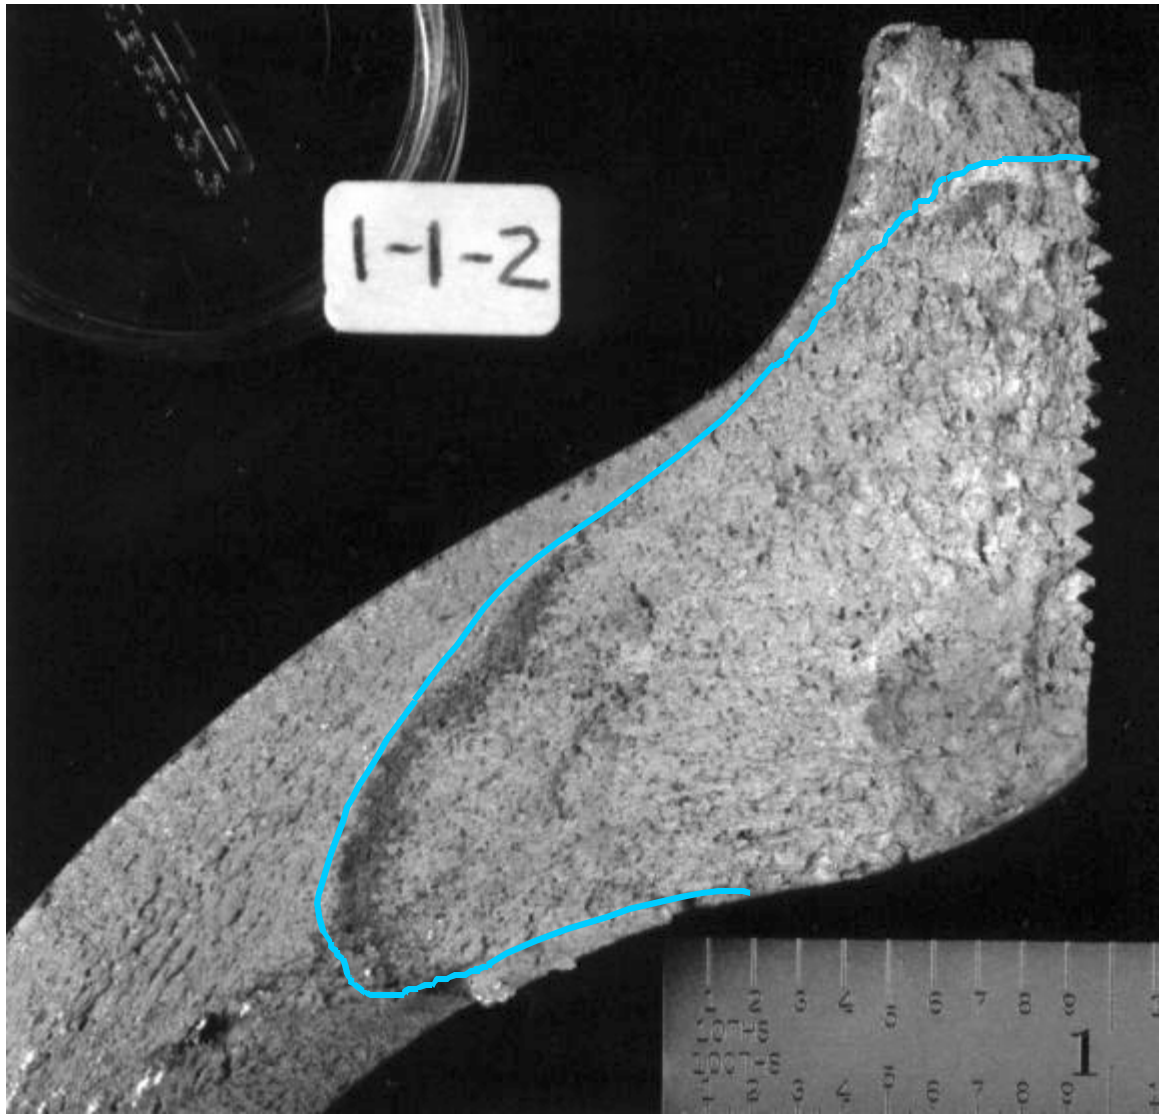
Figure 20: Approximate extent of subcritical crack growth on the 1-1-2 fracture surface.
