**CHEMICAL AND METALLURGICAL ANALYSIS
OF A RUPTURED DOT-3AL
SPECIFICATION COMPRESSED GAS CYLINDER**

Vishwanath Sahay
Paul J. Lare

December 15, 1994

U.S. DOT/RSPA
400 7th Street, S.W.,
Washington, D.C. 20590-0001

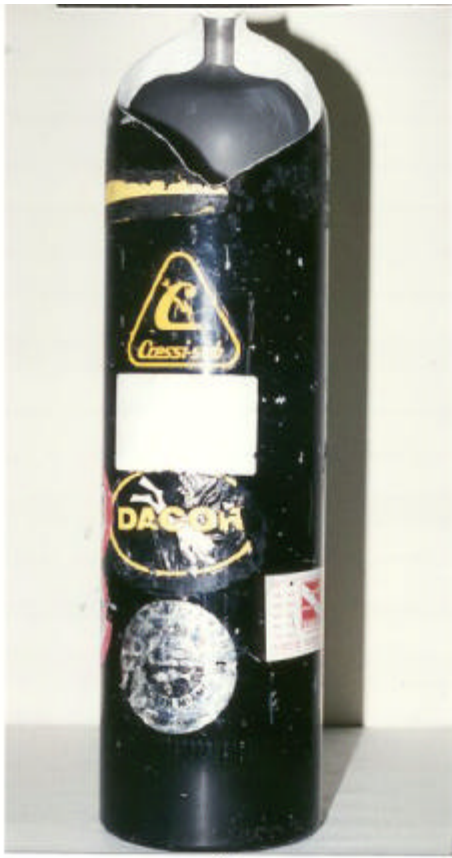
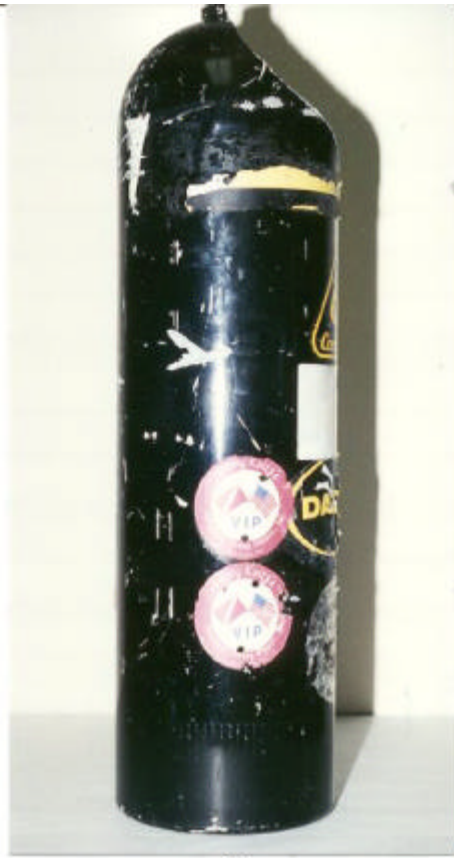
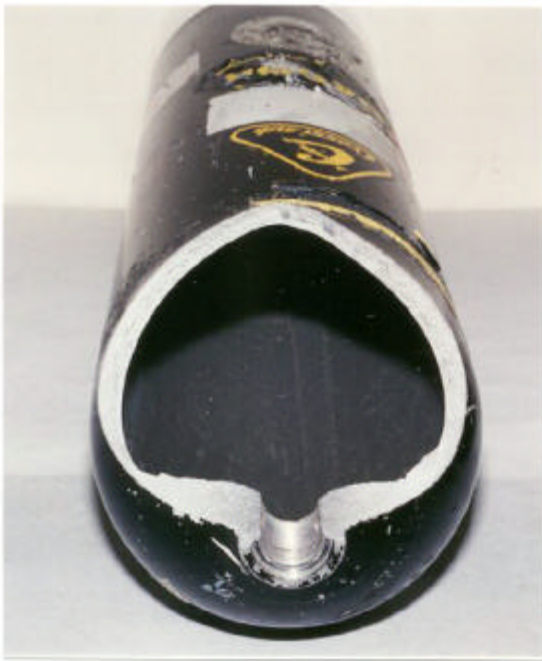
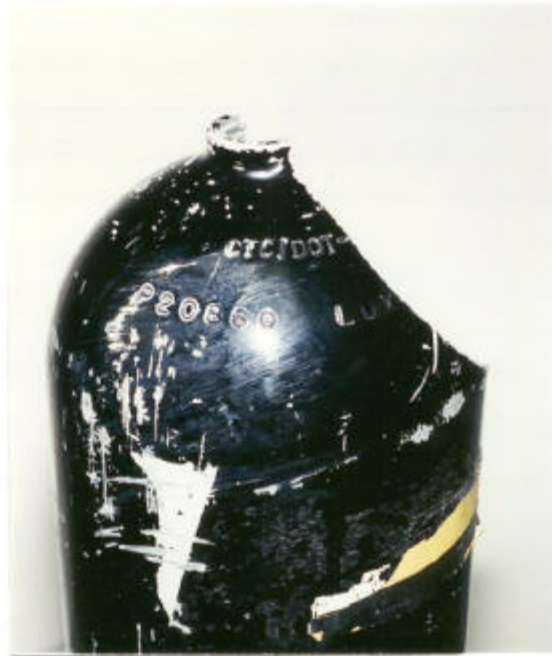
Figures 1-4: As-received views of the subject cylinder's general conditions, identification markings and an overall view of the fracture surfaces.

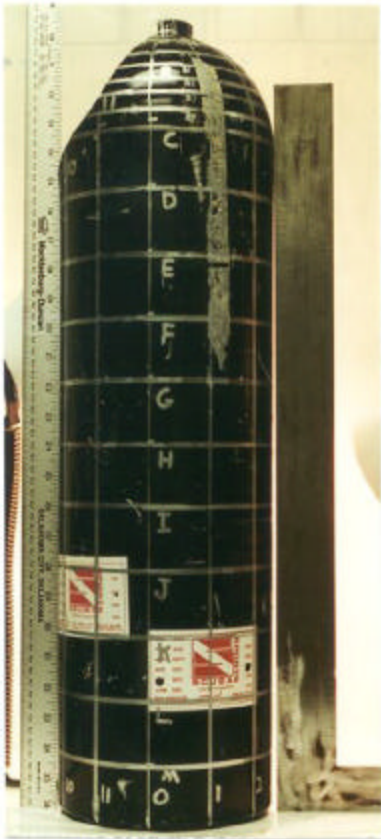
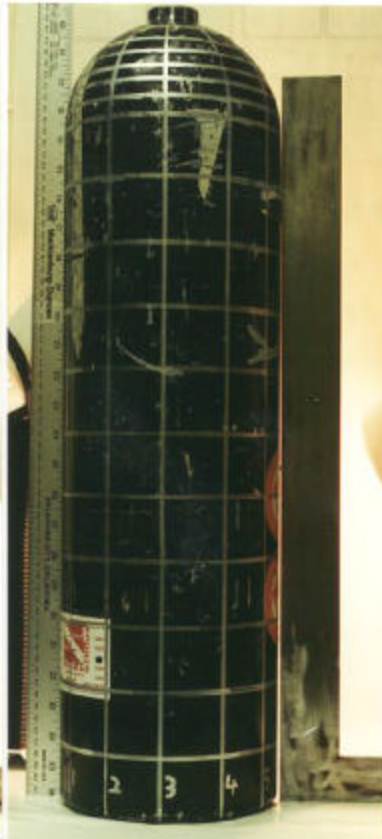
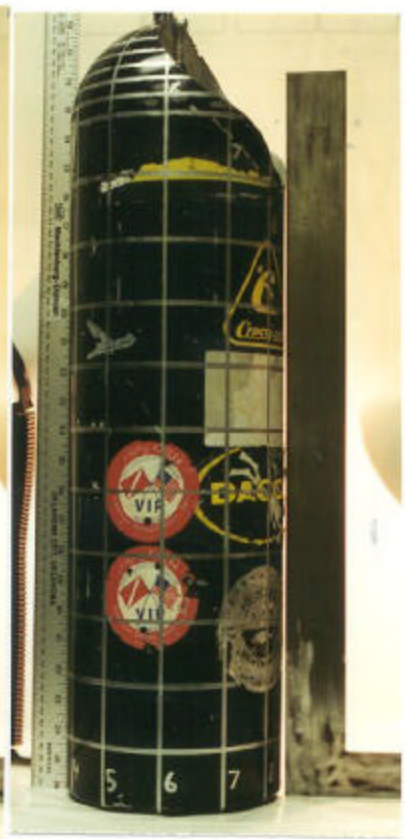
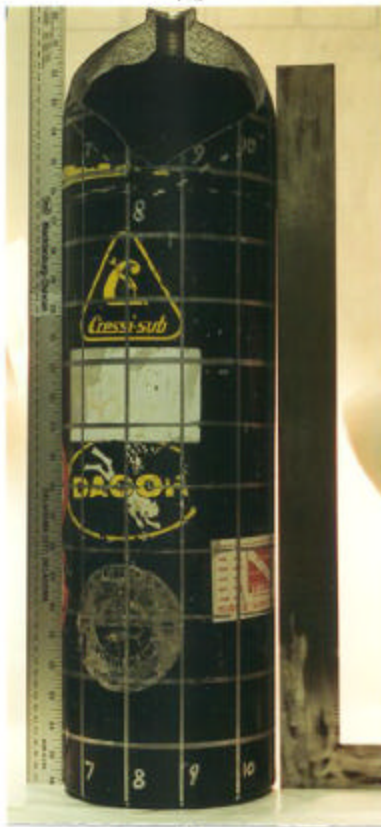
Straightness of the cylinder was documented by abutting a 90° metallic ruler against its outer surface and photographing the gap along its length (see figures 14-17).

Figure 14-17: Photographs exhibiting the grid layout. They also show overall straightness of the cylinders. There appears to be slight bulging near the base of the dome part of the cylinder.

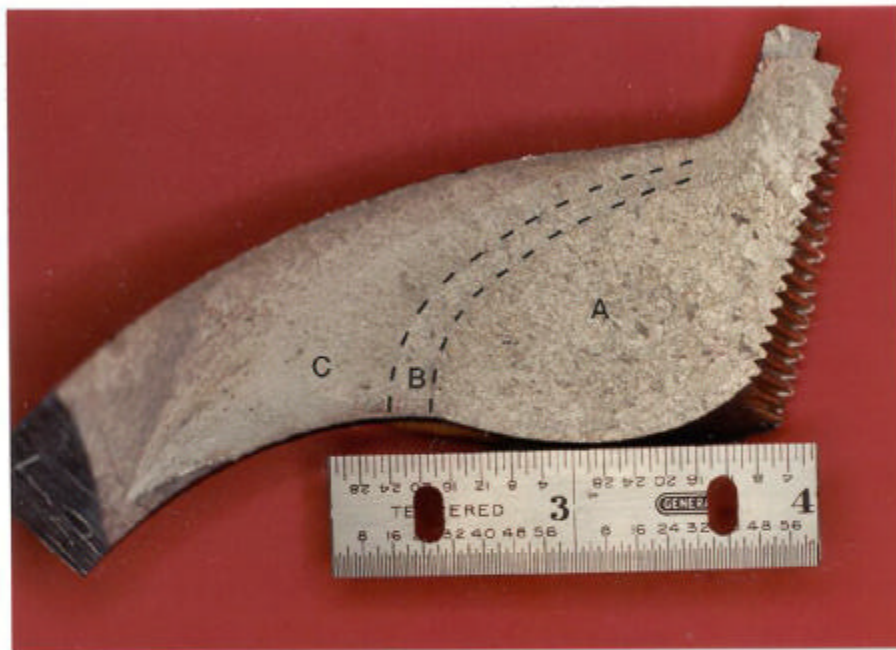
An enlarged macro view of this fracture section is shown in figure 20. It exhibited three distinct regions (A-C) as marked on the photograph. Each region was examined under a scanning electronic microscope (SEM).

Figure 20: An enlarged view of section 1 (figure 18B) shows three distinct regions on the fracture surface marked A, B and C.

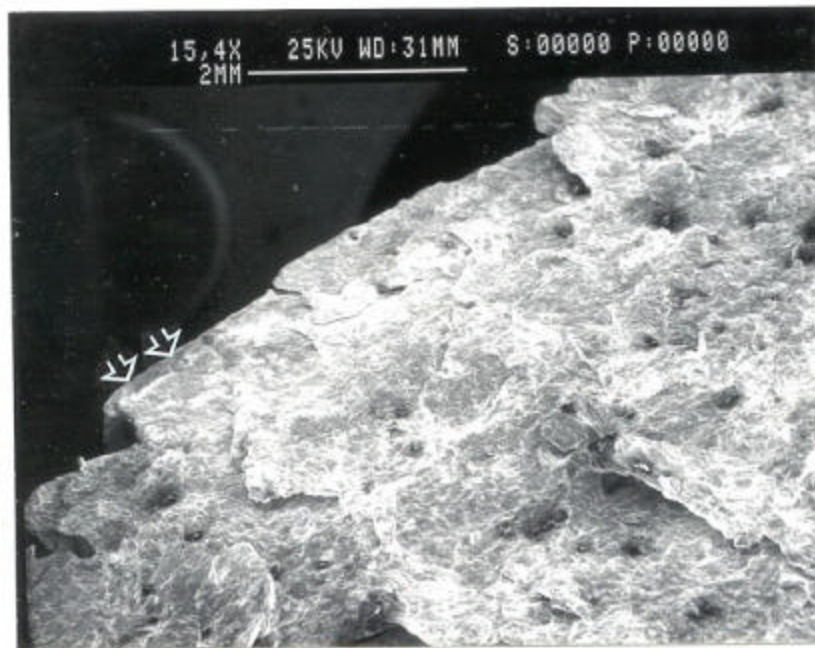
Figure 21 - This low magnification fractograph shows region A near the last thread.

Figure 21: A low magnification SEM fractograph of region A shows areas near the last thread, X15.

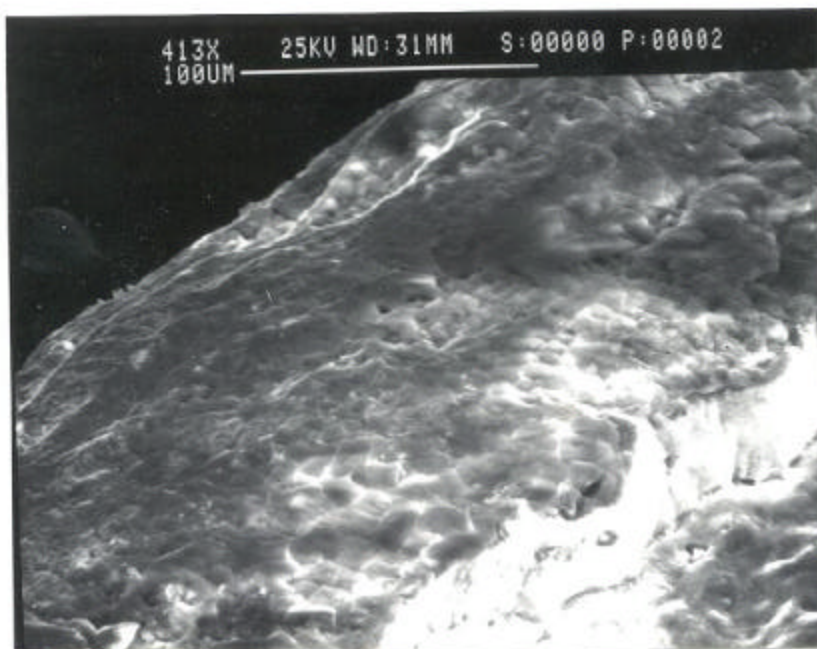
Figure 22 - It is from a location close to the last thread in region A, showing metal fold, formed during extrusion process, on the internal surface (near neck). It exhibits a featureless area.

From examination of the fracture surfaces, it appears that the cracks initiated along extrusion folds on the internal surface in the thick section region near the last thread. Three regions of fracture (A, B, and C), discussed earlier in reference to fracture section 1, were formed during three separate one-time events characterized by two arrest marks bordering region B. Region C (third event) continued into fracture sections 2 and 3. None of the regions on the fracture surfaces exhibited any role of fatigue damage; each fracture region exhibited failure due to a single tension-type overload. The fracture surfaces revealed a mixed mode of failure of intergranular decohesion, some dimpled rupture and featureless regions probably formed due to transgranular failure as discussed in the metallographic analysis section.

Figure 22: Enlarged view of the edge indicated by arrows in Figure 21, exhibits a featureless metal fold formed during extrusion process, X413.

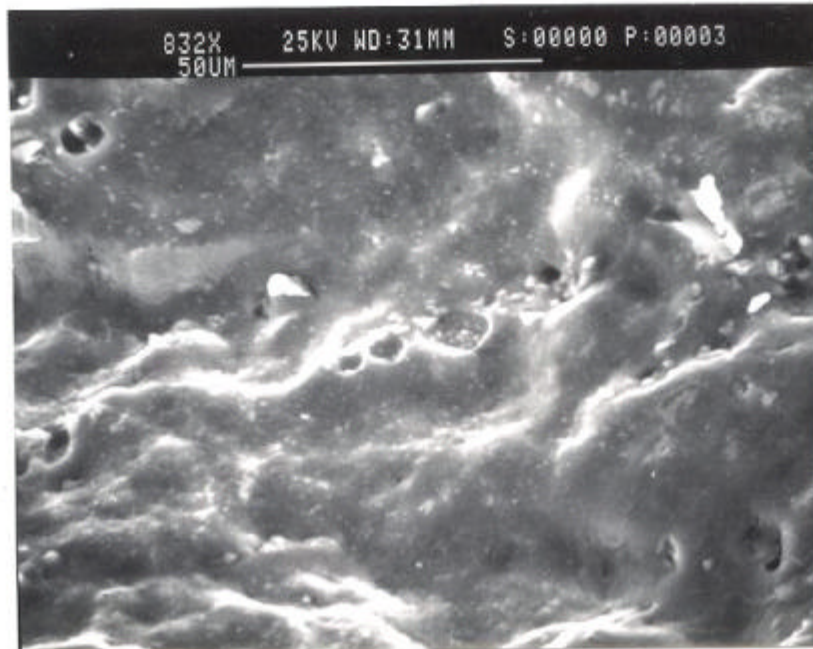
Figure 23 - It is from a location deeper in region A. It shows a featureless fracture. Some evidence of localized dimpled rupture and grain boundary decohesion was also observed.

Figure 23: Fractograph of an area deeper in region A shows featureless fracture. Some evidence of dimpled rupture and intergranular failure was also observed, X832.

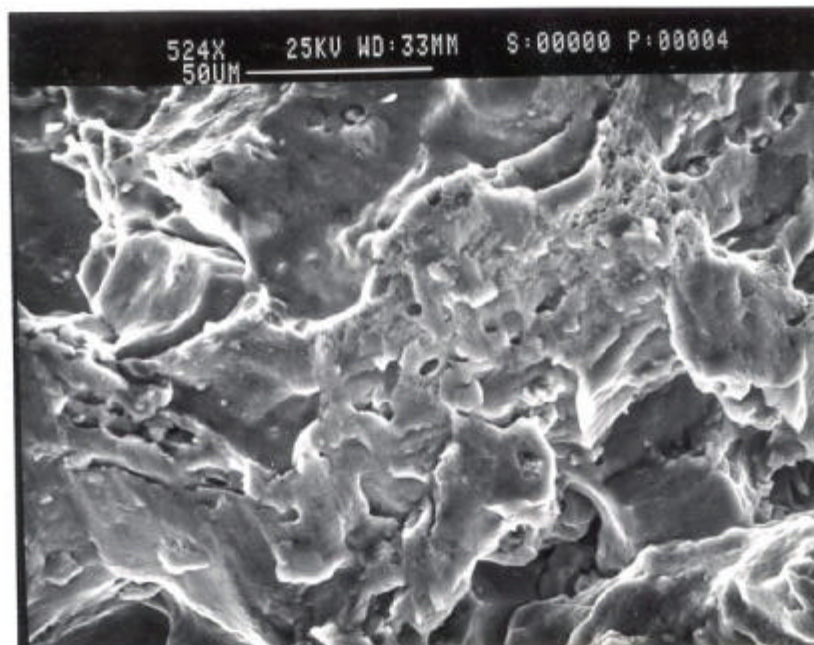
Figure 24 - It is from a location in region A (near region B). It also shows featureless regions as in figure 23, but dimpled regions and grain boundary separation are easily identifiable.

Figure 24: Fractograph from an area in region A (near region B) is featureless as in figure 23. However, evidence of dimpled rupture and grain boundary decohesion is more discernible, X524.

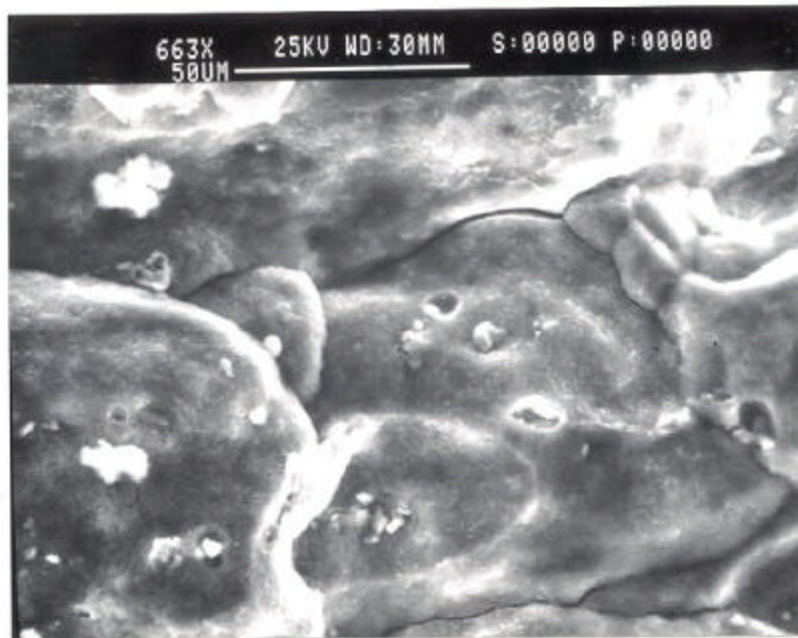
Figure 25 - It is from a location in region B. It shows featureless smooth facets as in figures 23 and 24. Well defined evidence of grain boundary decohesion was also observed.

Figure 25: Fracture in region B exhibited featureless regions. It also clearly indicated evidence of grain boundary failure, X663.

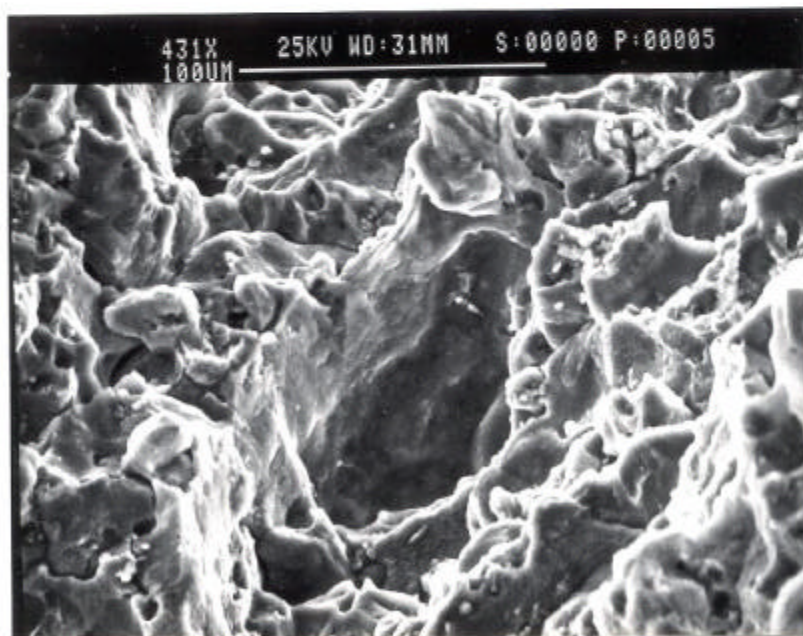
Figure 26 - It is from a location in region C. It shows similar fractures as in figure 24.

Figure 26: Fractograph from an area in region C. It shows similar features as in figure 24.

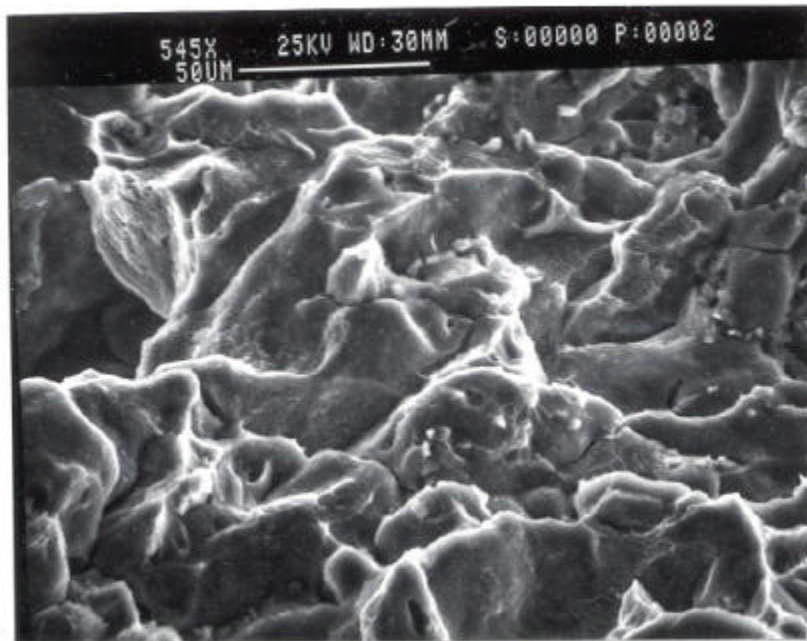
Figure 27 - It is from a location in region C, farther away from location in figure 26. It exhibits clearly defined intergranular failure.

Figure 27: Fractograph from an area deeper in region C. It exhibits clearly defined intergranular failure, X545.

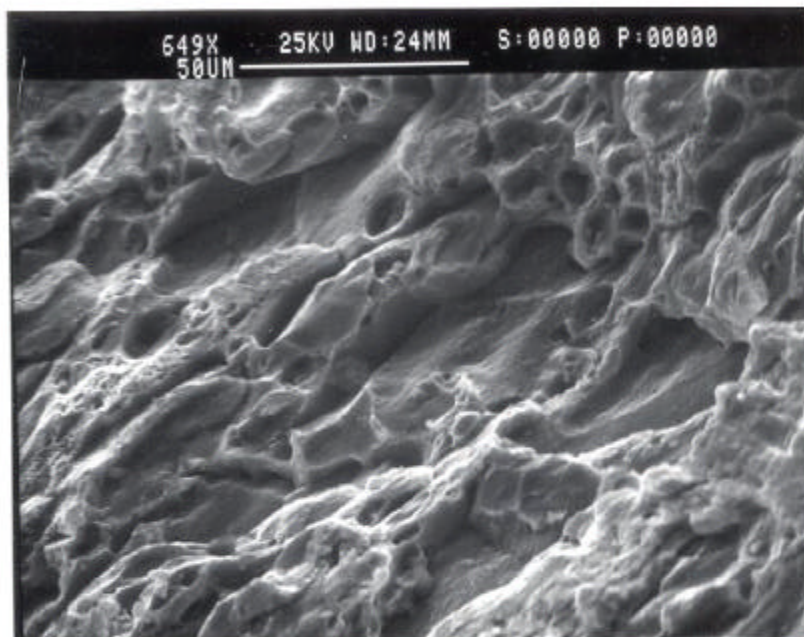
Entire fracture areas in these sections exhibited intergranular failure in general. Dimpled rupture was also observed in certain areas. A typical fractograph is presented in Figure 28.

Figure 28: A typical fractograph of the fracture surface in sections B and C showing largely intergranular failure. Some evidence of dimpled failure can also be observed, X649.

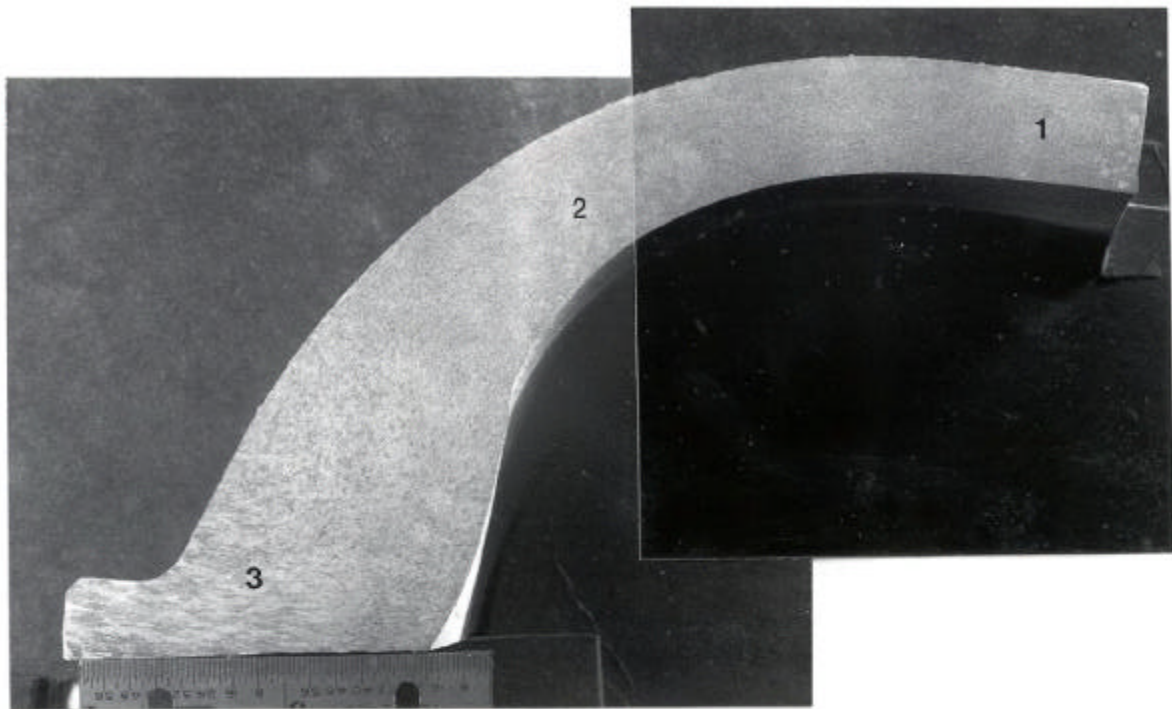
The macro section outlined in figure 30 was lapped up to 600 grit paper and etched with Keller's reagent. The overall macrograph of the section is shown in figure 31. It exhibits fine grain structure in the barrel region; grain size slowly becomes large towards the neck region. Areas marked 1, 2, and 3 were photographed at a larger magnification which clearly indicate significant difference in grain size between the neck and barrel regions; see figures 32-34. The material in the neck region appears to have undergone recrystallization and appreciable grain growth; no apparent grain growth was observed in the barrel region.

Figure 31: Macrograph of the section indicated in figure 30. It exhibits fine grain structure in the barrel section and coarse grains near the neck region, X1.14, Keller's Etch.

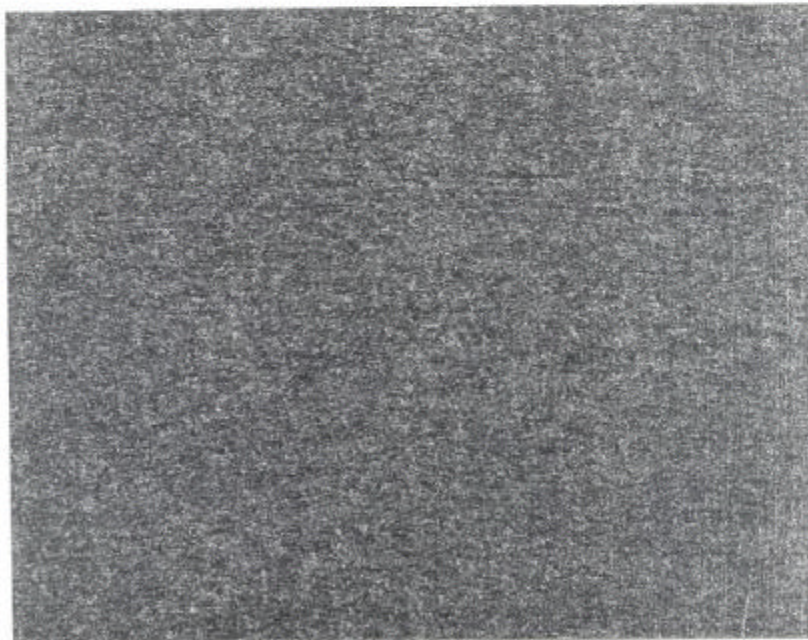
Section 32: Enlarged view of the area marked 1 in figure 31 shows a very fine grain size, X10.

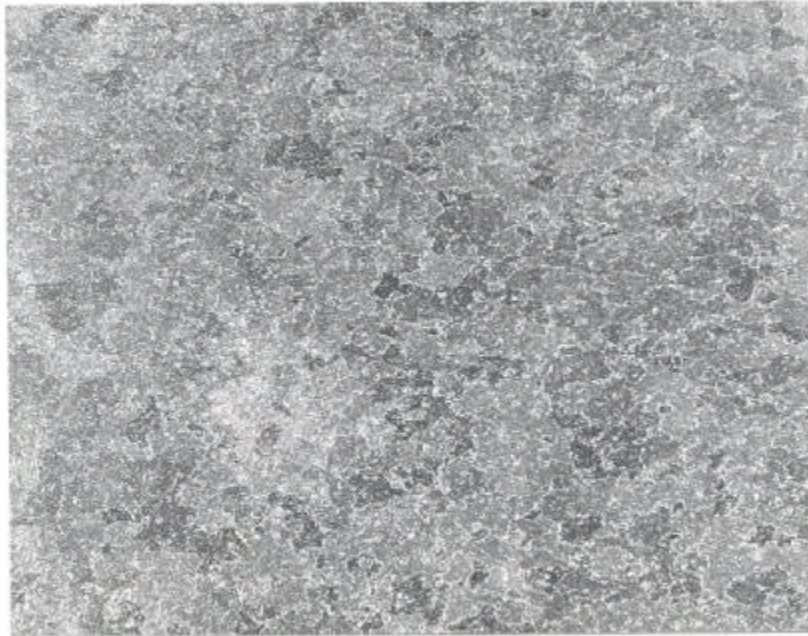
Figure 33: Enlarged view of the area marked 2 in figure 31 shows coarse grains as compared to those shown in figure 32, X10.

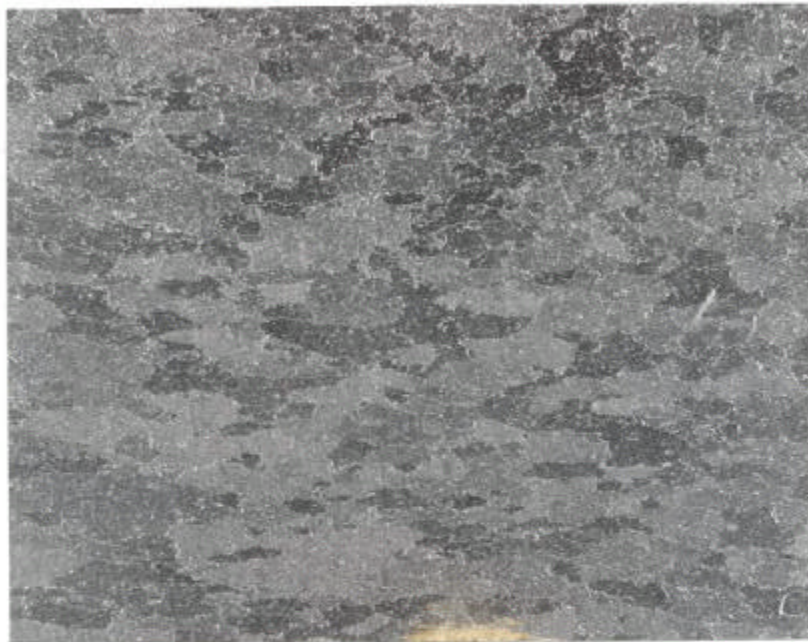
Figure 34: Enlarged view of the area marked 3 in figure 31 shows coarse grains as compared to those shown in figure 33, X10.

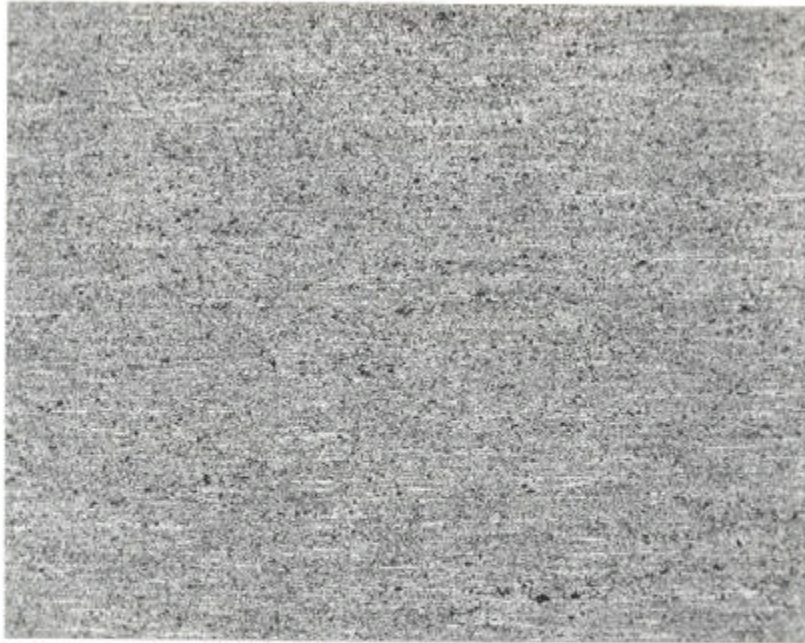
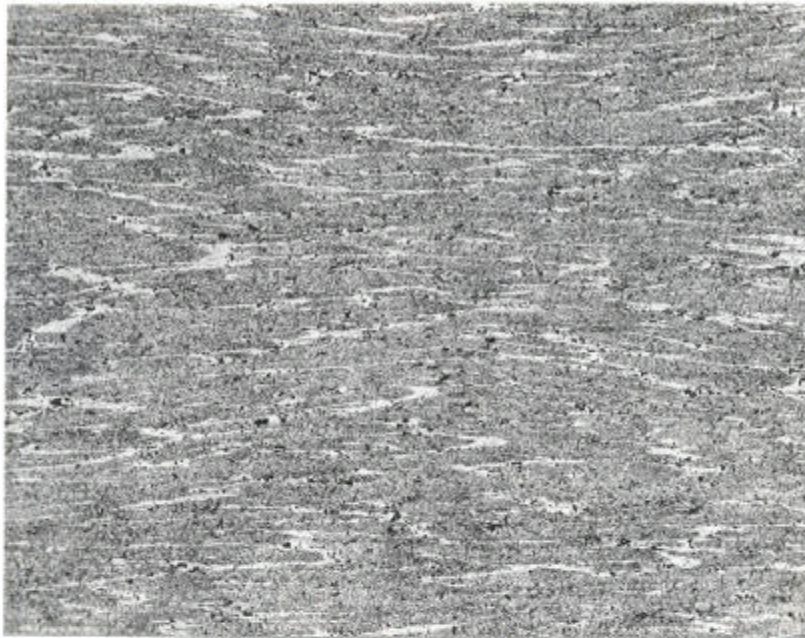
Figure 35: The micrographs representing the inside and outside surfaces show flow lines formed during the extrusion process. The inside surface appears to have much finer grains as compared to the outside surface.

The presence of some coarse particles was observed both along grain boundaries and inside grains in figures 35 and 36. These particles were later detected to have substantial presence of Pb and Bi; see metallographic analysis section.

Figure 35: Photomicrographs showing microstructures near the inside surface (A) and near the outside surface (B). Extrusion flow lines are apparent. Grain size near the inside surface appears to be much finer as compared to that near the outside surface, X100.

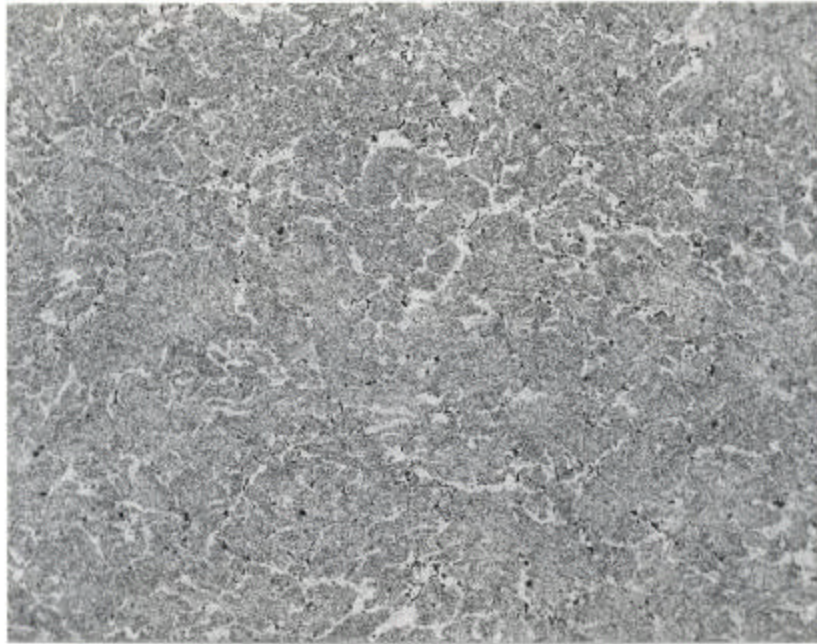
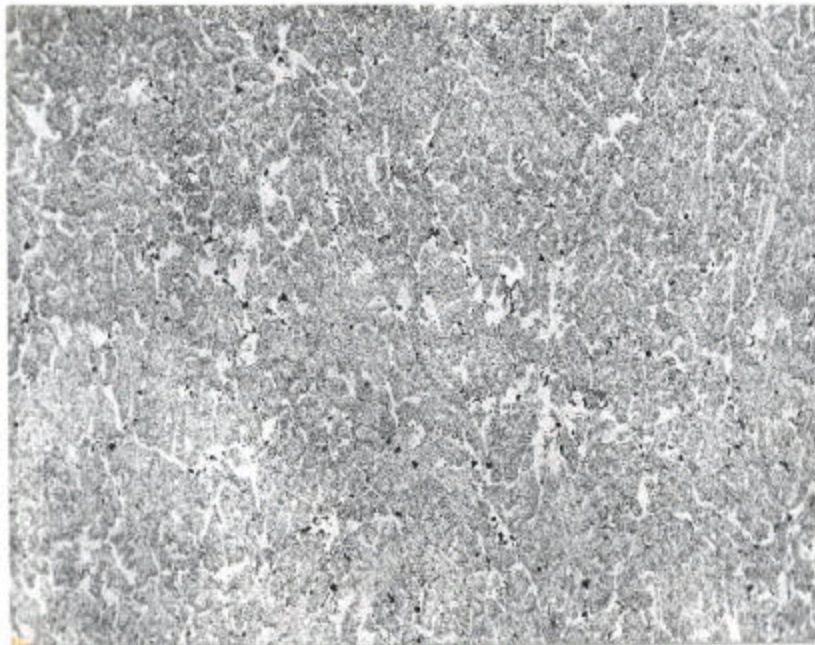
Figure 36: Extrusion flow lines seen in the barrel region (figure 35) were not present in the neck region. The micrographs representing the neck region indicate that material in that area underwent recrystallization and extensive grain growth throughout the section. Both the inside and outside surfaces exhibited a similar microstructure having very coarse grains relative to the barrel region.

Figure 36: Photomicrographs showing microstructures near the inside surface (A) and near the outside surface (B). No extrusion flow lines are present. They exhibit extensive grain growth in the area. Some precipitate particles can be seen along grain boundaries and inside grains, X100.

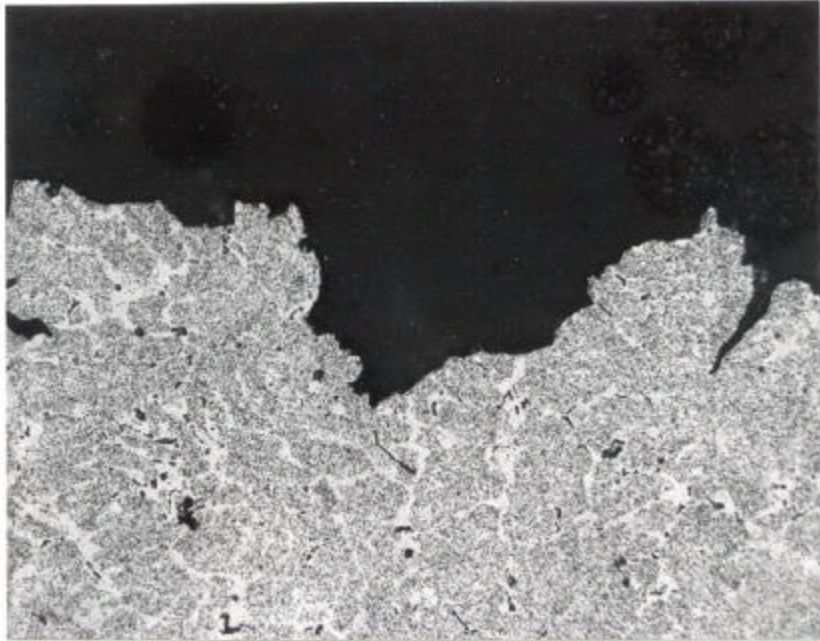
Figure 37: This is a micrograph showing areas near the fracture face. Examination along the fracture face revealed an intergranular and transgranular mixed mode failure. Intergranular failure is attributed to weakened grain boundaries (white regions in the micrographs) due to the presence of Pb and Bi. Weakness of the grain boundaries is shown by a Knoop microhardness indentation in figure 38; half of the indentation falling in white region is larger than the other half in the dark region indicating that the white area is softer than the dark area. A likely cause of transgranular failure is due to the presence of crack initiation sites offered by some Pb - Bi particles trapped inside grains, which could have occurred during the recrystallization process.

Figure 37: Photomicrographs showing the microstructure along the main crack front. It indicates a mixed mode fracture consisting of intergranular and transgranular failure, X200.

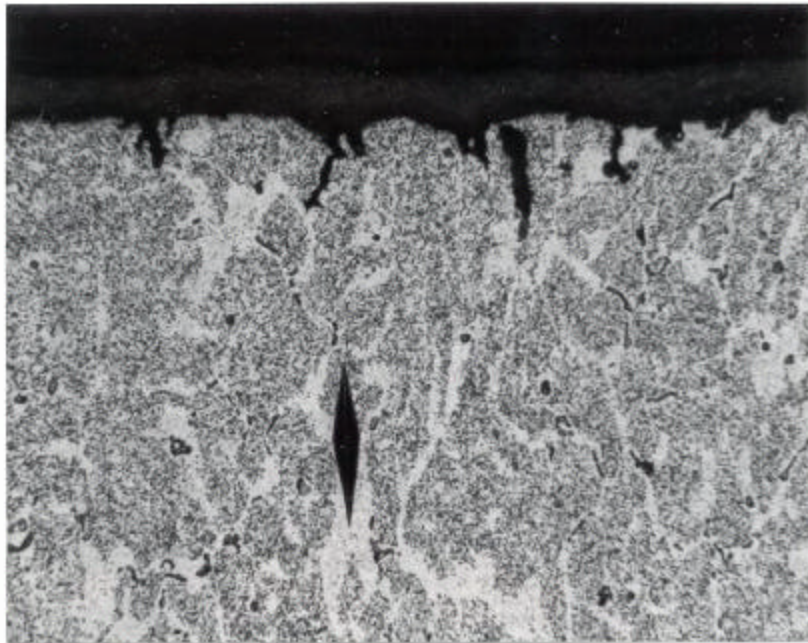
Figure 38: Photomicrograph exhibits a Knoop microhardness indentation showing its half diagonal located in the white region larger than the other half in the dark region, X300.

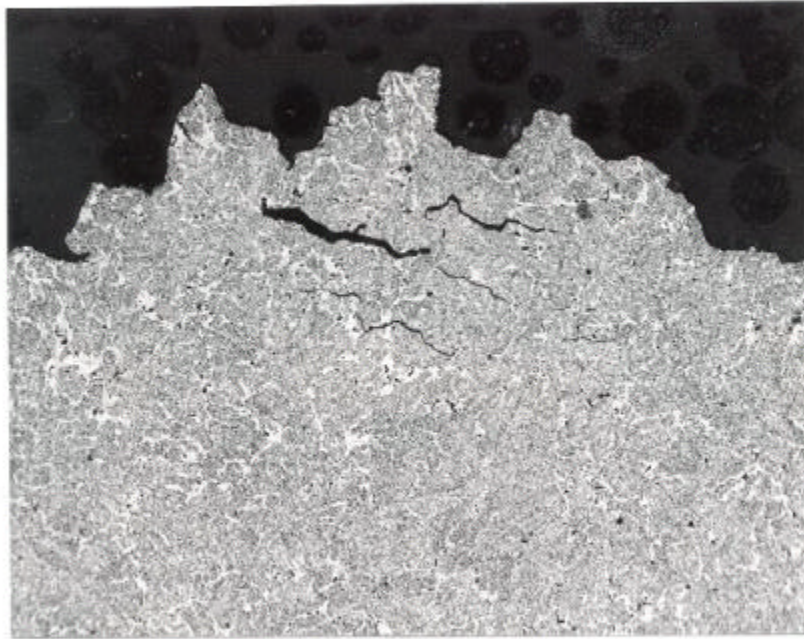
Figure 39: It shows internal cracks running almost parallel to the main crack front. It is attributed to inherent weaknesses in the material mentioned in figure 37 description which caused cracks to initiate under tensile load (Hoop stress) while the cylinder was under pressure.

Figure 39: Photomicrograph shows internal cracks running parallel to the main crack front, X100.

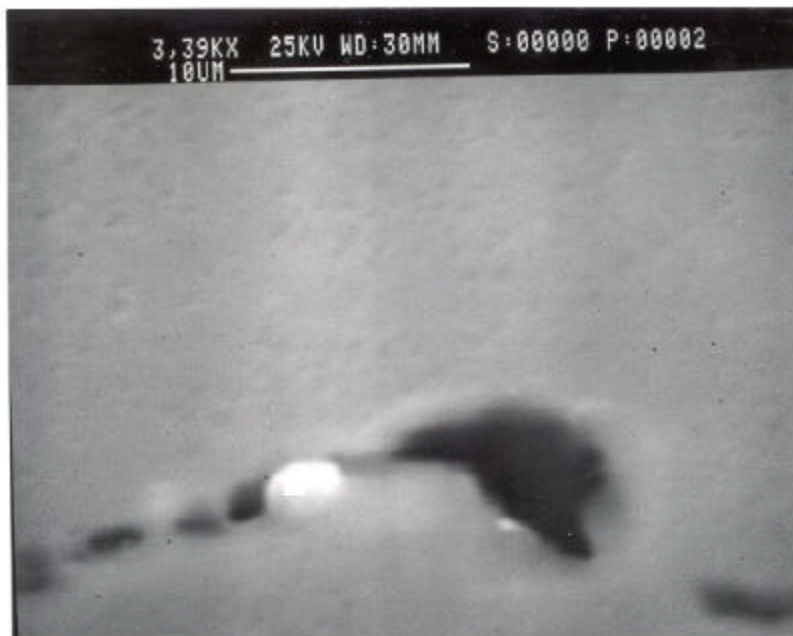
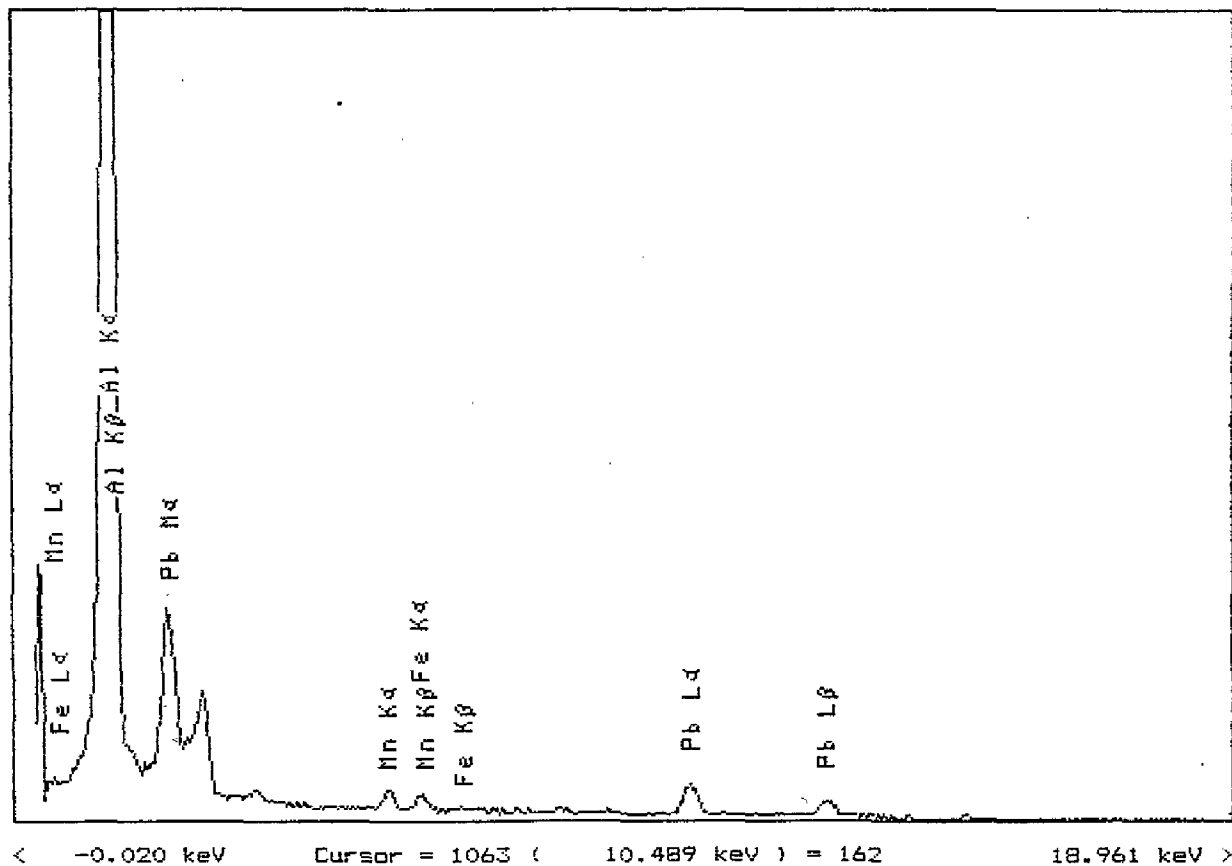
Figure 40: Coarse particles observed along grain boundaries and inside grains were analyzed using energy dispersive spectrometer (EDS). The SEM micrograph showing the analyzed spot

and the EDS spectrum are presented in figure 40; it indicates a strong presence of Pb along with Fe and Mn (figure 40B). Another spot analysis revealed the presence of Bi (figure 40C).

Figure 40A: SEM micrograph exhibits the spot on a precipitate particle which was analyzed using EDS, X3390.

Figure 40B: EDS spectrum of the spot shown in figure 40A indicates the presence of Pb, Mn, and Fe.

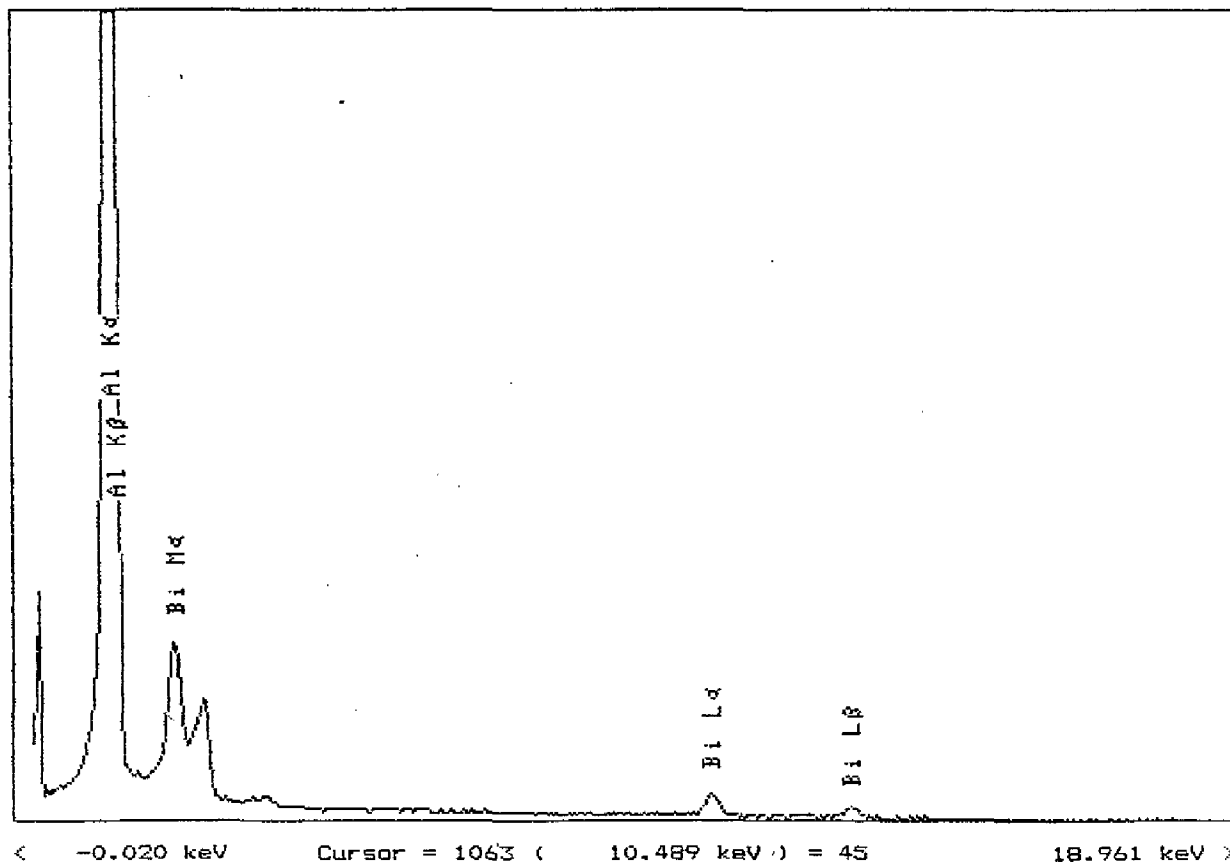
Figure 40C: EDS analysis of another spot on the same mount as in figure 40A detected appreciable presence of Bi.

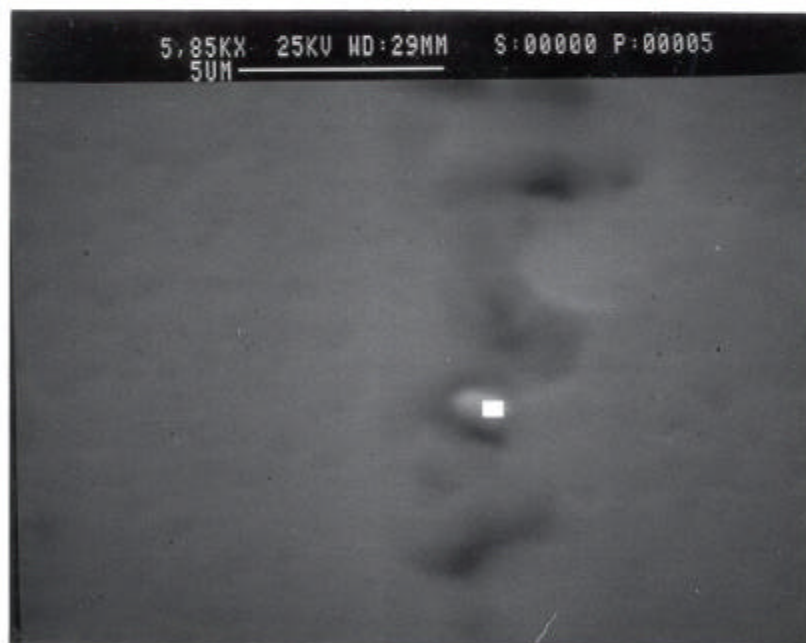
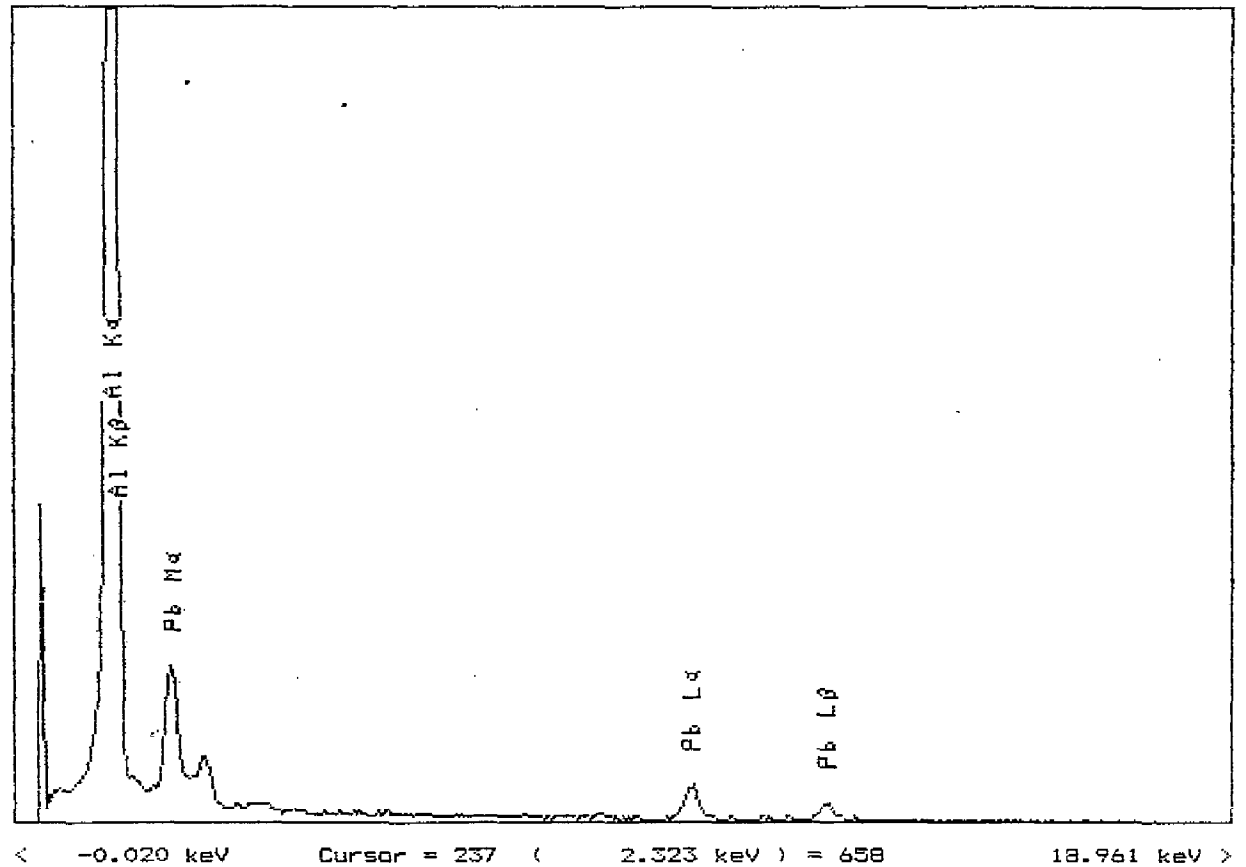
Coarse particles observed in figure 35 were analyzed using EDS. The SEM micrograph showing the analyzed spot and the EDS spectrum are presented in figure 41. It indicates a strong presence of Pb in the material.

Figure 41A: SEM micrograph showing the spot on a precipitate particle which was analyzed using EDS, X5850.

Figure 41B: EDS spectrum of the spot shown in figure 41A shows the presence of Pb.
