Exponent
Failure Analysis Associates®

**Metallurgical Evaluation Of
DOT E6498-2216 Aluminum
Gas Cylinder – T119168**

08/30/99

Project No.: DC18234.000
QA ID No.: DC18234.000/C0F0/0899/TS03

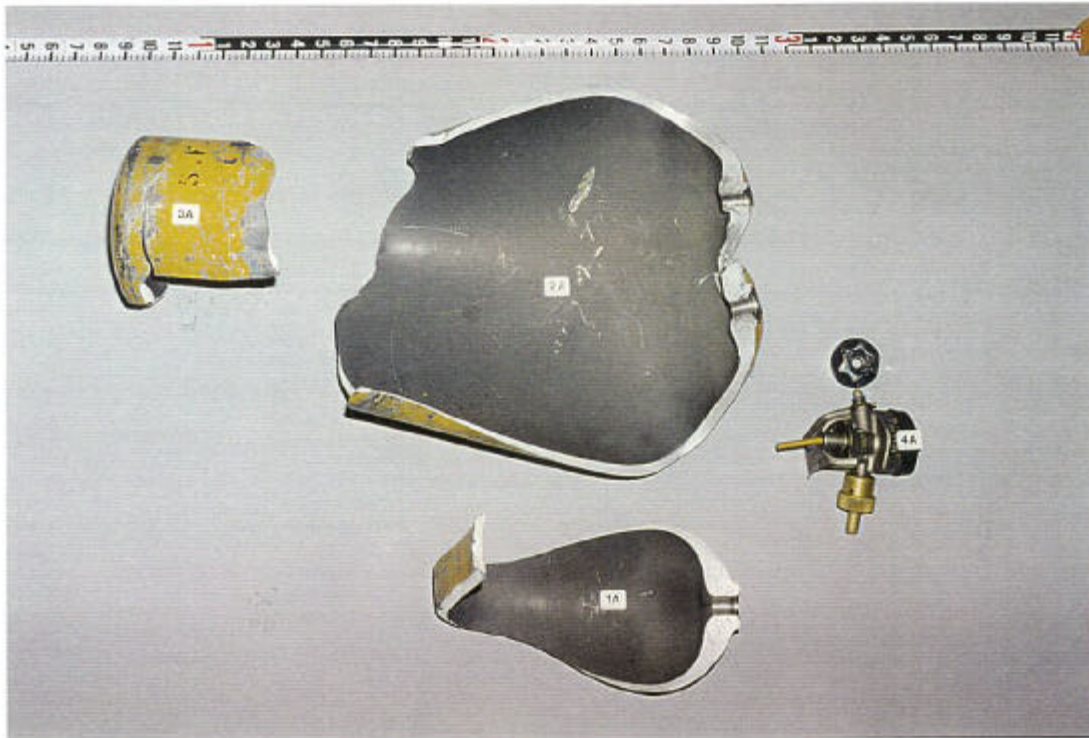
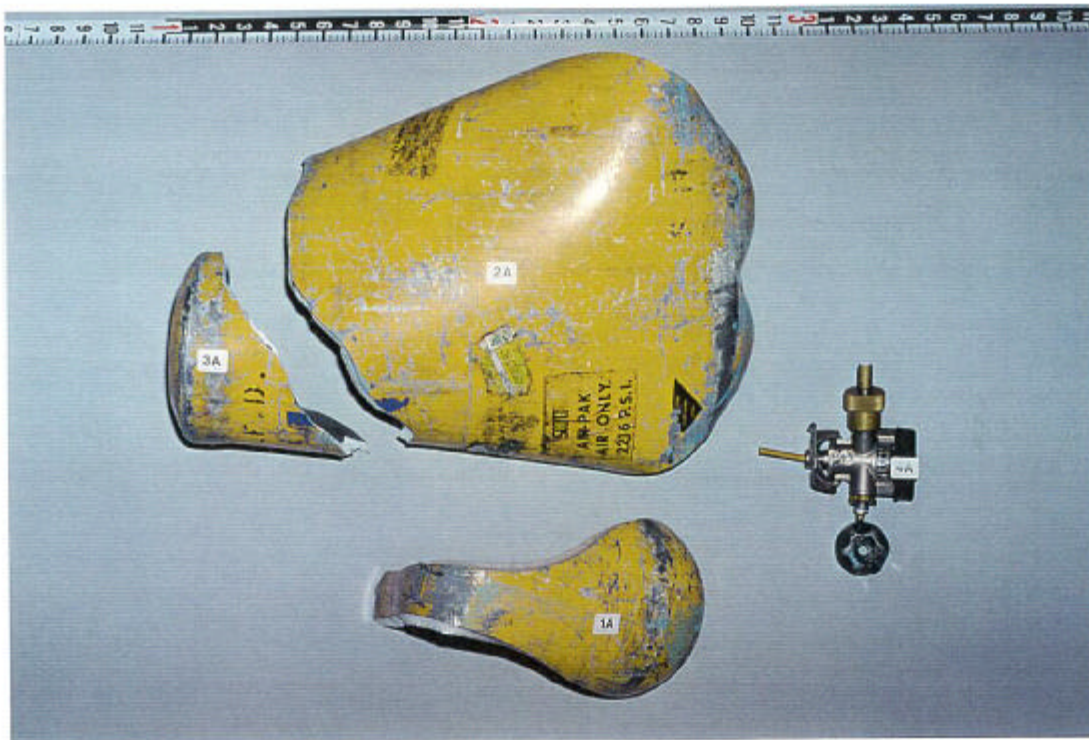
A visual examination of the provided cylinder fragments was performed. The fragments are shown in the as-received condition in Figure 1. The cylinder separated into three fragments. The piece labeled 1A spanned approximately half of the cylinder at the neck, with two flat fracture surfaces along a diameter, then tapered to a small width just above the cylinder bottom. Fragment 2A comprised the balance of the cylinder side-wall. The circular, slightly domed bottom of the cylinder was labeled 3A. The valve assembly from the cylinder was also recovered, and was designated 4A.

Figure 1: Gas cylinder fragments in their as-received condition.

- (a) Inside surface and fracture surfaces (Photo ID: DC18234-R1E11)
- (b) Outside surface (Photo ID: DC18234-R1E9)

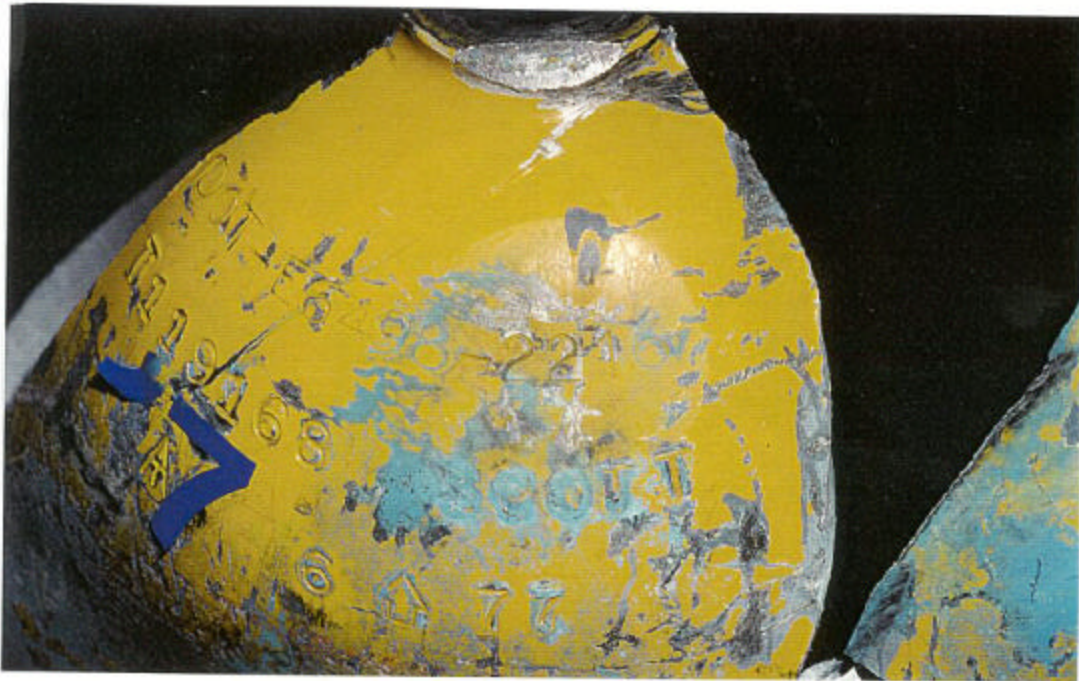
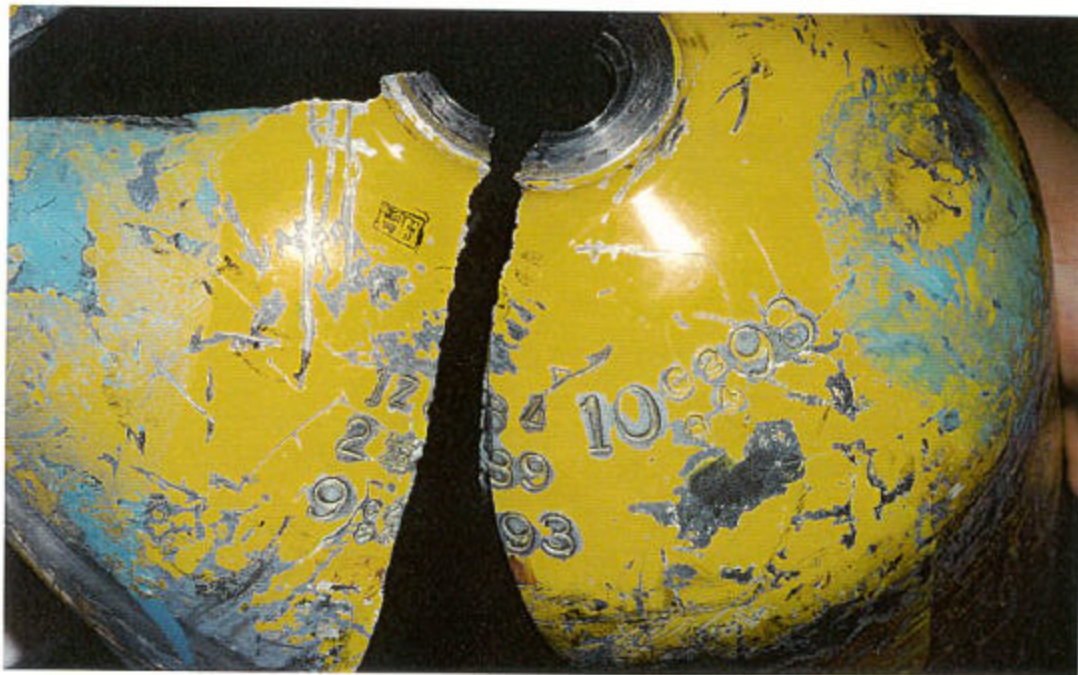
Stampings on the exterior of the neck indicate that the cylinder was manufactured by Luxfer USA, per the DOT E6498 exemption¹ and its serial number was T-119168, Figure 2². The first hydrostatic test on the cylinder, also indicated by stampings, was performed in June 1977. This was taken as its date of manufacture. Other inspection stampings indicated that the cylinder had been pressure re-tested on 1/84, 2/89, 9/93 and 10/98, as shown in Figure 2. Neck stampings and a decal on the side of the cylinder identified its rated pressure as 2216 psi.

Figure 2: Neck Stampings
(a) Exemption, serial number and first hydrostatic test.
(Photo ID: DC18234-R2E3)
(b) Inspection markings
(Photo ID: DC18234-R2E5)

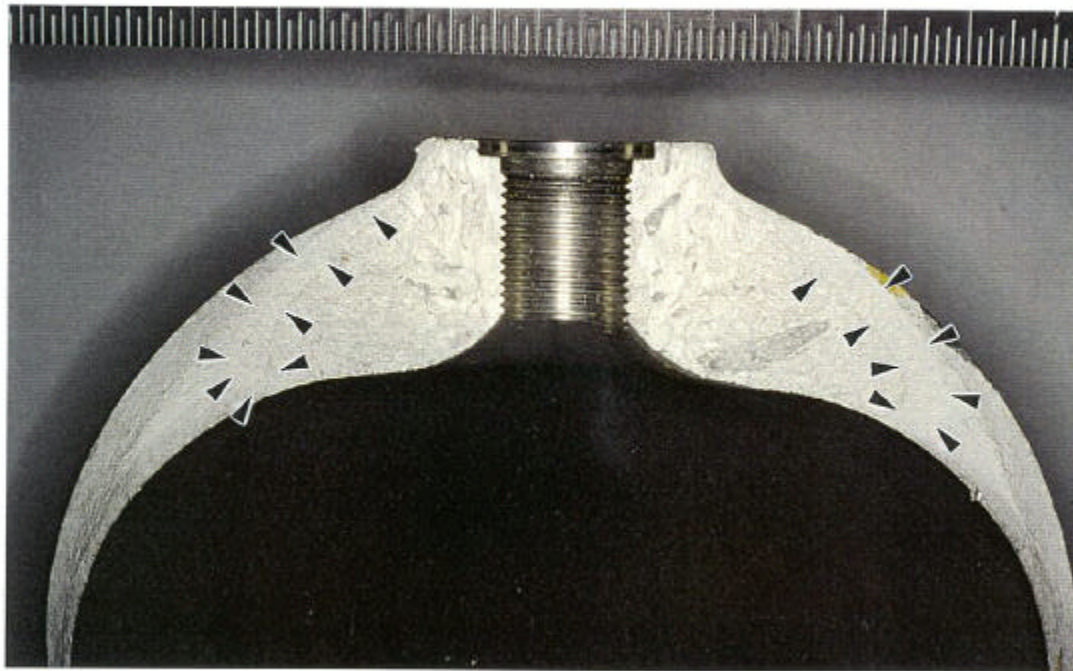
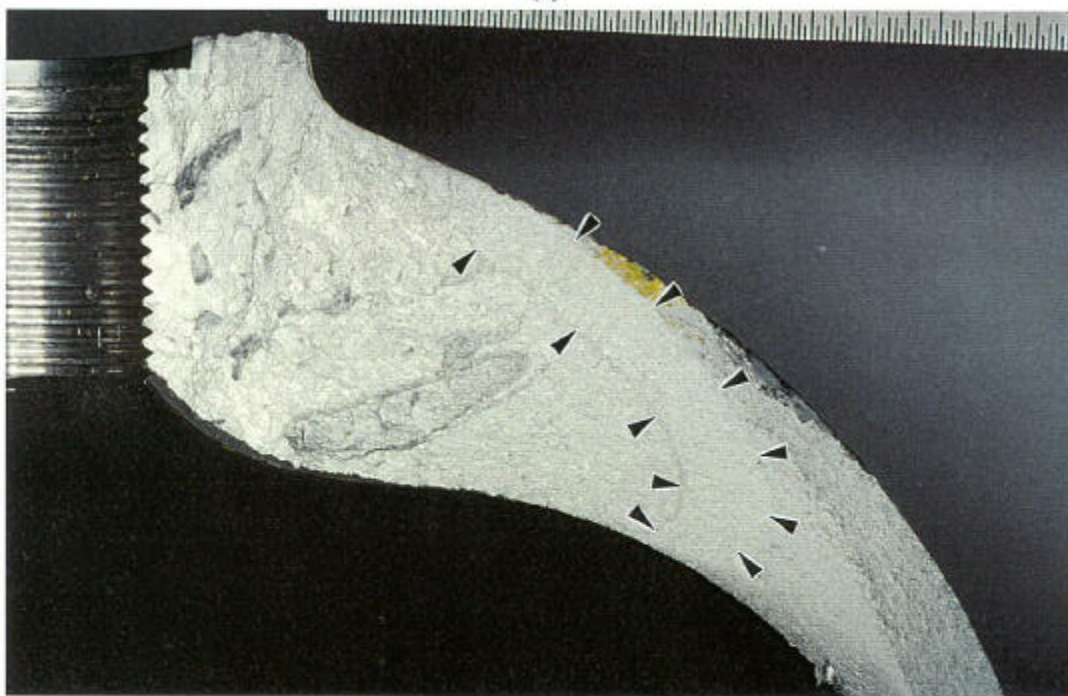
In the neck region, the fracture surfaces of the cylinder fragments were flat and approximately coincident with the cylinder radial-axial plane (Figure 3). In the regions away from the cylinder neck, the fracture surfaces were inclined to the radial direction, with features consistent with shear fracture. Figure 3(b) shows one of the fracture surfaces in the neck region. Beach marks³ appear to be emanating from near the bottom of the threaded hole. The recovered fragments had sustained some impact damage, presumably all as a result of the rupture event, on both the fracture surfaces and on the cylinder exterior. Remains of yellow paint were visible over the outside of the cylinder. Traces of other colors of paint and other contaminants were found on the cylinder fragments and on the fracture surfaces. These materials were not further identified.

Both of the sections containing the flat-faced fracture surfaces shown in Figure 3 (section 1A-2) were examined optically and in the scanning electron microscope (SEM). The optical examination revealed that, in both cases, the flat-faced region of the fracture surface showed little macroscopic ductility. Just outside of this region, the fracture surface transitioned to an inclined shear-type of fracture.

A significant fold was observed to intersect each fracture surface along the inside surface of the cylinder, near the base of the cylinder neck (Figure 3(b)). The fold was

approximately 0.040 inches (1 mm) deep on fracture 1A-2. On fracture surface 1A-1, a similar neck fold at the edge of the fracture surface was about 0.008 inches (0.2 mm) deep. EDS analysis of a fold surface showed the presence of a chromium-containing coating, similar to that found on the cylinder ID, indicating that the fold had been present from the time of manufacture.

Figure 3: Detail of the fracture surface at the cylinder neck.

(a) Fracture surface at cylinder neck (Photo ID: DC18234-R2E29)

(b) Detail of fracture surface at the neck. (Photo ID: DC18234-R2E6)

Note the beachmarks shown at the arrows.

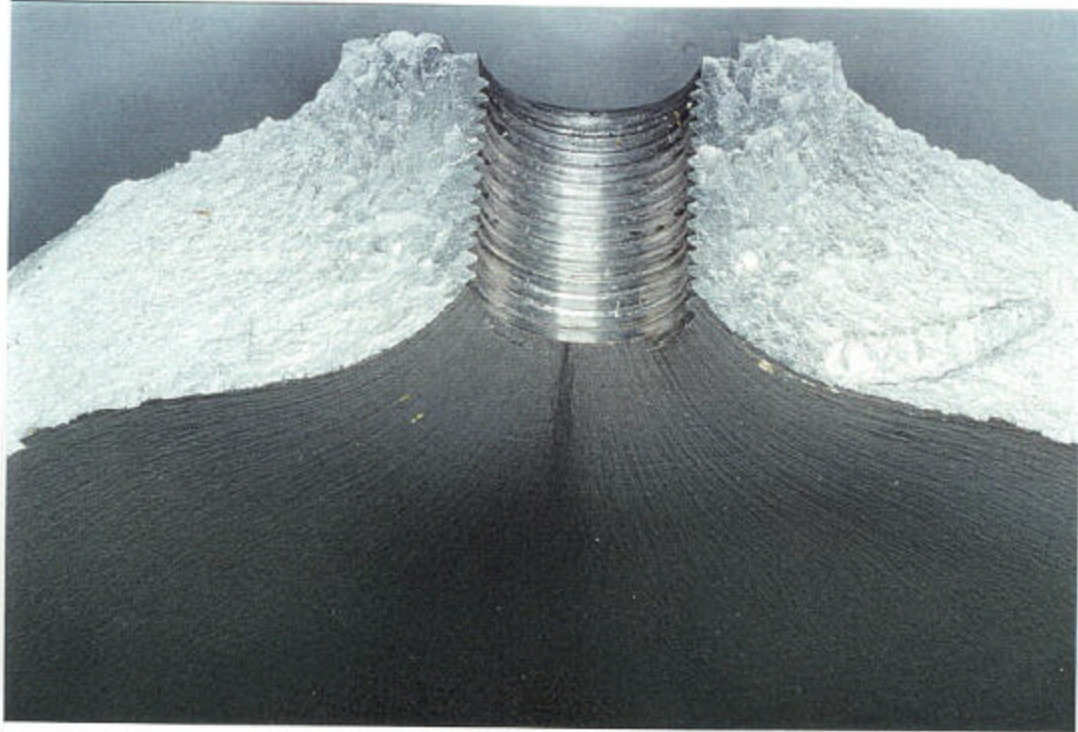
(Photo ID: DC18234-R4E15)

The inside wall of the cylinder in the neck region showed multiple folds (or cusps) from the original manufacturing process (see Figures 4 and 5). Two orientations of folds were noted. The predominant ones were along the axis of the cylinder; however a second set of shallow folds oriented circumferentially were also present, Figure 4. A small crack was observed to extend from one of the folds across the lowest thread in the neck, as shown in Figure 5. Also notable in this figure is the absence of deposits in the inlet hole threads. Some deformation in the threads was noted, particularly in the lowest threads. The inside surface of the cylinder was generally uniform in color, and no evidence of corrosion was visually observed.

Figure 4: **Folds or cusps at the cylinder neck.**
Note axial and circumferential orientations of the folds on the inner wall of the cylinder.

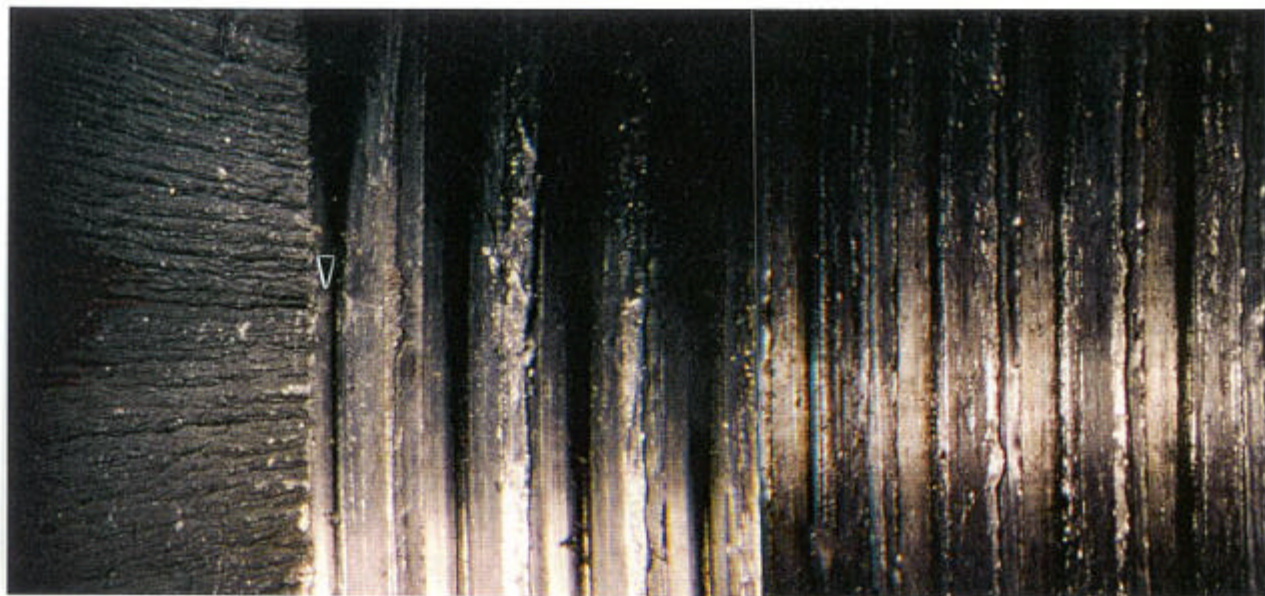
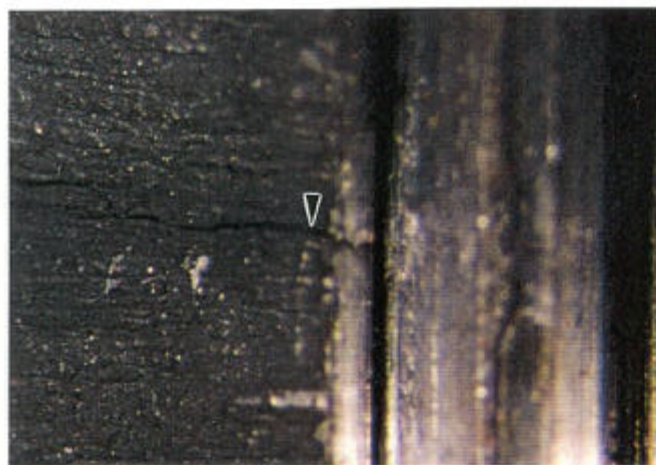
Figure 5: Crack from a neck fold, extending across the lowest thread. (Photo IDs: DC18234-R5E7, -R5E12, -R5-E15)
Note the crack shown at the arrows.

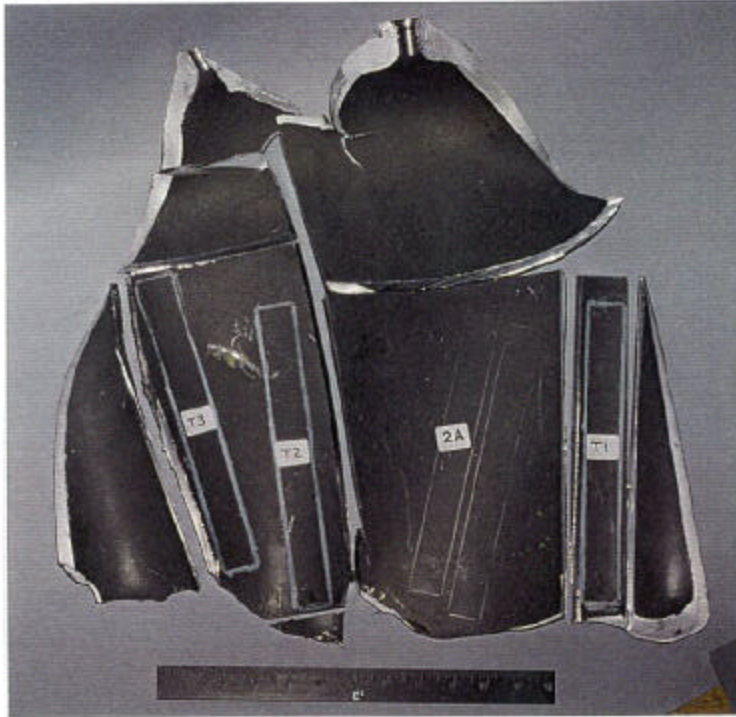
(Photo ID: DC18234-R6E11)

Full thickness tensile test coupons were cut from the cylinder wall, aligned approximately along the cylinder axis, Figure 6. Some difficulty was experienced in obtaining suitable specimens due to the nature of the deformation induced to the remains during the rupture event. Suitable coupons were obtained, however, and were tested at room temperature in accordance with ASTM B-557 and following the procedure given by 49 CFR 178.46(i)⁵. The results of these tests are shown in Table 2.

Figure 6: Sectioning of cylinder fragment 2A to remove mechanical test specimens.

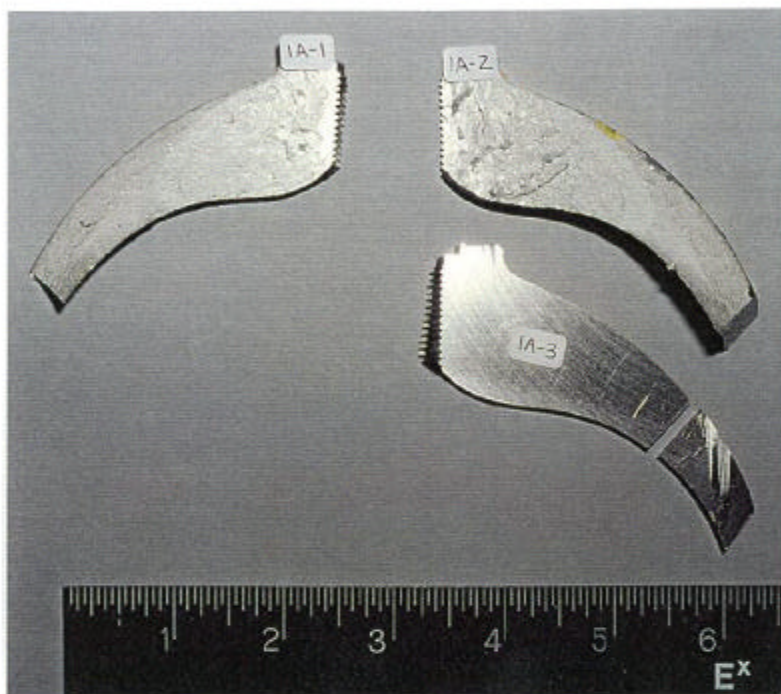
(Photo ID: DC18234-R3E15)

A slice of material was removed from the neck region of the cylinder, designated specimen 1A-3, shown in Figure 7. A total of ten Rockwell B hardness (HRB) measurements were made on this slice, using a Leco RT-370 Rockwell hardness tester. The results are shown in Table 3. The typical hardness of AA6351 material in the T6 temper has been reported to be 95 BH (Brinell), which is equivalent to about 56 HRB⁶. No significant difference in hardness was observed between the area adjacent to the neck threads and an area approximately two inches away from the threads.

Sections cut from cylinder fragment 1A are shown in Figure 7. Two wafer sections of the fracture surface, one on each side of the inlet hole, were cut such that the flat-faced portion of the fracture surface was separated from the parent fragment. These wafers were labeled 1A-1 and 1A-2 and were used for optical and scanning electron fractography. An additional section, labeled 1A-3, was cut from the cylinder neck behind 1A-2 and was used for both hardness measurements and metallography.

Figure 7: Sectioning of the cylinder neck region. Specimens 1A-1 and 1A-2 were cut from the neck for fractography. Specimen 1A-3 was cut behind 1A-2 for hardness testing and metallography.

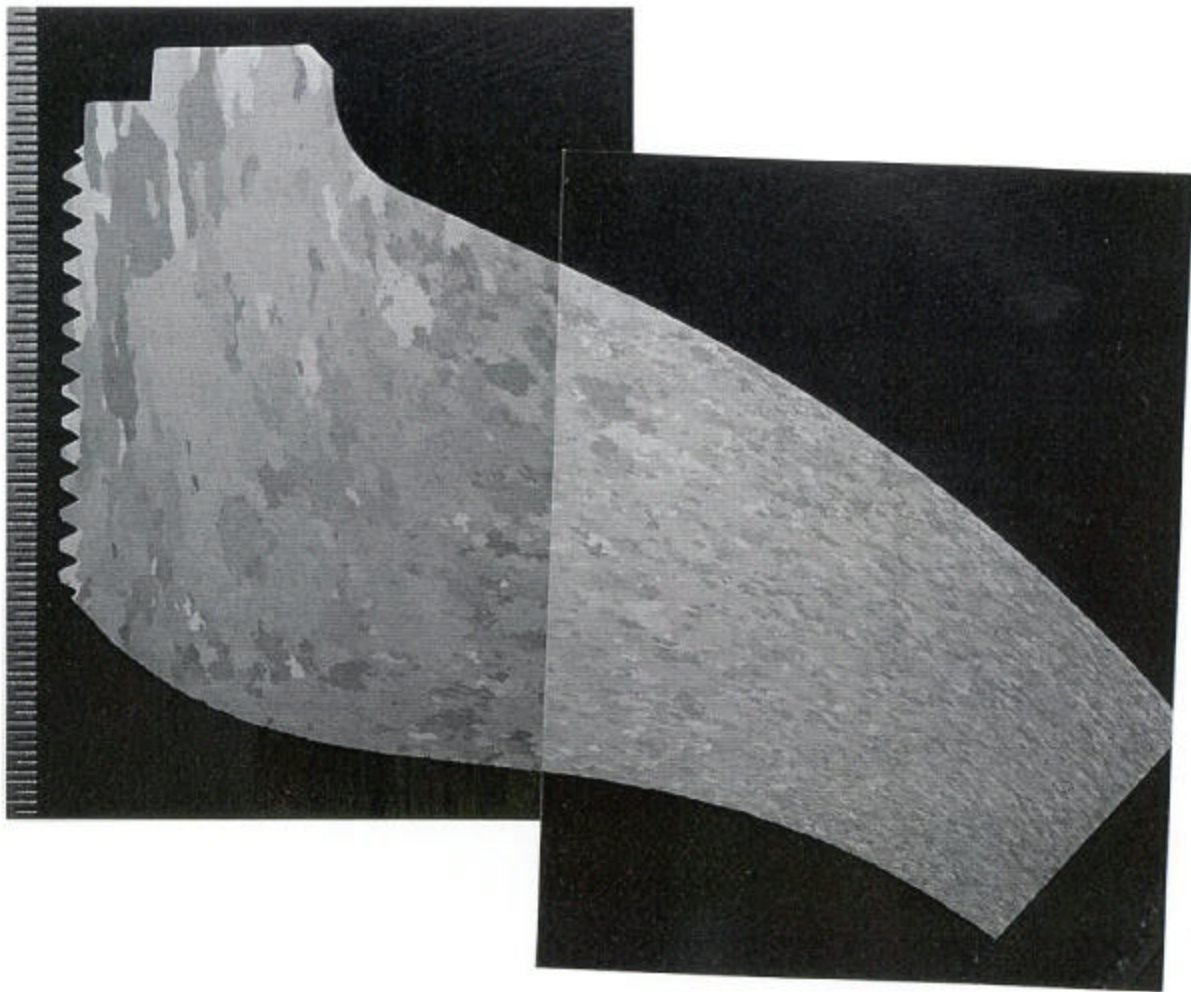
Section 1A-3 from the neck region was metallographically polished and etched, as shown in Figure 8. The microstructure, as shown in Figures 8 and 9, was typical of AA6351 material in the T6 temper condition [3,4]. The grains, in general, were very elongated (i.e., with an aspect ratio > 1). The grains along the sidewall of the cylinder were significantly smaller and less elongated than those in the thickest section near the neck.

Figure 8: Metallographic section of the cylinder neck, specimen 1A-3. From the thick section near the threads toward the cylinder sidewall, there is significant reduction in grain size and an increase in grain aspect ratio. The grains are oriented in the forming direction of the cylinder.

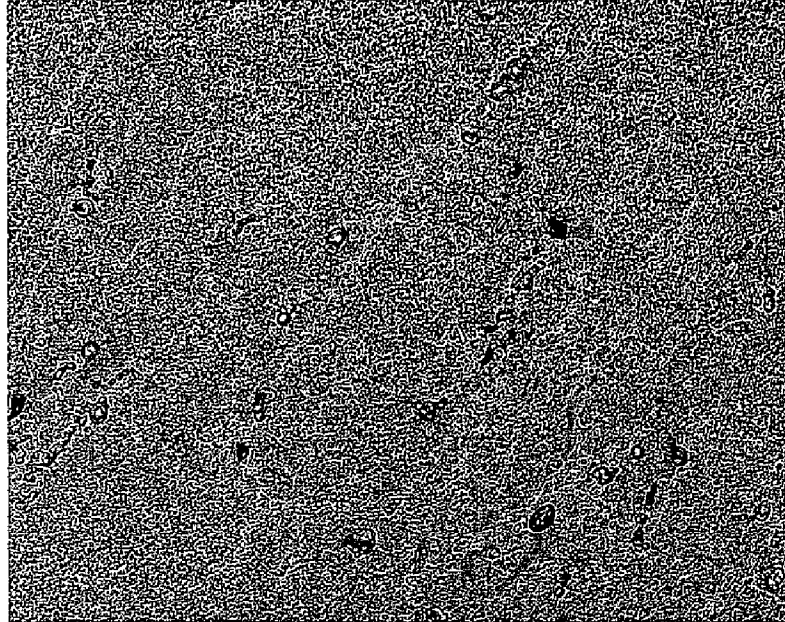
Figure 9: Microstructure near cylinder neck, 500x.
The structure is typical of AA6351 in the T6 condition.

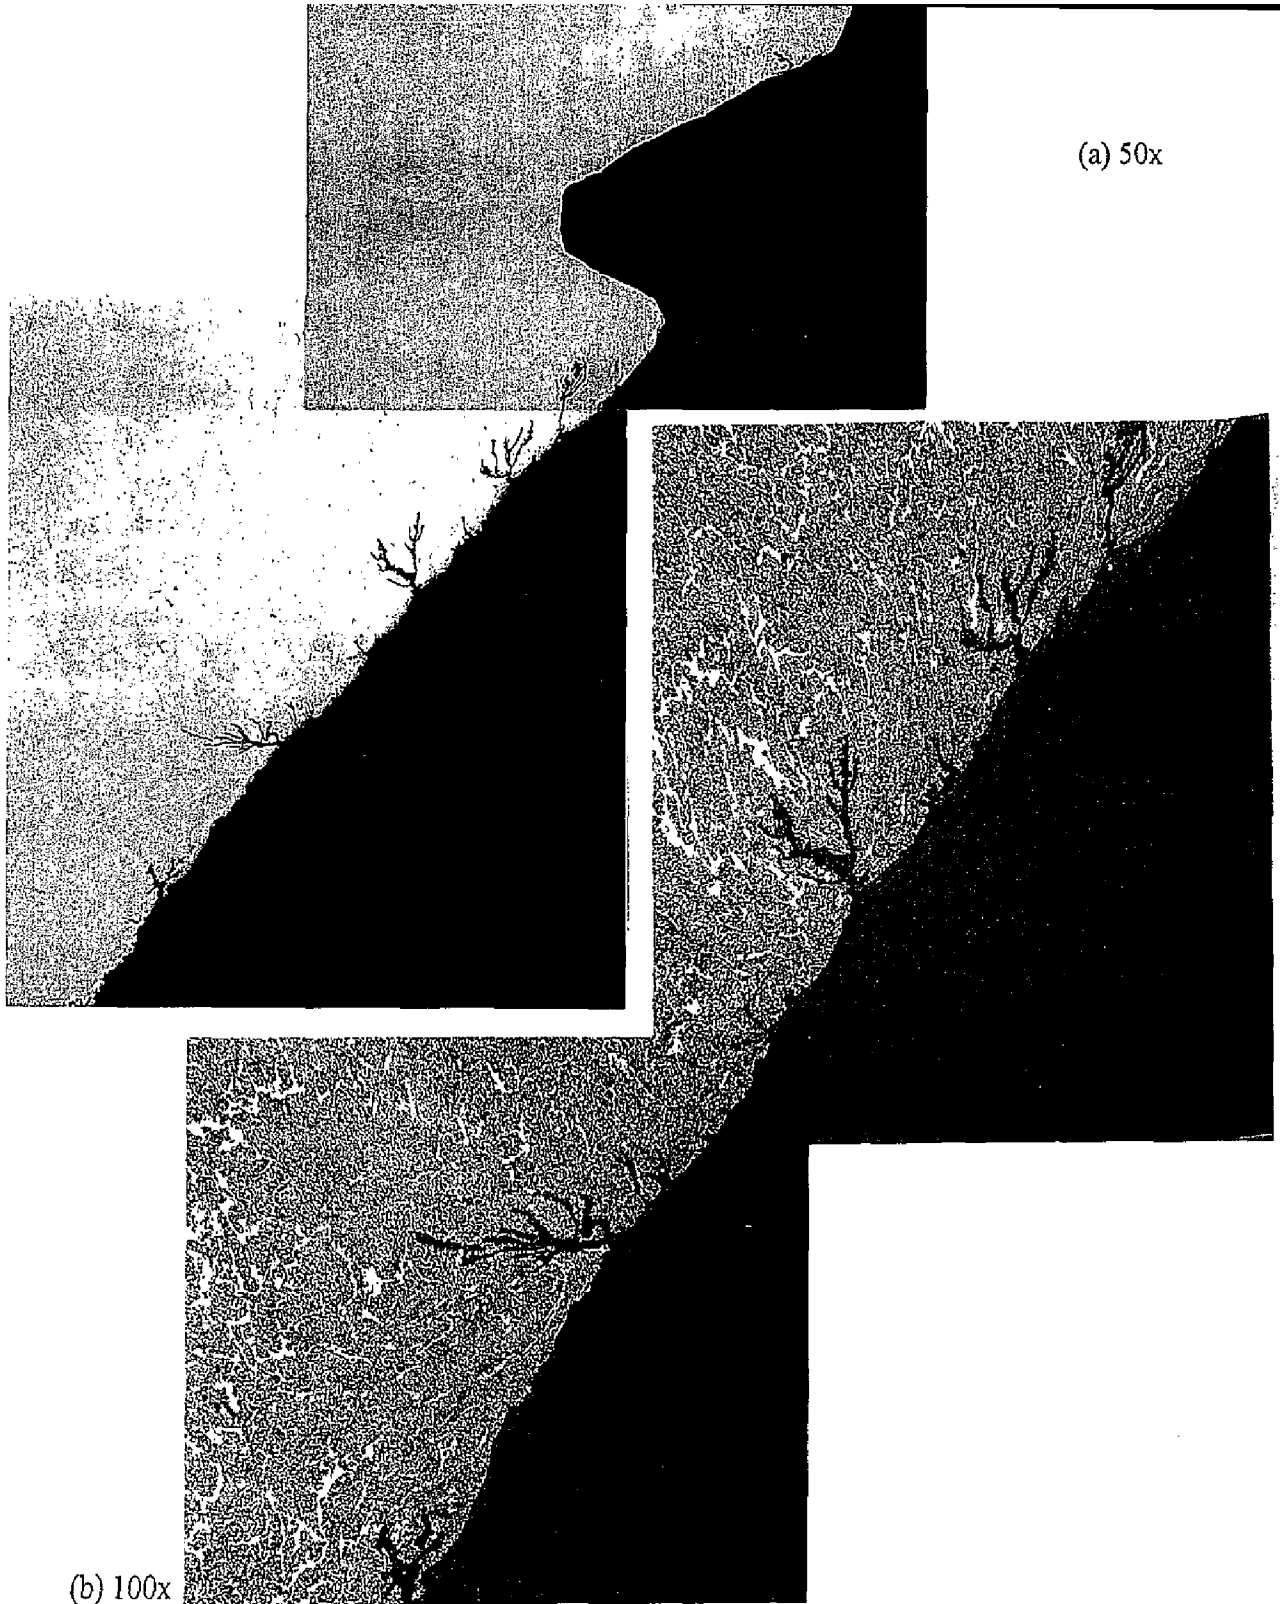
A series of cracks extended from the interior surface of the cylinder, as shown in Figure 10. The cracks appeared to emanate from small circumferentially-oriented folds on the inside cylinder wall. The cracks were branched and appeared to preferentially follow the lighter-etching regions of the microstructure.

Figure 10: Branching cracks at the inside of the cylinder wall.

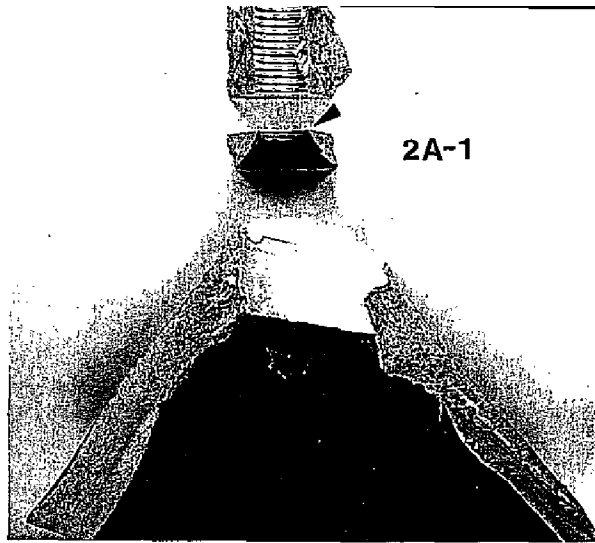
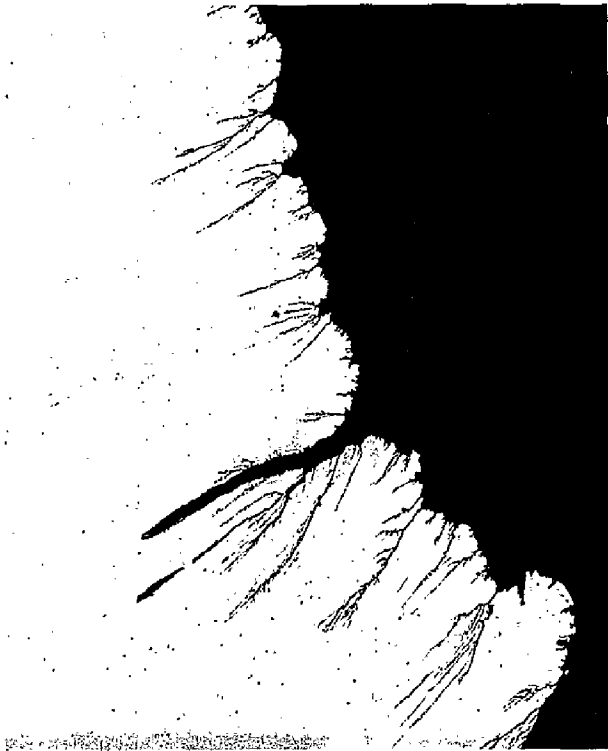
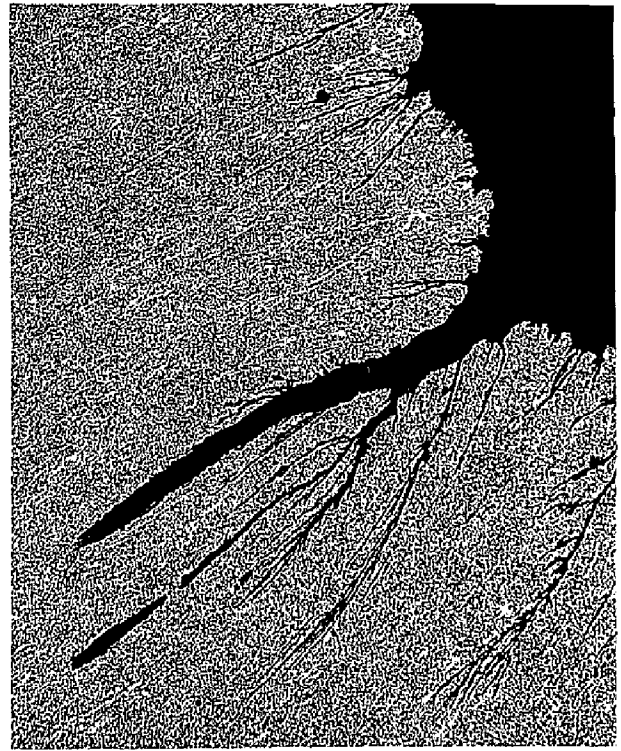
A second microstructure sample, 2A-1, was prepared perpendicular to the cylinder neck axis, as shown in Figure 11(a). Examination of this specimen confirmed branching cracks extending from axially-oriented folds around the circumference of the neck, Figure 11. Several other cracks were observed in the same specimen, running approximately parallel to a flat-faced fracture surface, as shown in Figure 12.

Figure 11: Metallographic section at the base of the neck threads.

(b) (c) Branching cracks extend from the base of the threaded region into the cylinder neck.

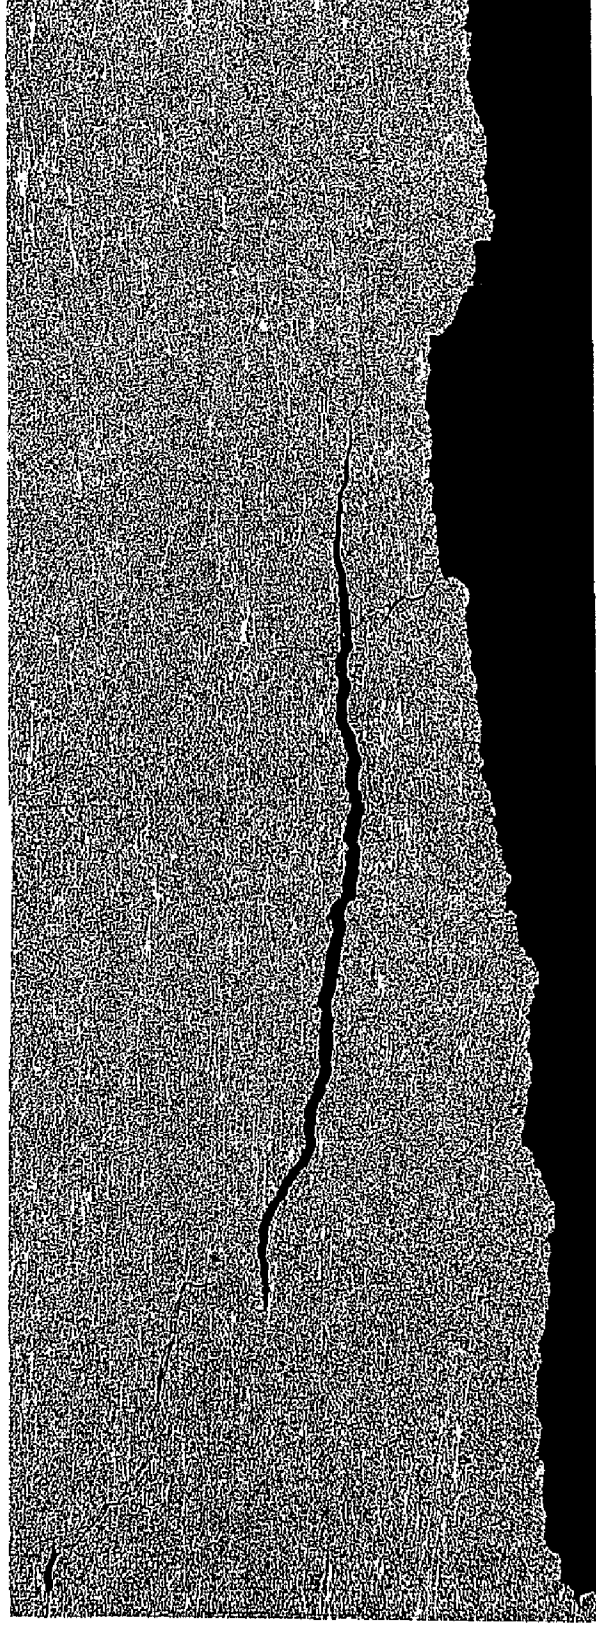
Figure 12: Cracking parallel to a flat-faced fracture surface at the neck, 100x.

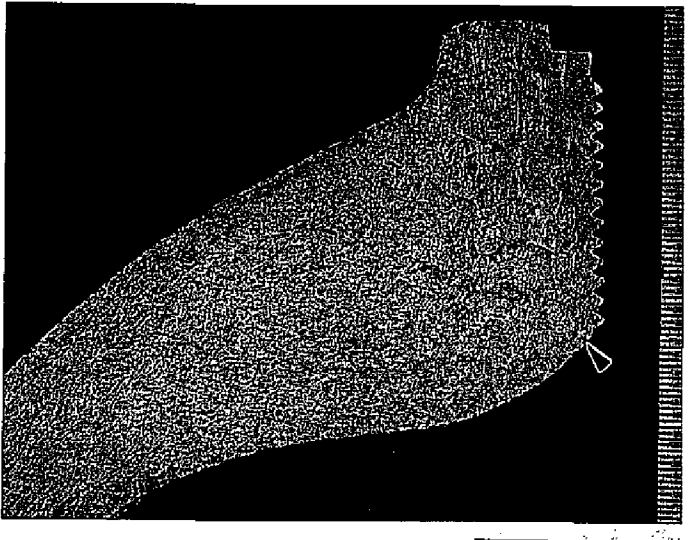
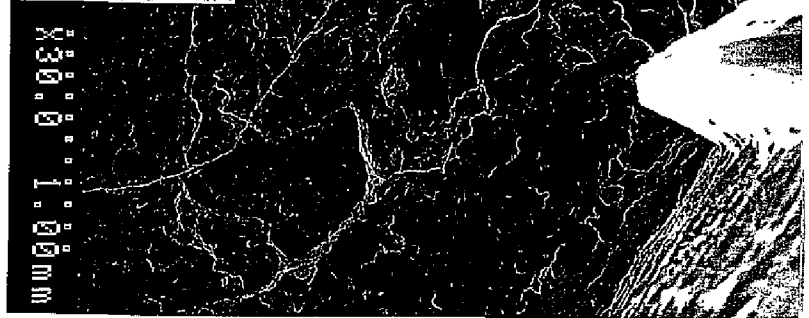
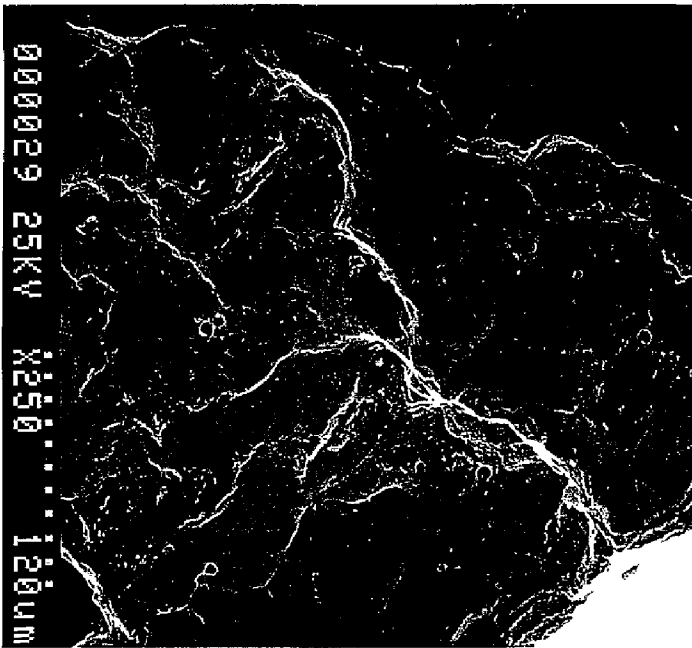
The area of the fracture surface near the neck fold in 1A-1 is shown in Figure 13. Near this fold, the fracture surface was flat, with fine scale features consisting of incompletely formed dimples and round, shallow holes. Although predominantly flat, the fracture surface did contain steps (reflecting the local grain size, see Figure 8), indicating that the cracking was intergranular. Similar flat fracture with microdimpling extended from the base of the neck (Figure 13) to the top of the inlet hole (Figure 15).

The presence, shape, and location of the beach marks on the fracture surface segments (Figures 13 and 14) suggest that the cracks propagated subcritically and slowly for the majority of the flat-faced region, over the 20+ year life of the cylinder. This process continued up to the extent defined by the last beach mark on each side of the inlet hole. This feature is interpreted to mark the onset of rupture by fast fracture. The crack origins for each of the three axial neck cracks were at surface folds on the inside surface below the threads. These postulated origins are consistent with the roughly symmetric morphology of the beach markings. Figure 5 shows cracking from the folds, and Figure 3(b) shows that folds were associated with the main fracture surface. The cracks that developed on the sides of the inlet hole show very similar characteristics and appear to have grown by the same mechanism.

Figure 13: SEM fractography of specimen 1A-1, near fracture origin.

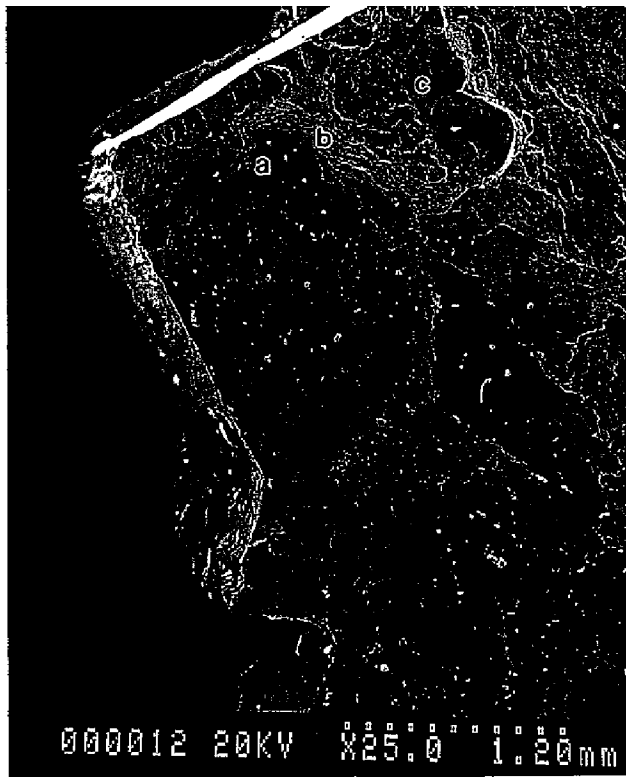
Figure 15: SEM fractography of specimen 1A-2, at top of neck.

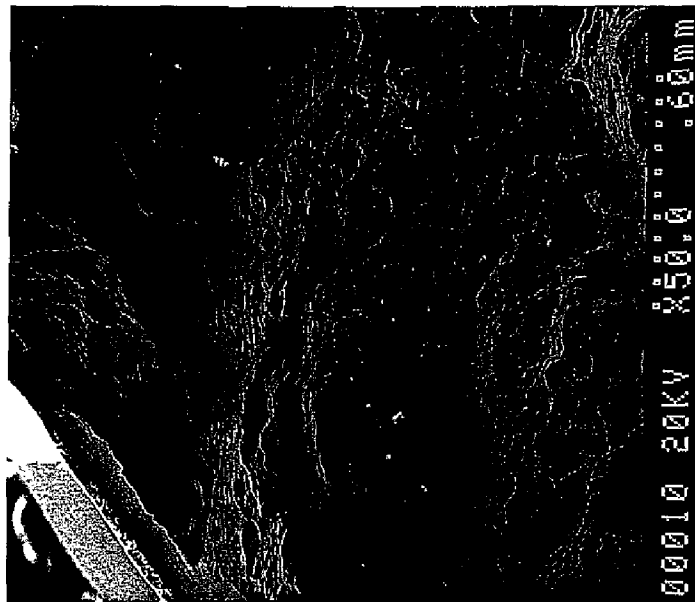
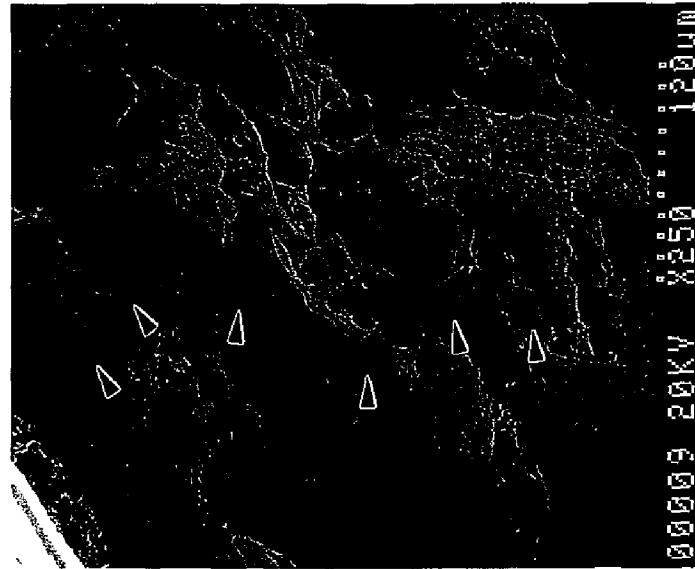
Near the outer surface of the cylinder neck, the fracture surface was again predominantly low ductility intergranular, with shallow holes and micro-dimples visible on the fracture surface. As the crack approached the outer surface, the fraction of ductile features increased. Figures 16 and 17 depict two areas in which "fingers" of low-ductility fracture were found to extend to the cylinder outside surface. The distance along the outer surface from Figure 16 to Figure 17 was approximately 1/4 inch.

Fractographic examination of the right-hand fracture surface (1A-2) revealed pathways of SLC propagation to the outer surface of the cylinder. Examples of these pathways are shown with a series of arrows in Figures 16 and 17. The SLC "fingers" reached the outer surface of the cylinder along a line at least 0.25 inches long. Thus, slow progressive crack growth extended to the outer surface of the cylinder in this area, prior to unstable crack growth and rupture. This finding is consistent with the report that the cylinder was leaking prior to rupture. No observations reliably estimate the width of a through-wall crack, or the time such a crack may have been present before rupture of the cylinder occurred. The stability of any such crack (and therefore, the time of leaking) would be expected to depend strongly on the crack shape or aspect ratio⁹, the pressure in the cylinder, the temperature, and possibly other factors that cannot be determined from a fractographic study alone.

Figure 16: SEM fractography of specimen 1A-2, at outer surface.

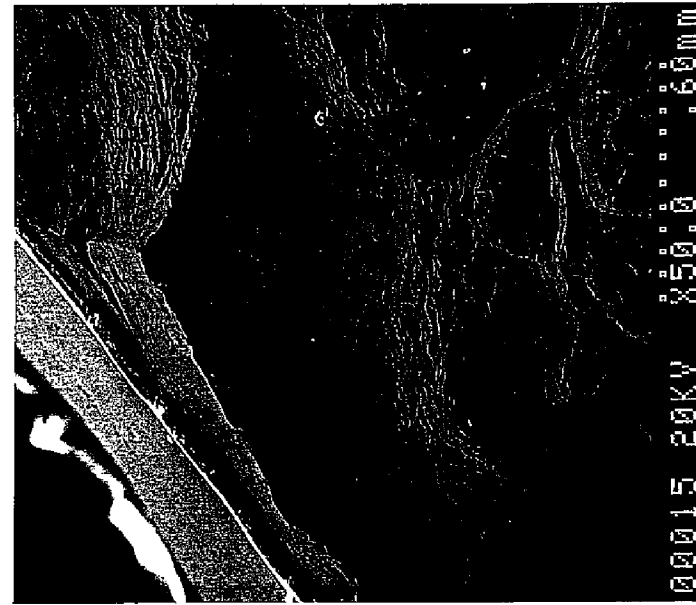
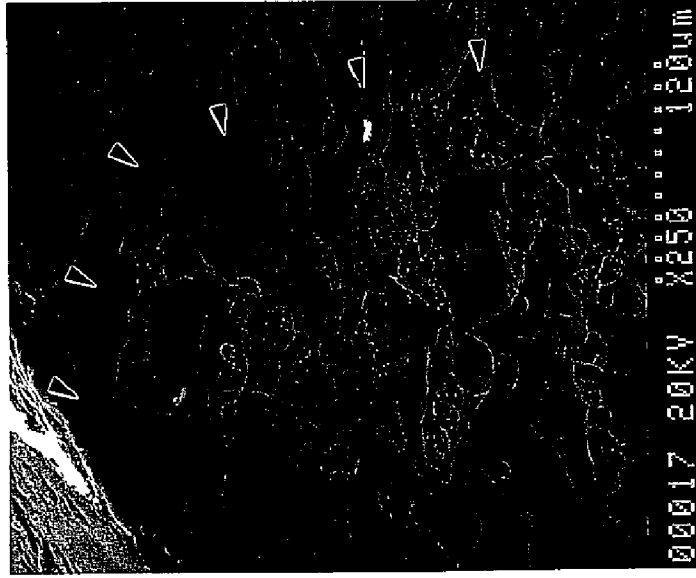
Figure 17: SEM fractography of specimen 1A-2, at outer surface.

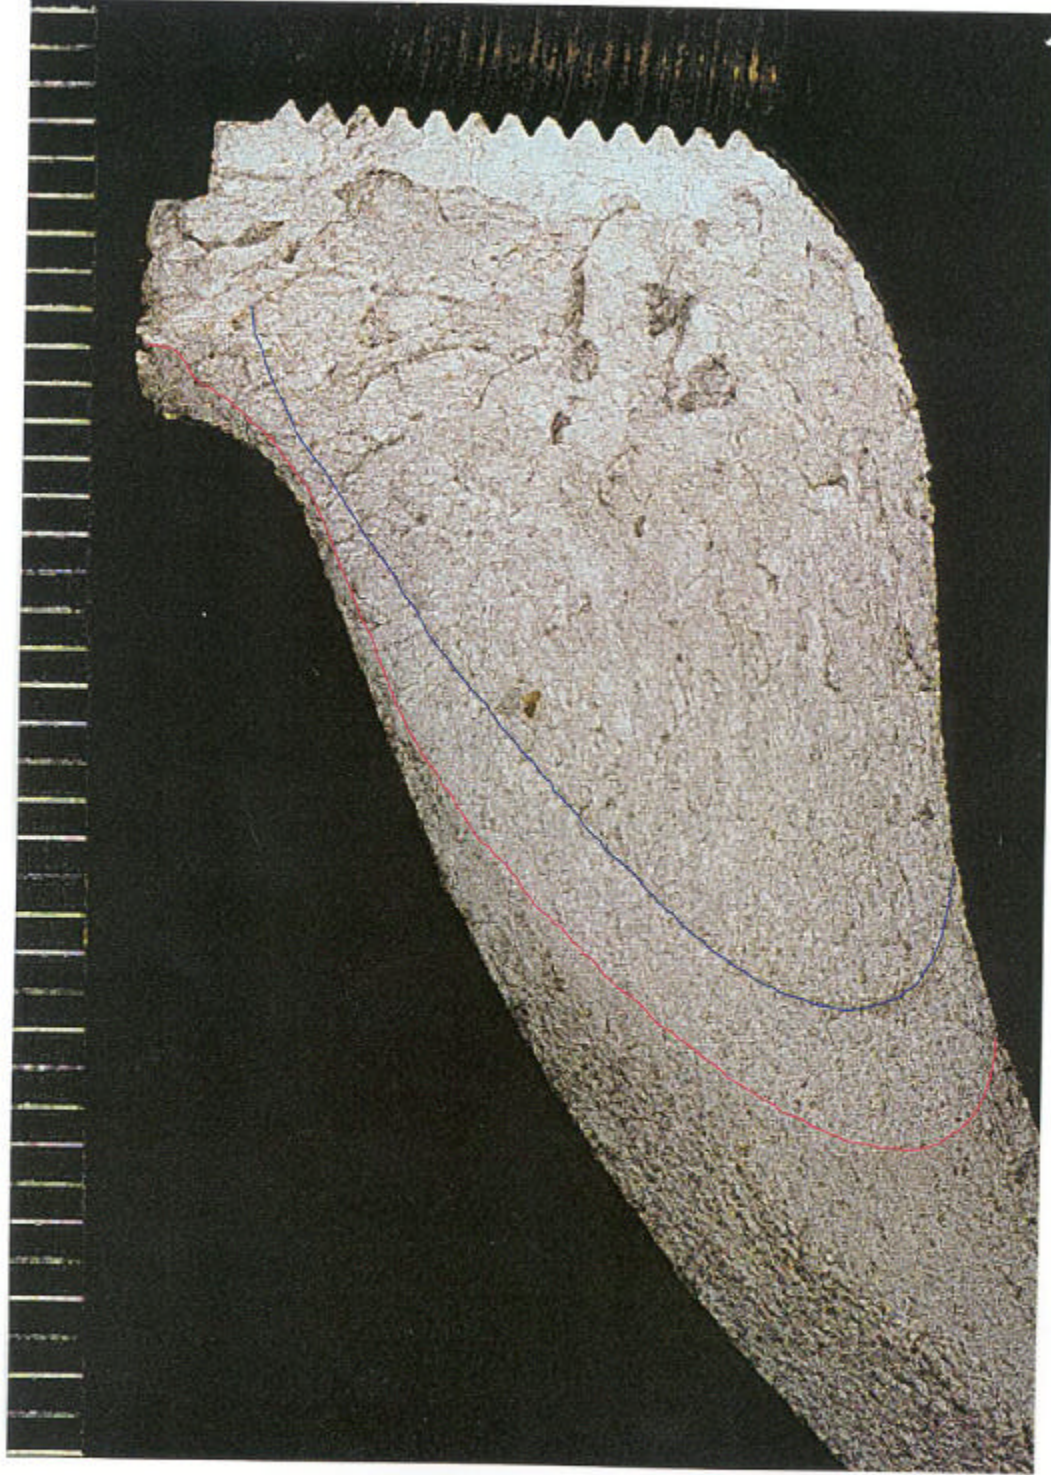
To estimate crack length, drawing overlays were developed for the two main neck fracture surfaces, Figures 18 and 19. These overlays correspond to beach marks that

indicate positions of each crack's advancement. In both figures, the blue lines denote visible beach marks in the sub-critical zone, whereas the pink lines denote the extent of the cracking close to the onset of final fast fracture. An interpretation of the blue lines is that they define possible crack arrest (and subsequent re-initiation) positions associated with the internal pressure in the cylinder dropping (through use) to a level at which the local stress intensity, K_I , is below the threshold value necessary for detectable SLC advancement⁷.

A measurement was taken from the postulated origin at the folds in the neck to the maximum extent of the pink line for the diametrically-opposed fracture pair. These measurements provide estimates of the crack length at the onset of fast fracture. For the right fracture, this estimate is 47.2 mm; for the left fracture, this estimate is 42.3 mm⁸.

Based on the above arguments, the beach marks outlined by the pink lines on the fracture surfaces (Figures 18 and 19) denote the extent of subcritical SLC propagation. For the mechanism to be operative, the local applied stress intensity, K_I , has to be above the threshold value necessary for detectable SLC advancement. If no significant periods of

Figure 18: Fracture surface 1A-1, showing crack fronts at different time points (beach marks).
