Exponent
Failure Analysis Associates®

**Metallurgical Evaluation Of
DOT E6498-2216 Aluminum
Gas Cylinder – T119168**

08/30/99

Project No.: DC18234.000
QA ID No.: DC18234.000/C0F0/0899/TS03

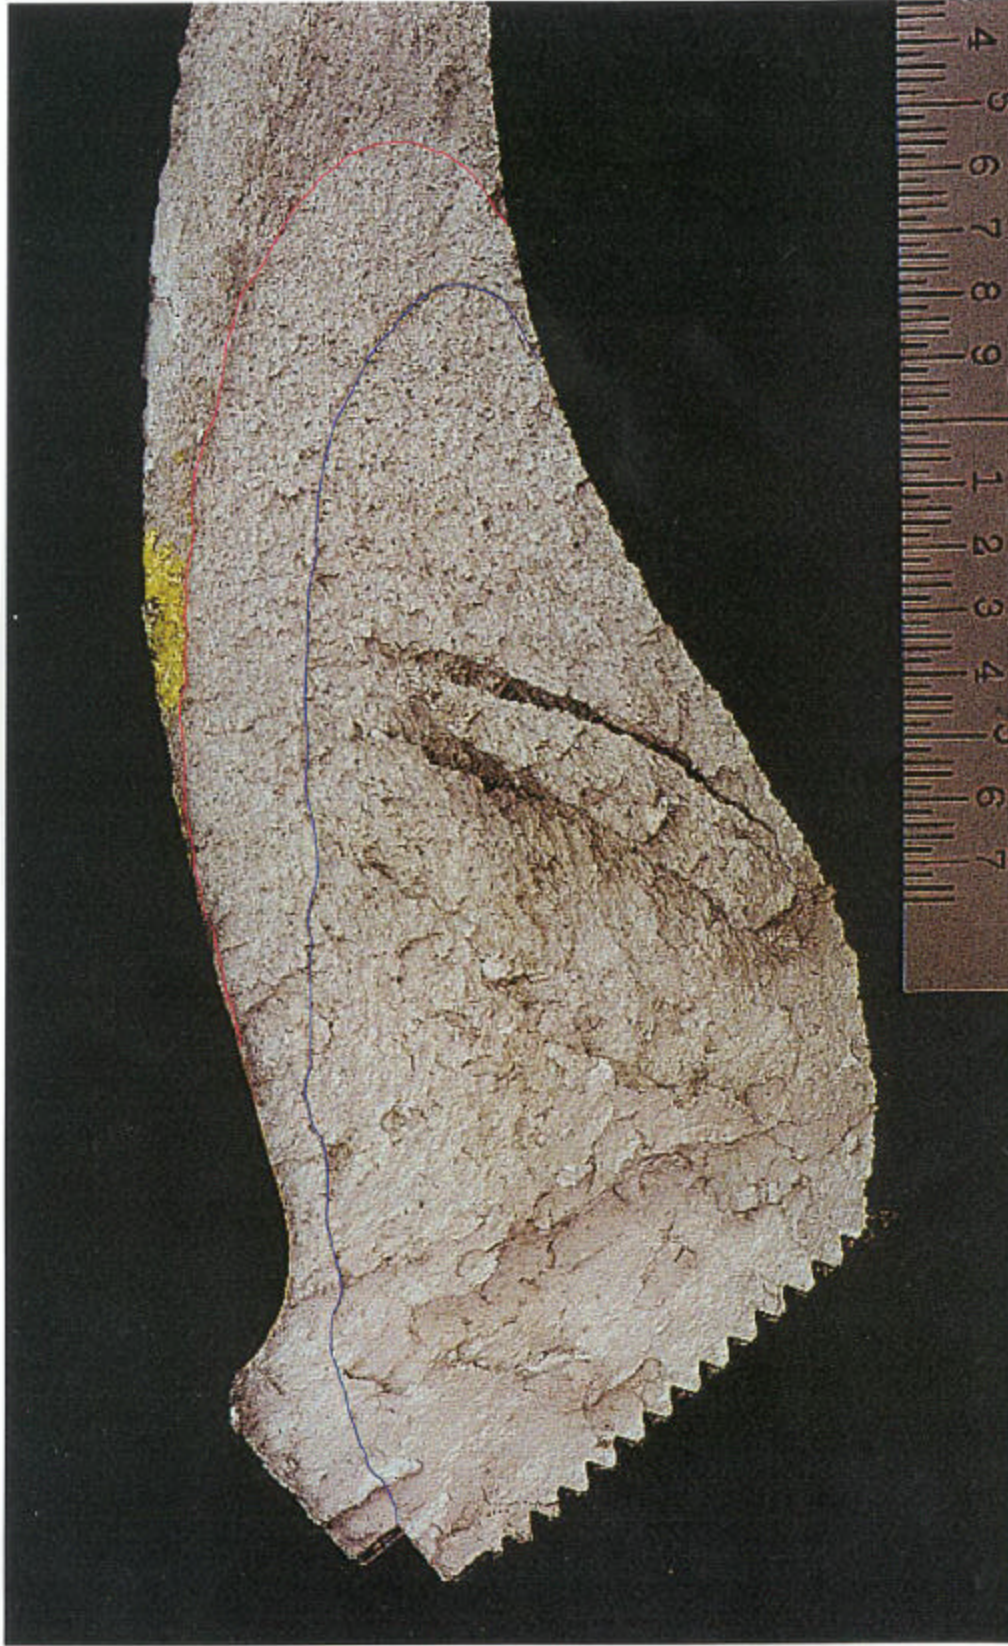
To estimate crack length, drawing overlays were developed for the two main neck fracture surfaces, Figures 18 and 19. These overlays correspond to beach marks that

indicate positions of each crack's advancement. In both figures, the blue lines denote visible beach marks in the sub-critical zone, whereas the pink lines denote the extent of the cracking close to the onset of final fast fracture. An interpretation of the blue lines is that they define possible crack arrest (and subsequent re-initiation) positions associated with the internal pressure in the cylinder dropping (through use) to a level at which the local stress intensity, K_I , is below the threshold value necessary for detectable SLC advancement⁷.

A measurement was taken from the postulated origin at the folds in the neck to the maximum extent of the pink line for the diametrically-opposed fracture pair. These measurements provide estimates of the crack length at the onset of fast fracture. For the right fracture, this estimate is 47.2 mm; for the left fracture, this estimate is 42.3 mm⁸.

Based on the above arguments, the beach marks outlined by the pink lines on the fracture surfaces (Figures 18 and 19) denote the extent of subcritical SLC propagation. For the mechanism to be operative, the local applied stress intensity, K_I , has to be above the threshold value necessary for detectable SLC advancement. If no significant periods of

The crack front established on the right fracture by the pink line (Figure 19) results in a crack "length" or extent of 47.2 mm. Using a mean propagation rate [12] of 0.61×10^{-3} mm/hr, the time to rupture is estimated to be 8.8 years. The crack length measured on the left fracture is 42.3 mm, giving an estimated cracking time of 7.9 years using the same propagation rate. Thus, a propagating crack of some size existed at the neck for at least this time frame. This period is a significant portion of the roughly 22 years that the cylinder was in service, following its apparent first hydrostatic test in 1977.

Figure 19: Fracture surface 1A-2, showing crack fronts at different time points (beach marks).
