**METALLURGICAL EVALUATION OF
A DOT-E6498-2216 CYLINDER
FaAA Project No.: DC17916.000**

U.S. Department of Transportation
400 Seventh Street S.W.
Washington D.C. 20590

Timothy R. Smith, Ph.D., P.E.
Failure Analysis Associates, Inc.
310 Montgomery Street
Alexandria, VA 22314

January 1997

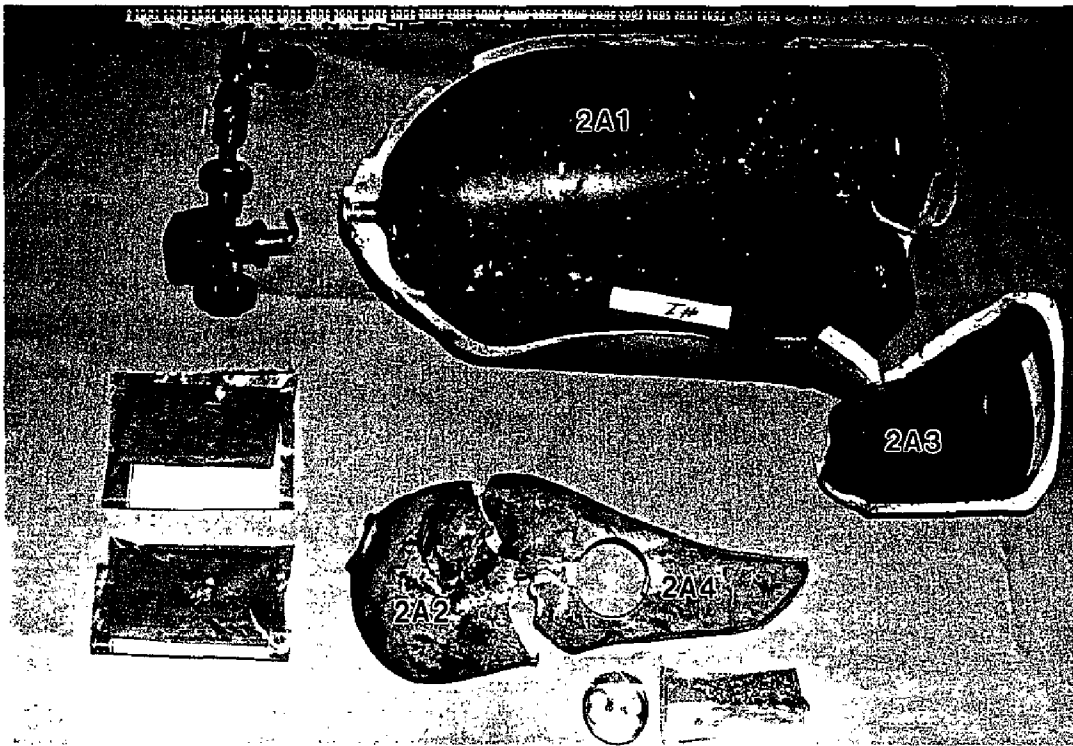
A visual examination of the cylinder remains was performed. The remains are shown in Figure 1, in the as-received condition. The cylinder broke apart into four large pieces and at least two small fragments. At the time of FaAA's inspection, a circular sample of material had been cut from one piece and contained burn markings, presumably from tests by optical emission spectroscopy to determine its bulk chemistry. In addition, some aluminum chips, presumably from drilled holes at unknown location(s), were also included in the remains.

Figure 1. Remains of the cylinder, as received.
Photo ID: DC17916-R4E6.

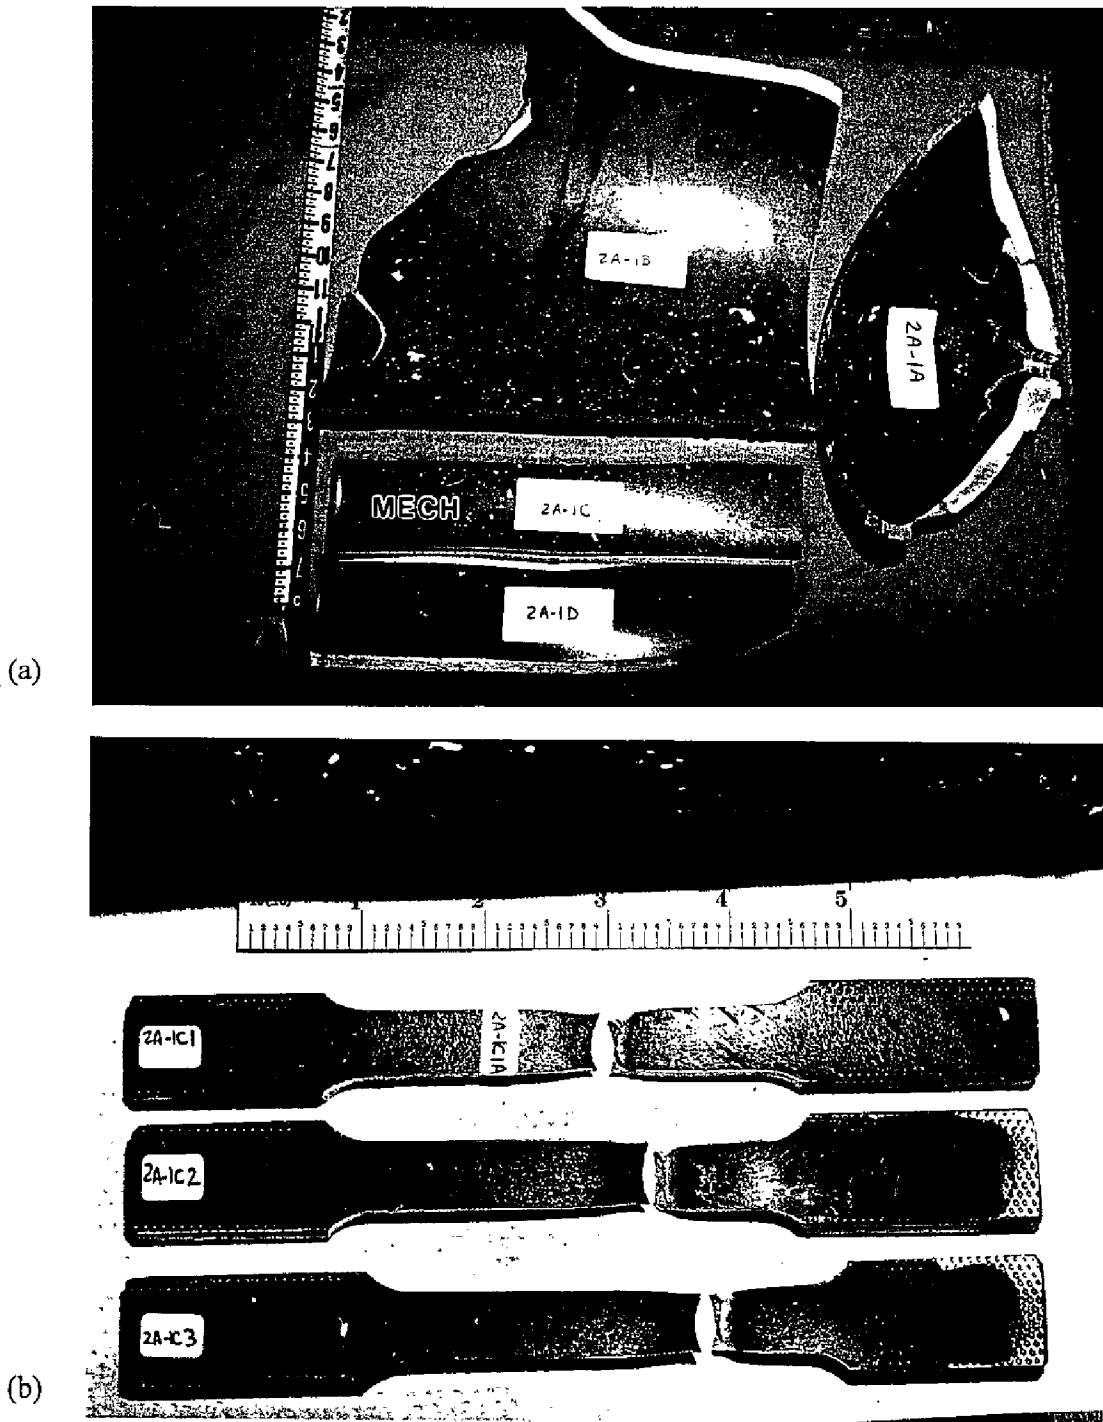
Standard size ASTM 370 tensile test coupons from the cylinder wall, aligned along the cylinder axis, were tested at room temperature. Fragment 2A-1 was sectioned, Figure 4(a), and component 2A-1C was used for tensile test coupons, as it contained material minimally deformed by the cylinder rupture. Three full-thickness coupons were chosen and Figure 4(b) shows them in the post-tested configuration. The test data are shown in Table 3.

Figure 4. Cylinder fragment 2A-1.
(a) Sections cut. Mech denotes the piece used for machining tensile test coupons.
Photo ID: DC17916-R12E1.
(b) Tensile test coupons in the post-tested condition.
Photo ID: DC17916-R11E21.

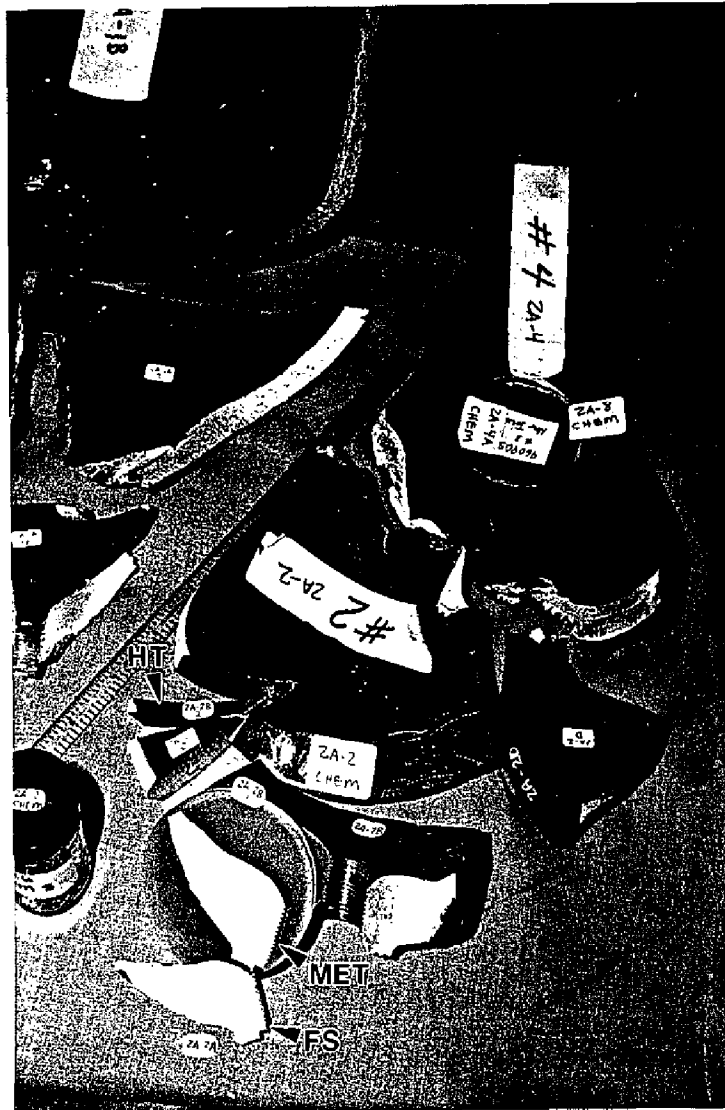
Figure 5 shows the sections cut from cylinder fragments 2A-2 and 2A-4. A section of the fracture surface was cut from cylinder fragment 2A-2 that removed the flat-faced portion on one side of the inlet hole. A wafer approximately 0.05 inch thick was generated ("FS" in Figure 5) in this process. The remaining piece was then sectioned in a parallel slice, as close as possible to the previous cut. This section was then polished and etched to reveal

Figure 5. Sectioning of fragments 2A-2 and 2A-4.

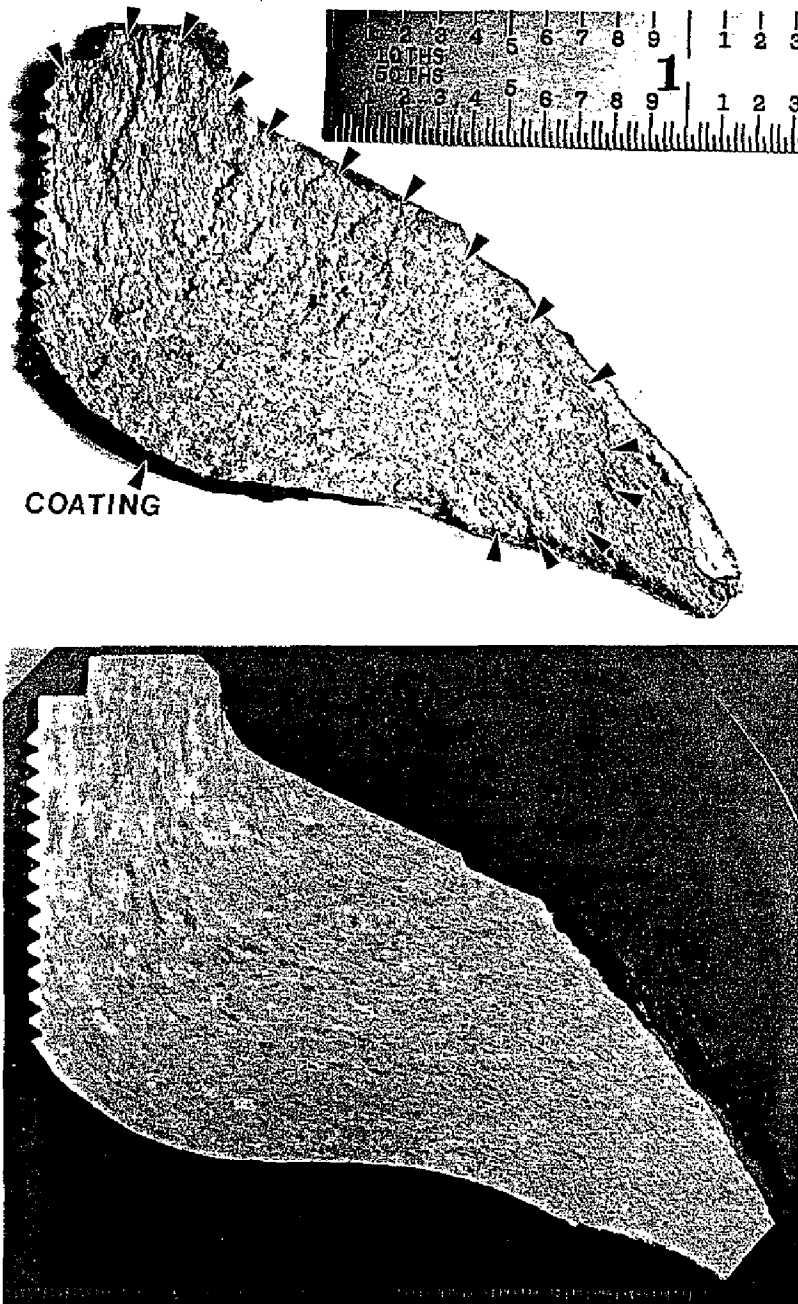
Figure 6(a) shows the wafer containing the fracture surface from Figure 5 and Figure 6(b) shows the etched macrostructure of the same region from the second wafer sliced parallel to the fracture surface. Some correspondence between features on the fracture surface and the grains is seen. Note that the grain size is relatively small, compared to the thickness at the neck.

Fractography of the wafer also shows an apparent beach mark (see Figure 6) in the flat-faced region. SEM fractographs taken from inside and beyond this beach mark, however, fail to provide a clear distinction in the failure mode between these two regions. Figure 12 shows a series of SEM fractographs taken from this fracture surface. Region 1 (Figure 12a) was from near the inside of the tank, close to the threads at the inlet hole. Higher magnification view of region 1 are shown in Figure 12(b) and (c). This region contains a mixture of intergranular and transgranular fracture, with very fine-scale dimples on the faceted surfaces. In region 2 (Figure 12a), in the flat-faced region, the fracture surface contains larger-scaled dimples but still contains intergranular facets with very fine-scale dimples. SEM fractographs of this region are shown in Figure 12 (d) and (e). Region 3 (Figure 12a) is in the shear-lipped region outside of the flat-faced portion of the fracture. This region shows predominantly dimpled rupture, Figure 12(f) and (g). Figure 13 shows energy dispersive spectroscopy (EDS) surface chemistry results captured from region 1 (near to the inlet hole threads) and region 2 (on the flat-faced fracture away from the inlet hole). The presence of oxygen in region 1, as compared to region 2, suggests that region 1 formed earlier. This is consistent with the flat oxidized appearance of the fracture surface in region 1. These spectra also show chromium (Cr), silver (Ag), calcium (Ca), and chloride (Cl) contamination. The Cr and Ag are likely from the exterior paint and/or the chromate interior coating, perhaps deposited during solvent cleaning of the remains.

The location of a beach mark on the fracture surface segment studied in detail (Figures 6 and 12) suggests that this crack propagated sub-critically (i.e., slowly) for the majority of the flat-faced region up to the extent defined by the beach mark. A similar, but perhaps less defined beach mark is present on the opposite side of the inlet hole. These beach marks are consistent with the morphology of cracked regions at the neck of other DOT-6498, DOT-3Al, and DOT-7235 aluminum cylinders that were rejected during hydrostatic retesting [4] and with an Australian-specification aluminum cylinder that leaked during filling [5]. This morphology is also consistent with the fracture surface of a DOT-3AL cylinder that ruptured during filling, provided for FaAA's examination by J. H. Smith of the National Institute of Science and Technology [6].

Figure 6. Wafers FS and MET from Figure 5.
 (a) Portion of flat-faced fracture surface from neck region of fragment 2A-1. Photo ID: DC17916-TRS-1-01/14/97.
 (b) Macrostructure of neck region of fragment 2A-1. HF/H₂SO₄/H₂O etch. Photo ID:DC17916-PAL-1-10/31/96. Scale is in 0.02 inch increments.
 Note: Inside cylinder coating on the fracture surface as shown. Unlabeled arrows define an apparent beach mark on the fracture surface.

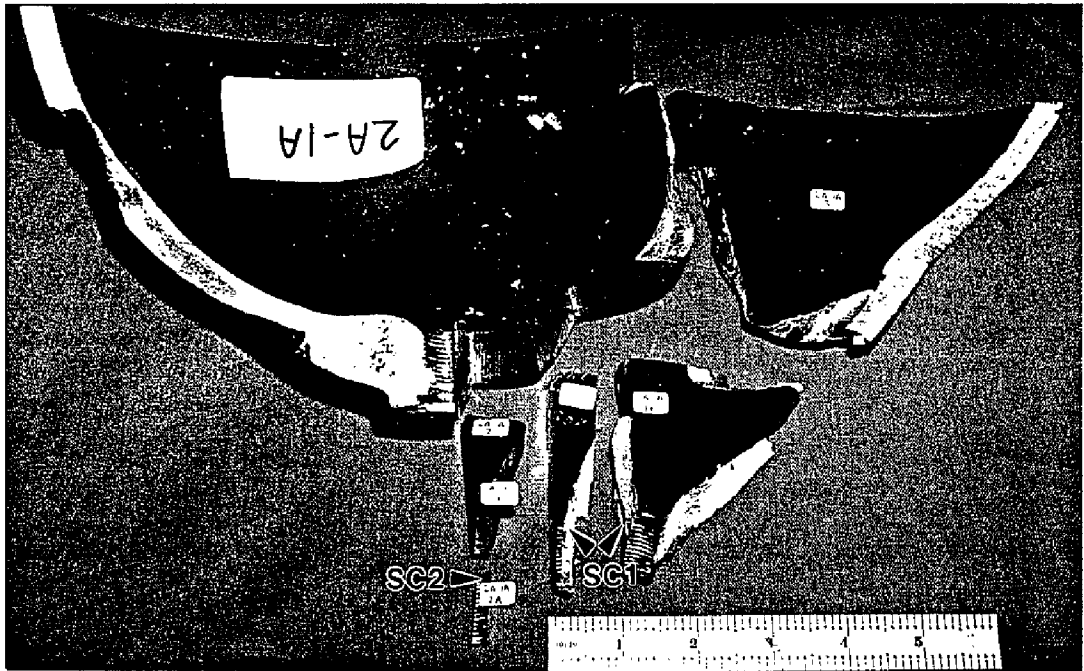
Figure 7 shows the sectioning performed on fragment 2A-1 from the neck region. The cracks, SC1 and SC2 (Figure 3), were selected for further study. Crack SC1 was forced open in the laboratory, after the remaining ligament was saw-cut part way through. The newly-formed fracture surfaces are shown in Figure 7. Crack SC2 was sectioned just below the inlet hole threads (section 2A-1A2B) and metallurgically polished to reveal its morphology.

Figure 7. Sectioning of fragment 2A-1 in the neck region.
Photo ID: DC17916-R11E2.
Note: The crack SC1 (see Figure 3) forced open in the laboratory and the crack SC2 contained within the sections 2A-1A2A and 2A-1A2B.

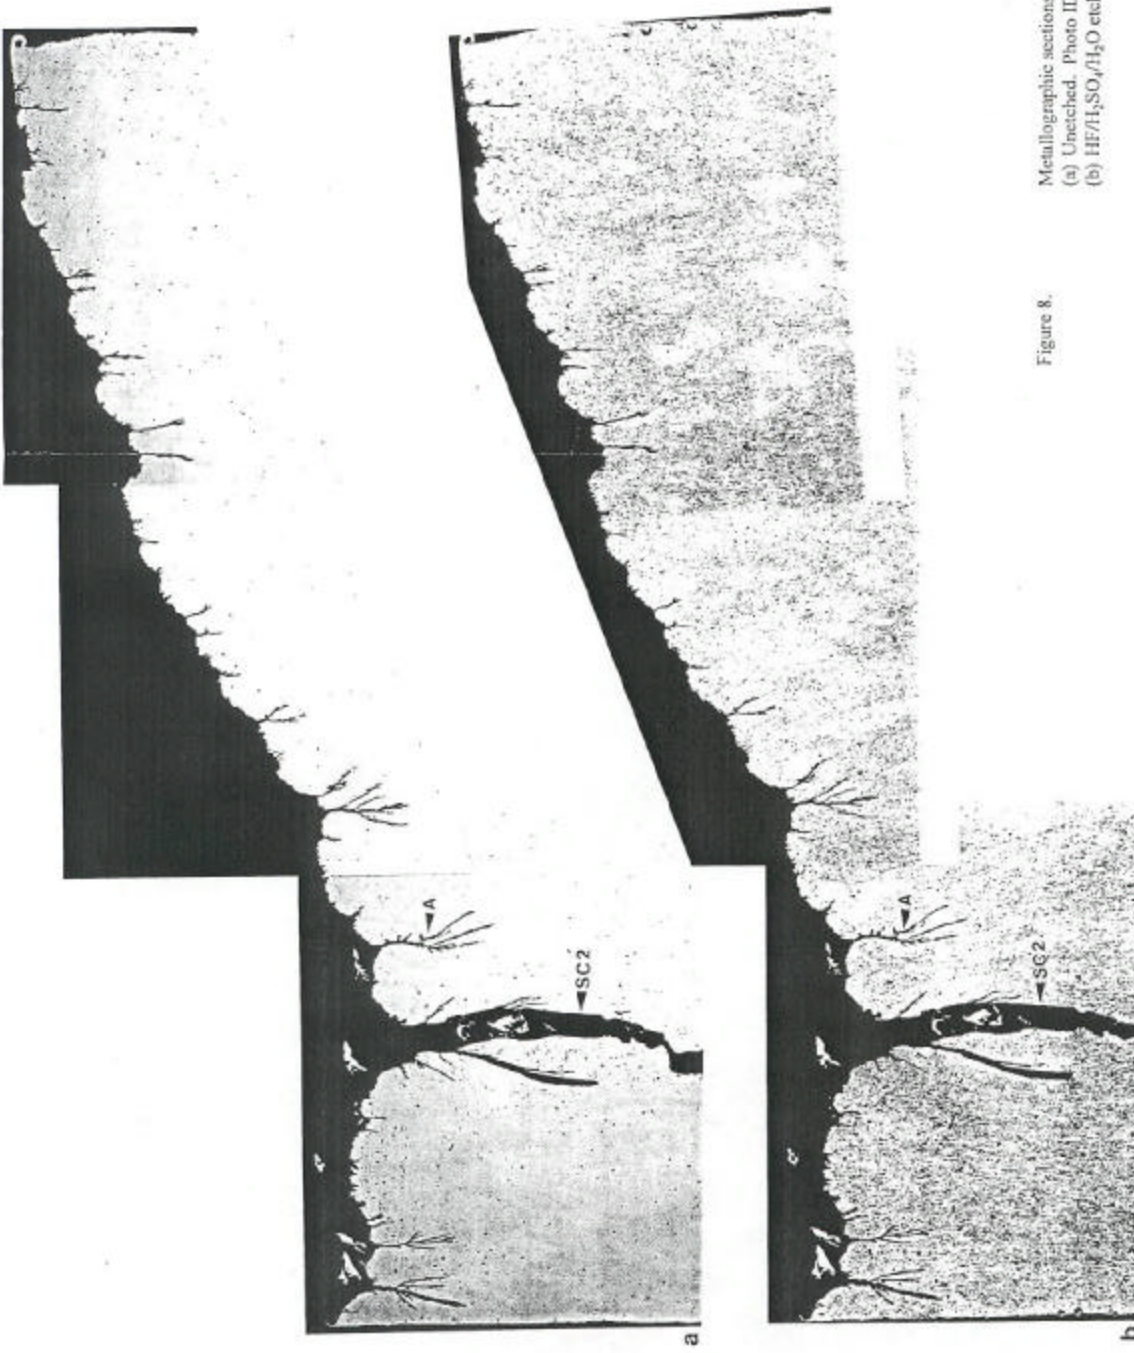
Figure 8 shows section 2A-1A2b containing crack SC2. Note the multiple folds at the inside surface and multiple branched cracks emanating from these folds. Figure 8(a) shows the section in the unetched condition and Figure 8(b) shows the microstructure after preparation with a $\text{HF}+\text{H}_2\text{SO}_4+\text{H}_2\text{O}$ etch. The microstructure is typical for AA6351 in the T6 temper condition. Figure 9 shows a higher magnification view of the crack marked "A" in Figure 8. Note that the main crack degenerates into multiple fine-scale branches.

Sectioning of the cylinder wall just below the threads at the inlet hole revealed multiple cracks from multiple origins at folds (or cusps) in the inside wall. These branched cracks are consistent with cracks found in the neck region of other DOT-6498, DOT-3Al, and DOT-7235 aluminum cylinders [4]. The possible association of cracks with AlFeSi compounds in the microstructure of the subject cylinder is consistent with other reported work on intergranular creep embrittlement of Al-Mg-Si alloys [3]. In this regard the observed cracks are consistent with studies of "sustained-load cracking" at ambient temperature reported in the literature for similar Al alloys [3, 7-9, 10-11].

Figure 8. Metallographic sections of 2A-1A2B containing SC2. 50X.
(a) Unetched. Photo ID: DC17916-PAL-1.2.3-11/08/96.
(b) HF/H₂SO₄/H₂O etch. Photo ID: DC17916-PAL-4.5.6-11/08/96.

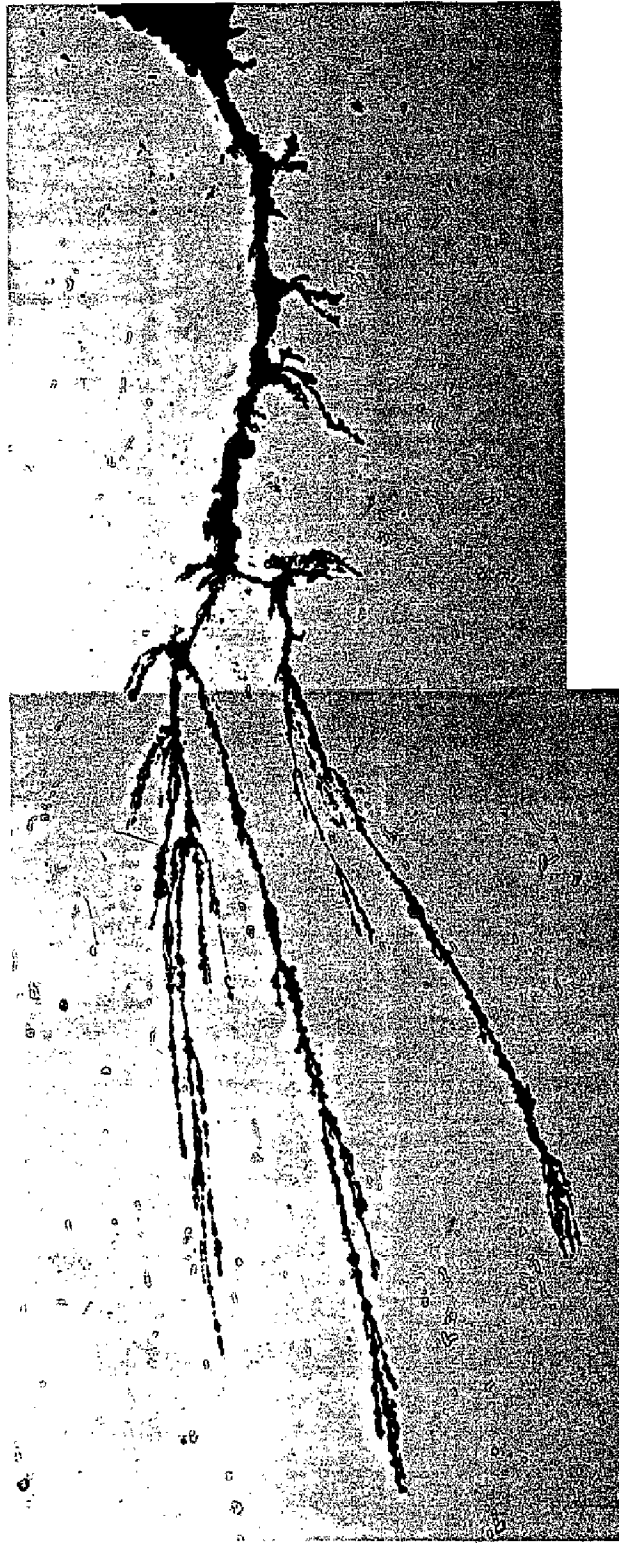
Figure 9. Close-up of crack "A" from Figure 8. 400X.
Unetched. Photo ID: DC17916-PAL-9,10-11/08/96.

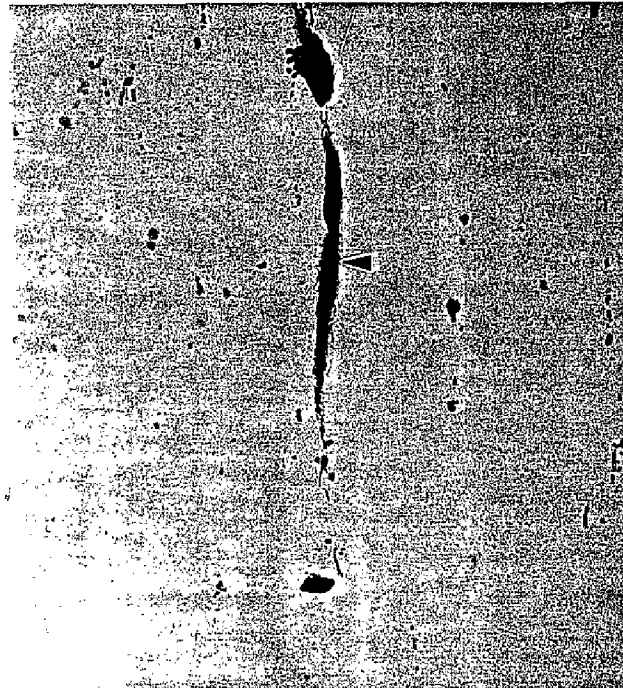
Figure 10 shows the tip of a crack from the subject cylinder that was examined metallographically. Note that the crack appears to be discontinuous. Formation of the crack also appears to be associated with Mg_2Si and AlFeSi compounds in the microstructure, shown as the distributed darker grey phases in Figure 10. To determine if the cracks were associated with a particular type of inclusion, a polished metallographic section was examined in the scanning electron microscope (SEM) and the chemical composition of the inclusions probed by energy dispersive spectroscopy (EDS). Figure 11 shows the results of this analysis. Note that the majority of inclusions seen in this micrograph (such as A and C) contain Fe and Mn, and thus are expected to be of the AlFeSi type, a variant of which also contains Mn substitutionally for Fe [2]. Inclusion B, with strong Mg and Si peaks, appears to be Mg_2Si . While not conclusive, Figure 10 and 11 suggest that the cracks form along stringers of AlFeSi compounds.

Figure 10. A crack tip from Figure 8.

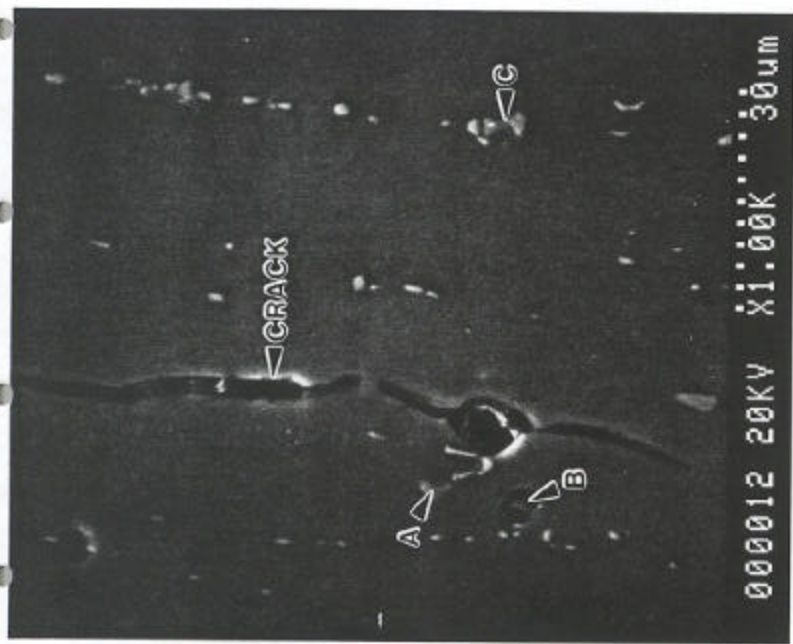
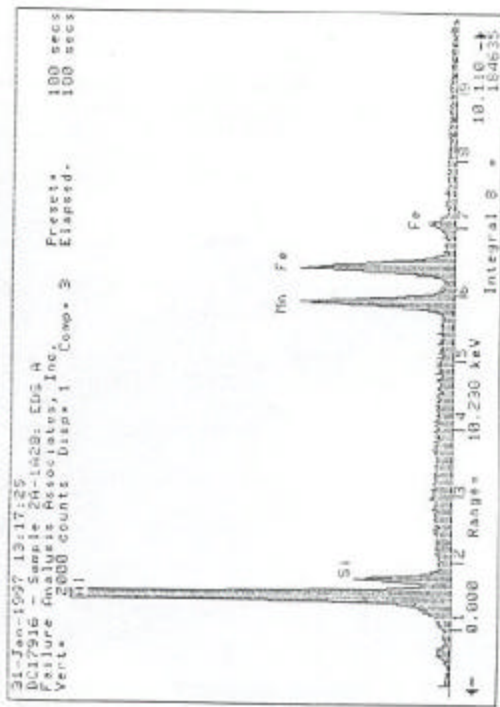
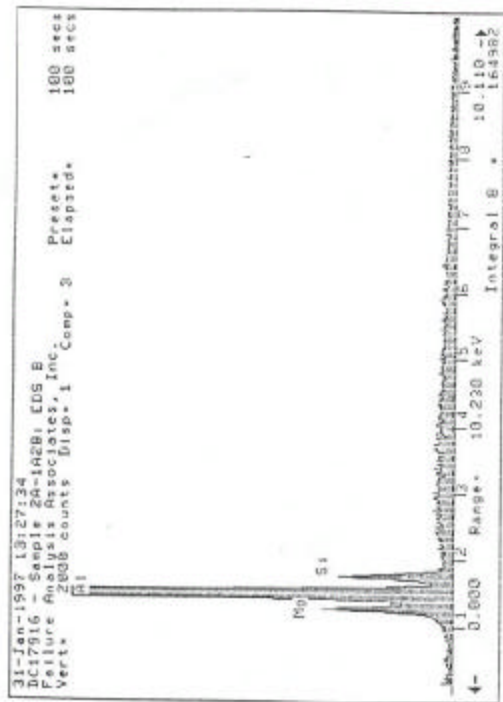
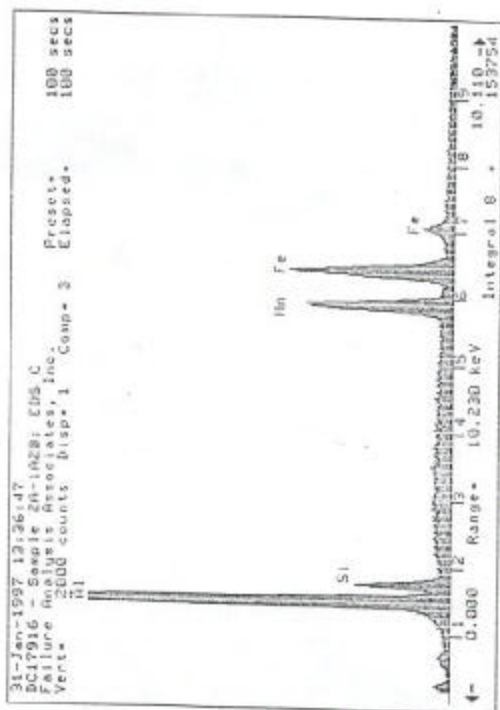
Figure 11. Precipitates near a crack tip.

(a) SEM micrograph of a crack tip.

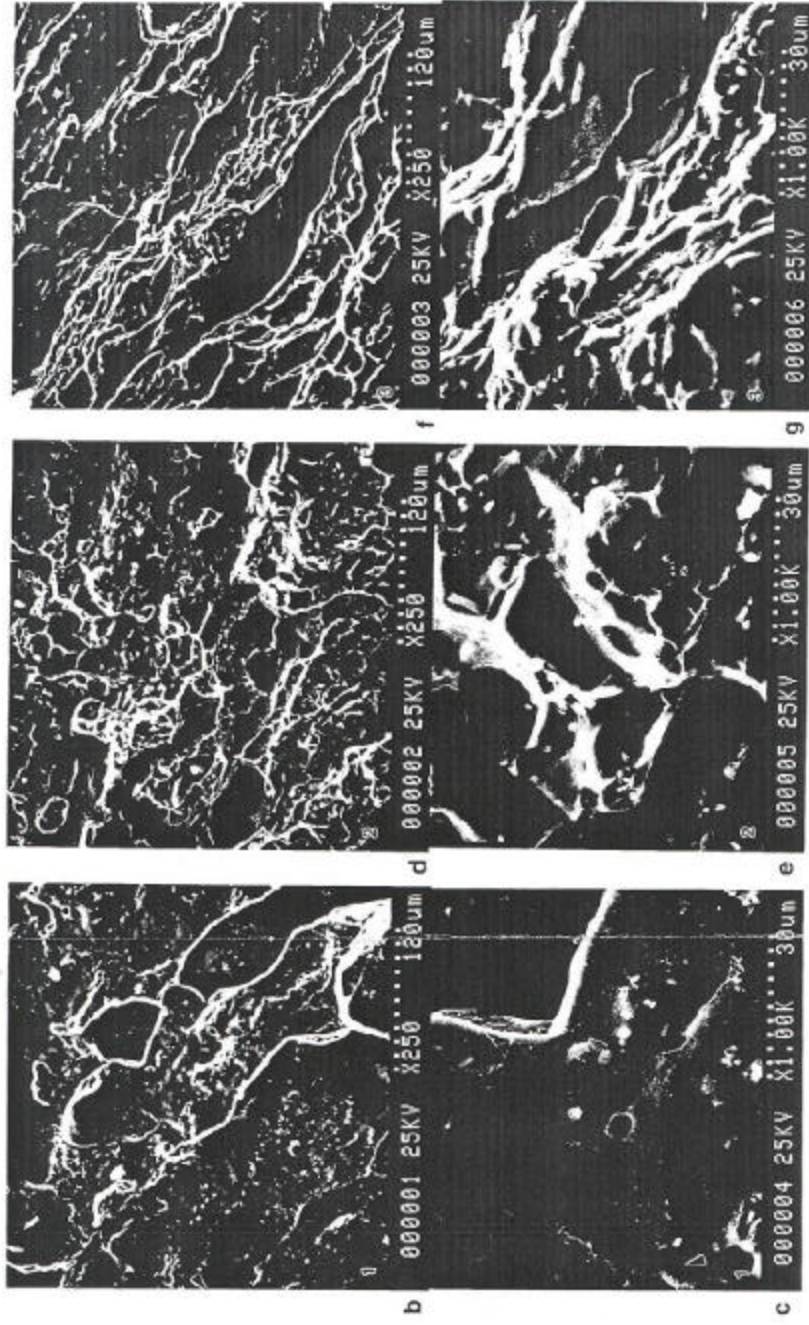
Figure 12. Fractography of fracture surface (planar region) from fragment 2A-2.
 (a) Optical fractograph depicting the neck region.
 Note the locations 1, 2, and 3.
 Photo ID: DC17916-PAL-4-10/15/97.
 (b) SEM fractograph from region 1. 250X
 Photo ID: DC17916-PAL-1-01/15/97.
 (c) SEM fractograph from region 1. 1000X.
 Photo ID: DC17916-PAL-4-01/15/97.
 (d) SEM fractograph from region 2. 250X
 Photo ID: DC17916-PAL-2-01/15/97.
 (e) SEM fractograph from region 2. 1000X.
 Photo ID: DC17916-PAL-5-01/15/97.
 (f) SEM fractograph from region 3. 250X.
 Photo ID: DC17916-PAL-3-01/15/97.
 (g) SEM fractograph from region 3. 1000X.
 Photo ID: DC17916-PAL-6-01/15/97.
 Note: Arrows in (a) define apparent beach mark.

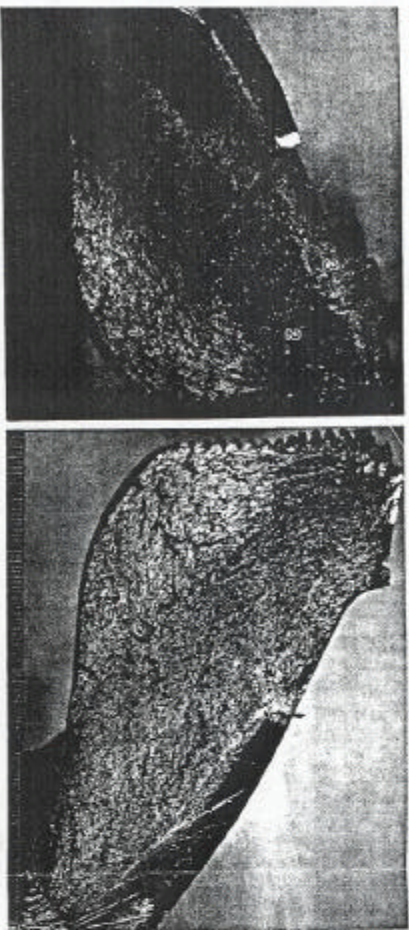
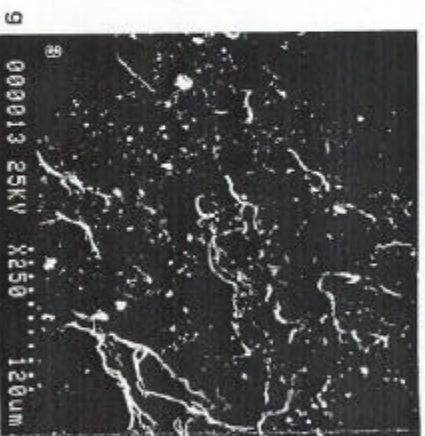
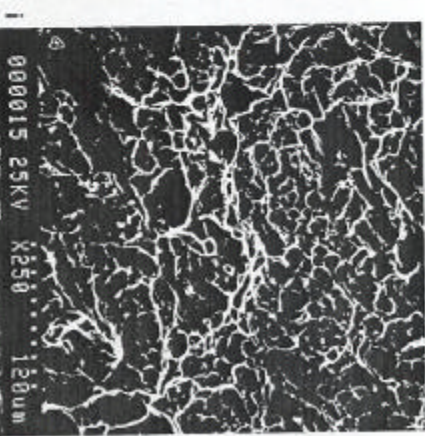
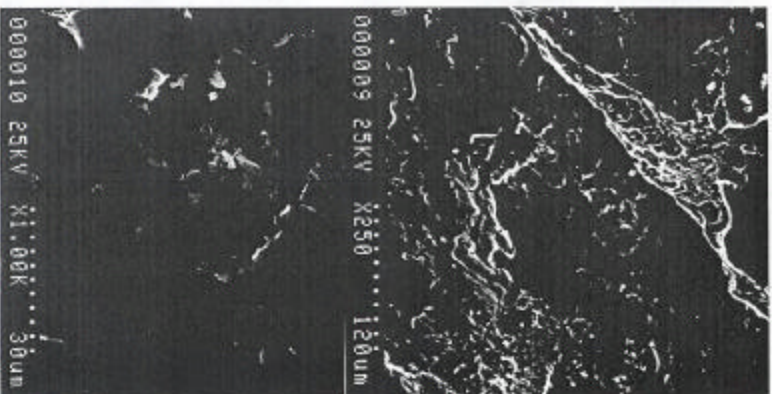
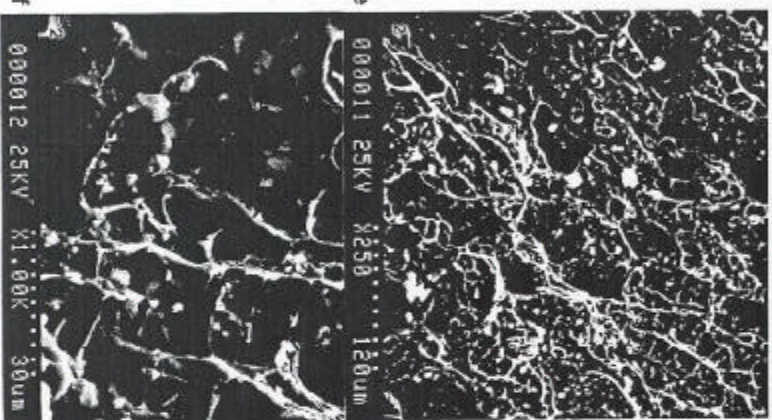
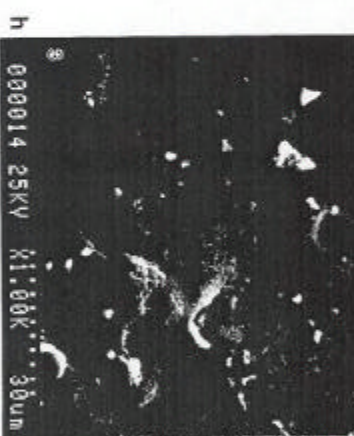
Figure 14 shows fractographs of the crack SC2 (see Figures 3 and 7) that was forced open in the laboratory. Figure 14(a) and (b) show matching halves of the fracture surface. Three distinct regions are apparent: region 1, a flat-faced region near to the cylinder's inside surface at the inlet hole; region 3, a similar flat-faced region near to the cylinder's outside surface at the inlet hole; and region 2, a curved fracture surface joining regions 1 and 3. Figure 14 (c)-(j) are a series of SEM fractographs from regions 1 - 3 described above, and from region 4, (see Fig. 12a), close to the extremity of the crack prior to it being forced open. Figure 15 shows EDS spectra captured from the fracture surface (as shown in Figure 12) from regions 1 - 4. Note Ag and Ca contaminants in region 2, similar to those found on the original fracture surface (see Figures 12 and 13).

Fractography of fracture surfaces of crack SC2 forced open in the laboratory.

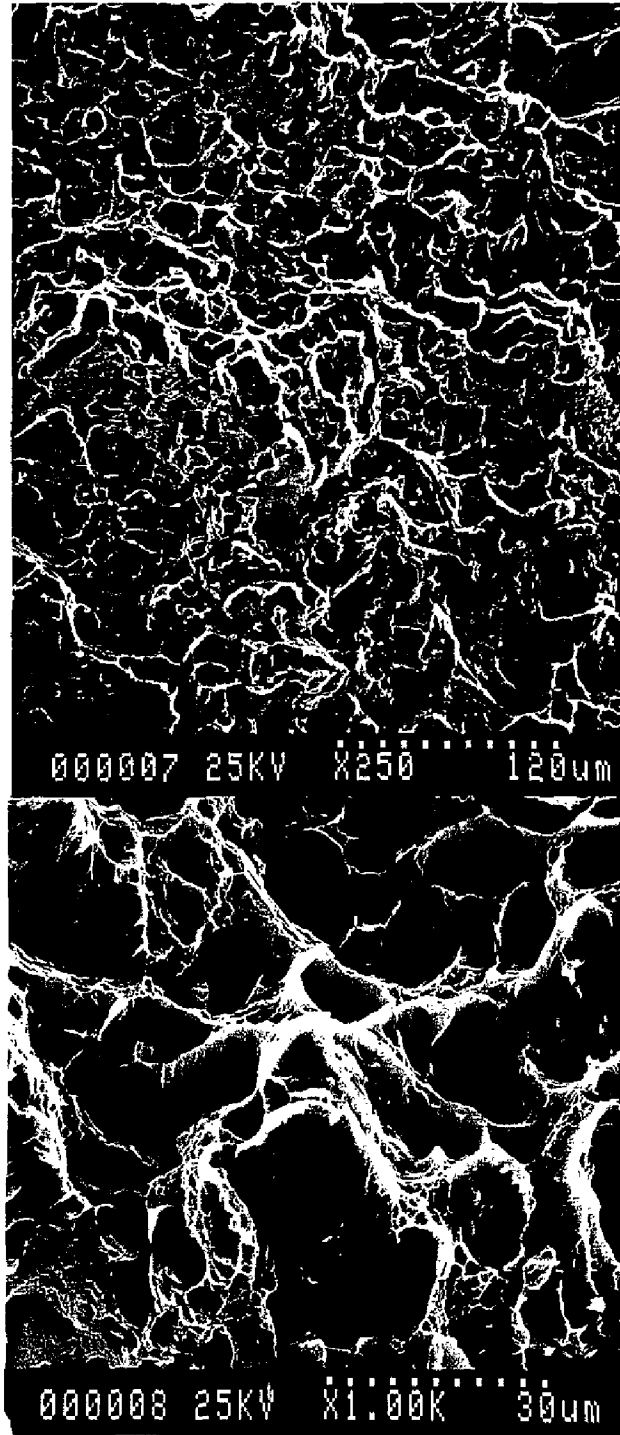
Figure 16 shows SEM fractographs of the fracture surface from one of the tensile specimens (specimen 2A-1C1, Figure 4) used for mechanical property determination. Note that the fracture surface is primarily ductile dimpled rupture, with both macro and micro dimples, and some intergranular faceting, with microdimpling on these facets. This morphology is consistent with fractographic studies of similar Al alloys in tensile and toughness testing [3]. A comparison of the Figure 16 fractographs with Figures 12

SEM fractographs of a tensile specimen.
