**METALLURGICAL EVALUATION OF  
A DOT-E6498-2216 CYLINDER  
FaAA Project No.: DC17916.000**

U.S. Department of Transportation  
400 Seventh Street S.W.  
Washington D.C. 20590

Timothy R. Smith, Ph.D., P.E.  
Failure Analysis Associates, Inc.  
310 Montgomery Street  
Alexandria, VA 22314

January 1997

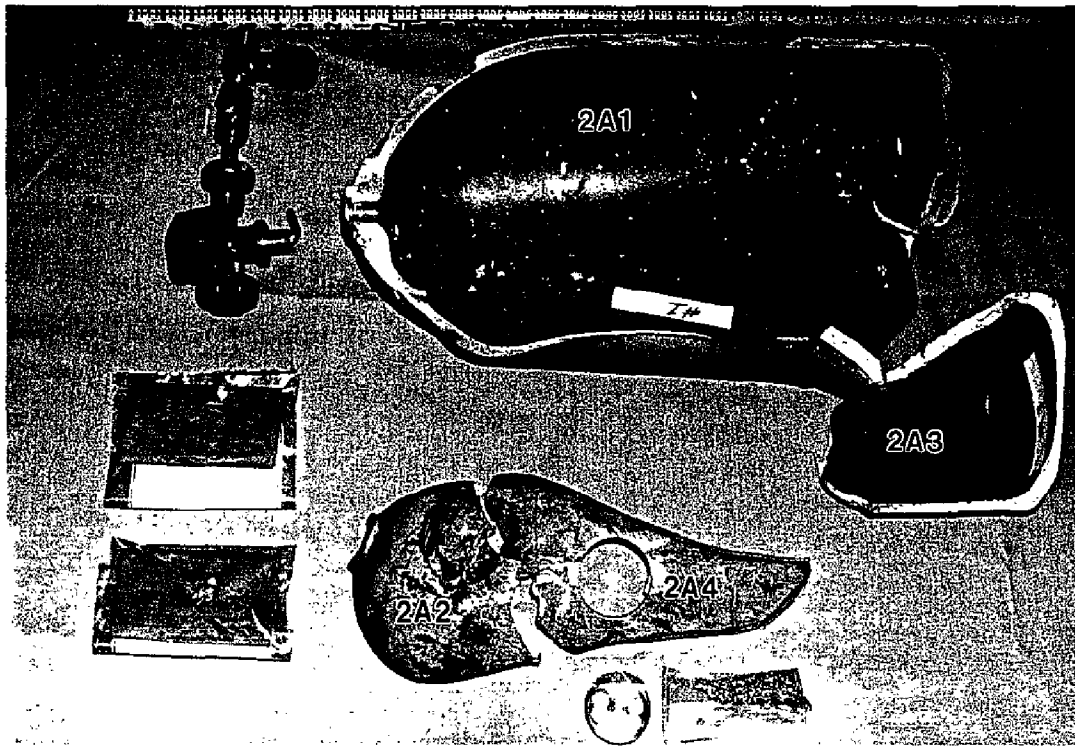
A visual examination of the cylinder remains was performed. The remains are shown in Figure 1, in the as-received condition. The cylinder broke apart into four large pieces and at least two small fragments. At the time of FaAA's inspection, a circular sample of material had been cut from one piece and contained burn markings, presumably from tests by optical emission spectroscopy to determine its bulk chemistry. In addition, some aluminum chips, presumably from drilled holes at unknown location(s), were also included in the remains.

Figure 1. Remains of the cylinder, as received.  
Photo ID: DC17916-R4E6.

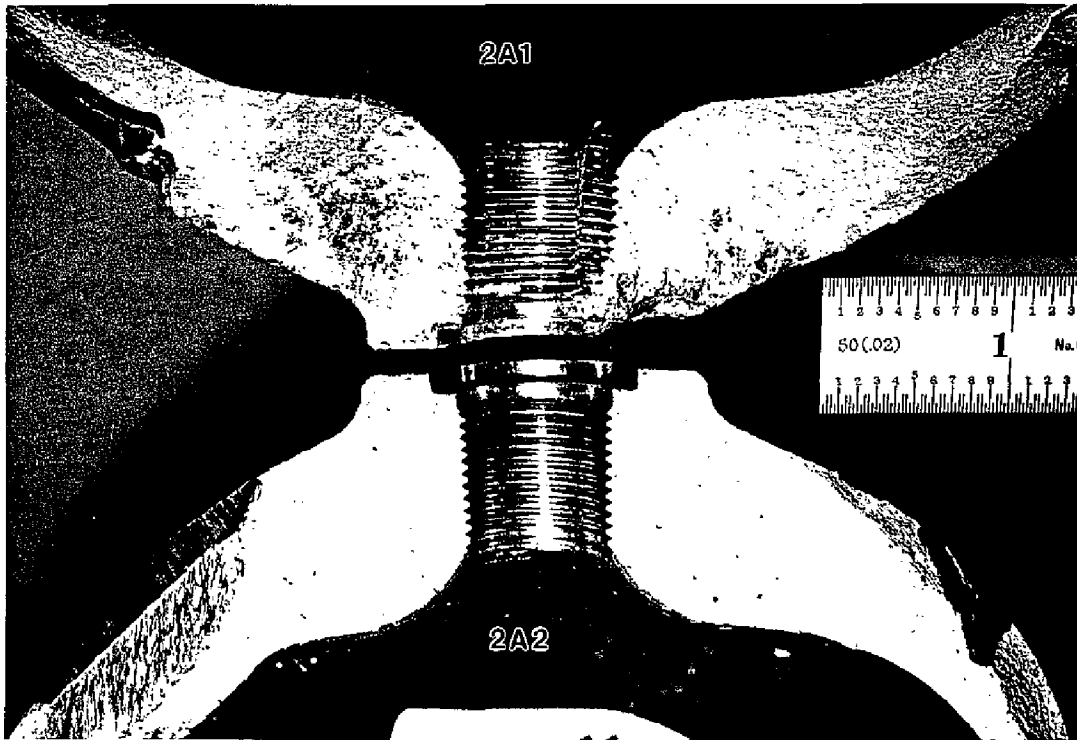
The fracture surfaces of the cylinder were inclined (i.e., non-radial with respect to the cylinder axis) shear-type, except in the neck region where the fracture surfaces were flat and radial with respect to the axis of the cylinder. The main fracture surface ran through essentially a full diameter of the inlet hole in the neck region. Figure 2 shows the matching halves of the fracture surface from the neck region (fragments 2A-1 and 2A-2). The larger of the two pieces (2A-1) had foreign contamination on the fracture surface on both sides of the inlet hole. This contamination appeared to be paint and either concrete dust or plaster. This piece also showed impact damage to the fracture surface at the inlet

Figure 2. Mating fracture surfaces (fragments 2A-1 and 2A-2) at the inlet hole. Note the fracture is planar in the neck region.  
Photo ID: DC17916-R5E5.

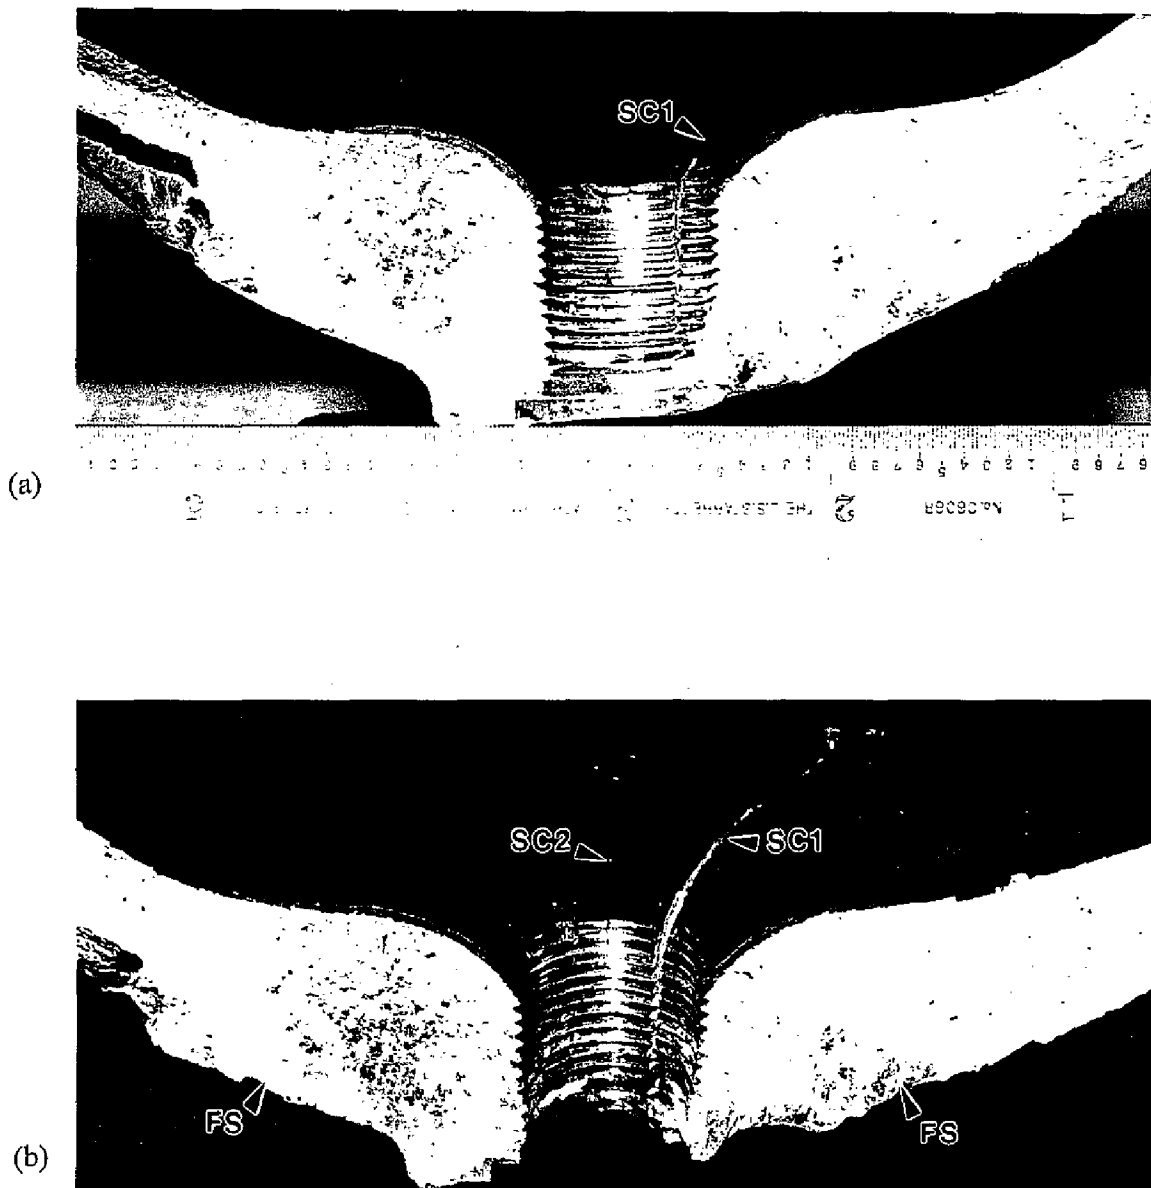
Figure 3 shows two views of the fracture surface of fragment 2A-1 from the neck region. The inside wall of the cylinder in this region shows multiple folds (or cusps) from the original manufacturing process. The fracture surface on both sides of the inlet hole appears to pass through deep folds of this type. On fragment 2A-1, there were a least two large cracks, labeled SC1 and SC2 on Figure 3, originating from these folds.

Figure 3. Fragment 2A-1 fracture surface, neck region.  
(a) View perpendicular to fracture surface.  
Photo ID: DC17916-R4E20.  
(b) View inclined to fracture surface.  
Photo ID: DC17916-R4E21.  
Note: FS marks the fracture surface, SC1 and SC2 are secondary cracks.
