Figure 13: SEM fractography of specimen 1A-1, near fracture origin.

Appendix A: Detailed Photodocumentation of Cylinder

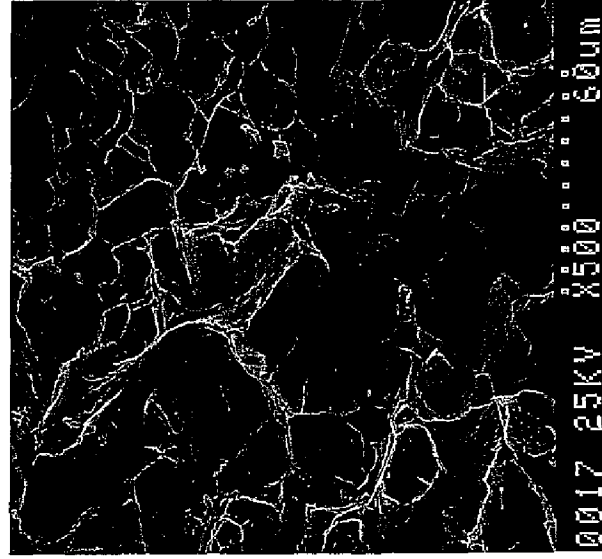
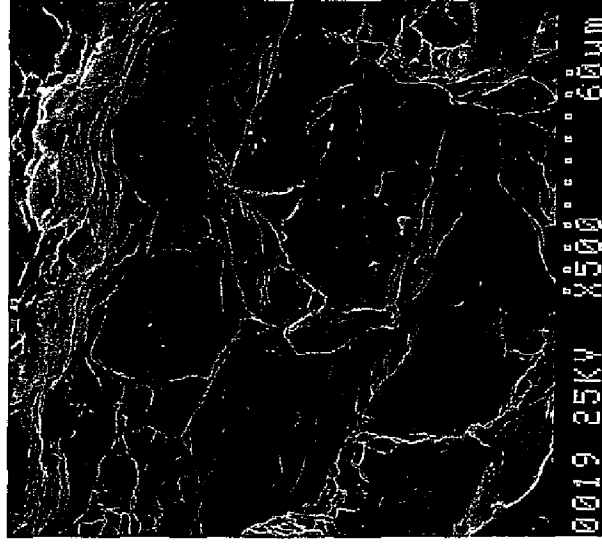
Figure 14: SEM fractography of specimen 1A-2, at first beachmark.

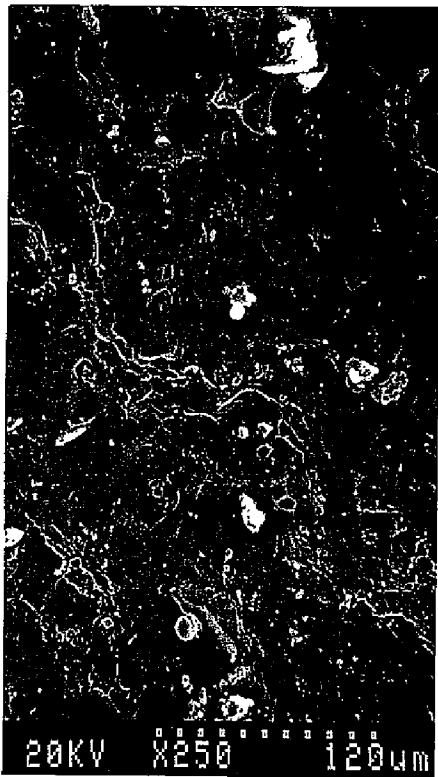
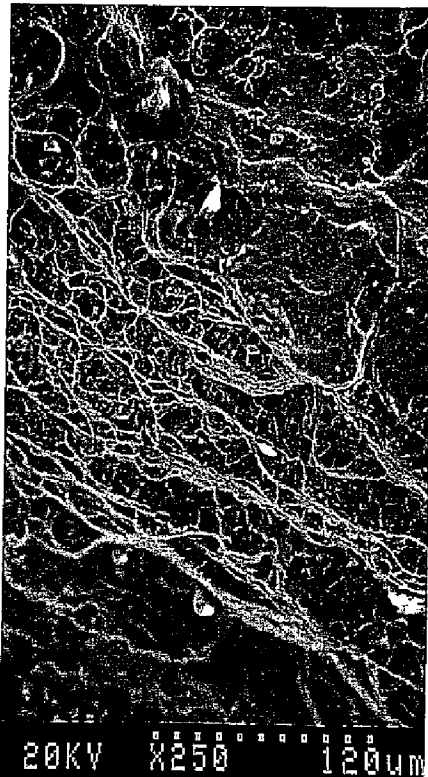
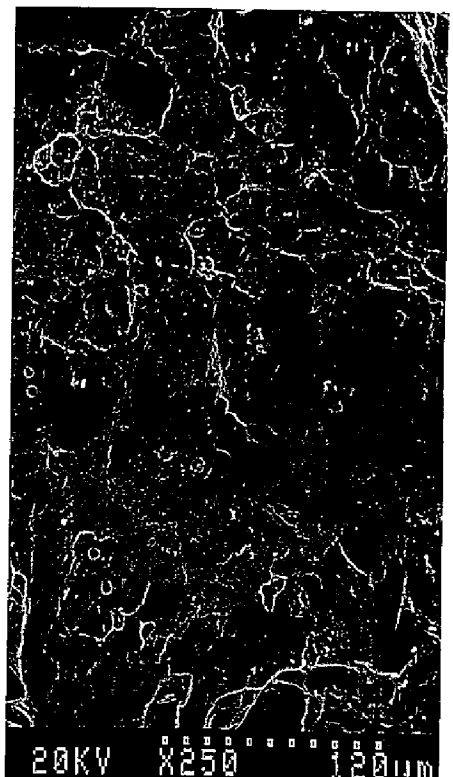
Figure 15: SEM fractography of specimen 1A-2, at top of neck.

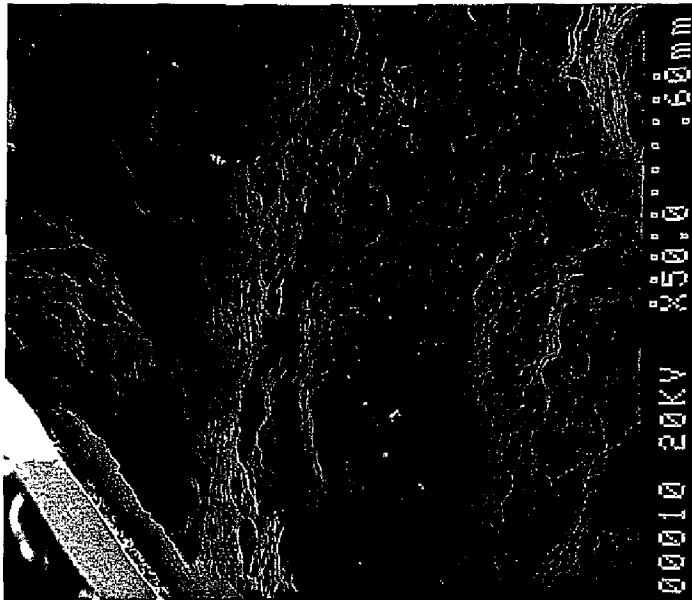
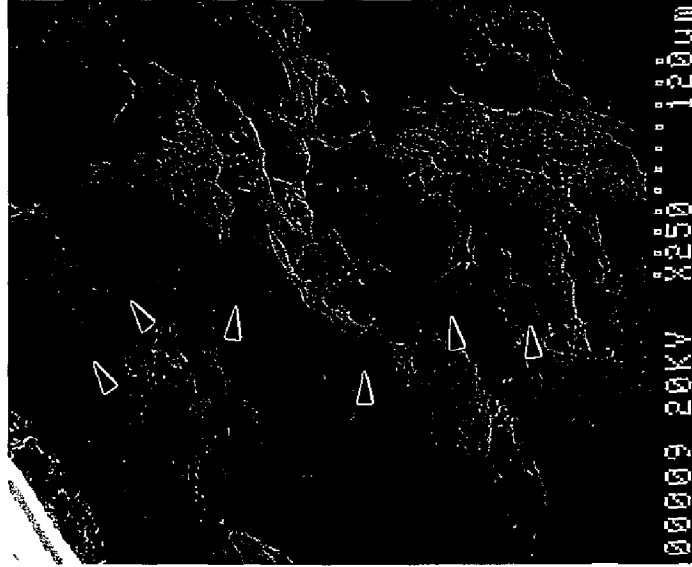
Figure 16: SEM fractography of specimen 1A-2, at outer surface.

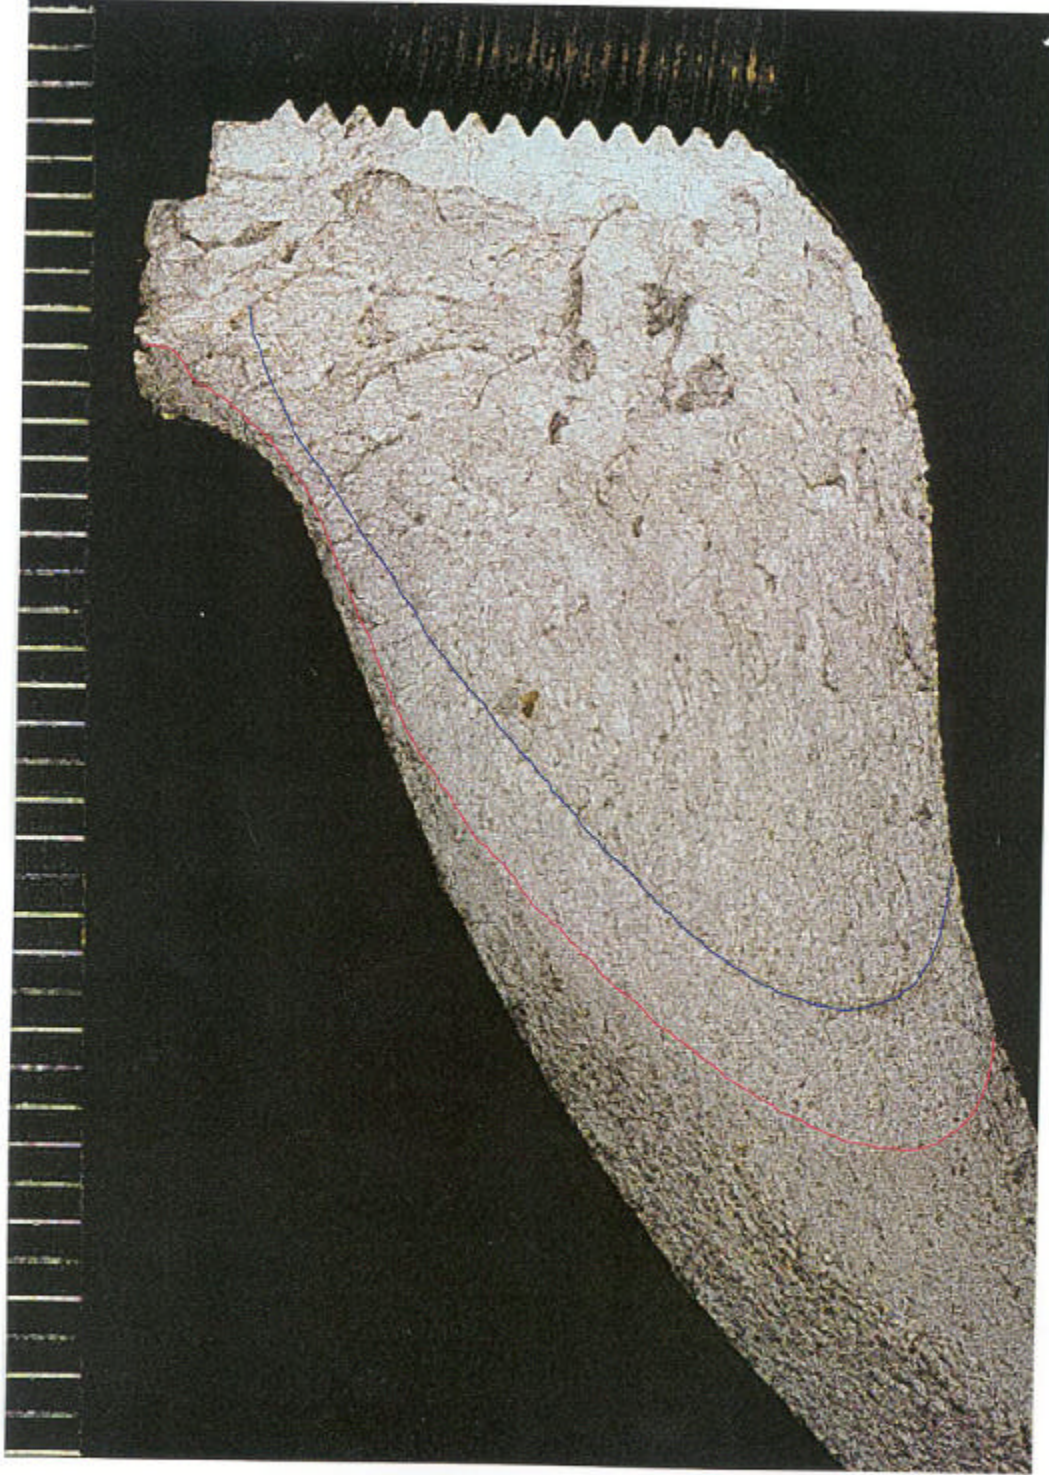
Figure 18: Fracture surface 1A-1, showing crack fronts at different time points (beach marks).
