**METALLURGICAL
EVALUATION OF
DOT-E7042-3000
CYLINDER D-99604**

U.S. Department of Transportation
400 Seventh Street S.W.
Washington D.C. 20590

Timothy R. Smith, Ph.D., P.E.
310 Montgomery Street
Alexandria, VA 22314

08/27/98

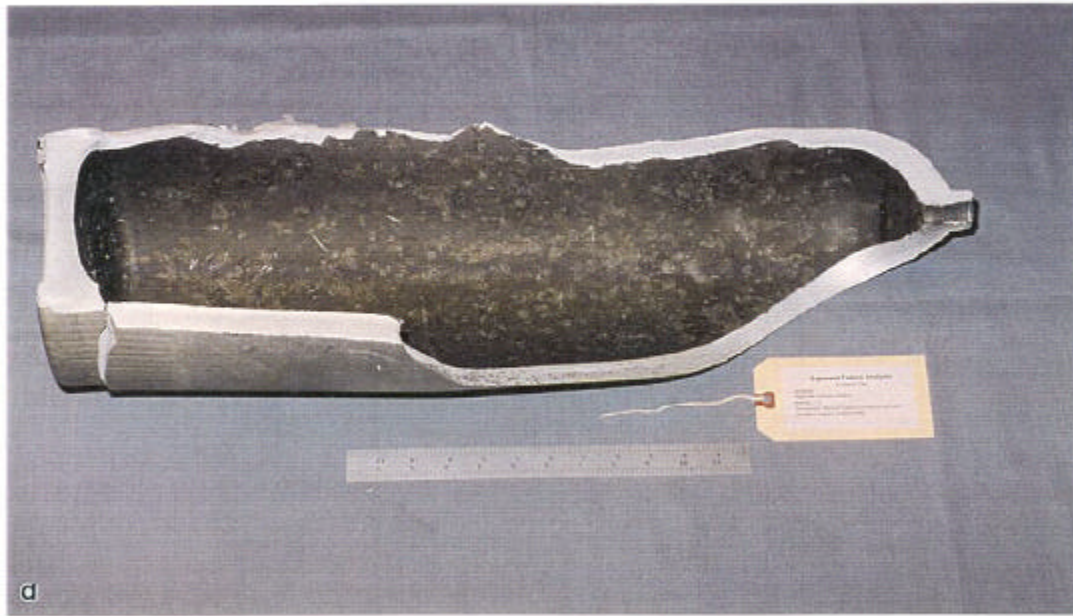
A visual examination of the cylinder remains was performed. The remains are shown in Figures 1 and 2, in the as-received condition. The cylinder broke apart into four pieces, designated 1A, 2A, 3A and 4A by FaAA.

Fragment 2A, containing one-half of the neck region, sustained impact damage to its fracture surface and to its portion of the cylinder exterior, presumably all a result of the

rupture event. Other pieces also showed impact damage at certain locations and scuffmarks. These also all appeared to be from the rupture event.

Figure 1: Cylinder remains, as received
(a) Fragment 1A. Photo ID: DC18129-R1E2.
(b) Fragment 2A. Photo ID: DC18129-R1E21.

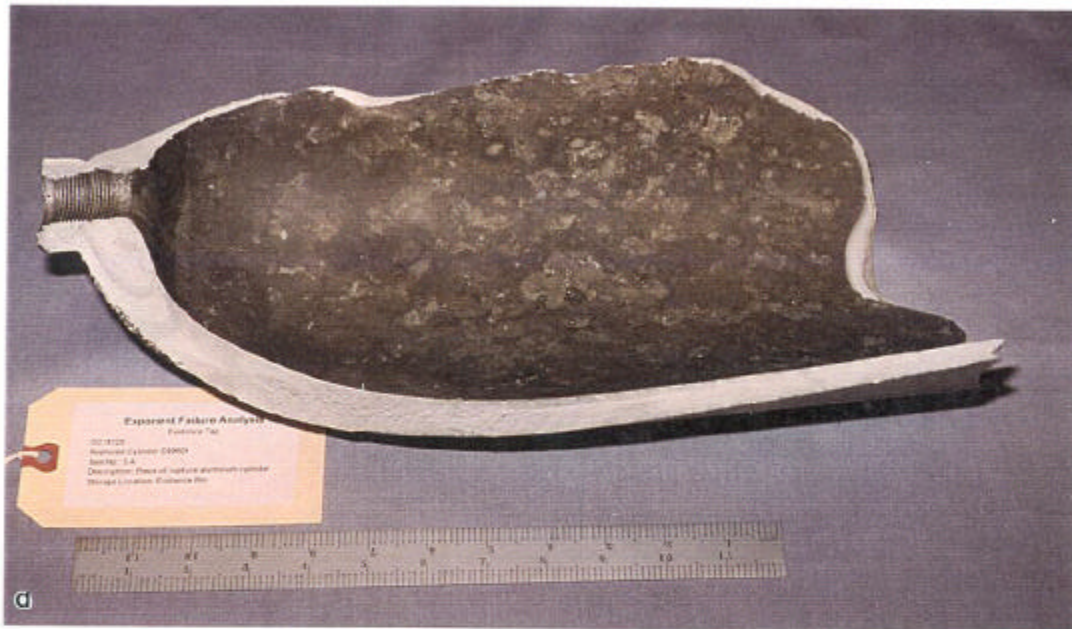
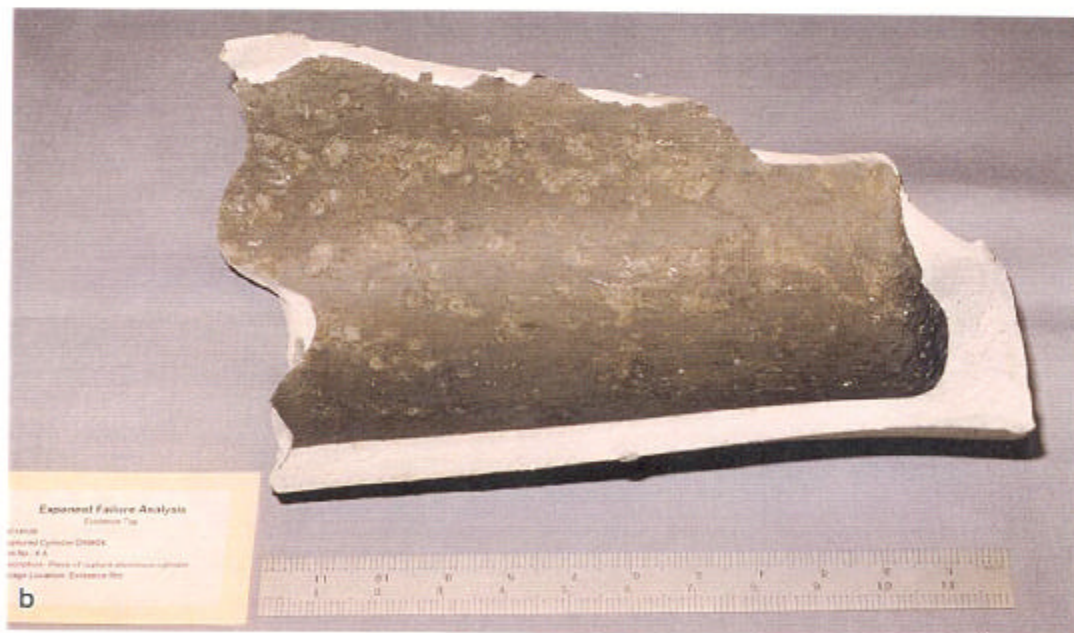
Figure 2: Cylinder remains, as received
(a) Fragment 3A. Photo ID: DC18129-R2E21.
(b) Fragment 4A. Photo ID: DC18129-R3E11.

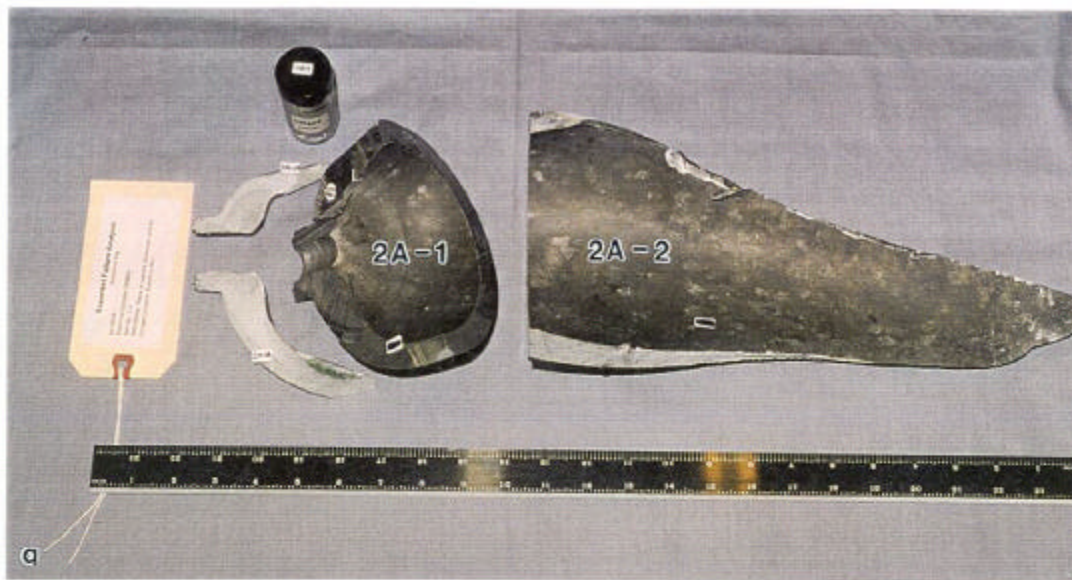
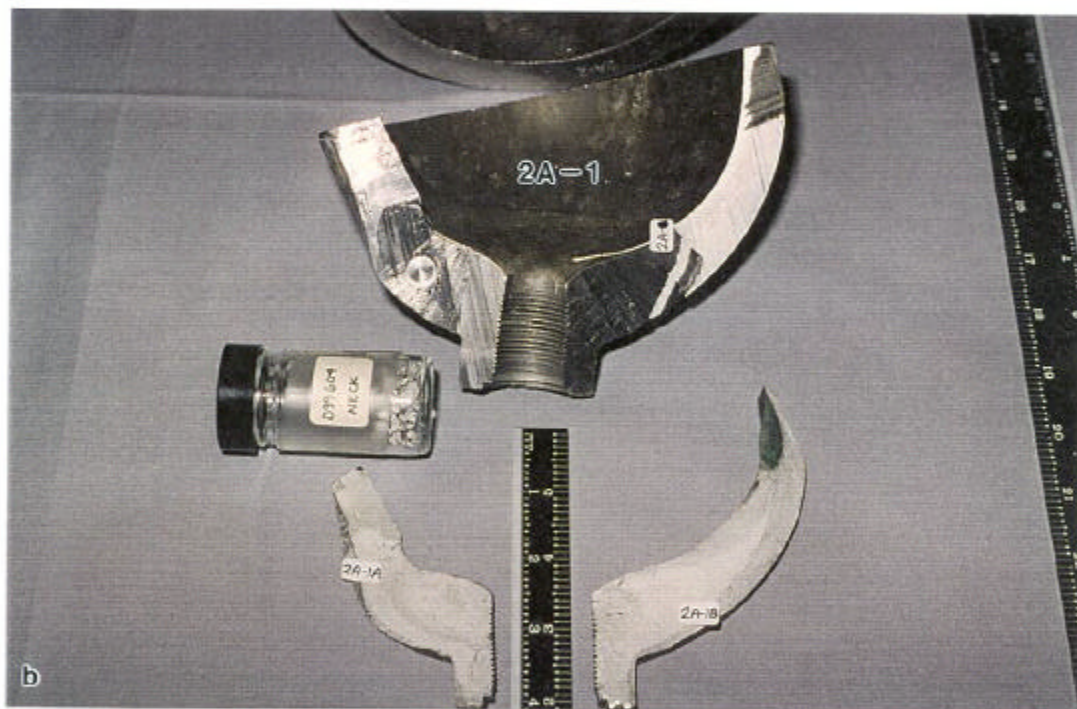
Figure 4 shows the sections cut from cylinder fragment 2A. Sections of the fracture surface on both sides of the inlet hole were cut such that the flat-faced portion of the fracture surface was separated from the fragment. Two wafers were generated in this process.

Figure 4. Sectioning of fragment 2A
(a) Overall view. Photo ID: DC18129-R3E4.
(b) Close up of neck region. Photo ID: DC18129-R3E8.
Note: the fracture surface portions that were removed and the drilling taken to determine chemical composition.
