Figure 13. Energy dispersive spectra captured from the fracture surface of Figure 12.  
(a) Spot analysis of coating region "A".  
(b) Spot analysis of surface deposits from region "B"

## **Recommended Scope of Work for Metallurgical Evaluation of Aluminum Cylinder**

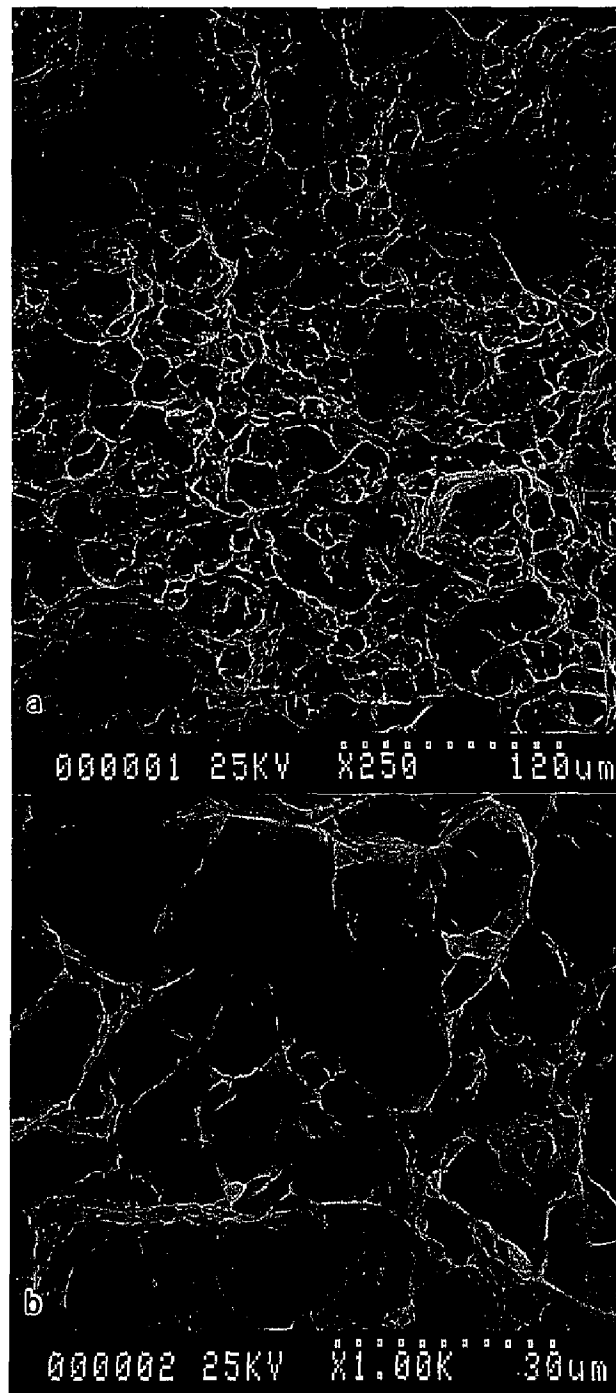
Figure 15. Fractography of tensile specimen T-3.  
(a) 250 X. Photo ID: DC18129-PAL-1-8/4/98.  
(b) 1000X. Photo ID: DC18129-PAL-2-8/4/98.
