**FRACTOGRAPHIC AND MICROSTRUCTURAL EXAMINATION  
OF A RUPTURED DOT-3AL  
SPECIFICATION COMPRESSED GAS CYLINDER**

July 27, 1995

U.S. DOT/RSPA/  
400 7th Street, S.W.  
Washington, D.C. 20590-0001

ARTECH File No. 9509.004

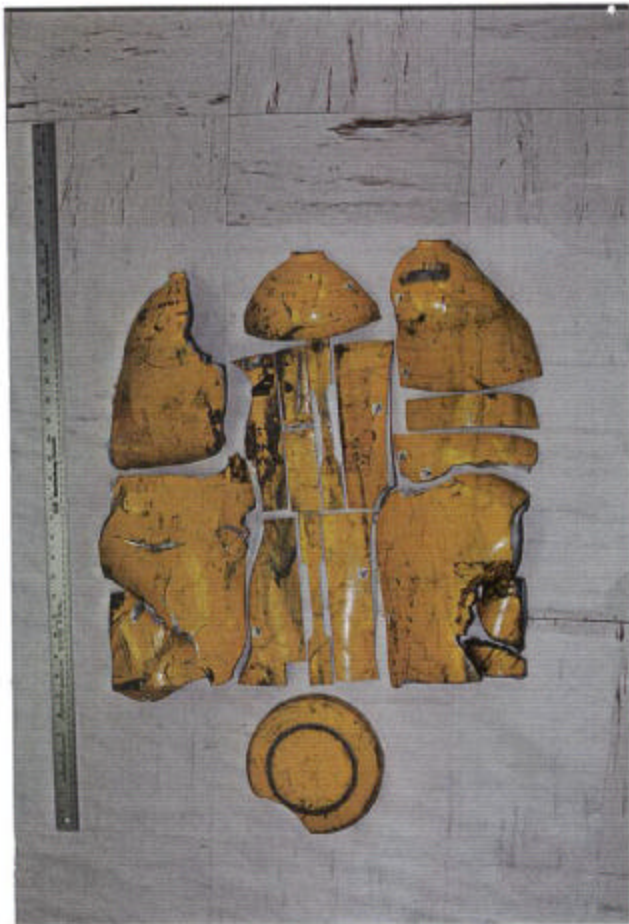
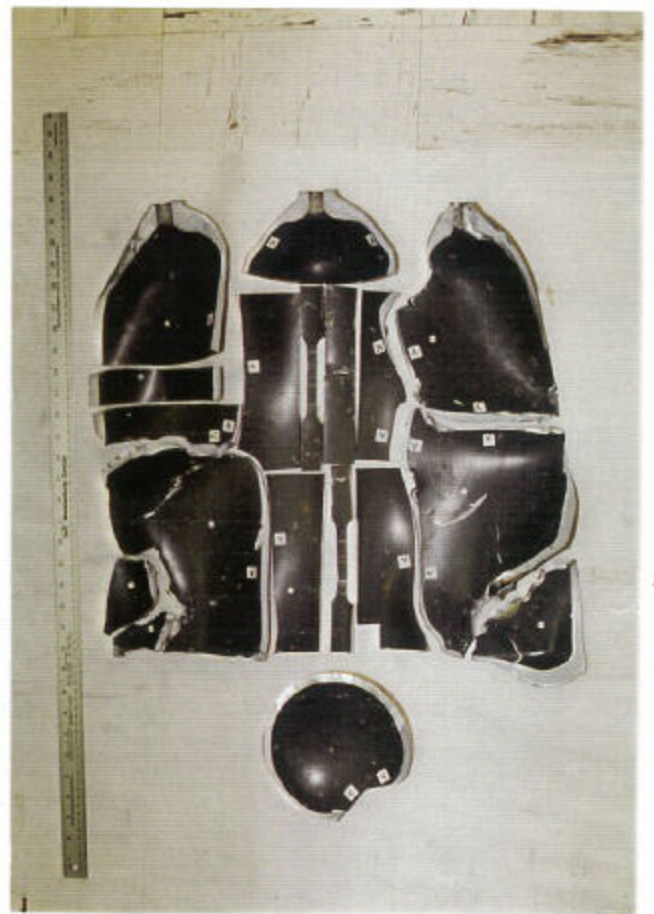
The major pieces of the exploded pressure cylinder are shown in Figure 1, in a best fit arrangement, that was based on the center nine (9) pieces (Figure 2) having been one continuous piece that had been analyzed previously. The remaining major pieces were then arranged on the basis of exterior and interior surface features and fracture profiles, as indicated in Figure 3.

Figure 1. Major pieces of exploded air pressurized (SCUBA) cylinder E6498-2216. Caret marks indicate clearly defined chevron patterns that point to the fracture origins.

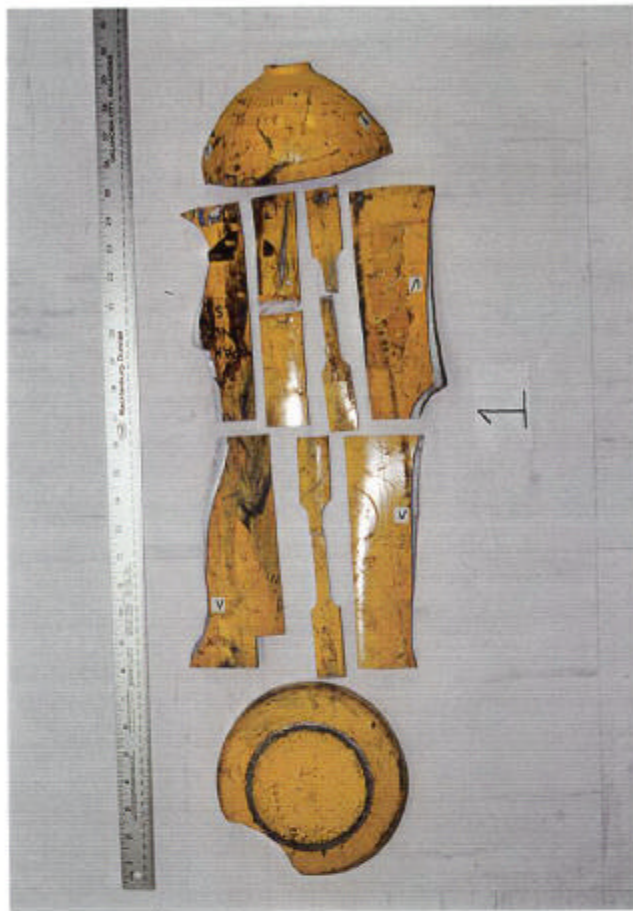
Figure 2. Arrangement of test coupons, from a previous examination, which constitutes one continuous failure section.

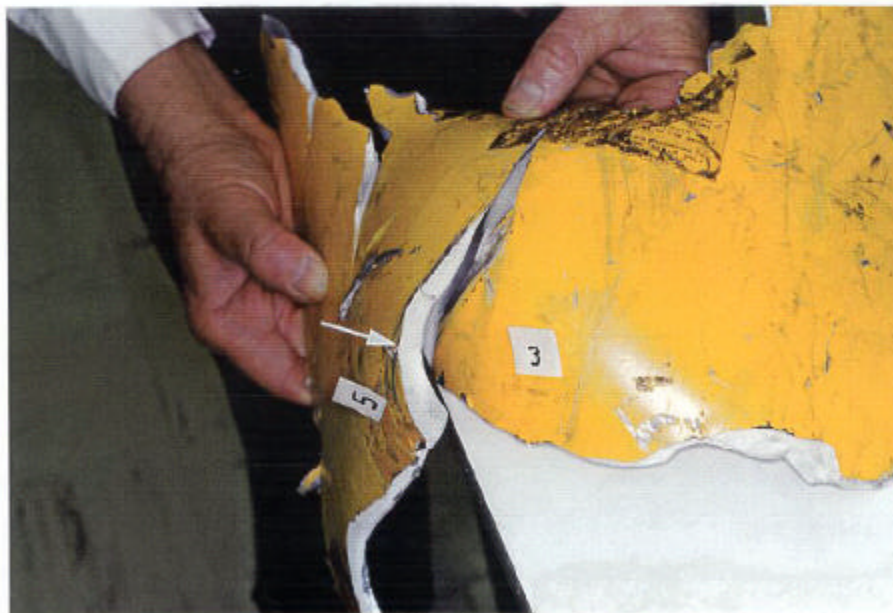
Figure 3. Matching (without touching) fracture profile of fracture piece #3 with #5. Arrow locates the only flat, 90° fracture area (approx. 1 inch long) within the cylindrical wall area.

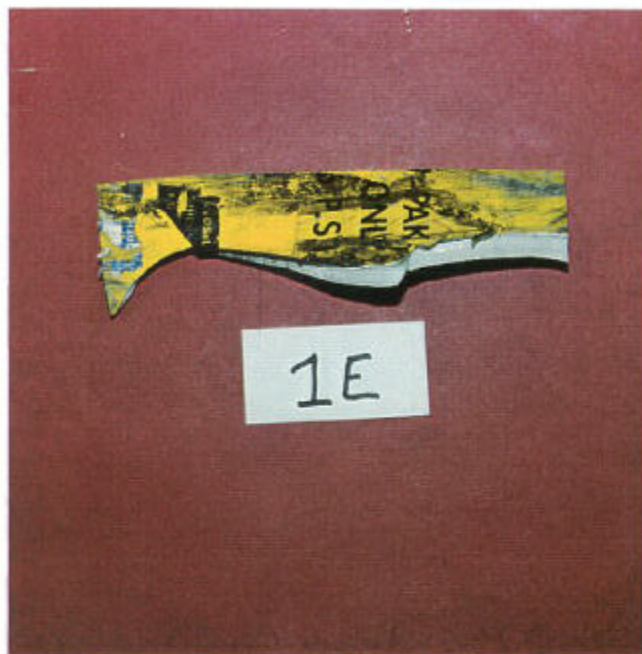
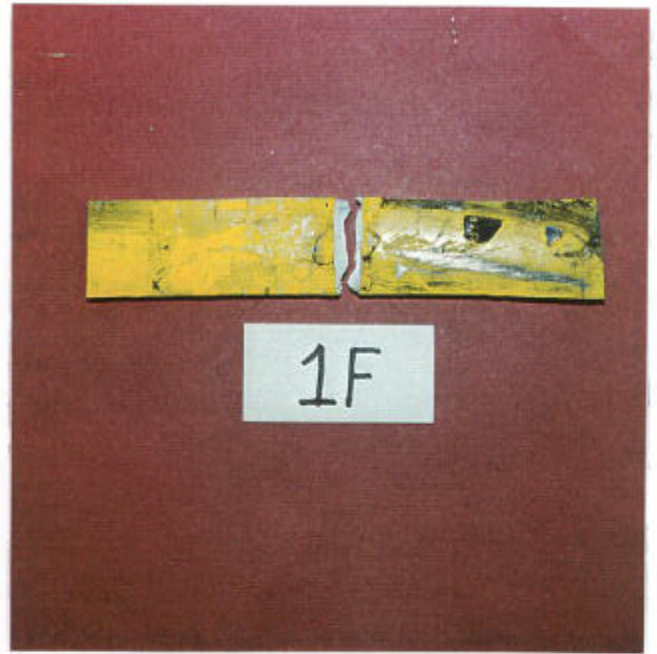
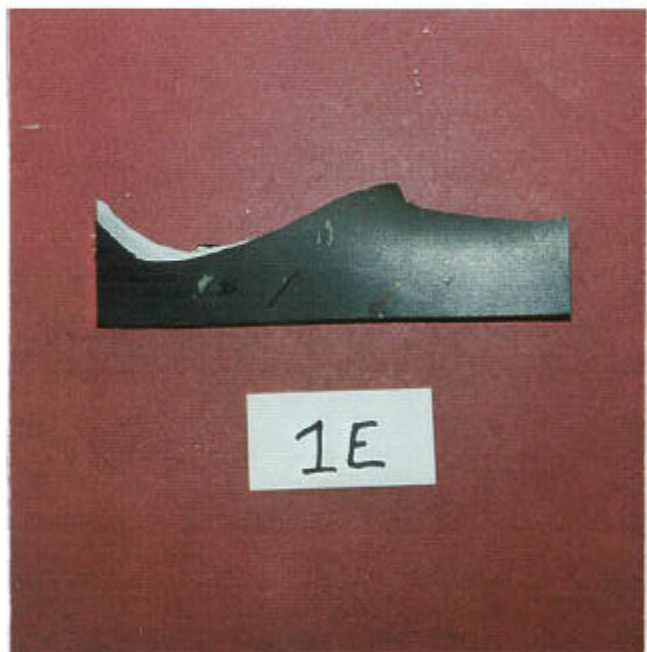
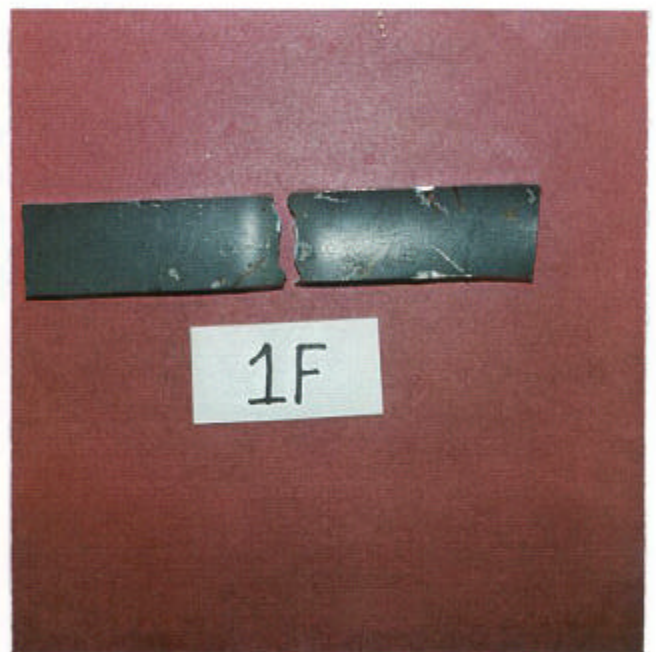
Figure 6. Upper left fracture edge section (1E) and adjacent failed bend test coupon (1F) shown in Figure 2.

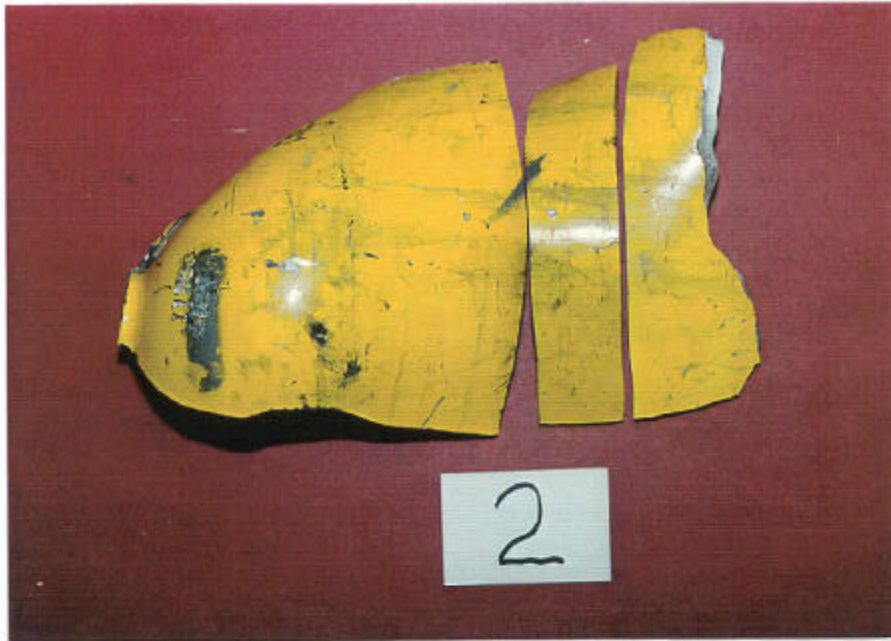
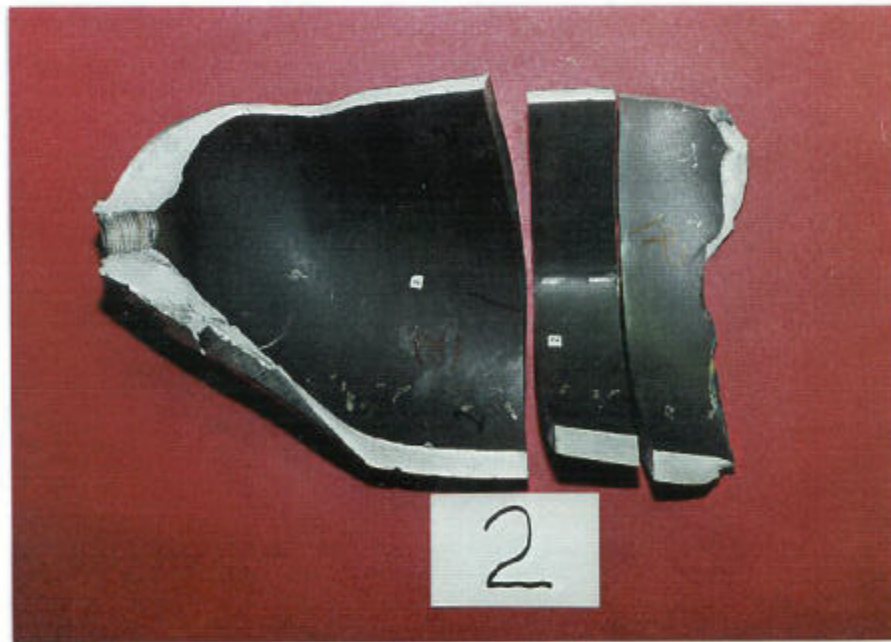
Figure 9. Fracture piece (2), with transverse section previously tested as a bend test coupon that failed during testing, shown in Figure 1.

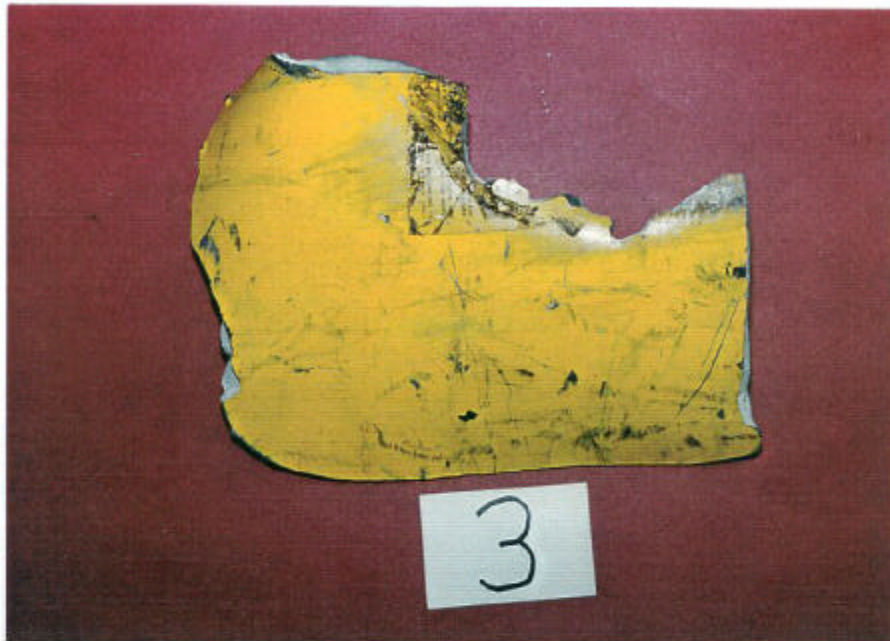
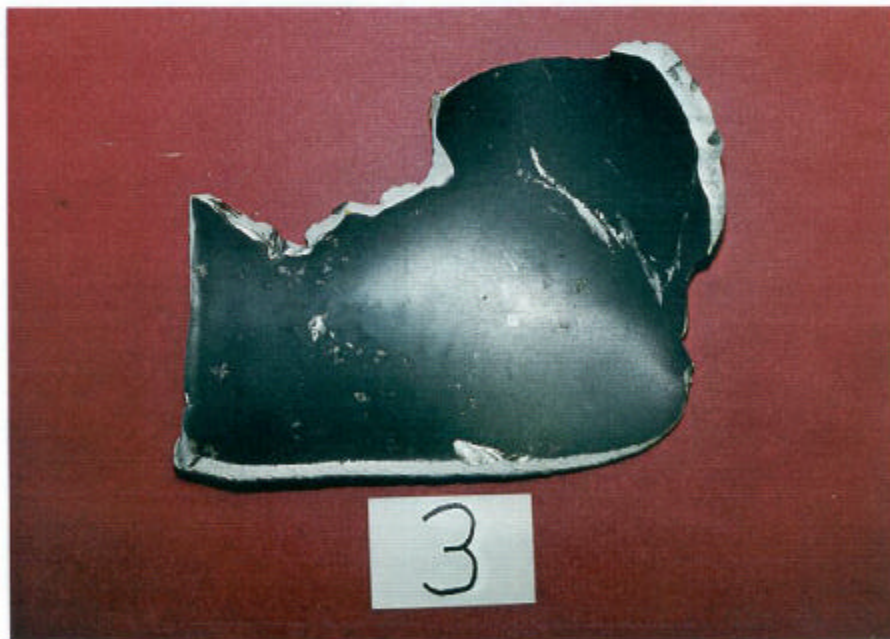
Figure 10. Fracture piece (3), adjacent to bottom of cylinder, shown in Figure 1.

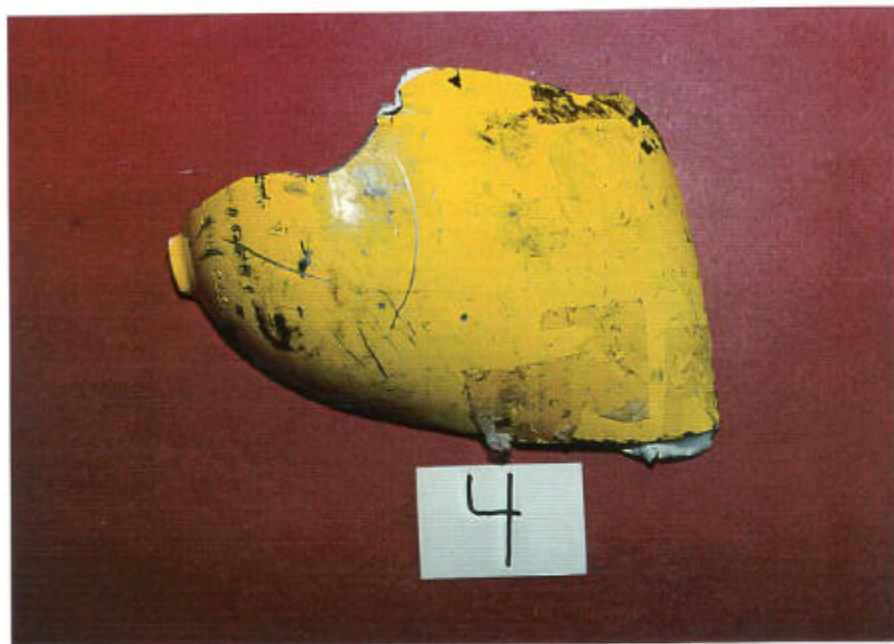
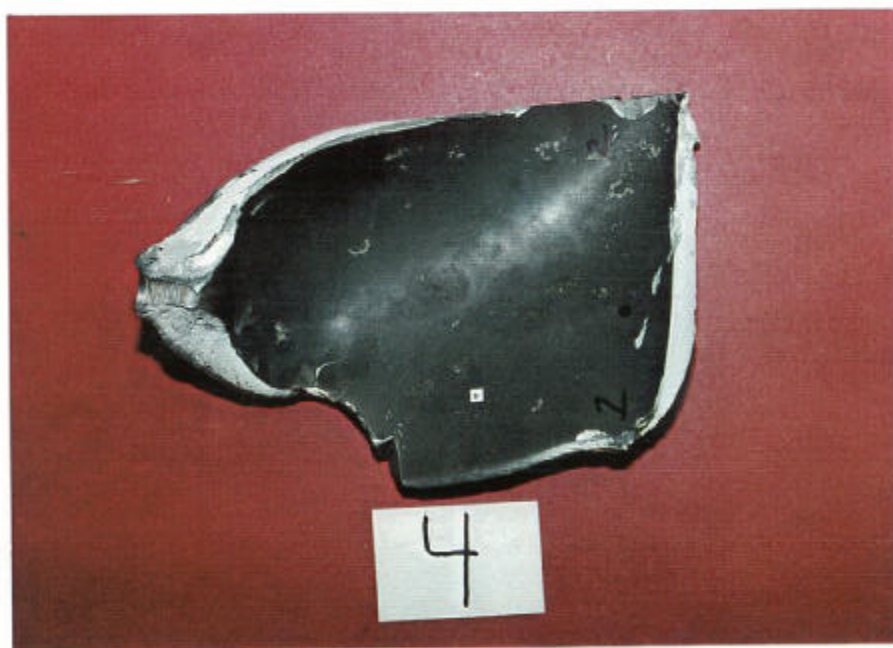
Figure 11.

Fracture piece (4), from top of cylinder shown in Figure 1.

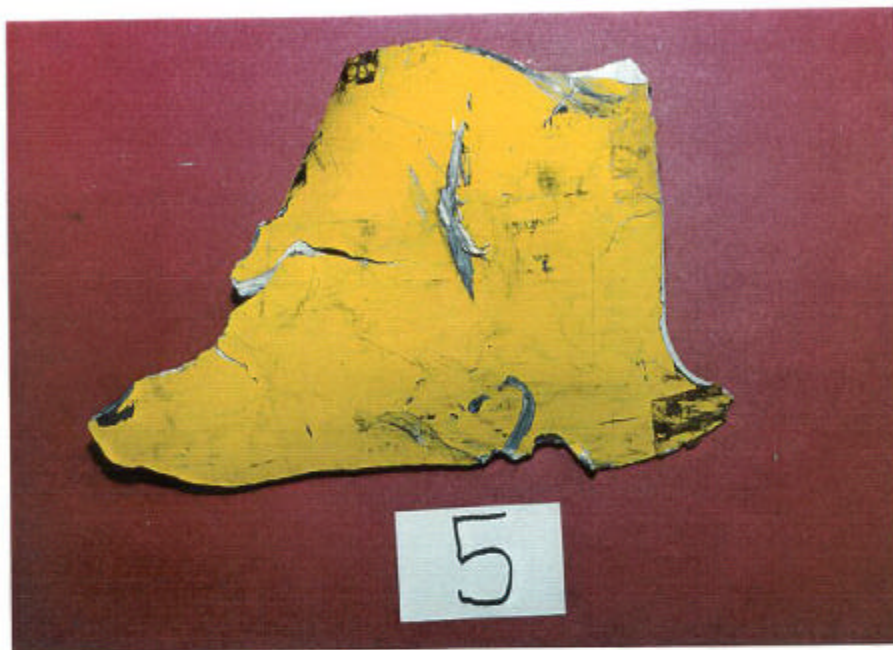
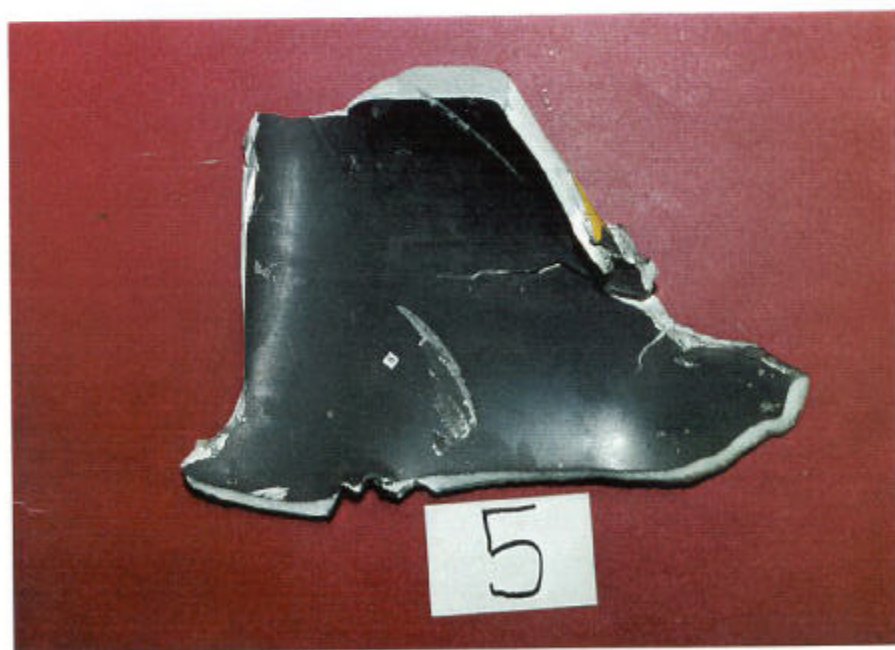
Figure 12.

Fracture piece (5) from lower half of cylinder shown in Figure 1.

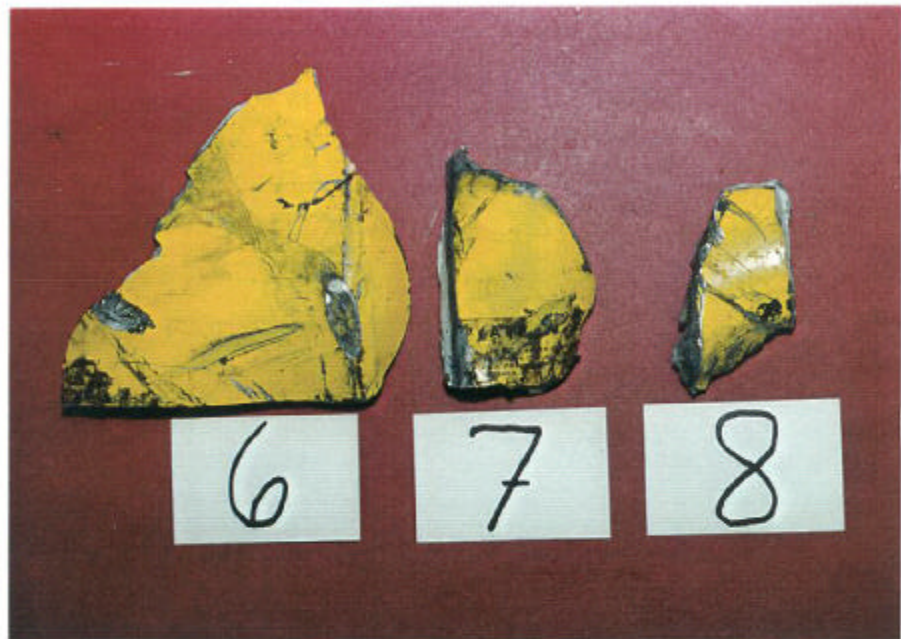
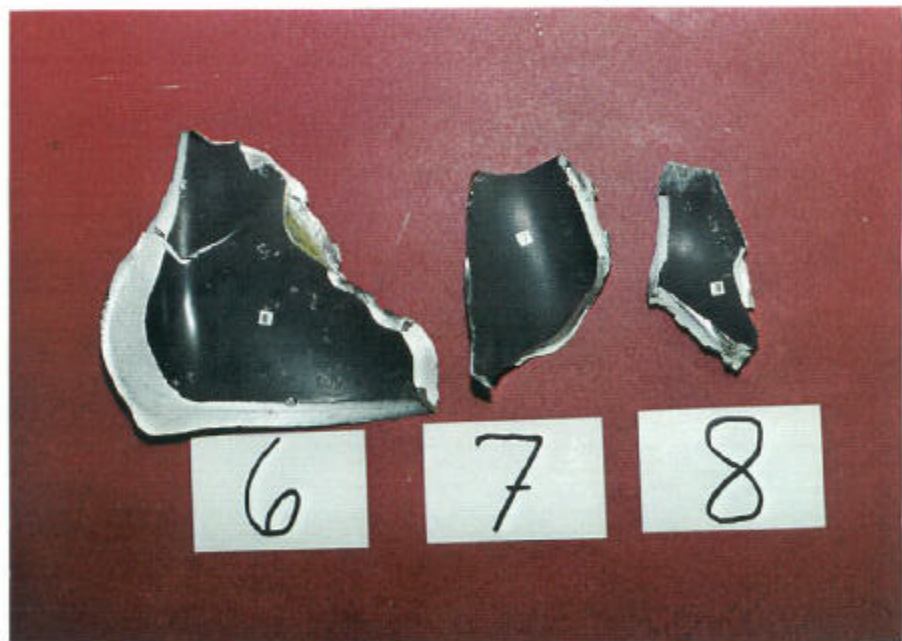
Figure 13.

Fracture pieces (6), (7), and (8) from side-wall area adjacent to bottom of cylinder shown in Figure 1.

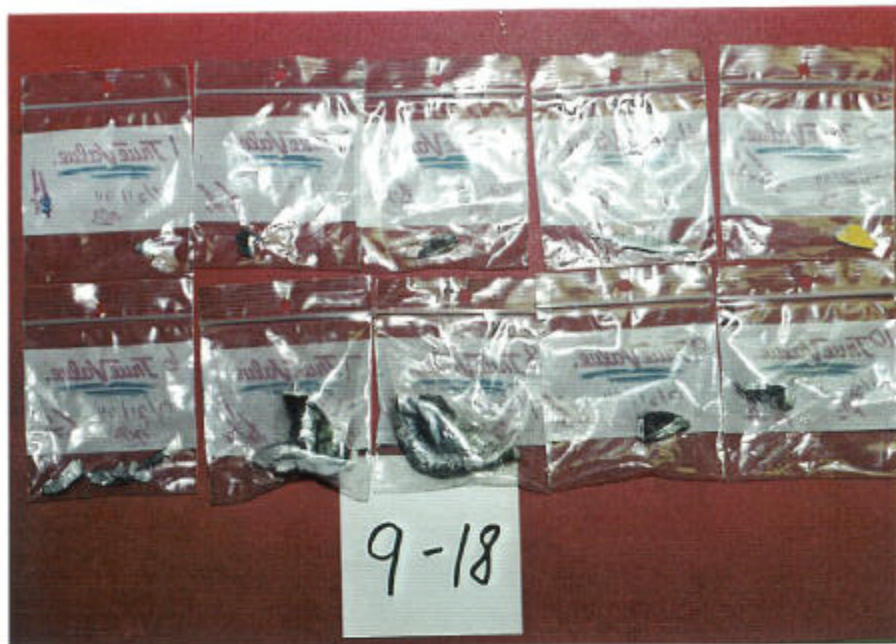
Figure 14. Fracture fragments (9) through (18) whose location was not identifiable due to small size and fracture surface damage.

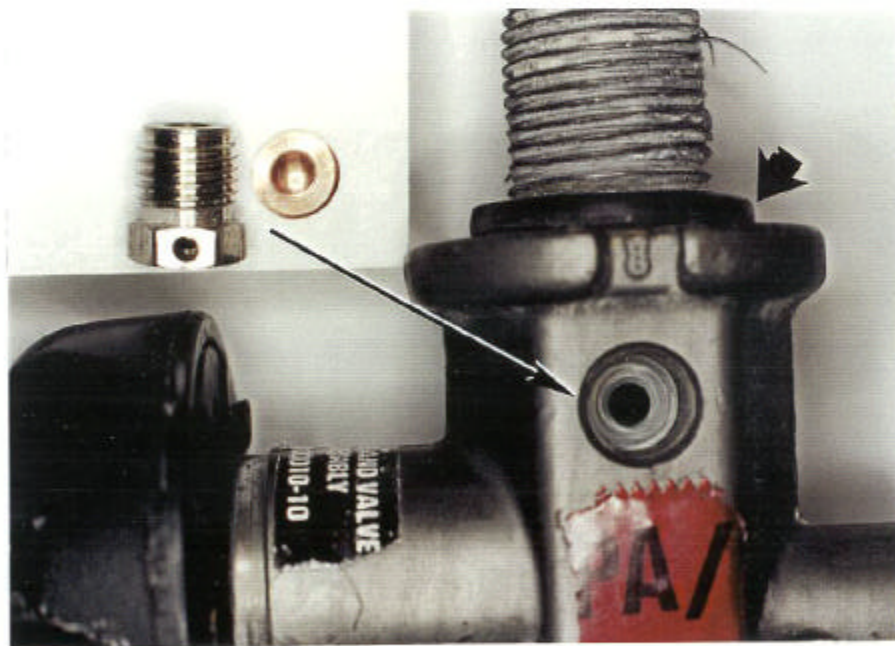
potential sites for corrosion activity. The deterioration of the threads by corrosion, however it occurred, raises the question of whether or not the valve can be explosively ejected.

Figure 15. Valve from exploded cylinder showing "O" ring seal (arrow), deformed and several sheared threads, deformed copper rupture disk and retainer. Note white corrosion product on threads.

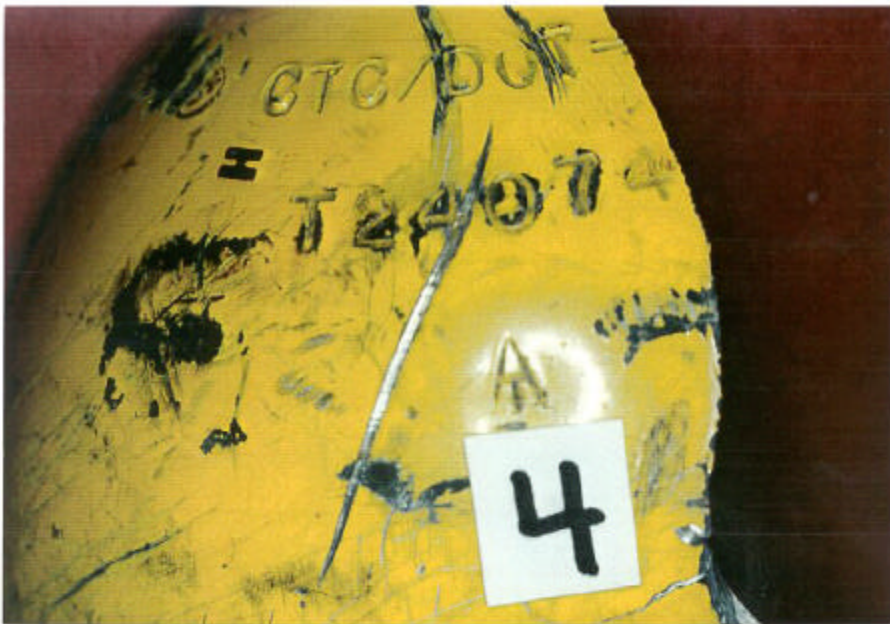
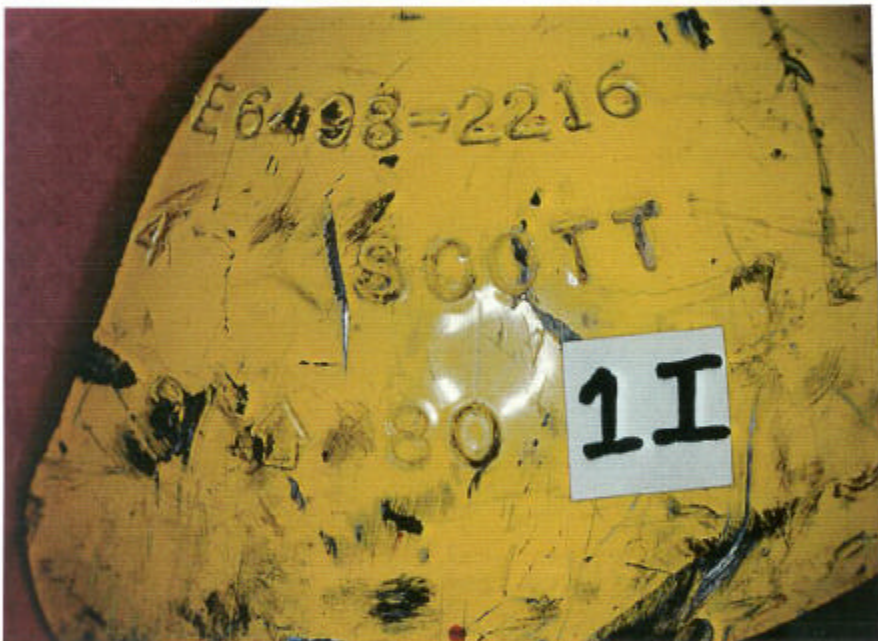
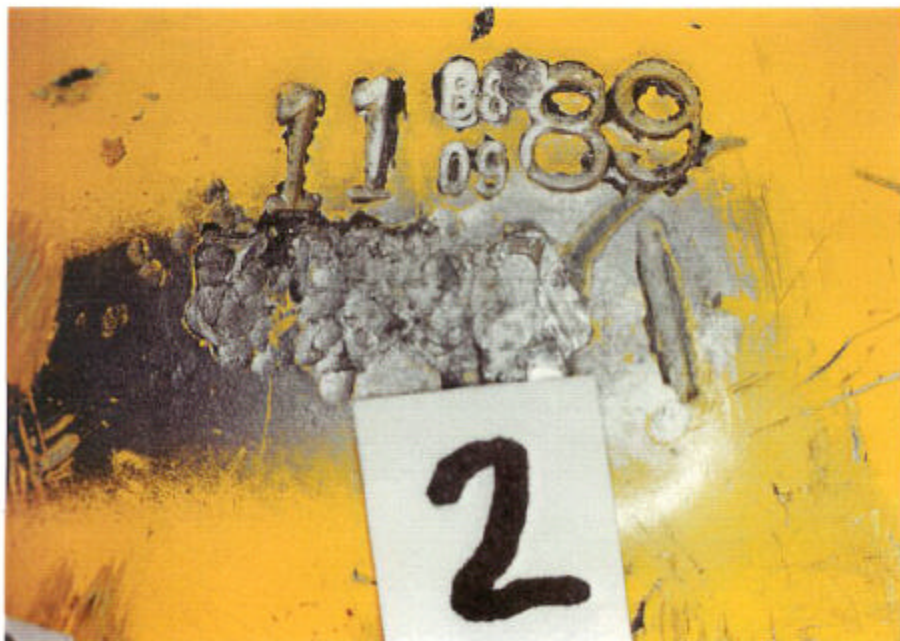
Figure 16.

Identification markings from heavy wall area at top of cylinder. Note ball peened area below the 11-89 Retester Identification Number.

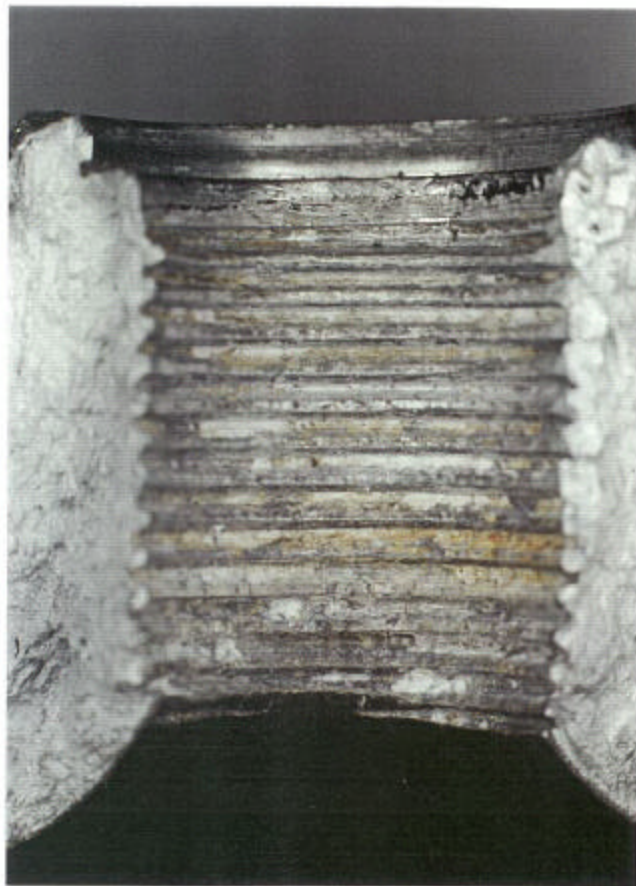
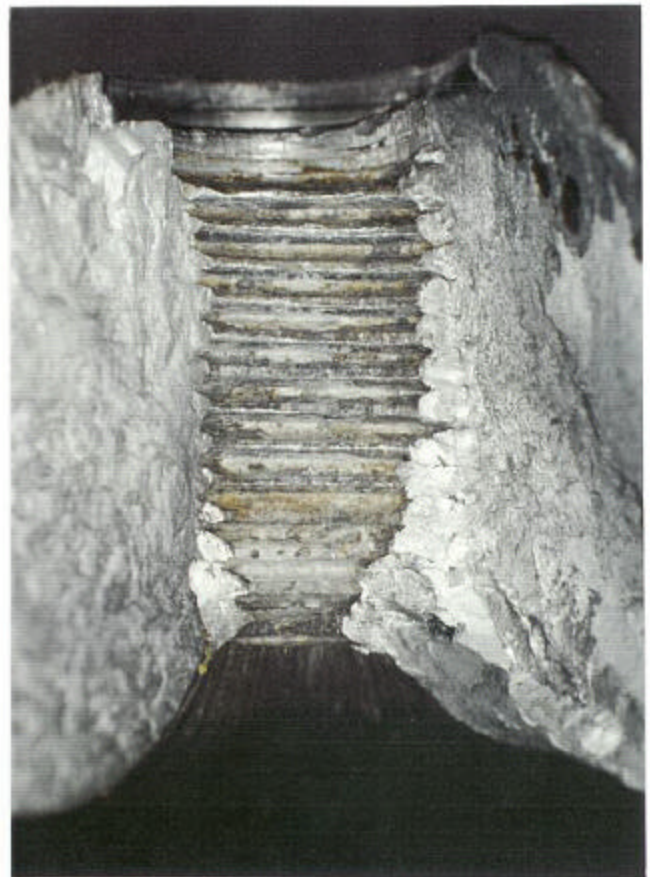
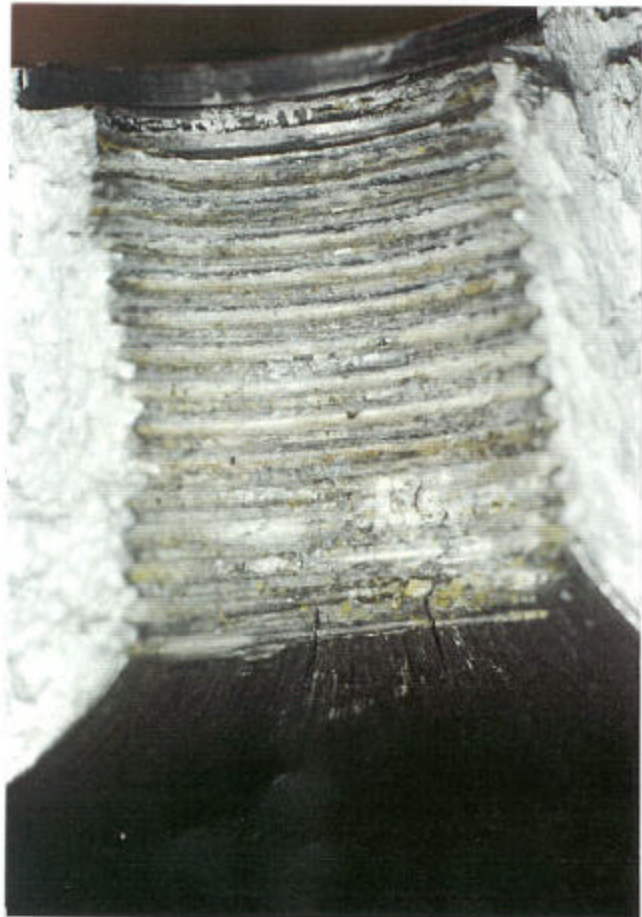
Figure 18.

Enlarged views of the internal thread for receiving the valve revealing the as-received condition of fracture piece (2) at top left, fracture piece (4) at top right, and fracture piece (1I) at lower left. Note the additional cracks in the interior neck area and the more corroded area of the fourth thread from the bottom.

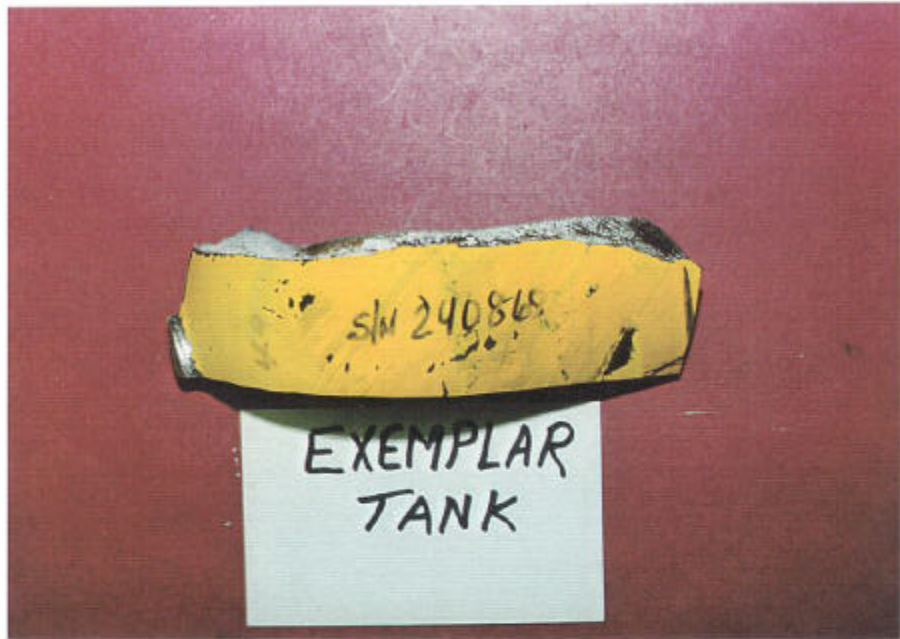
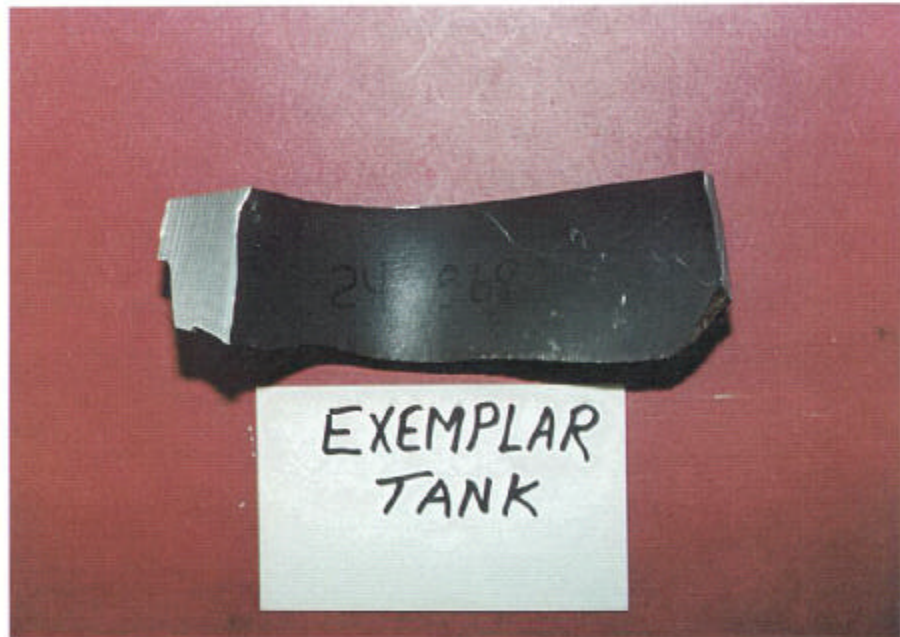
Figure 19.

For comparison with the exploded cylinder material, a small section of an exemplar cylinder (Figure 19) was provided, wherein the exemplar cylinder had been burst tested in excess of the design burst pressure. The extent of over-pressurization is not known at this time.

Fracture specimen from an exemplar cylinder (S/N 240868) from Lot Code X59 that was over-pressurized in excess to the design burst pressure.

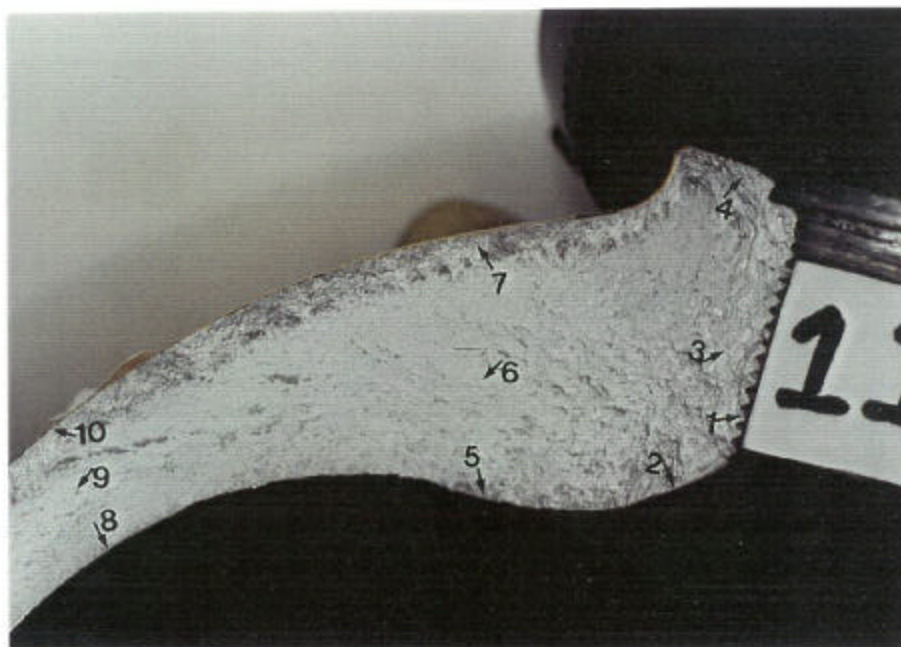
FRACTURE SURFACE #1 - The fracture section was retrieved from the neck region of the cylinder, shown earlier in the report. A macro view of the fracture surface is presented in Figure 20. The failure appeared to have initiated on the inside surface in the thick region near the neck. The fracture section was solvent-cleaned using standard laboratory practices. Optical microscopic examination at higher magnifications revealed the presence of a considerably large population of dark streaks all over the fracture surface (Figure 21). These streaks were thin slender voids having textured surfaces as depicted in the SEM micrograph in Figure 22. Examination of several of these voids suggests that chunks of dross\* had been entrapped in the material at various locations during manufacturing and voids had formed at those locations when the mass of dross dislodged or pulled out during the fracture process. It should be noted that the presence of dross in the material is detrimental to its physical properties.

Figure 20. A macro view of the fracture surface #1 which was examined to characterize the fracture features. Areas indicated by arrowed numbers were examined at higher magnifications under the SEM.

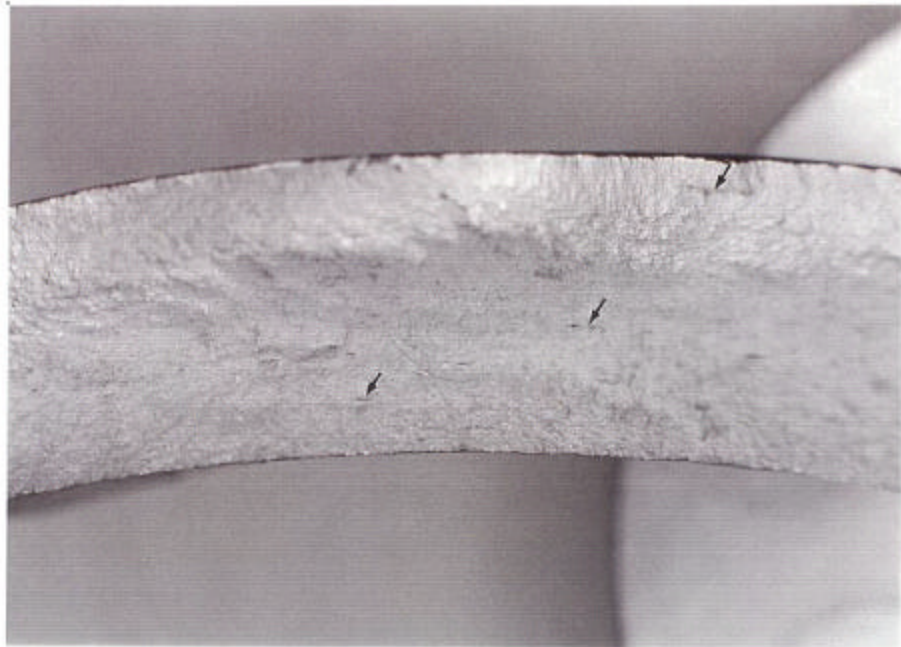
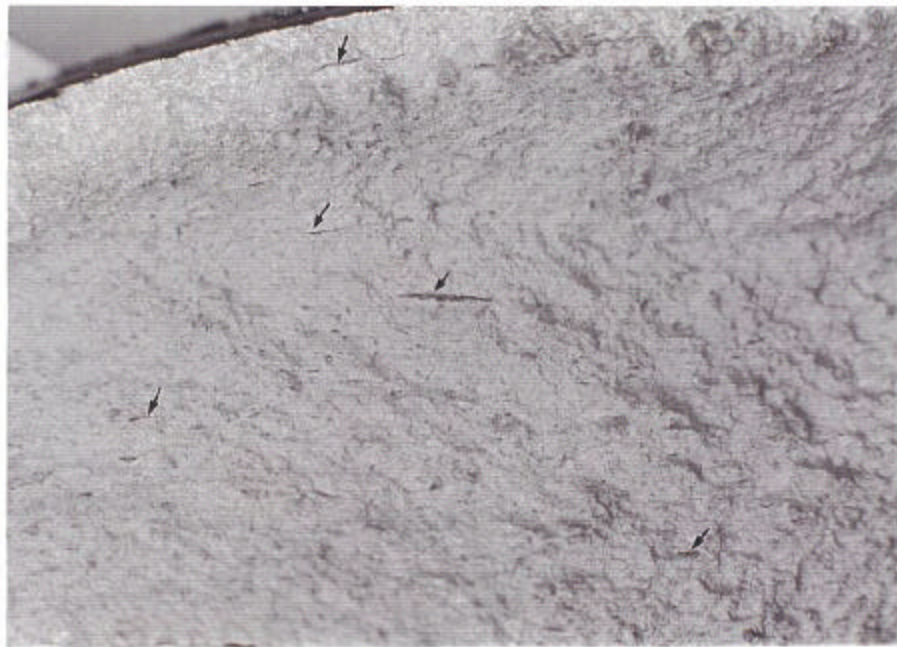
Figure 21. Enlarged photographs of the fracture surface show a large population of dark streaks.

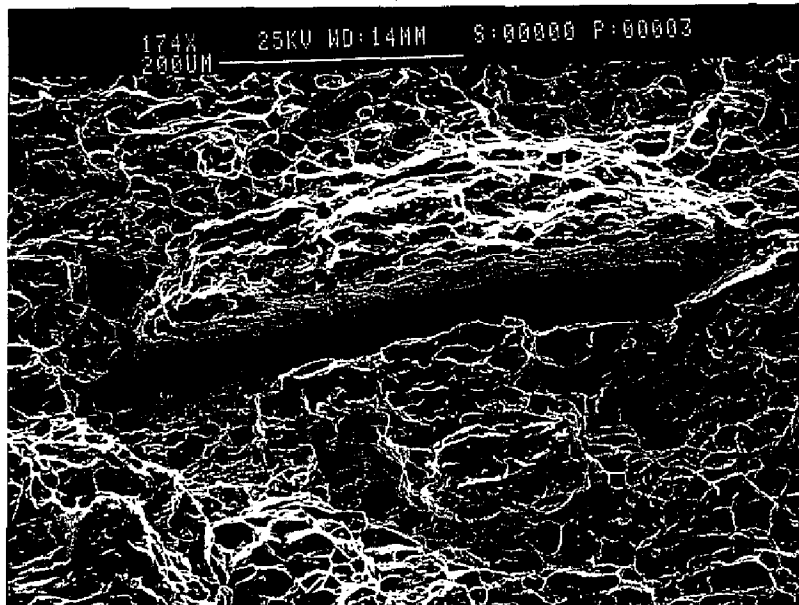
Figure 22.

SEM micrograph shows a high magnification view of dark streaks indicated in figure 21. It appears like voids having textured/rough surfaces; X174.

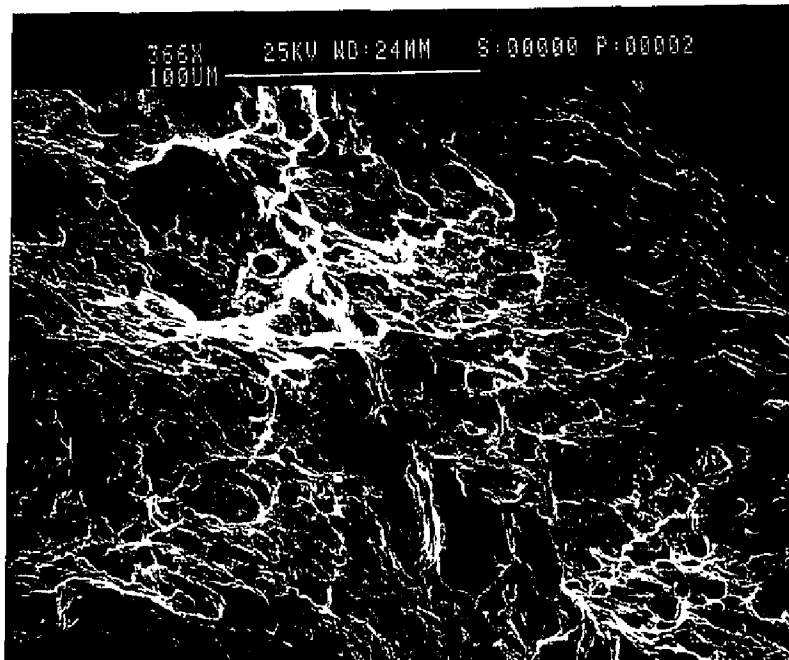
Figure 23. The shape and orientation of dimples shown in the fractograph taken at location 1 indicate that the failure initiated in the threads in tearing mode

due to overload and progressed inward.

SEM fractograph, from location #1 in Figure 20, exhibits fracture initiating at threads. The failure occurred in tearing mode due to overload, indicated by elongated dimples; X366.

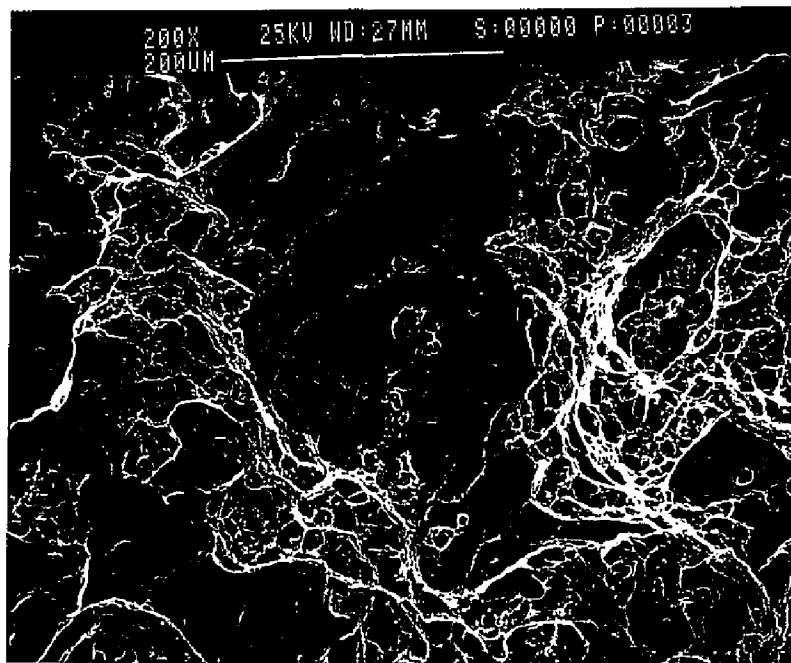
Figures 25. The fractographs show similar characteristics as  
& 26. in Figure 24.

Figure 25. Fractograph from location #3 shows similar features as in Figure 24; X200.

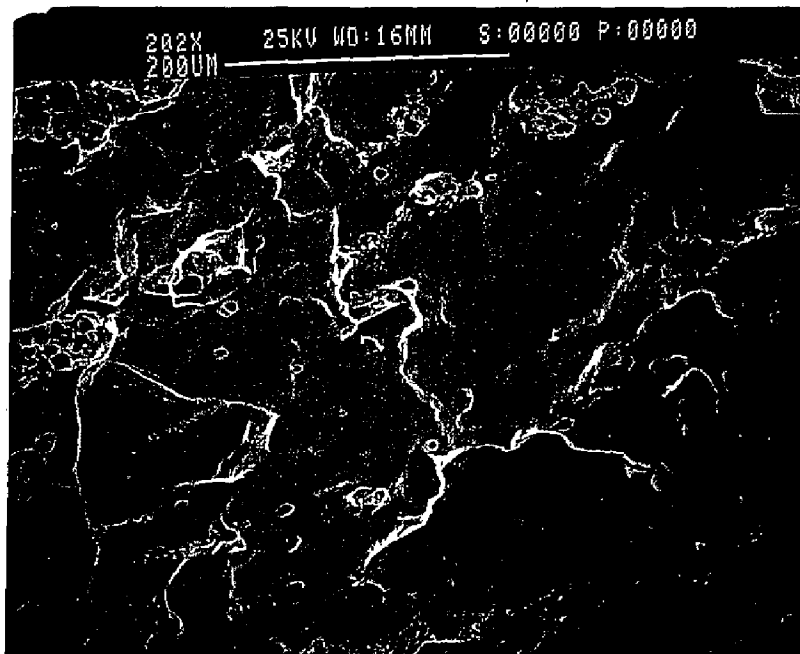
Figure 27. It exhibits featureless facets as in Figures 24-26. The failure is still due to overload. The fracture initiated along the metal fold on the inside surface, formed during manufacturing process.

Figure 27. Fractograph from location #5 shows similar features as in Figure 24. The fracture initiated along the metal fold formed on the inside surface during manufacturing process; X202.

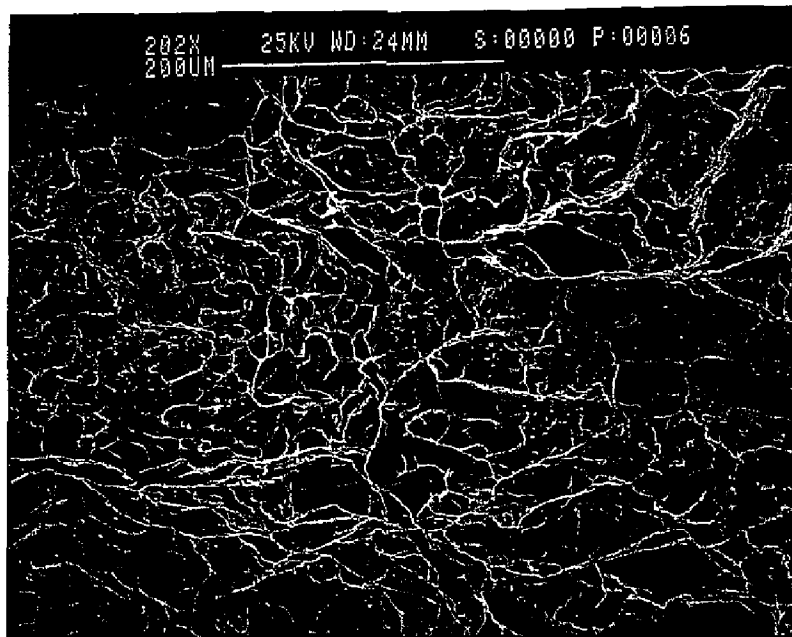
Figures 28. These fractographs are taken from the regions  
& 29. having finer grain structure. The failure mode is typical of overload. Unlike featureless facets in Figures 24-27, a relatively larger number of dimples was observed.

Figure 28. Fractograph from location #6 shows failure due to dimpled (overload) fracture; X202.

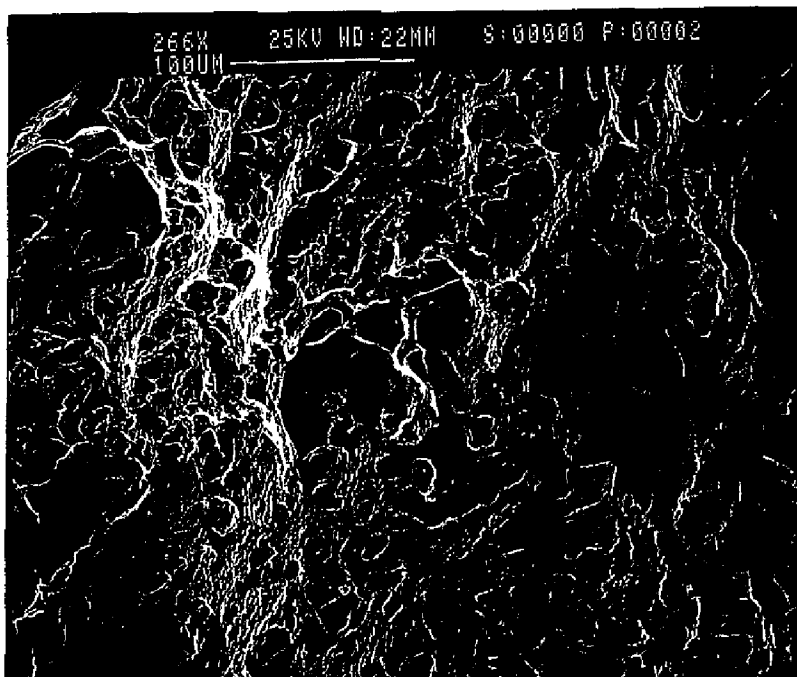
Figure 29. Fractograph from location #7 showing similar features as in Figure 28; X266.

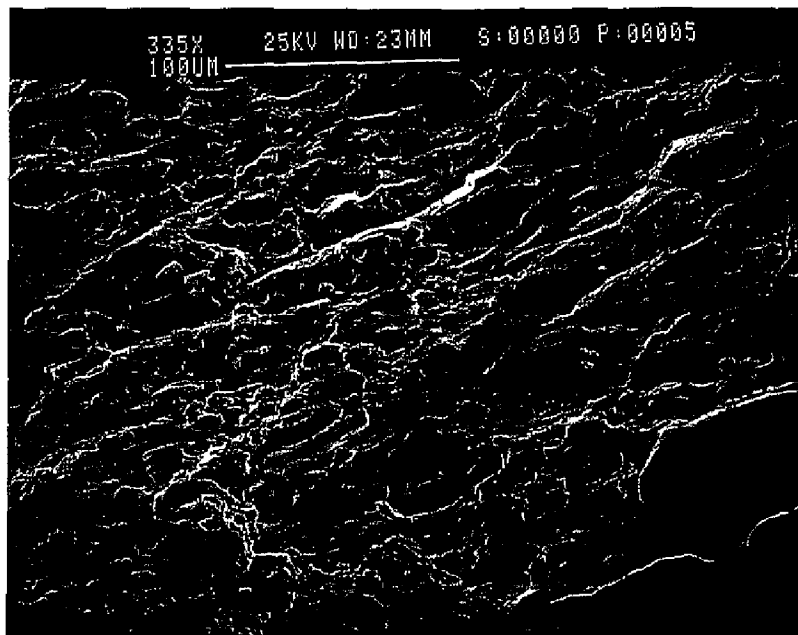
Figures 30. The fractographs are from locations 8 and 9  
& 31. respectively. They show a mixed mode of fracture consisting of dimples and intergranular failure. Both features are indicative of failure due to overload.

Figure 30. Fractograph from location #8 showing failure due to overload. Some indications of grain boundary failure are evident; X335.

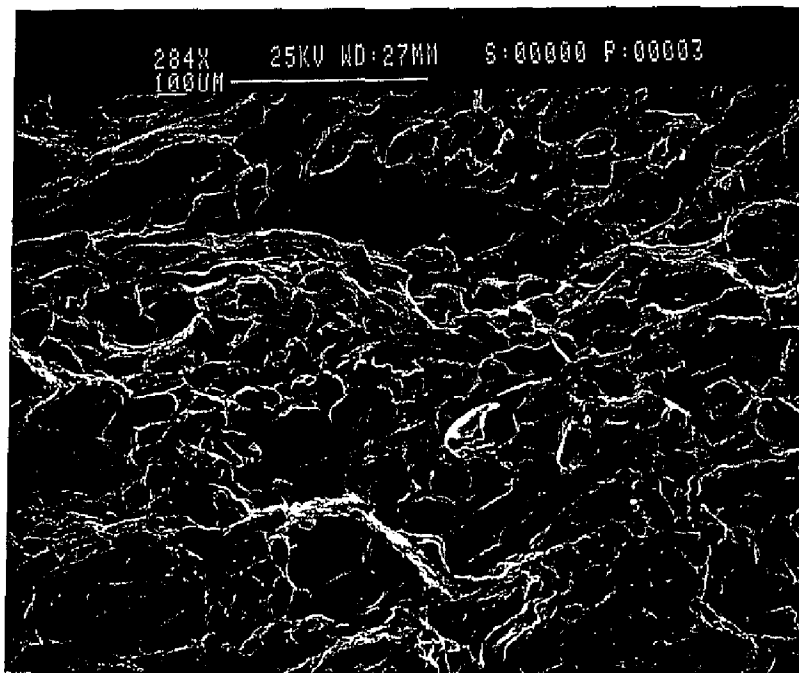
Figure 31. Fractograph from location #9 exhibits similar features as in Figure 30 showing a mixed mode of failure; X284.
