**FRACTOGRAPHIC AND MICROSTRUCTURAL EXAMINATION  
OF A RUPTURED DOT-3AL  
SPECIFICATION COMPRESSED GAS CYLINDER**

July 27, 1995

U.S. DOT/RSPA/  
400 7th Street, S.W.  
Washington, D.C. 20590-0001

ARTECH File No. 9509.004

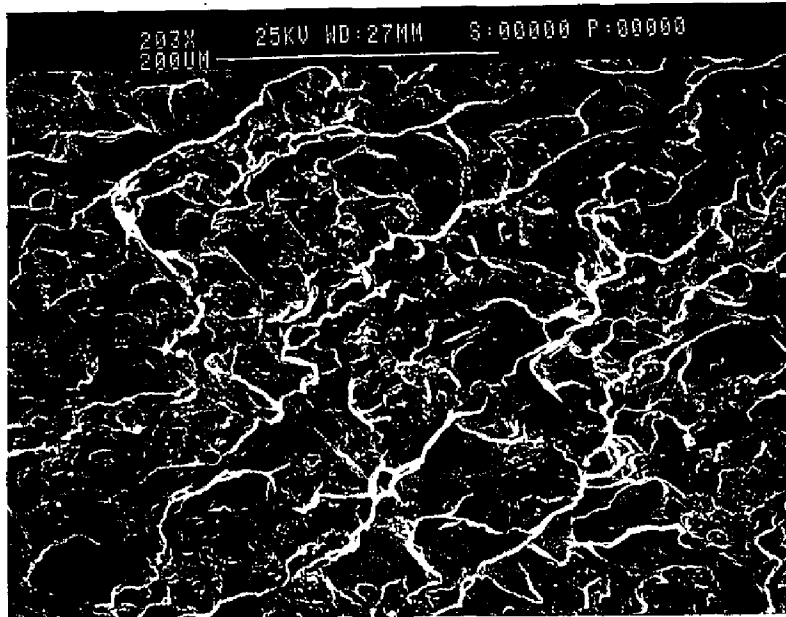
Figure 32. Fractograph from the shiny edge of the fracture exhibits features of shear overload failure.

Fractograph from location #10 shows failure due shear overload; X203.

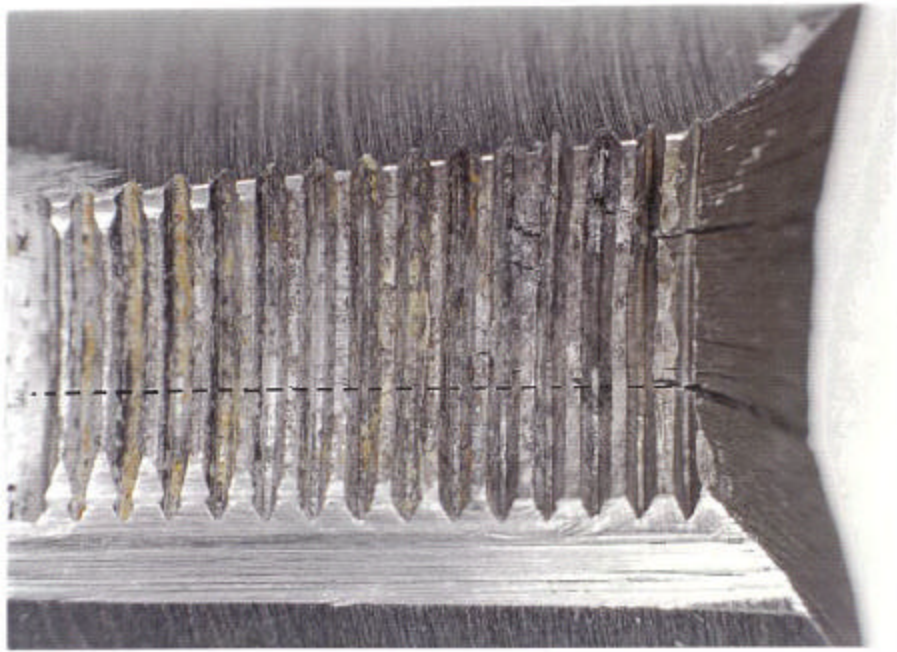
undisturbed view of the inside surface of the section is presented in Figure 33. Notice crack-like features in the threads as well as on the adjacent internal surface. A through-thickness saw cut was made along the dotted line shown in Figure 33a. A fresh fracture was created by flexing the remaining ligament; the newly created fracture contained the crack-like feature shown in Figure 33b. An enlarged view of the lab-created fracture surface is presented in Figure 34. The crack-like feature was about 0.017 inch deep. Its color was similar to the rest of the inside surface of the cylinder which suggests that the crack was formed during the manufacturing process. The presence of such cracks is detrimental to integrity of the cylinder because they offer a ready site for cracks to propagate under favorable stress conditions.

Photographs of an area from the neck region showing the threaded zone (a) and the adjacent internal surface (b). Note the crack-like features in both photos. The crack indicated by arrow was opened for detailed examination.

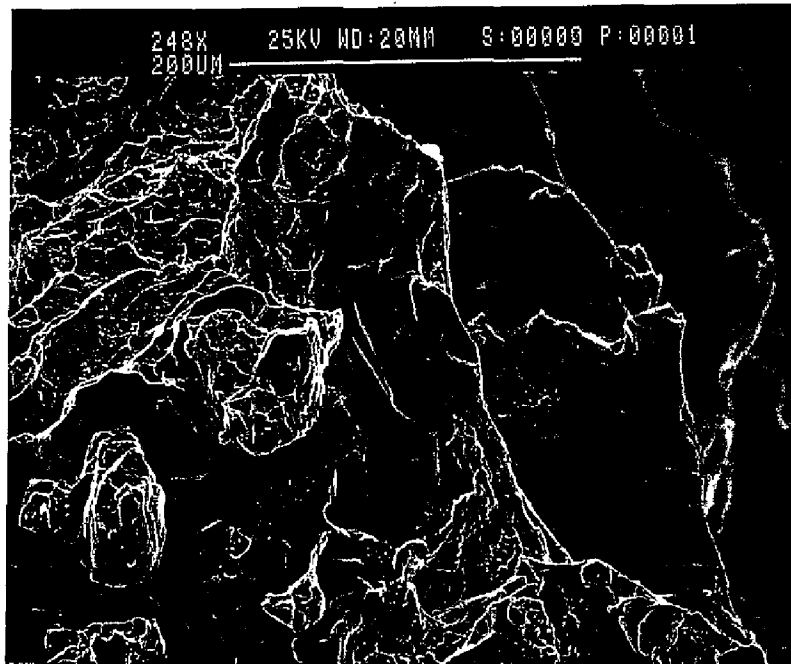
Figure 35. Fractograph shows featureless facets as exhibited in Figures 24-27; smoothness of these facets suggests that there was no interfacial cohesion in those areas. Fractograph also shows some areas having dimpled rupture.

Figure 35. Fractograph, from location #1 in Figure 34, exhibits featureless facets as indicated in Figures 24-27. It also shows some area having dimpled rupture; X248.

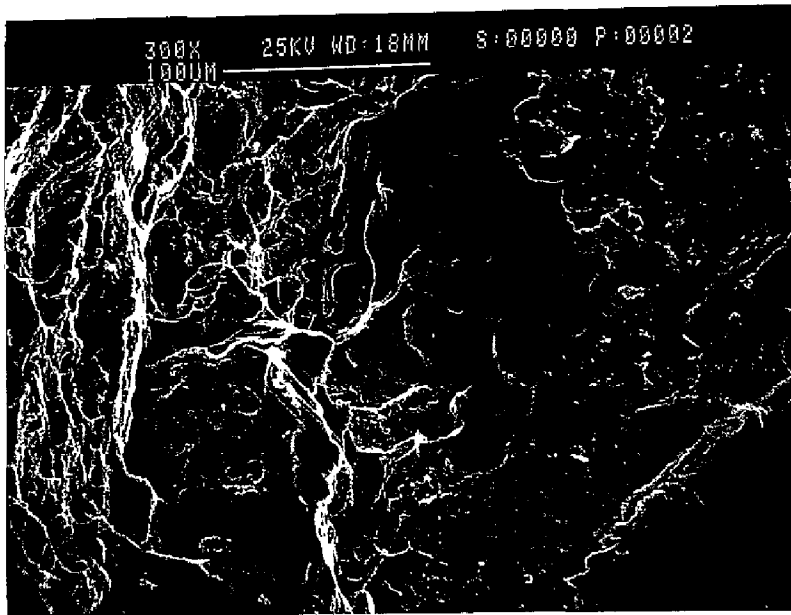
Figure 36. It shows similar features as in Figure 35.

Figure 36. It shows similar features as in Figure 35; X248.

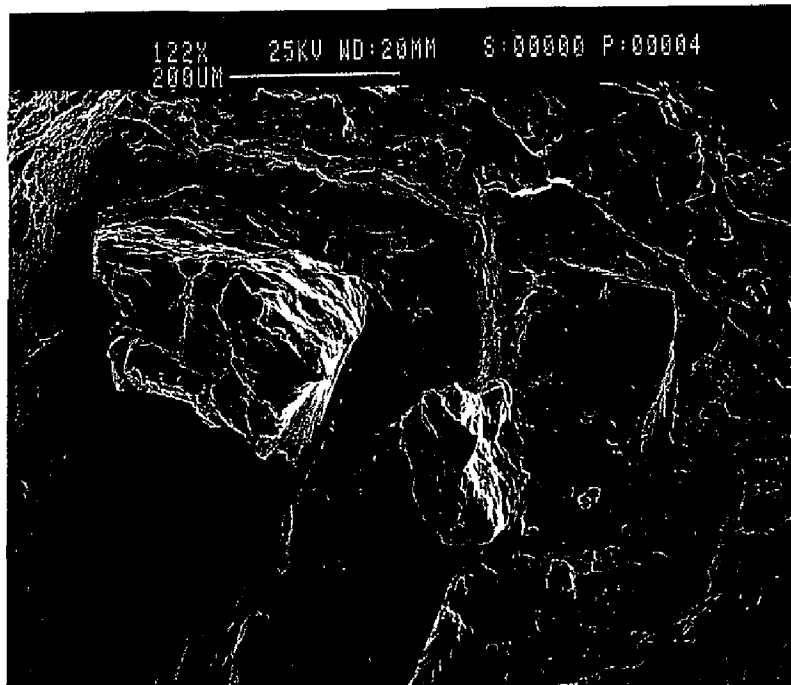
dimpled ruptures. A semi-quantitative chemical analysis, using energy dispersive spectroscopy (EDS), of the particle-like object in the micrograph was performed and result was compared with that of the matrix. No difference in chemical composition was detected. Similarity between the two chemistries suggests that the particle is part of dross which was entrapped in the material during manufacturing.

Figure 37. Fractograph exhibits featureless facets and some dimpled rupture. The particle-like object (arrow) appears to be a chunk of dross. X122.

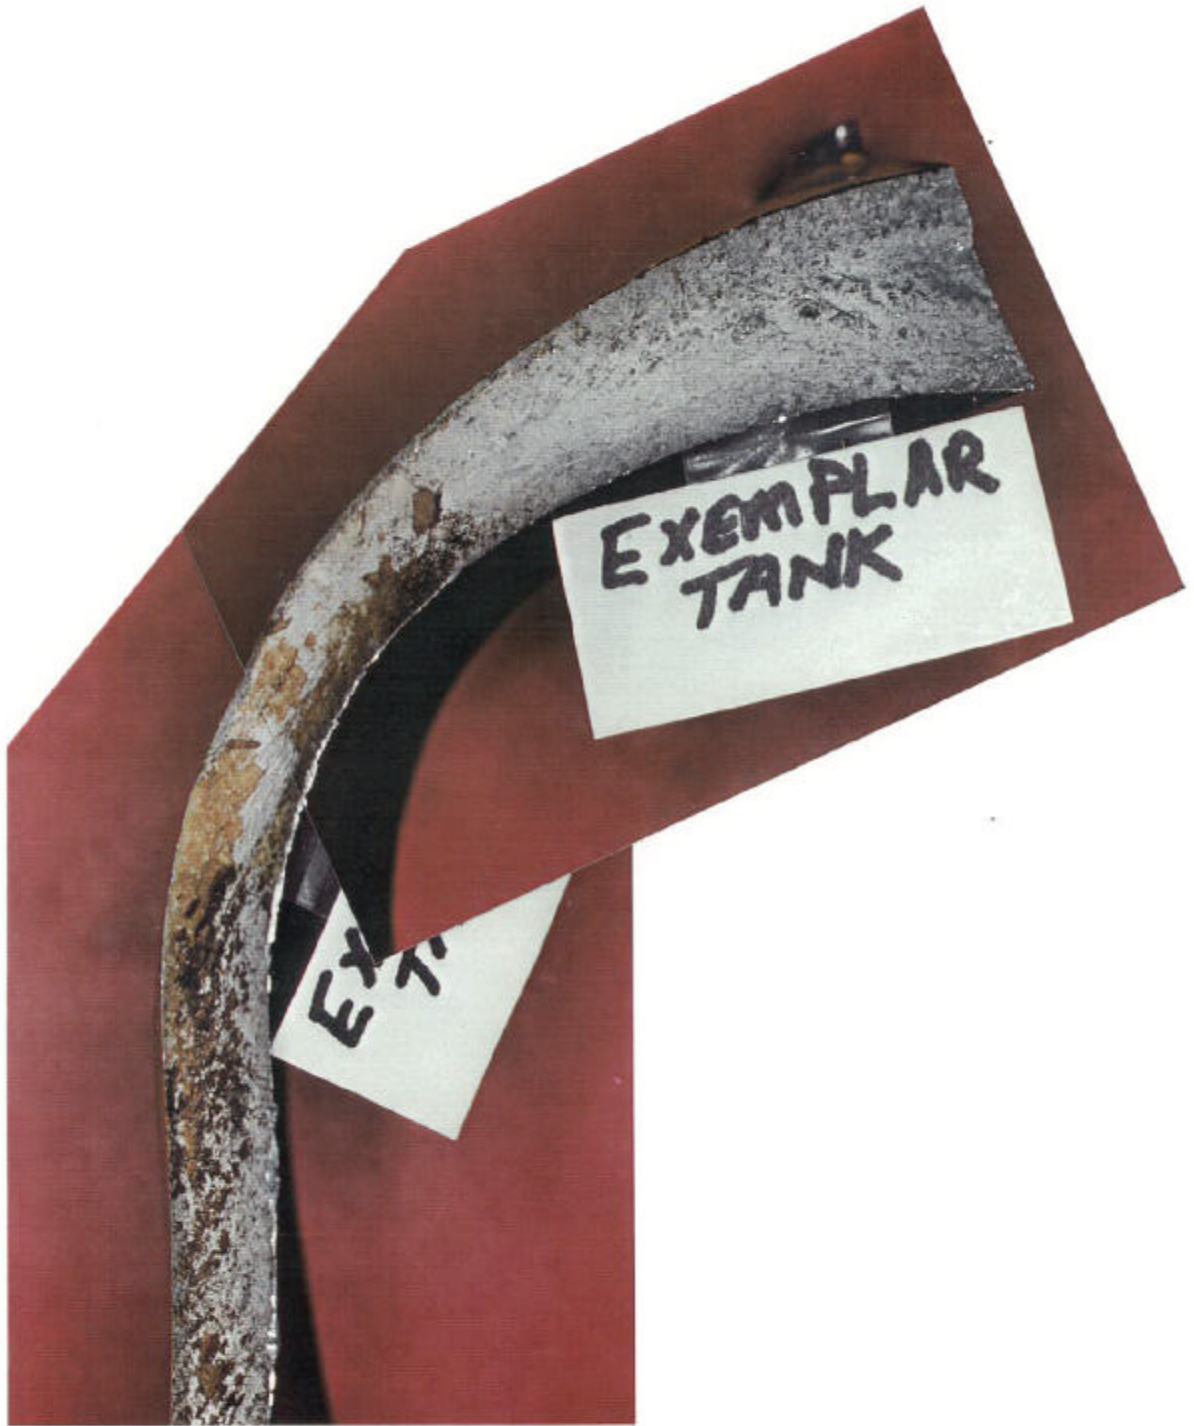
Figure 38. As-received view of the exemplar fracture surface.

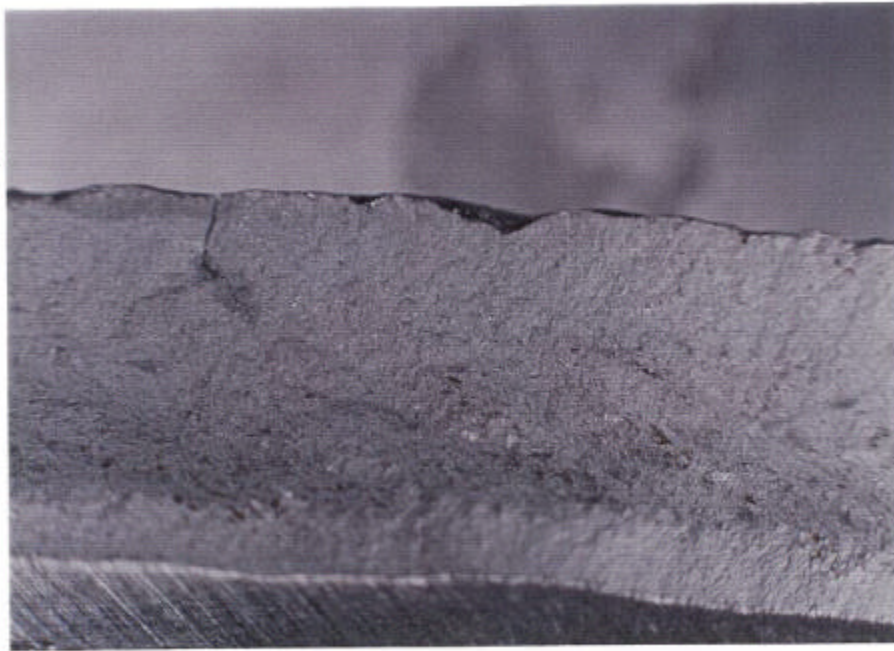
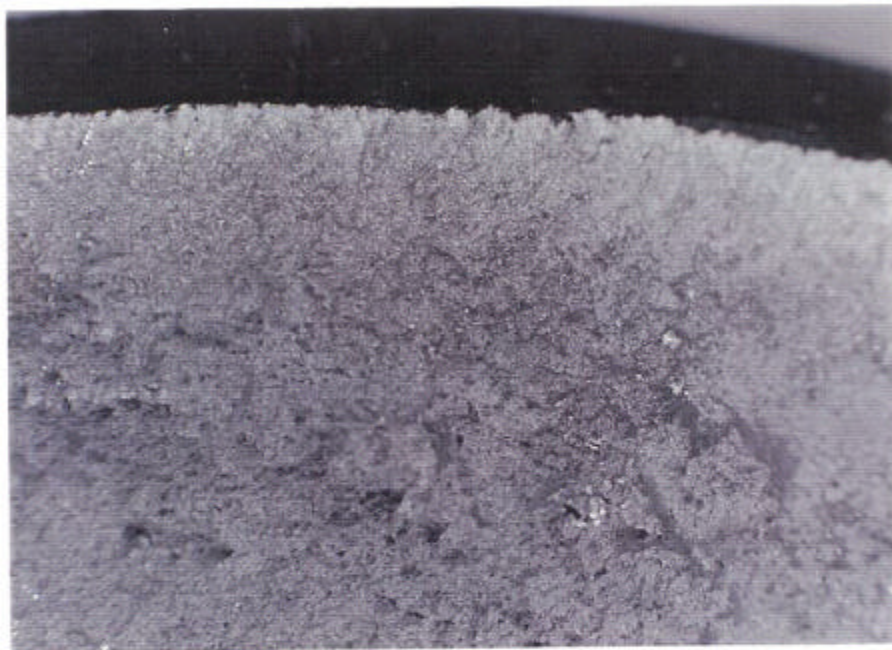
An as-received view of the fracture surface is presented in Figure 38. Because it was badly contaminated, it had to undergo extensive cleaning prior to examination. Unlike the subject cylinder, the material of the exemplar cylinder was almost free from dross and voids. See Figure 39; compare this Figure to Figure 21. SEM examination revealed that the mode of failure was similar to that of the subject cylinder; it exhibited typical features of overload fracture (Figure 40). The featureless facets seen in Figures 24-27 and 35-37 were not observed on the exemplar fracture surface.

Figure 39. Enlarged views of the fracture surface does not show the presence of dross and voids. Compare this Figure to Figure 21.

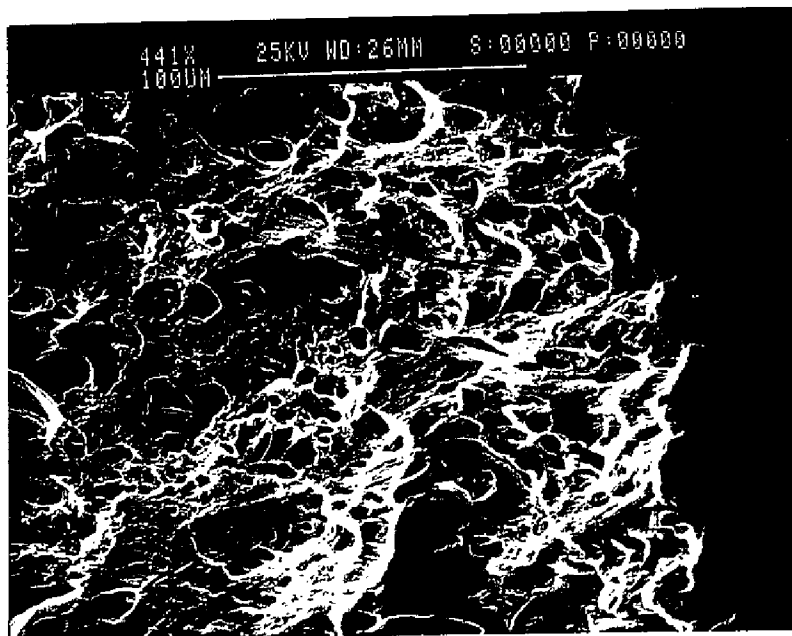
Figure 40.

SEM fractograph shows initiation of the failure occurring by overload tearing near the neck on the inside surface (a); a mixed mode failure consisting of dimpled rupture and intergranular fracture was observed in the region remote from the initiation zone (b). Compare these micrographs to Figures 23 and 30.

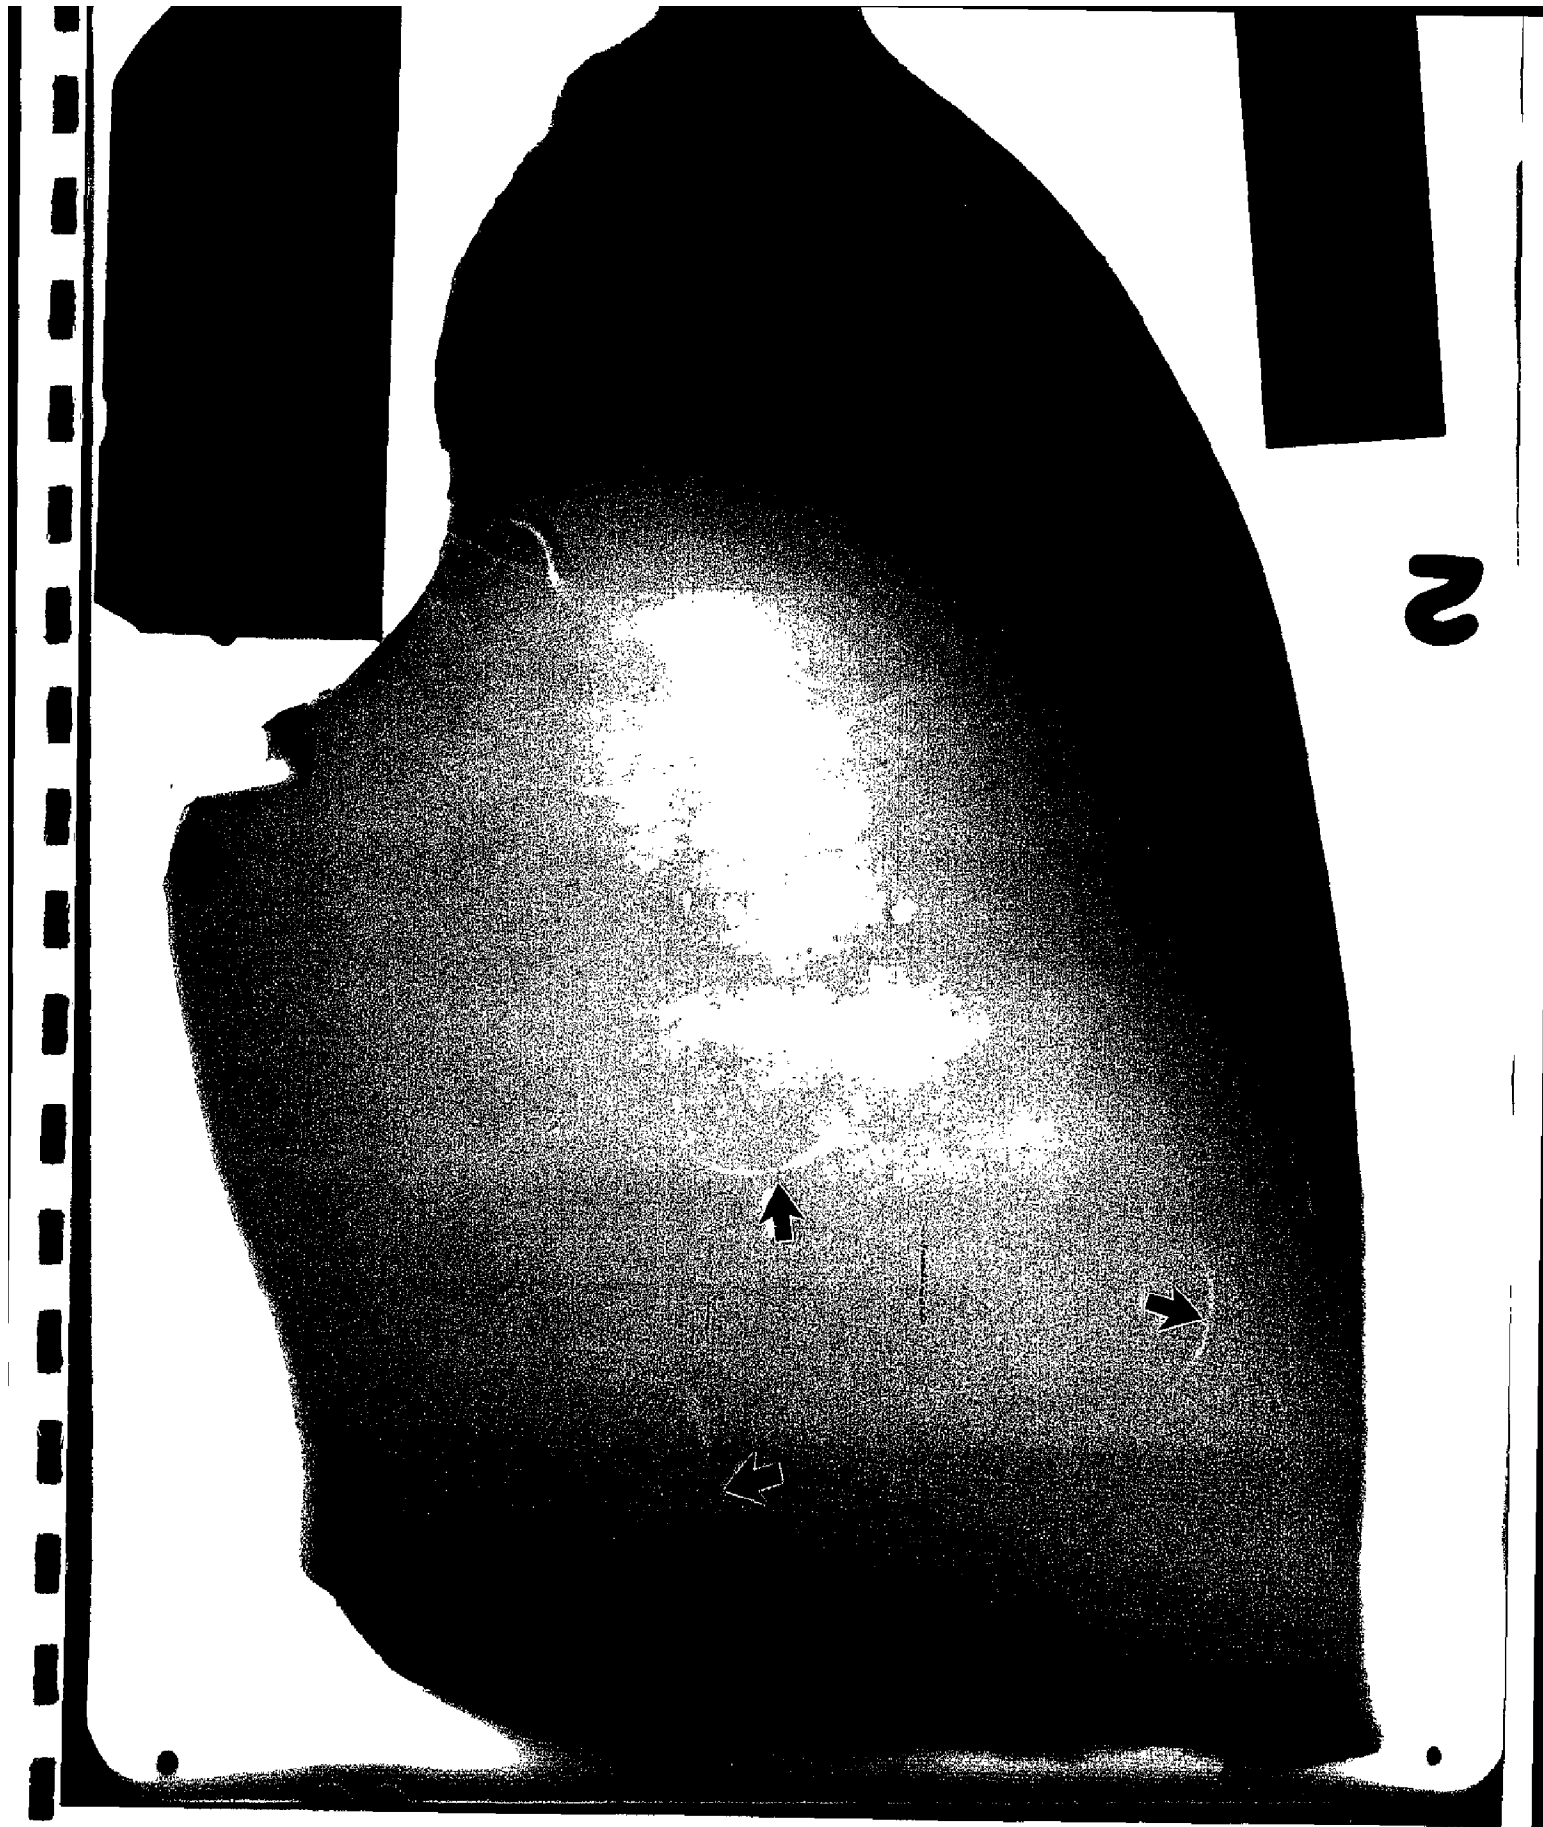
affect the structural integrity of the cylinder. Shown in Figure 41 is a positive print of an X-ray radiograph of fracture piece (4) in which several indications could not be related to surface damage. A transverse section was taken through the indication closest to a longitudinal fracture for metallographic comparison with a transverse section from the exemplar fracture sample. The sections were metallographically prepared in accordance with the standard practices of ASTM E3. As can be observed in Figure 42, the as-polished surface contains a relatively higher and more elongated inclusion content than observed for the exemplar surface. This observation was made on the basis of utilizing several metallograph preparation procedures and polishing materials to evaluate possible polishing artifact complicity.

Figure 41. Positive print of an X-ray radiograph of fracture piece (4) showing several indications (arrows) not attributable to surface damage.

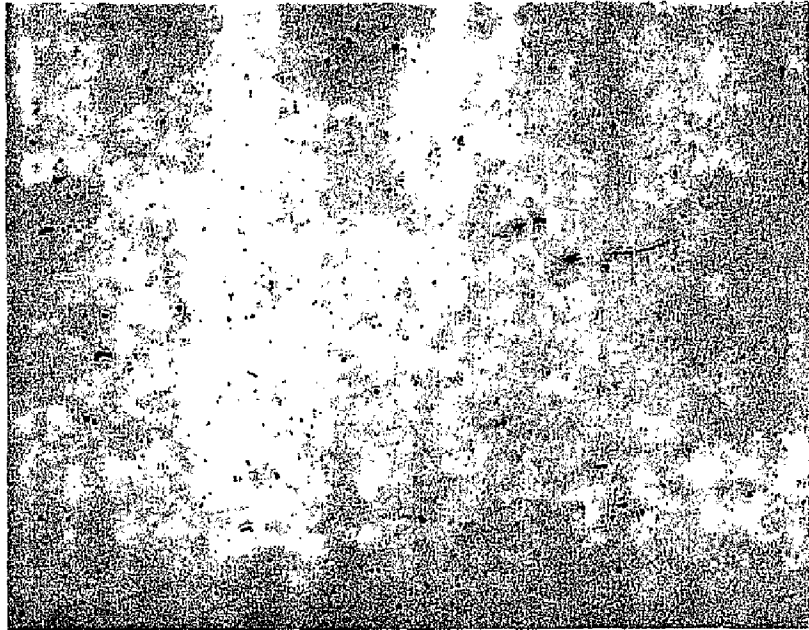
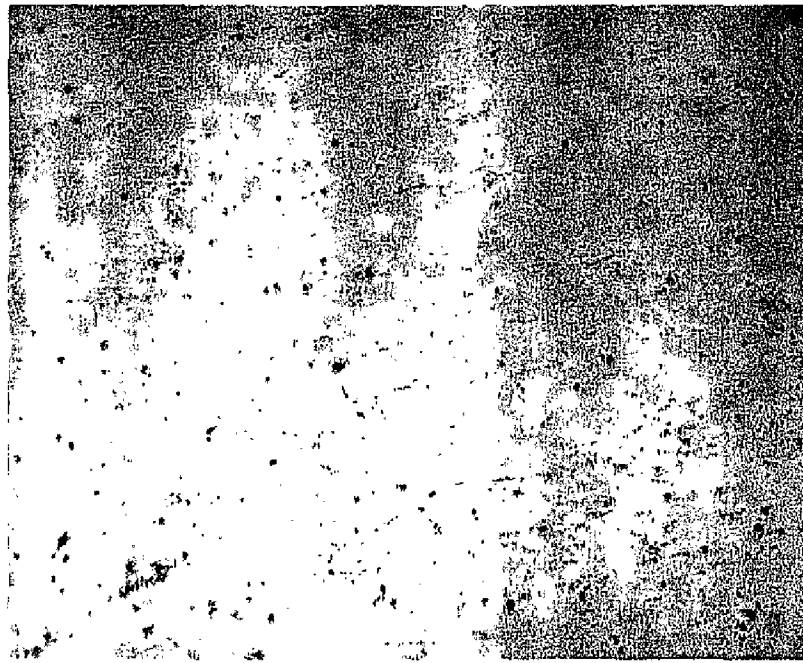
Figure 42.

As-polished transverse sections, from an X-ray radiograph indication in fracture piece (4) (top) and from exemplar fracture sample (bottom) showing relatively higher and more elongated inclusion content in the radiographic indication, X50.

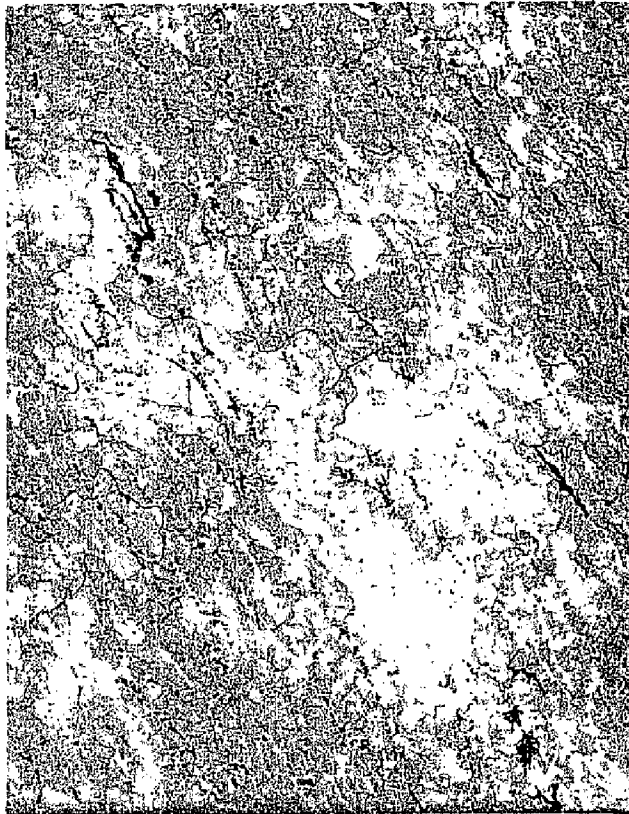
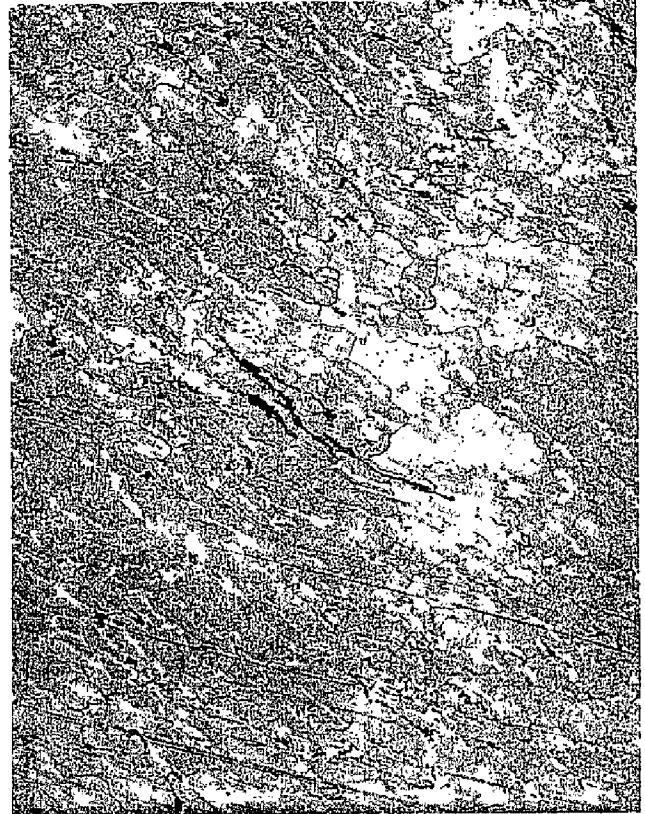
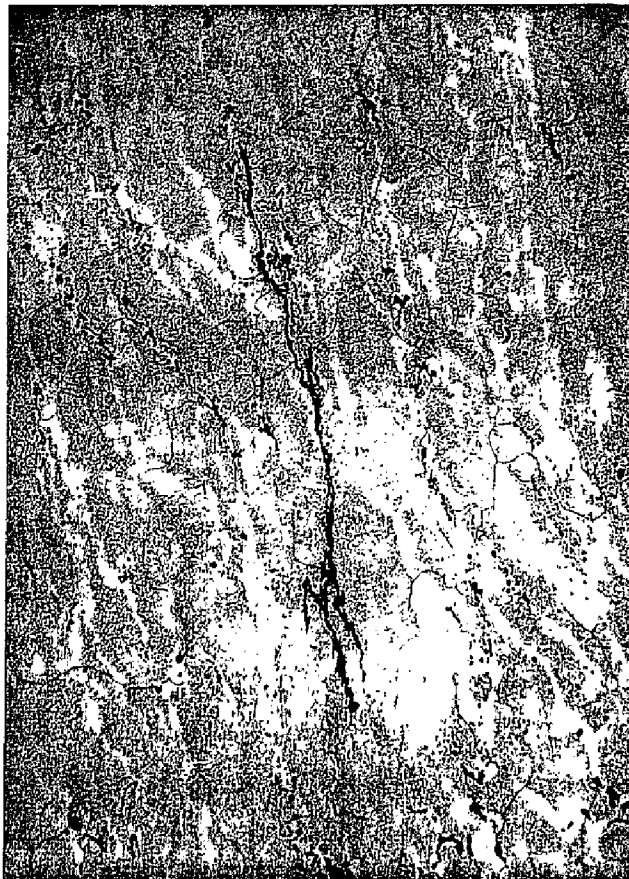
Figure 43.

To evaluate the cause of fragmenting of the subject cylinder into eighteen (18) pieces, metallographic sections were taken in and around the threaded, heavy-wall area as well as from the thinner wall areas having longitudinal and transverse fractures. Shown in Figures 43-46 are examples of dross entrapment that were found in all sections except for the singular exemplar fracture sample. As a result, all fracture surfaces were examined at magnifications of 7X to 40X with a stereoscopic microscope, and all fracture surfaces were found to contain delaminated segments of dross that varied in thickness and length.

Radial plane approximately 1/8 inch from fracture common to fracture pieces (1I) and (4) in the heavy wall area exhibiting several forms of entrapped dross, 1% NaOH etchant, X50.

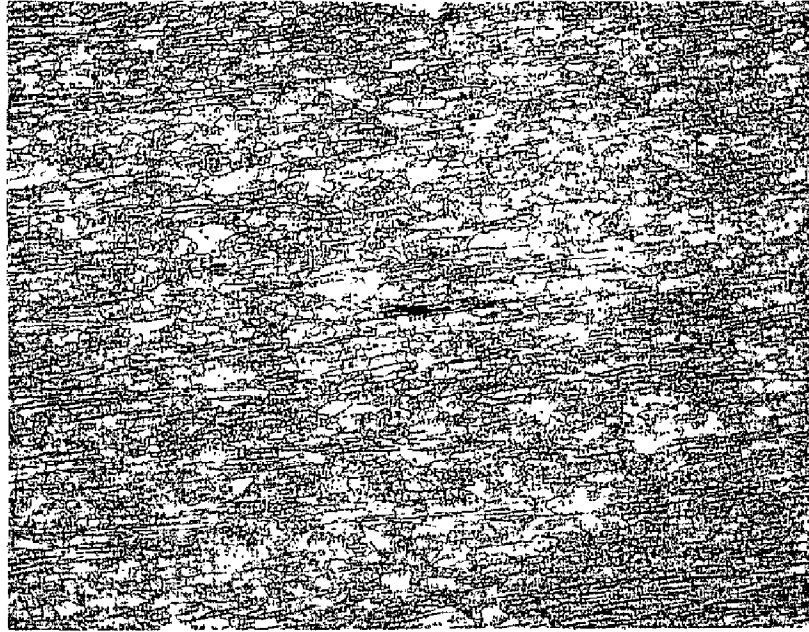
Figure 46. Dross entrapment in a transverse section from fracture piece (2), 1% NaOH etchant, X50.

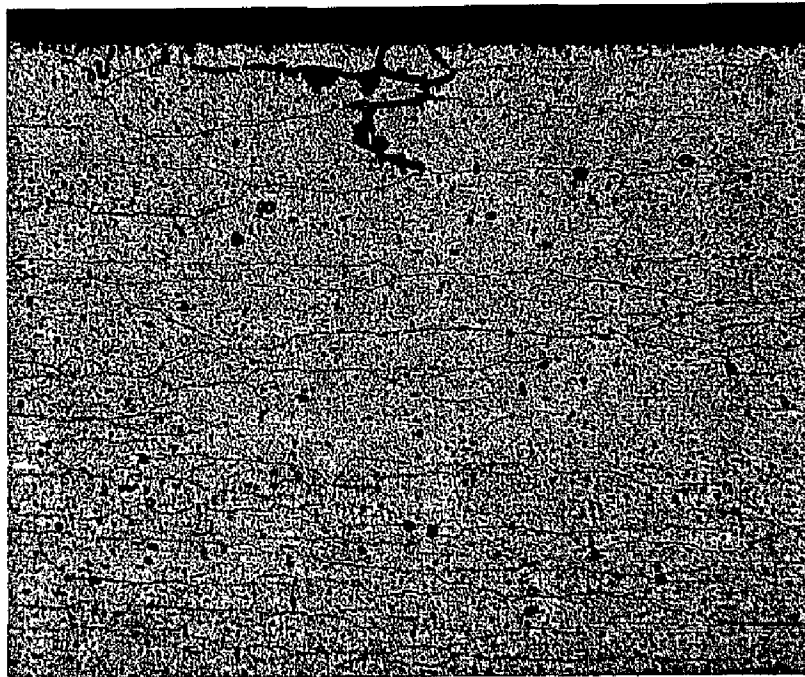
bottom to the side wall, as can be seen in Figure 47. Further evidence of this attack was found along the length of the thread though not as a continuous process, as indicated in Figures 48 and 49. Evidence of cold work on the upper portion of the thread (Figure 49) suggests that a thread mismatch, such as a tapered metric thread might produce, may have occurred at some point in the cylinder's service lifetime.

Figure 47. Grain boundary corrosion observed on interior surface in a radial section through the angular transition area of bottom to side wall, 1% NaOH etchant X200.

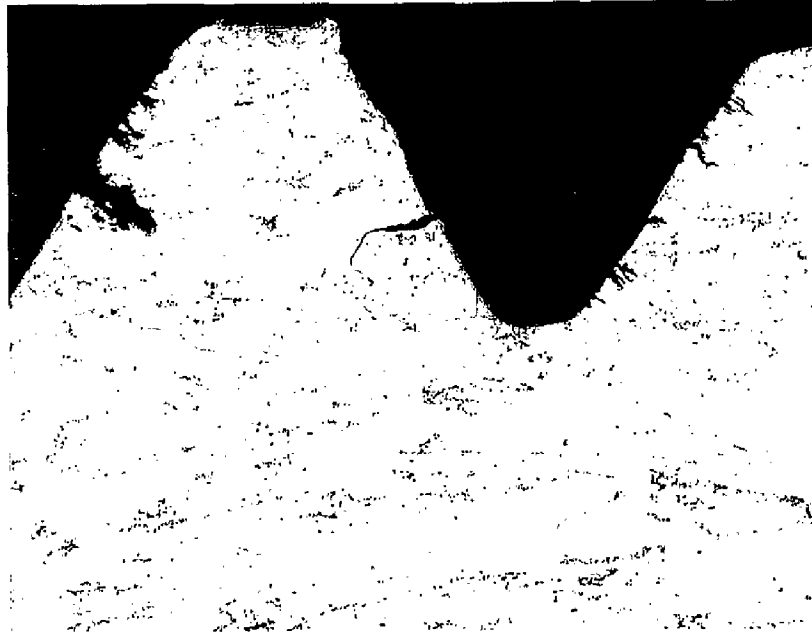
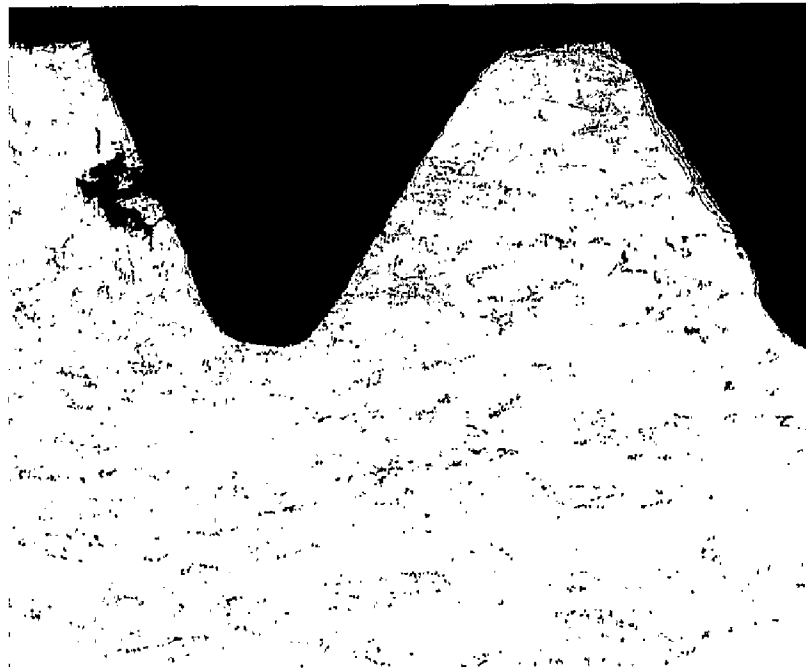
Figure 48.

Radial section through top area of threads, exhibiting corrosion attack normal to thread surface and along grain boundaries, 1% NaOH etchant, X50.

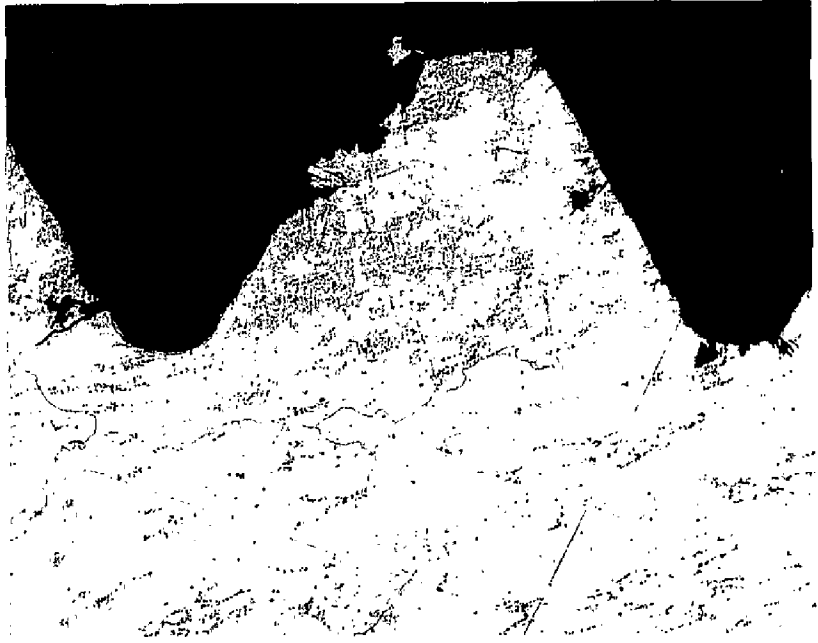
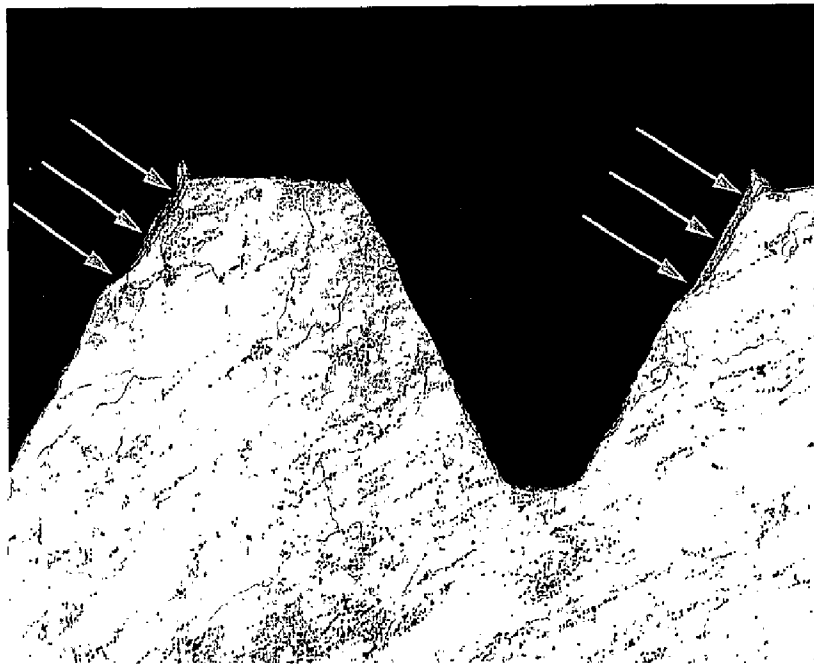
Figure 49.

Same section as Figure 48, but at end of threaded area exhibiting corrosion attack normal to thread surface and along grain boundaries. Note cold worked areas (arrows) in terminal threads that typically indicate mismatching of threads, 1% NaOH etchant, X50.

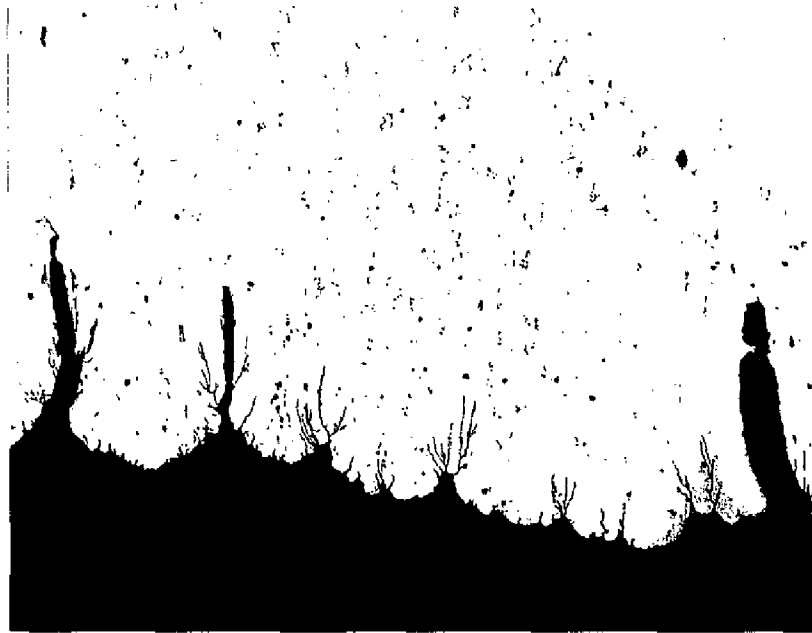
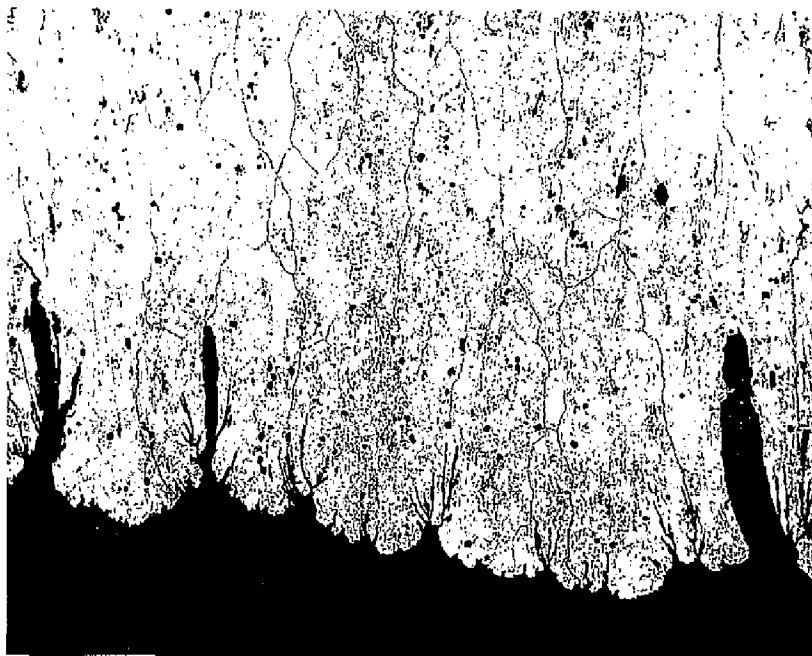
Figure 50.

Microstructural variation was found in the thickest wall section adjacent to the threaded hole. At the wrinkled internal surface, cracks were found to emanate from radial surface texture notches (Figure 50) that were produced during thermal-mechanical forming of the top of the cylinder. A relatively high inclusion content appeared to be dispersed in a large recrystallized grain structure. At the level of the bottom thread a slight increase in microconstituent alignment was observed (Figure 51). A highly aligned microstructure with very large, elongated grains was found at the level of the top thread (Figure 52). Also observed within the thick wall area of the threaded hole were several places in which a stacking or pile-up of microconstituents and unidentified inclusions occurred, as shown in Figure 53.

Longitudinal section behind threads and intersecting with wrinkled interior surface below threads (see Figure 8) revealing cracks emanating from surface texture notches, high apparent inclusion content, and large recrystallized grains; top, as-polished; bottom, 1% NaOH etchant; X100.

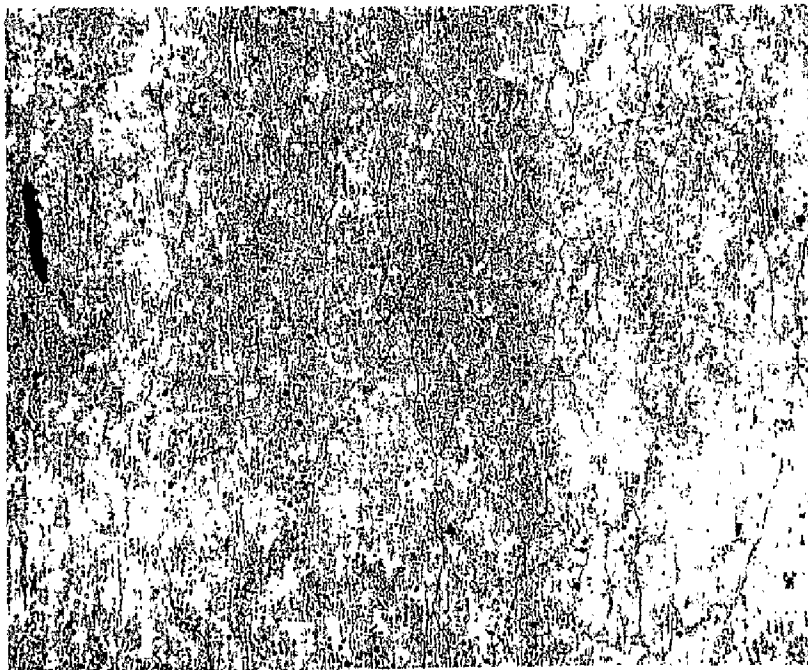
Figure 51.

Same plane as Figure 50, but at level of bottom thread revealing a slight increase in micro-constituent alignment; top, as-polished; bottom, 1% NaOH etchant; X100.

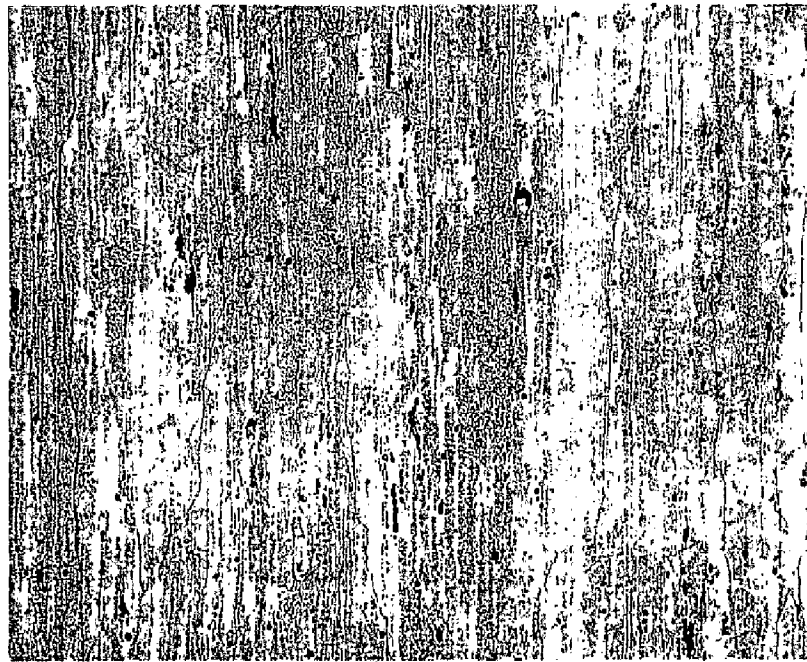
Figure 52. Same plane as Figure 50, but at level of top thread revealing a highly aligned microstructure and a very large elongated grain structure; top, as-polished; bottom, 1% NaOH etchant, X100.

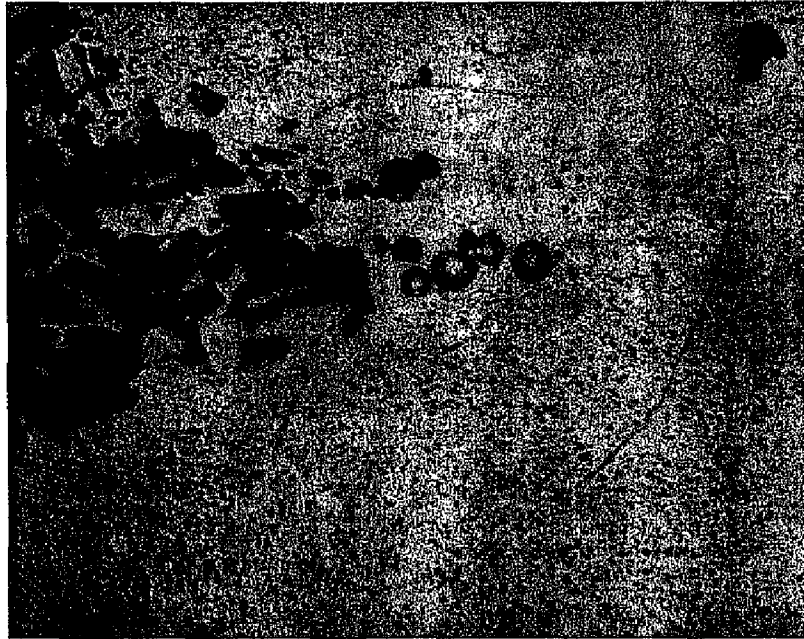
Figure 53. Stacking of microconstituents and unidentified inclusions observed in the radial section approximately 1/8 inch distant from heavy wall fracture surface common to fracture pieces (1I) and (4), 1% NaOH etchant, X1000.
