Figure 1. Major pieces of exploded air pressurized (SCUBA) cylinder E6498-2216. Caret marks indicate clearly defined chevron patterns that point to the fracture origins.

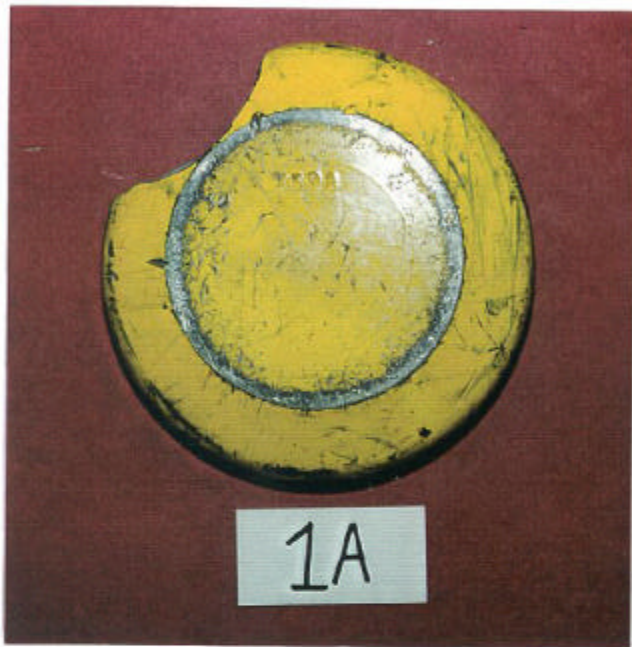
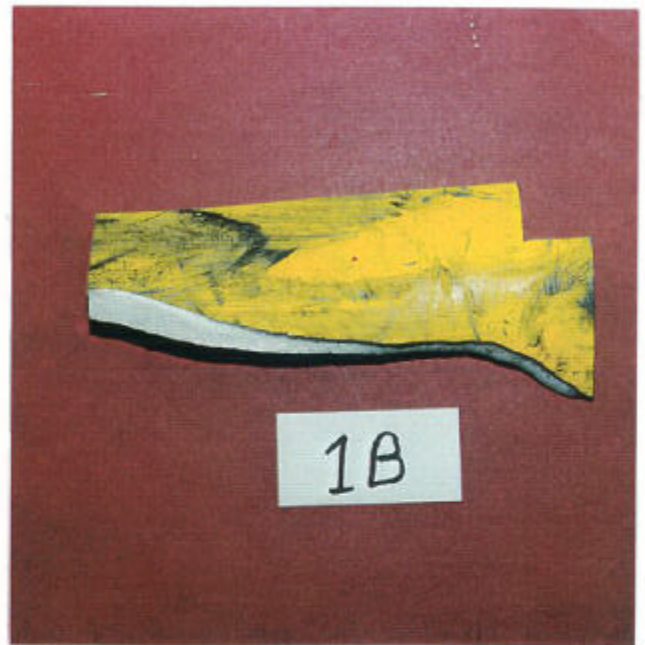
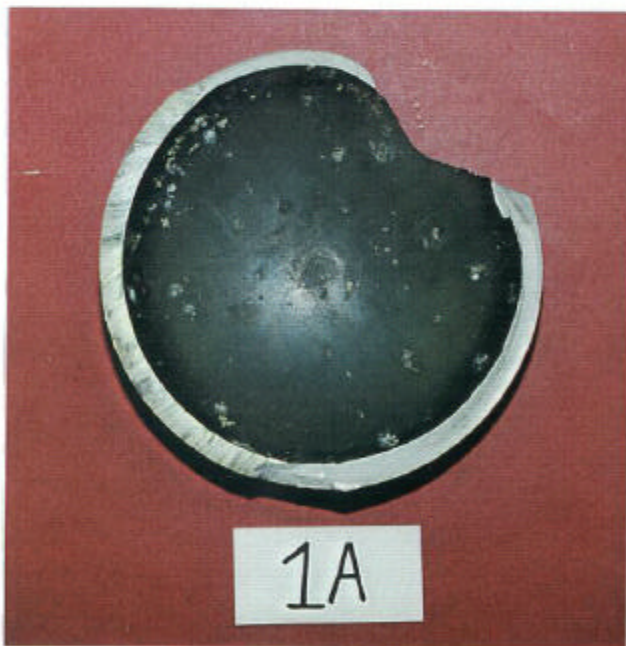
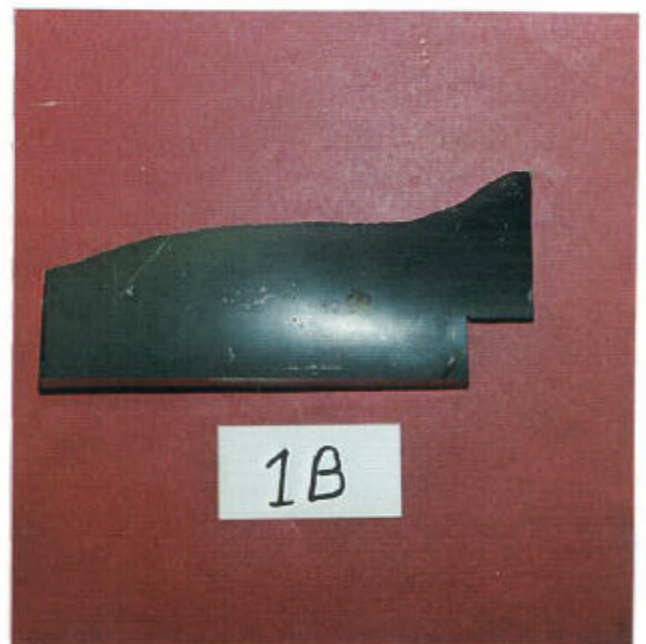
Figure 4. Bottom section (1A) and adjacent lower left side wall fracture edge section (1B) shown in Figure 2.

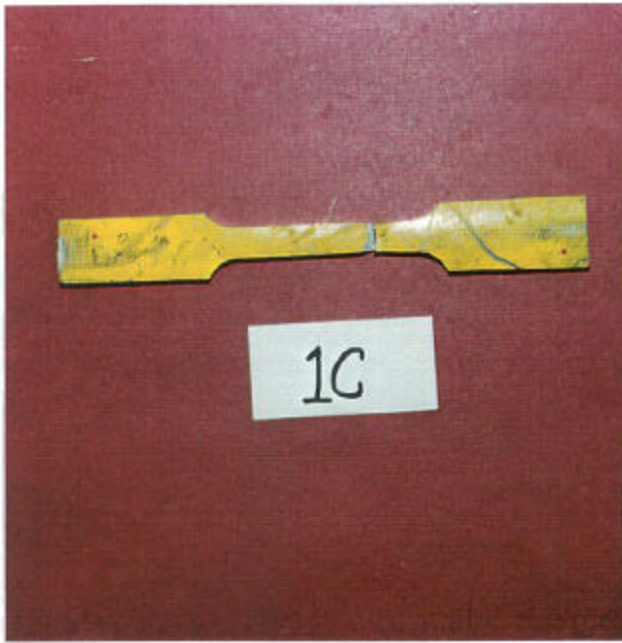
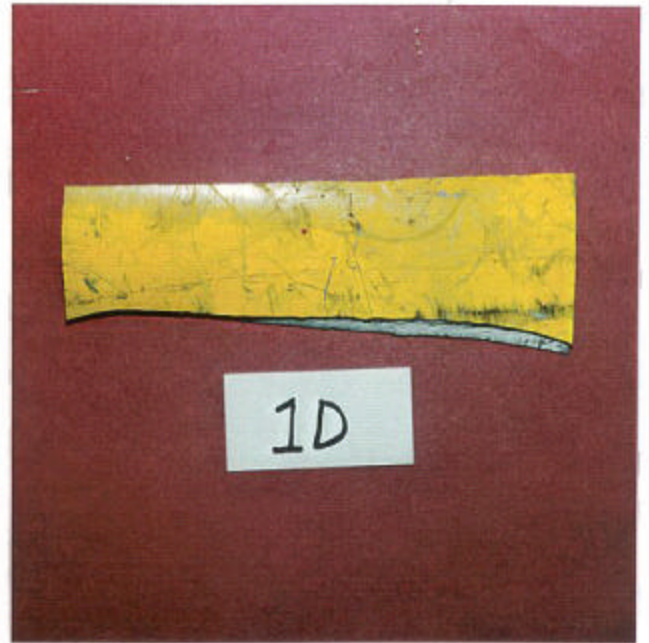
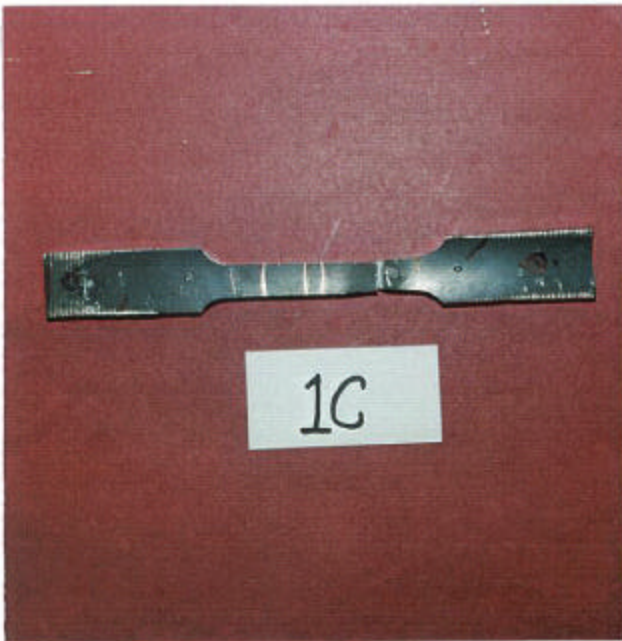
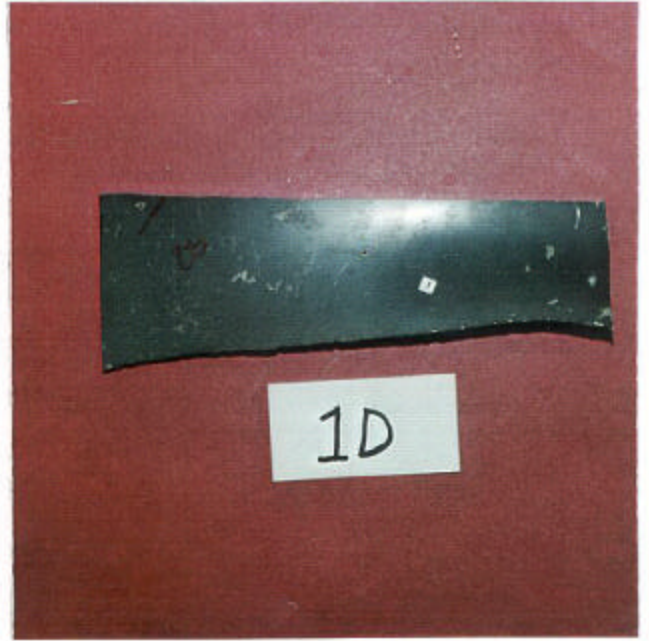
Figure 5. Tested longitudinal tensile coupon (1C) from lower center section having a 47.7 ksi 0.2% yield strength, 51.7 ksi ultimate tensile strength and 15.5% elongation in 2 in. and remaining lower right fracture edge section (1D) shown in Figure 2.

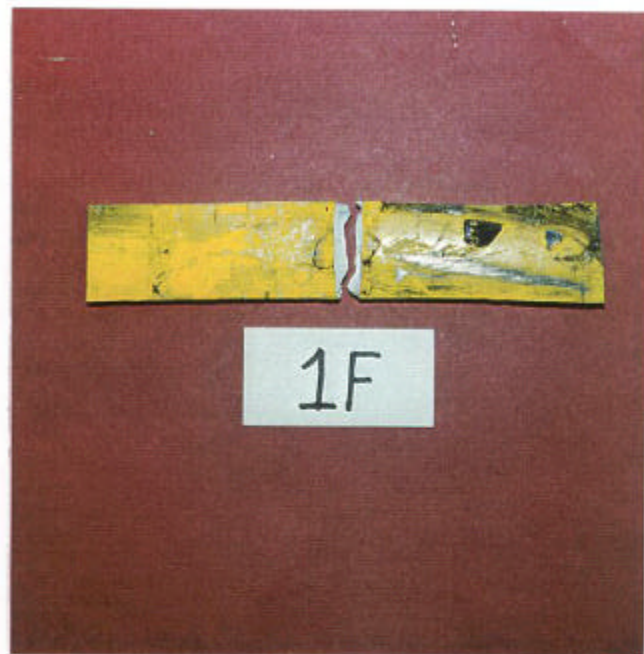
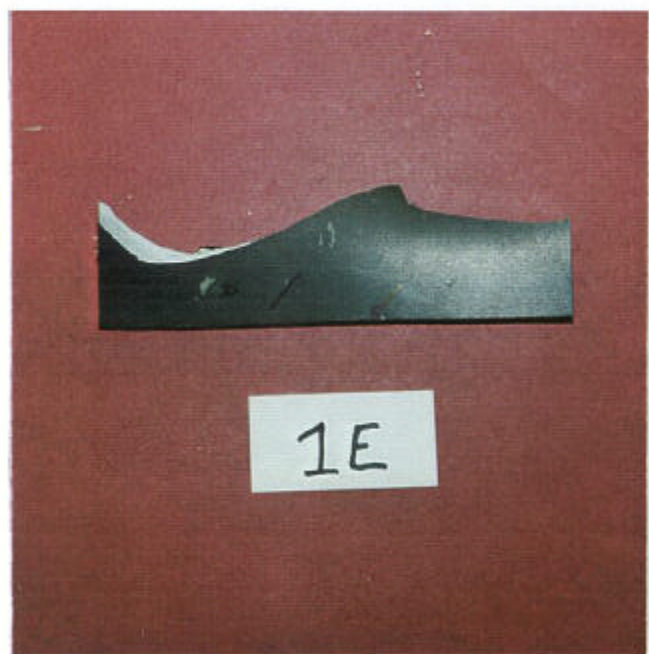
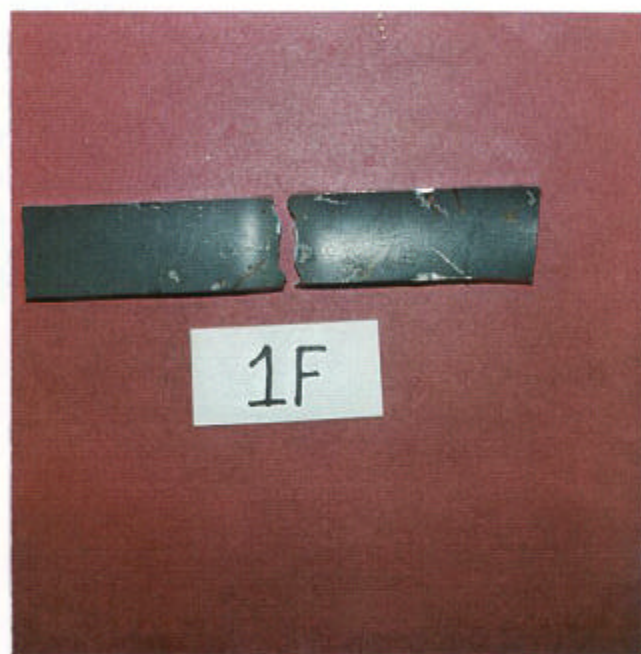
Figure 6. Upper left fracture edge section (1E) and adjacent failed bend test coupon (1F) shown in Figure 2.

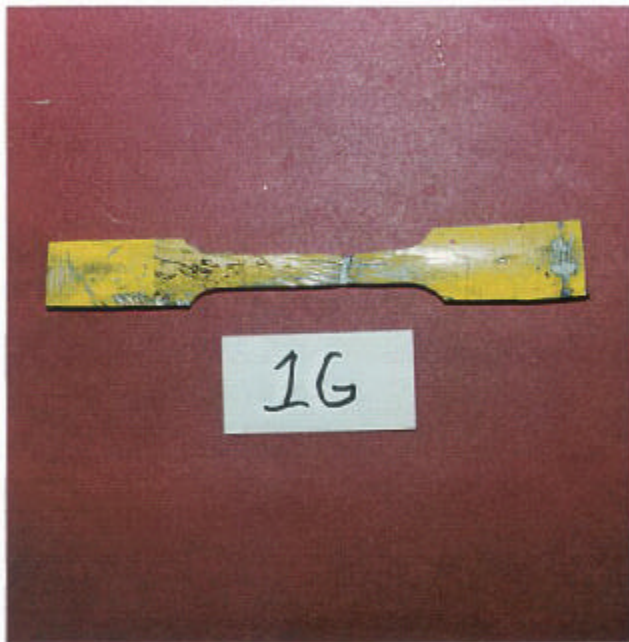
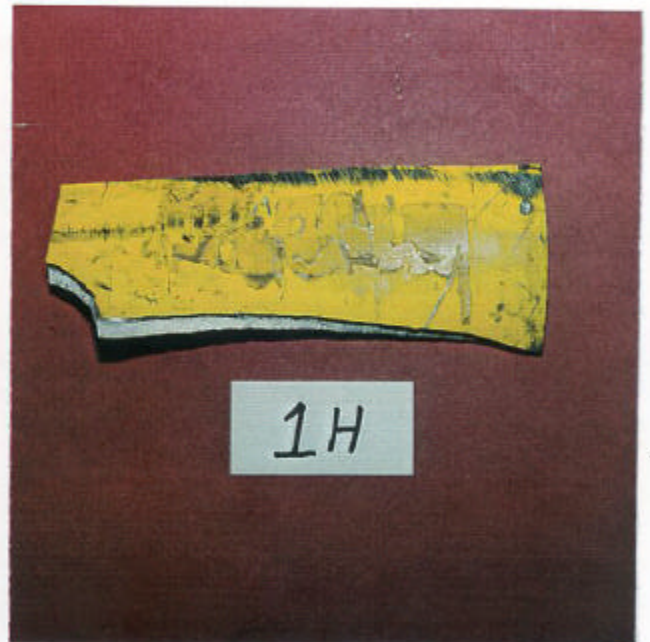
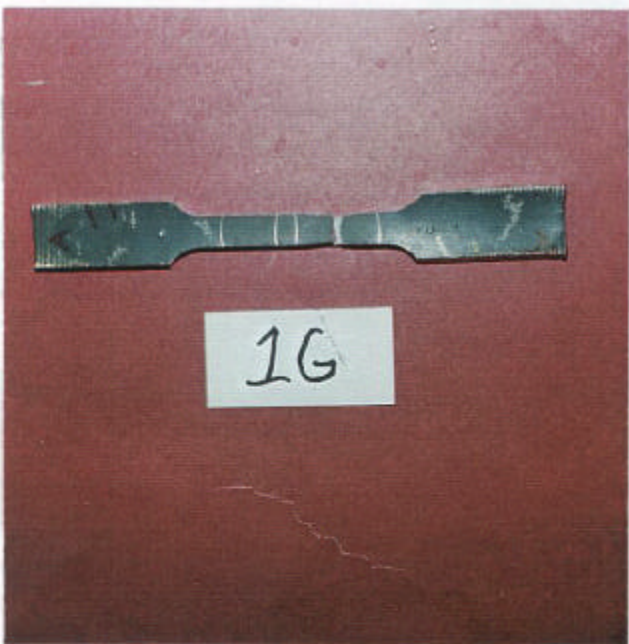
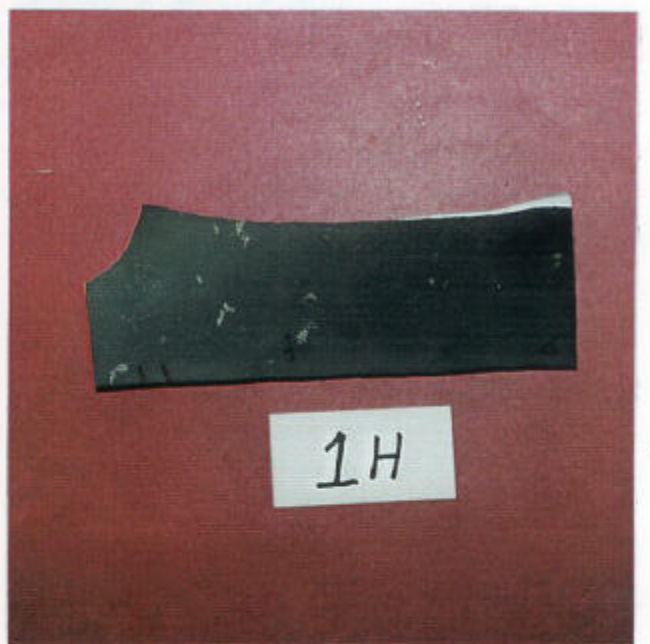
Figure 7. Tested longitudinal tensile coupon (1G) having a 48.0 ksi 0.2% yield strength, 51.5 ksi ultimate tensile strength, and 19.3% elongation in 2.0 in. and remaining upper fracture edge section of (1H) of the cylindrical wall shown in Figure 2.

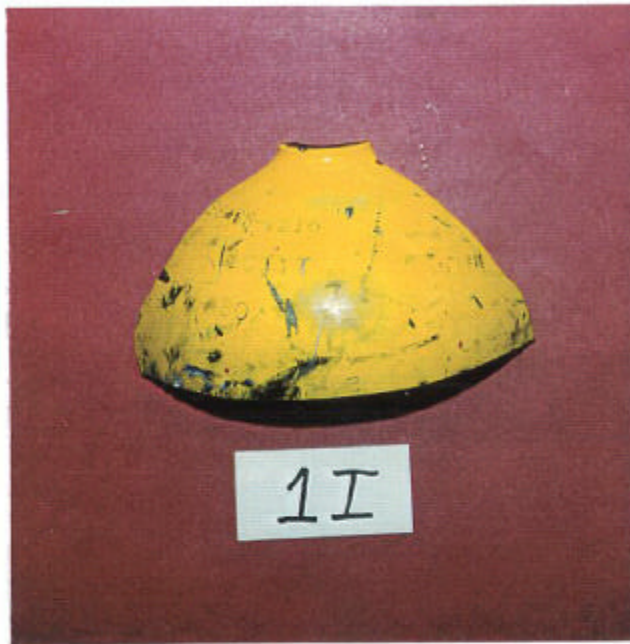
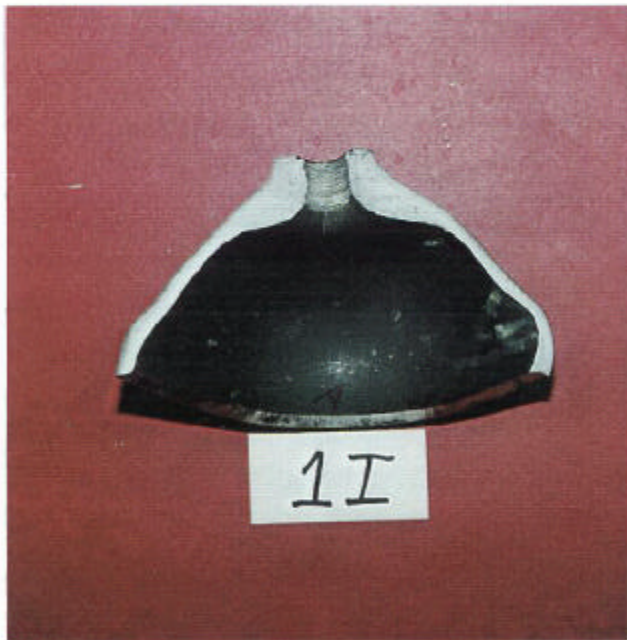
Figure 8. Top section (1I), with fracture faces roughly  $120^\circ$  apart, shown in Figure 2.
