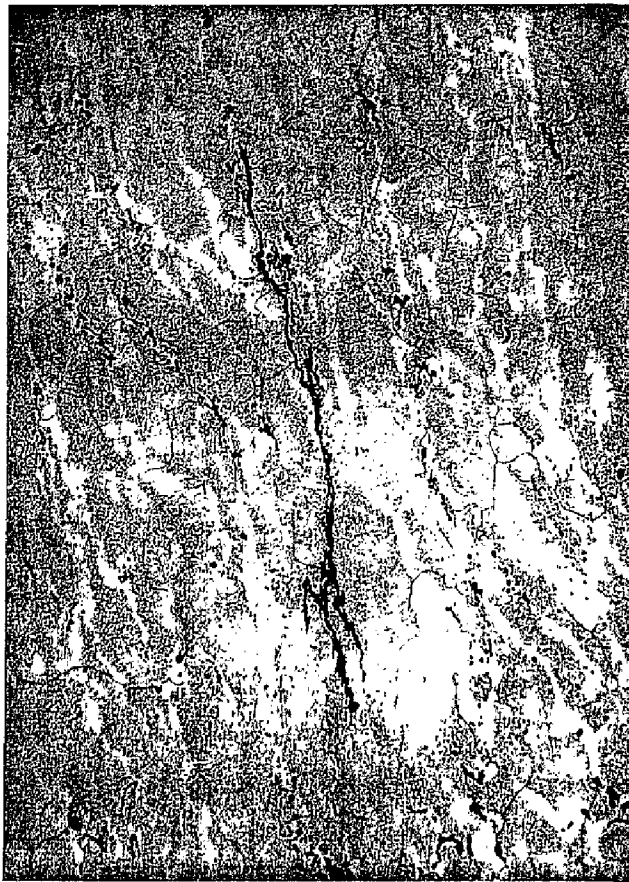
Figure 43.

Radial plane approximately 1/8 inch from fracture common to fracture pieces (1I) and (4) in the heavy wall area exhibiting several forms of entrapped dross, 1% NaOH etchant, X50.

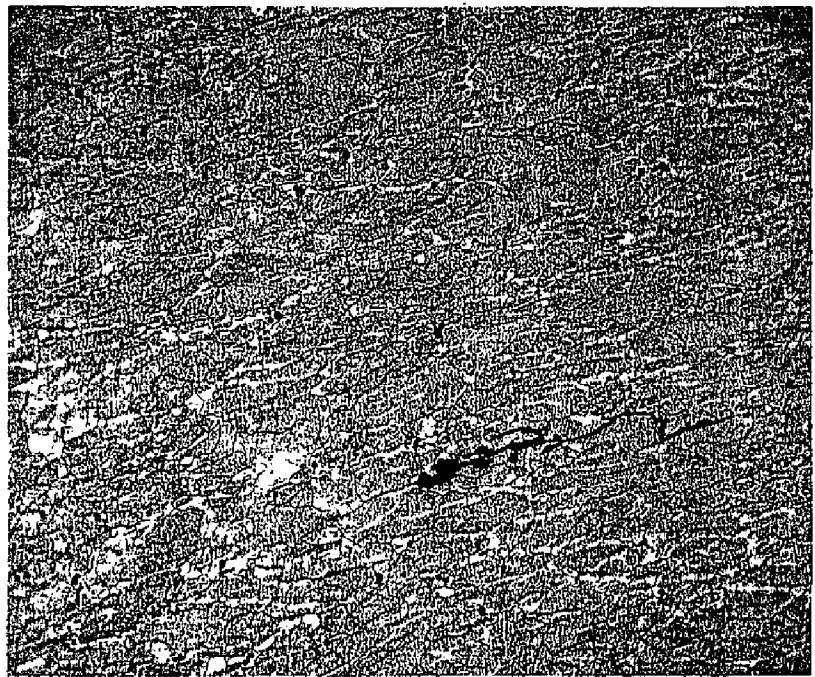
Figure 45. Dross entrapment in a radial section from the bottom of the fragmented cylinder, 1% NaOH etchant, X100.

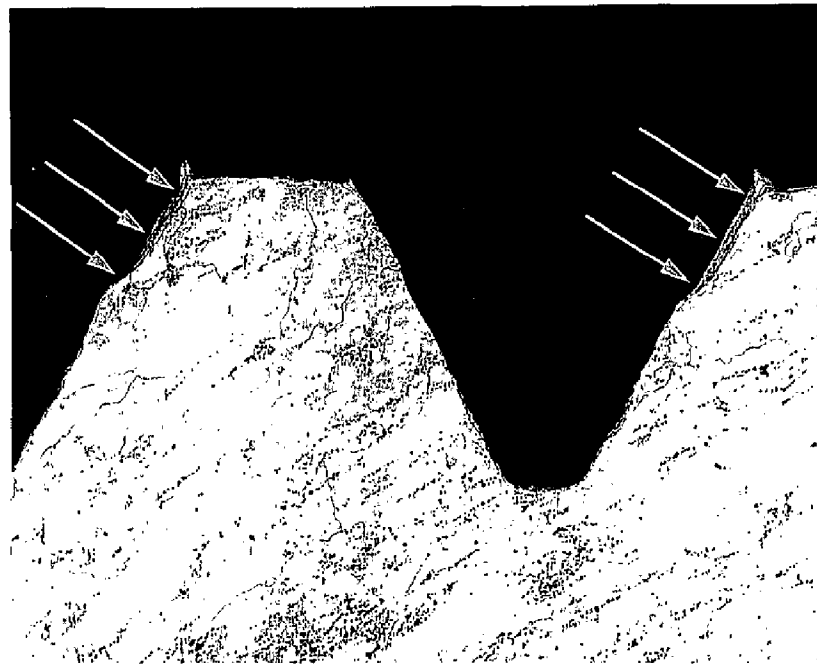
Figure 49.

Same section as Figure 48, but at end of threaded area exhibiting corrosion attack normal to thread surface and along grain boundaries. Note cold worked areas (arrows) in terminal threads that typically indicate mismatching of threads, 1% NaOH etchant, X50.

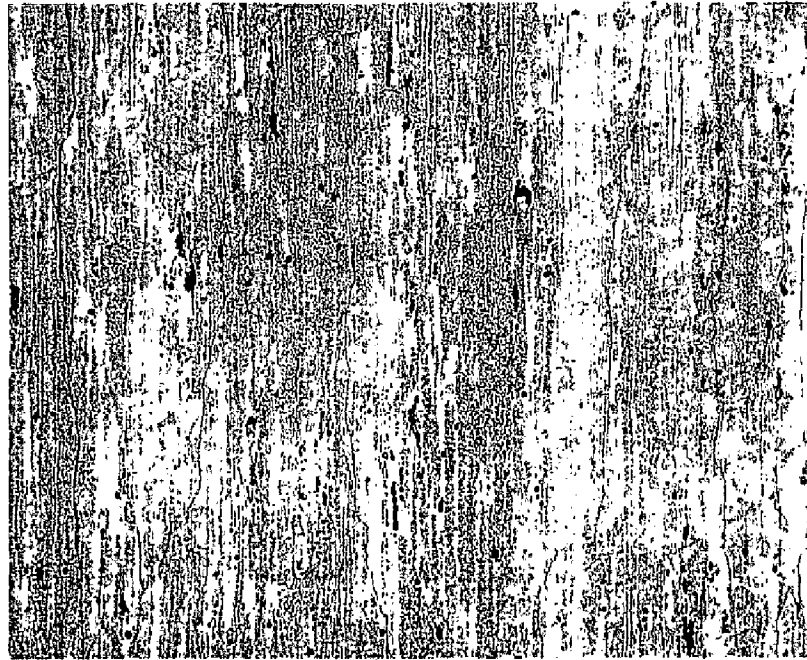
Figure 52. Same plane as Figure 50, but at level of top thread revealing a highly aligned microstructure and a very large elongated grain structure; top, as-polished; bottom, 1% NaOH etchant, X100.
