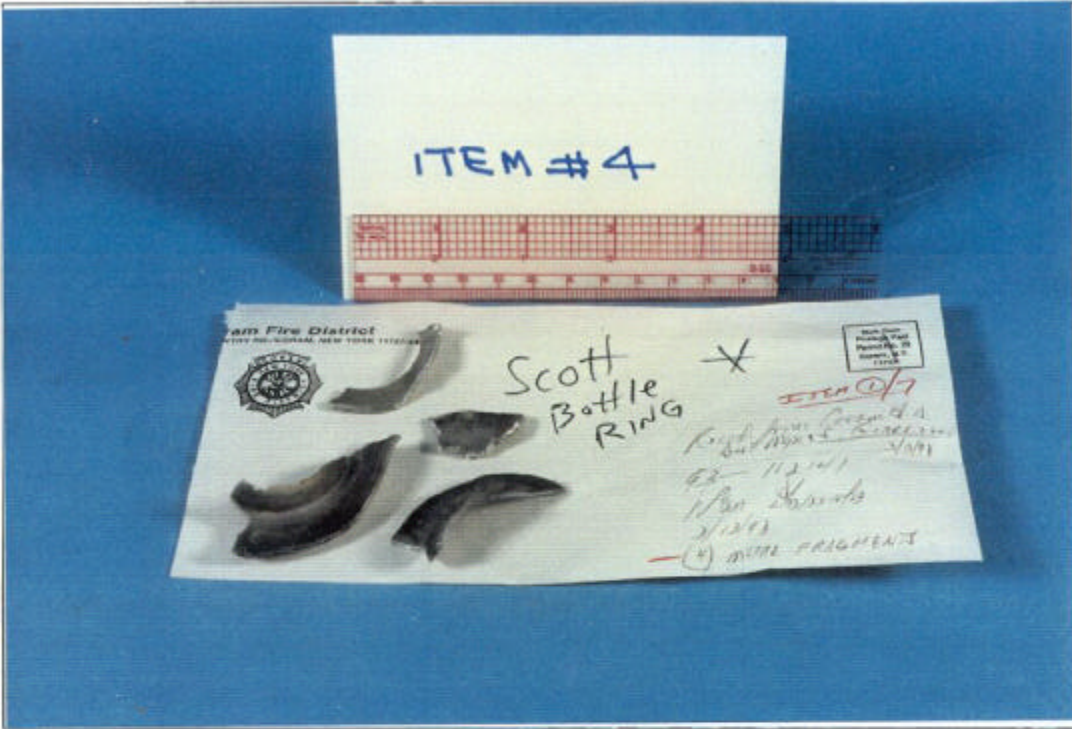
FIGURE 9 METAL FRAGMENTS RECOVERED FROM THE RUPTURED CYLINDER -- ITEM 4

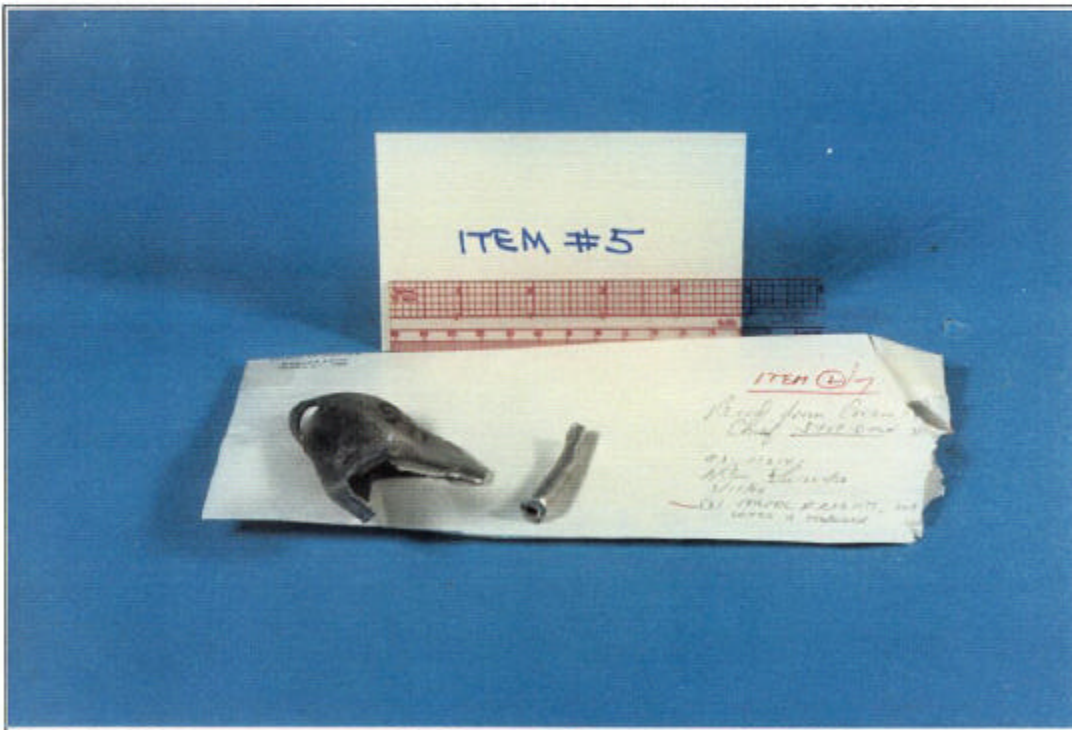
FIGURE 10 METAL FRAGMENTS RECOVERED FROM THE RUPTURED CYLINDER -- ITEM 5

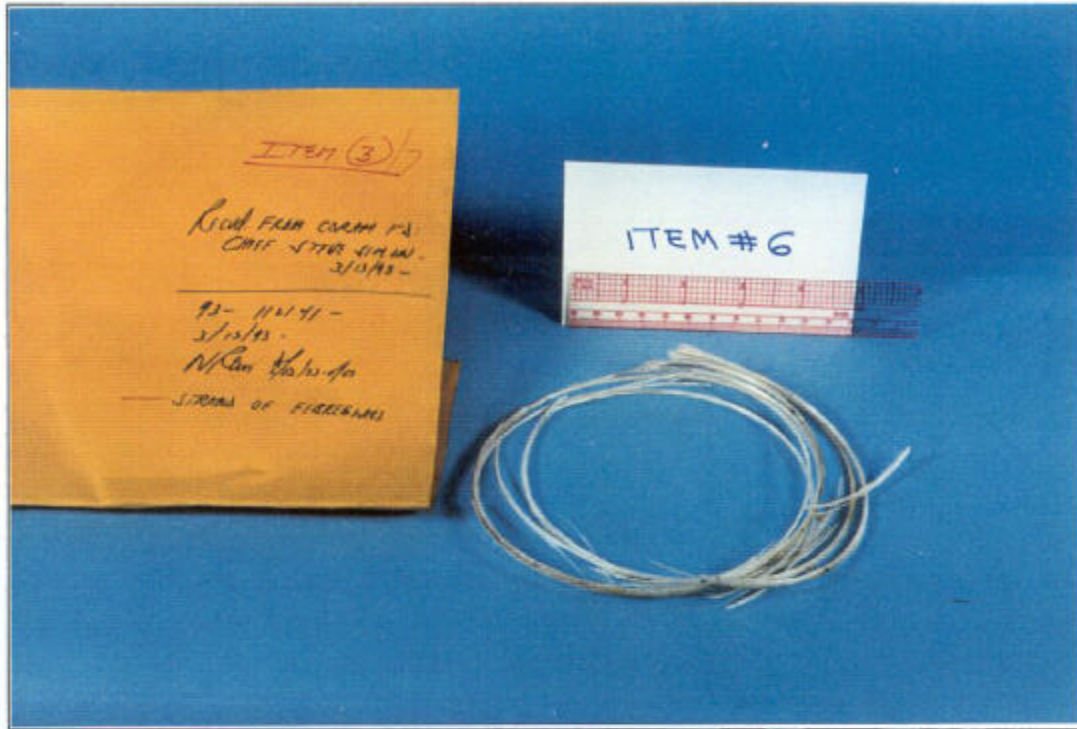
FIGURE 11 FIBERGLASS FROM THE RUPTURED CYLINDER -- ITEM 6

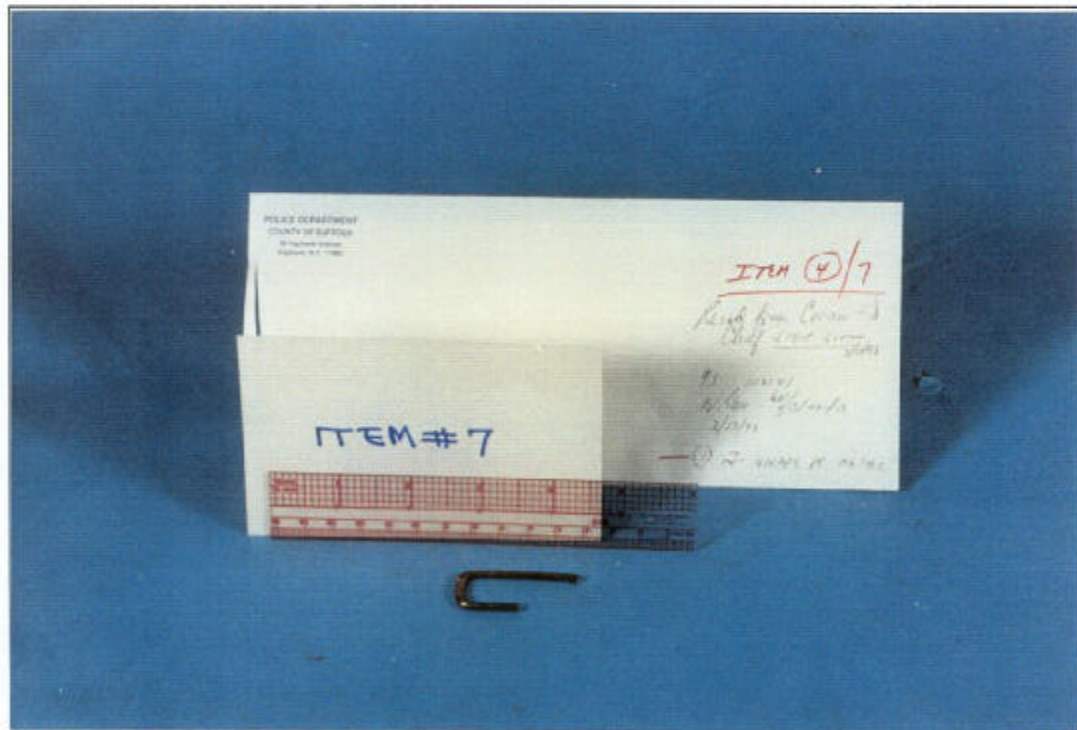
FIGURE 12 J-SHAPED PIECE OF METAL FROM THE RUPTURED CYLINDER -- ITEM 7

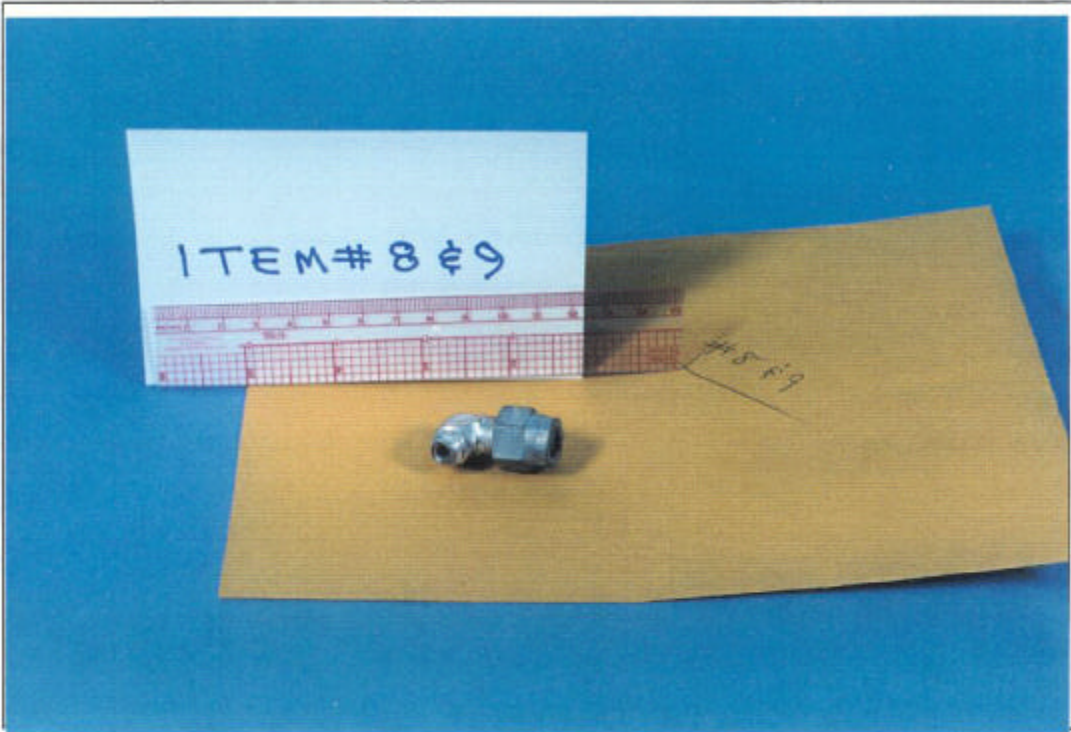
FIGURE 13 PIECES OF METAL RECOVERED FROM THE RUPTURED CYLINDER --
ITEMS 8 AND 9

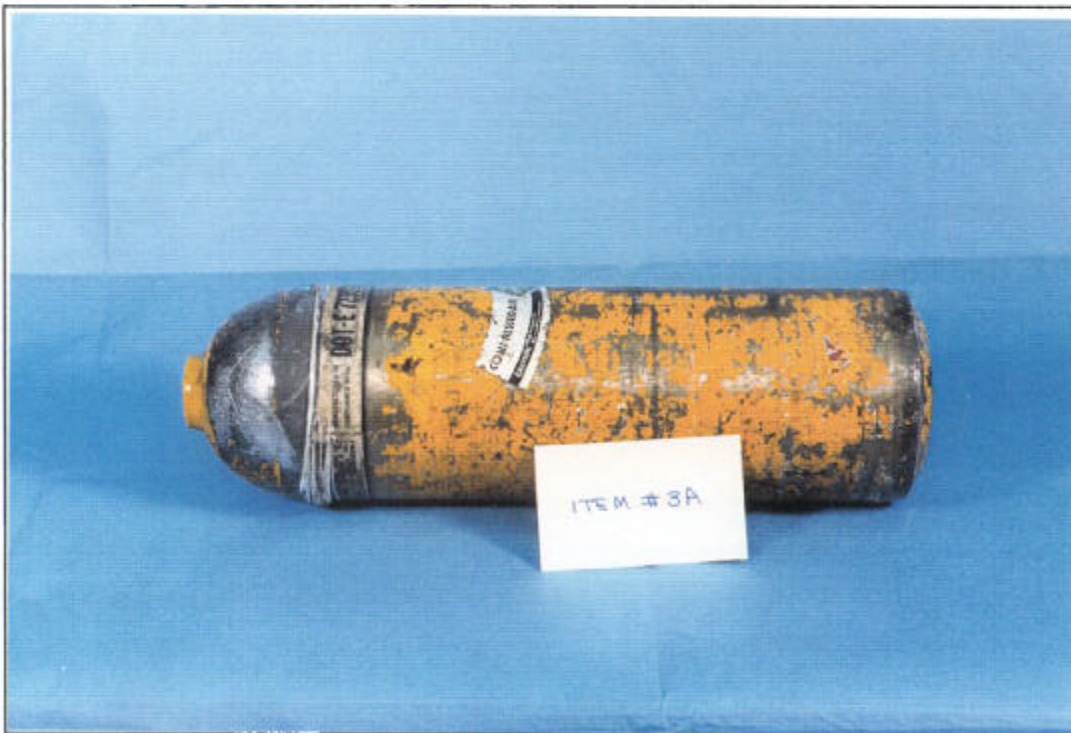
FIGURE 14 MARKING IDENTIFYING THE RUPTURED CYLINDER AS A TYPE
DOT-E-7235

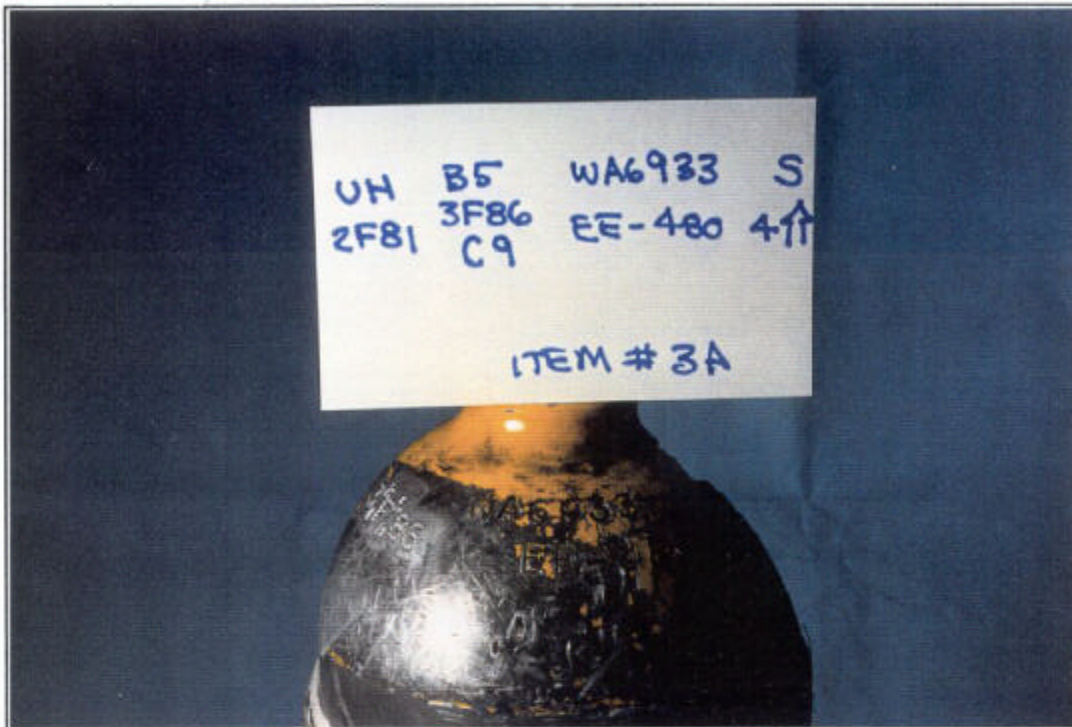
FIGURE 15 MARKINGS ON THE HEAD OF THE RUPTURED CYLINDER SHOWING THE SERIAL NUMBER -- ITEM 3A

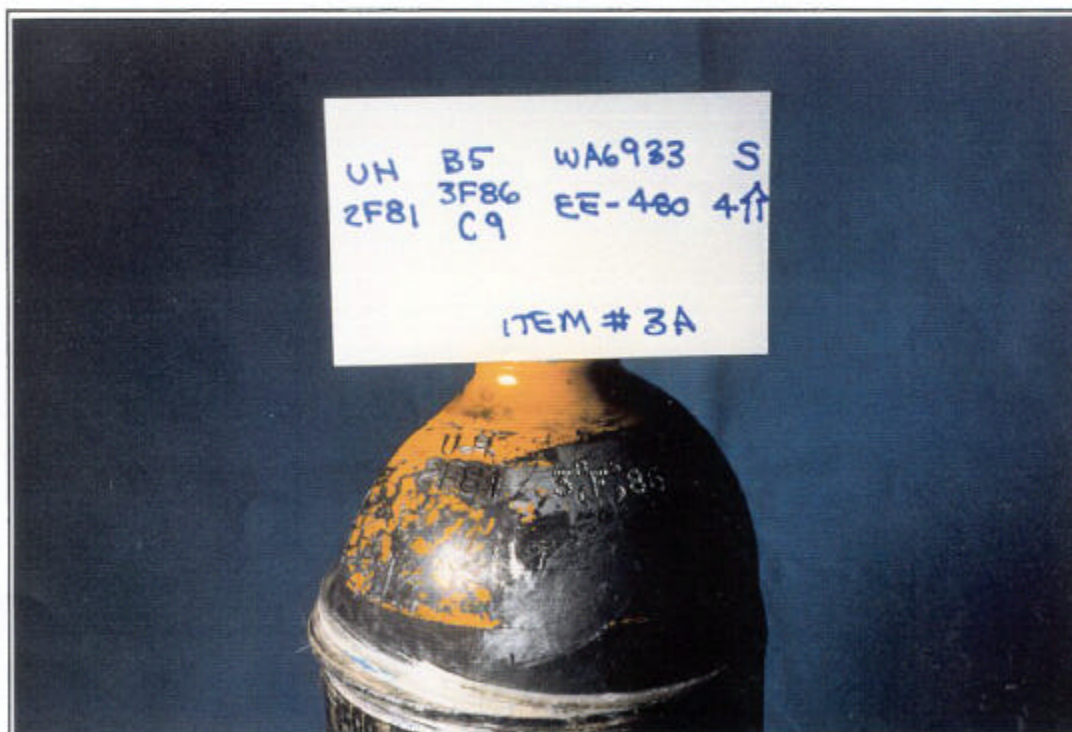
FIGURE 16 MARKINGS ON THE HEAD OF THE RUPTURED CYLINDER SHOWING THE DATE OF RETESTS -- ITEM 3A

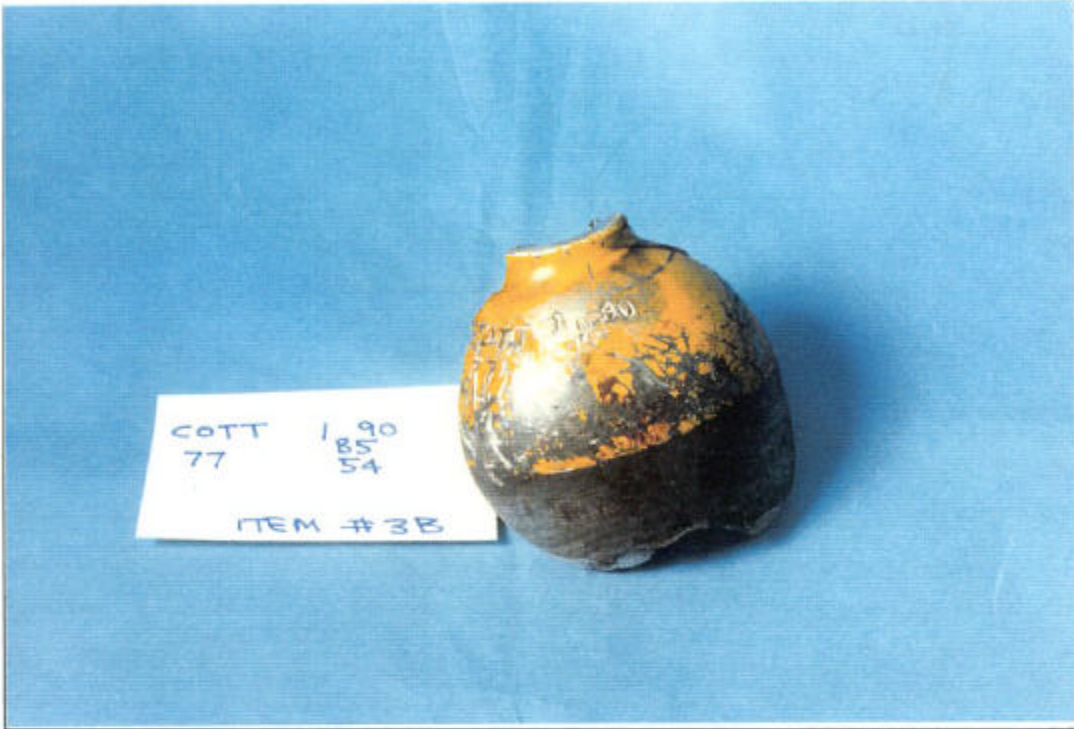
FIGURE 17 MARKINGS ON THE HEAD OF THE CYLINDER THAT RUPTURED SHOWING THE YEAR OF MANUFACTURE -- ITEM 3B

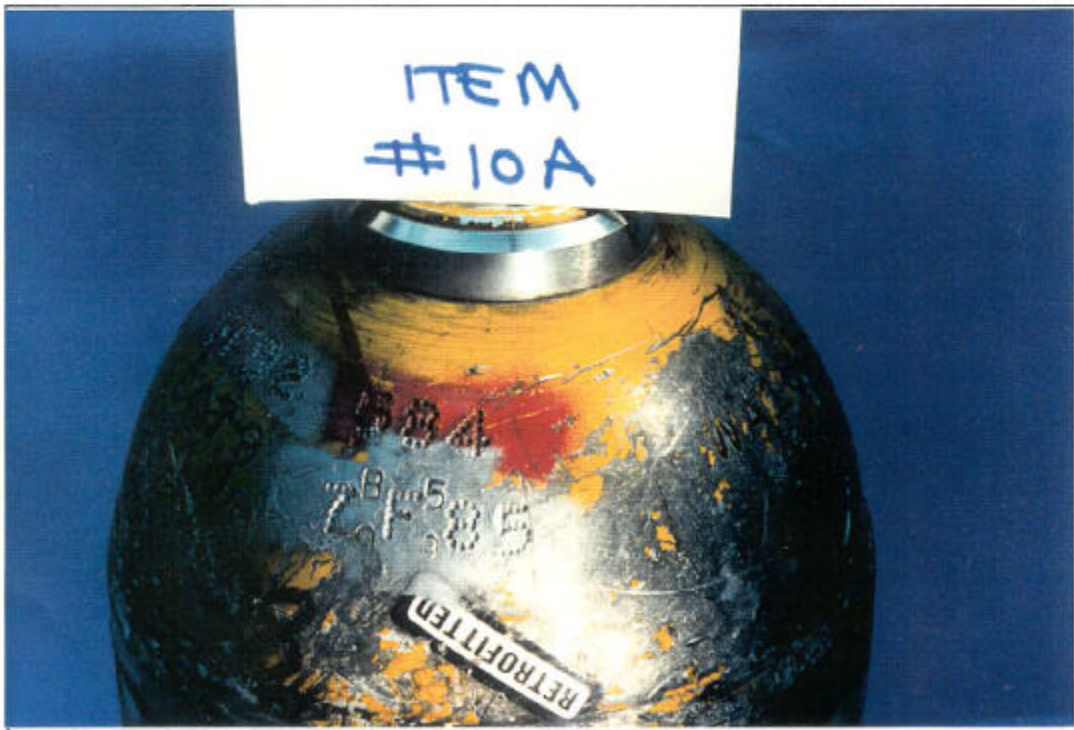
FIGURE 18 EXEMPLAR CYLINDER FITTED WITH STEEL NECK RING -- ITEM 10A

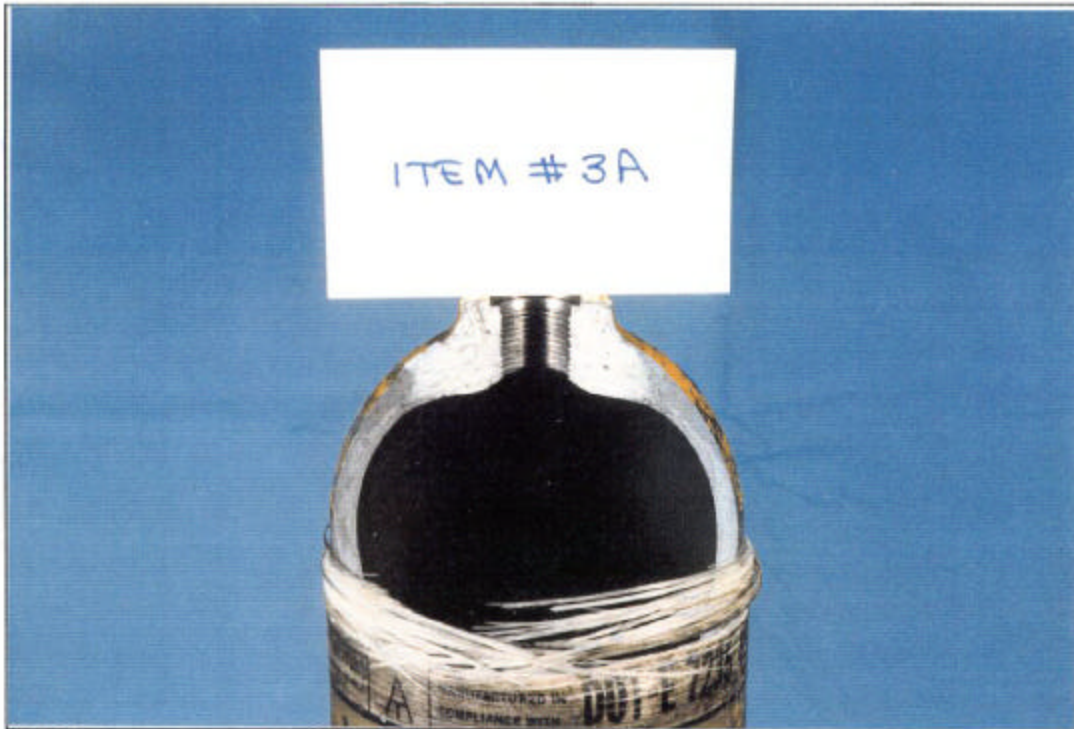
FIGURE 19 FRACTURE APPEARANCE OF THE HEAD OF THE RUPTURED CYLINDER -- ITEM 3A

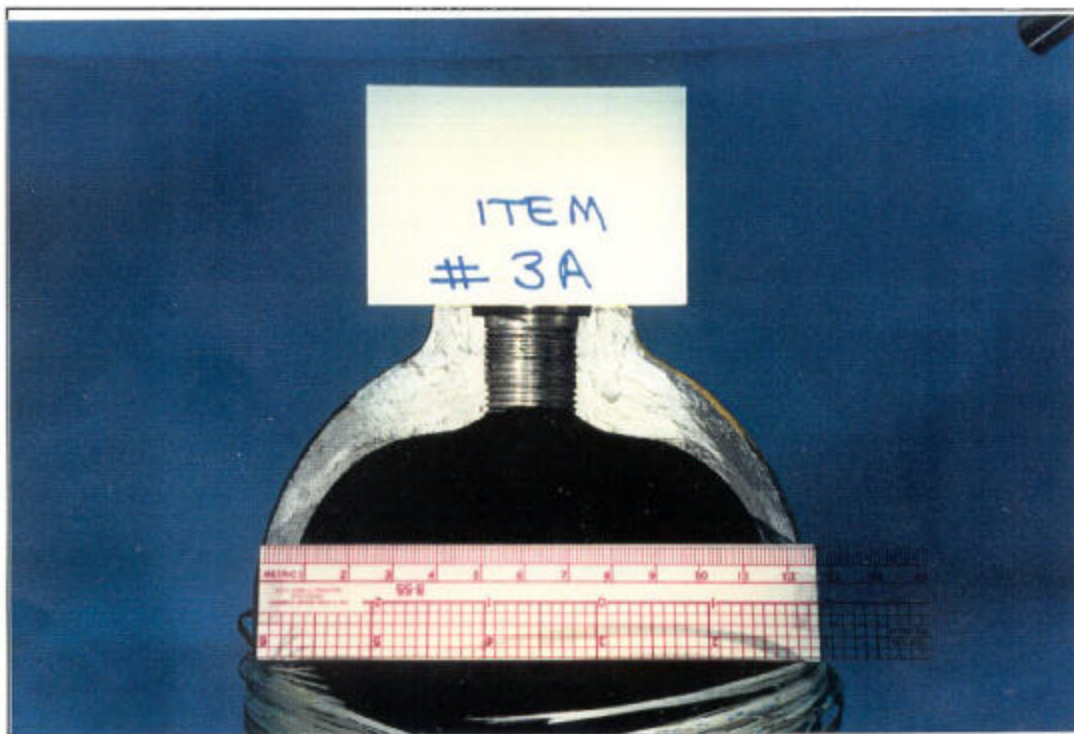
FIGURE 20 HEAD OF THE RUPTURED CYLINDER SHOWING LOCATION OF CRACKS IN THE SHOULDER OF THE CYLINDER HEAD -- ITEM 3A

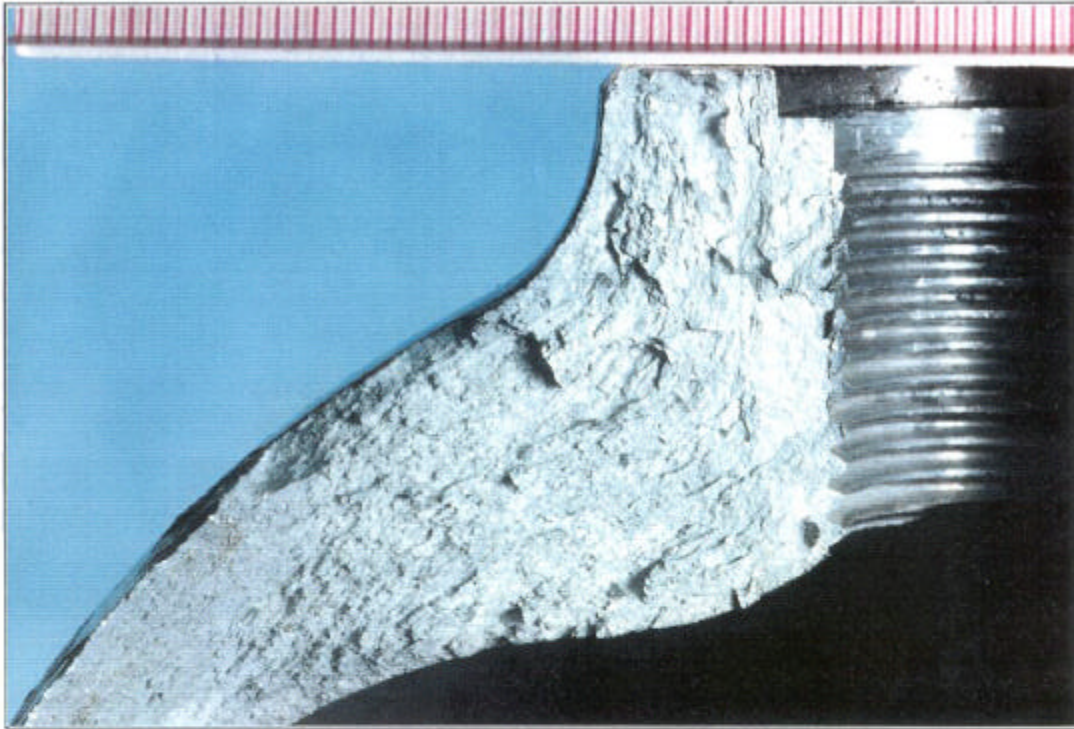
FIGURE 21 CLOSE UP PHOTOGRAPH OF THE CRACKED REGION OF THE CYLINDER HEAD -- ITEM 3A

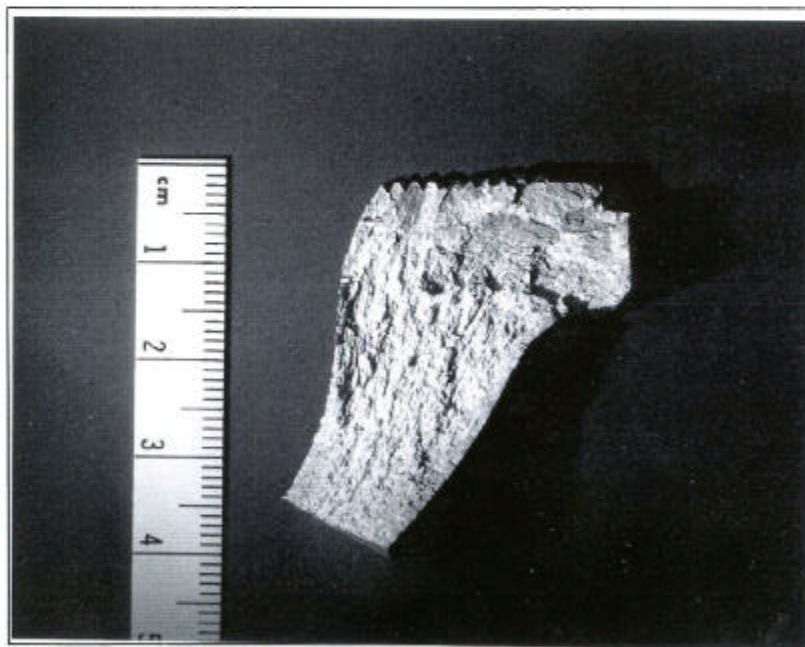
FIGURE 22 SPECIMEN FROM THE SHOULDER OF THE RUPTURED CYLINDER USED FOR MICROSCOPIC EXAMINATION

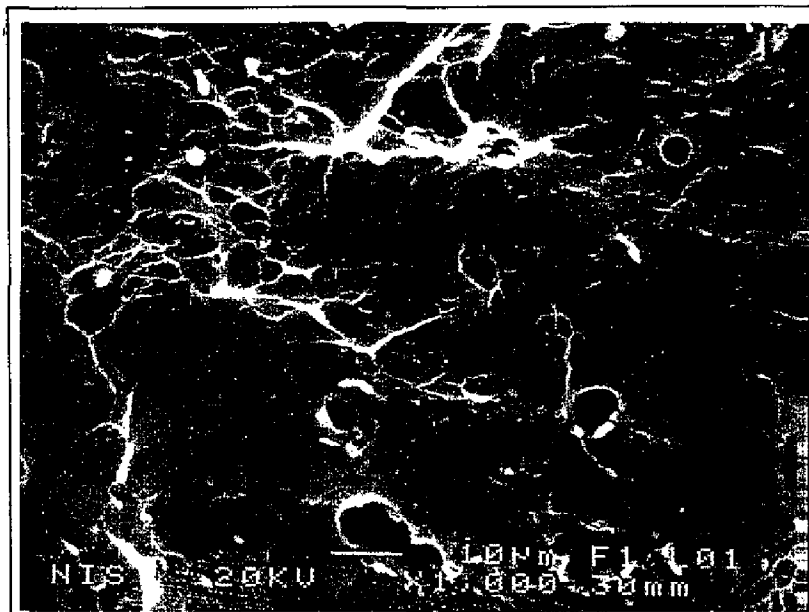
FIGURE 23 FRACTURE SURFACE OF THE SHOULDER OF THE RUPTURED CYLINDER THAT SHOWS SUSTAINED-LOAD-CRACKING (MAG. 1000X) -- ITEM 3A

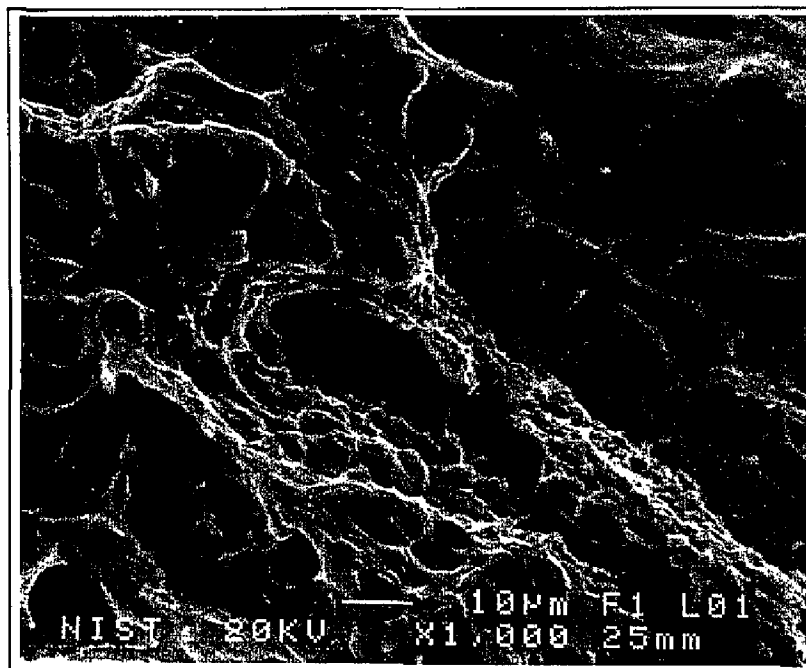
FIGURE 24 FRACTURE SURFACE OF THE SHOULDER OF THE RUPTURED CYLINDER THAT SHOWS DUCTILE TEARING TYPE OF FRACTURE (MAG. 1000X) -- ITEM 3A
