EVALUATION OF RUPTURED DOT-E-7235 CYLINDER

John H. Smith

Metallurgy Division

January 20, 1995

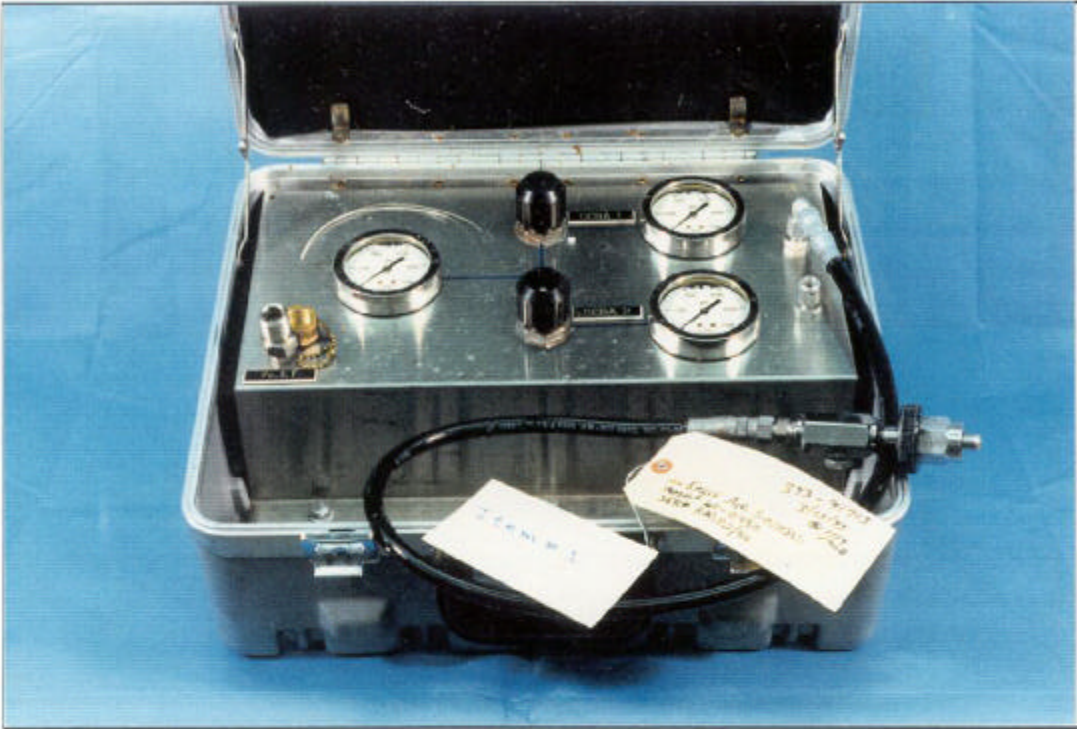
FIGURE 1 PORTABLE EAGLE AIR SYSTEM WITH CASE -- ITEM 1

Fourteen items were received by NIST for documentation and evaluation. These items are identified in Table I. The items to be documented and evaluated were: a portable "Eagle Air System" (Item 1) that was used for filling the cylinder that ruptured (Fig. 1), two example cylinders (Items 2A and 10A) that were of the same design type as the cylinder that ruptured (Fig. 2 and 3), two valve systems (Items 2B and 10B) from the example cylinders (Fig. 4 and 5), and all of the pieces and the valve system (Items 3A, 3B, 3C, 4, 5, 6, 7, 8, and 9) from the ruptured cylinder (Fig. 6, 7, 8, 9, 10, 11, 12, and 13). Detailed evaluation was carried out only on the parts from the ruptured cylinder (Items 3A and 3B). The other parts and cylinders were documented for the record only and no further evaluation of these parts (i.e. the valves, air system, example cylinders) was carried out.

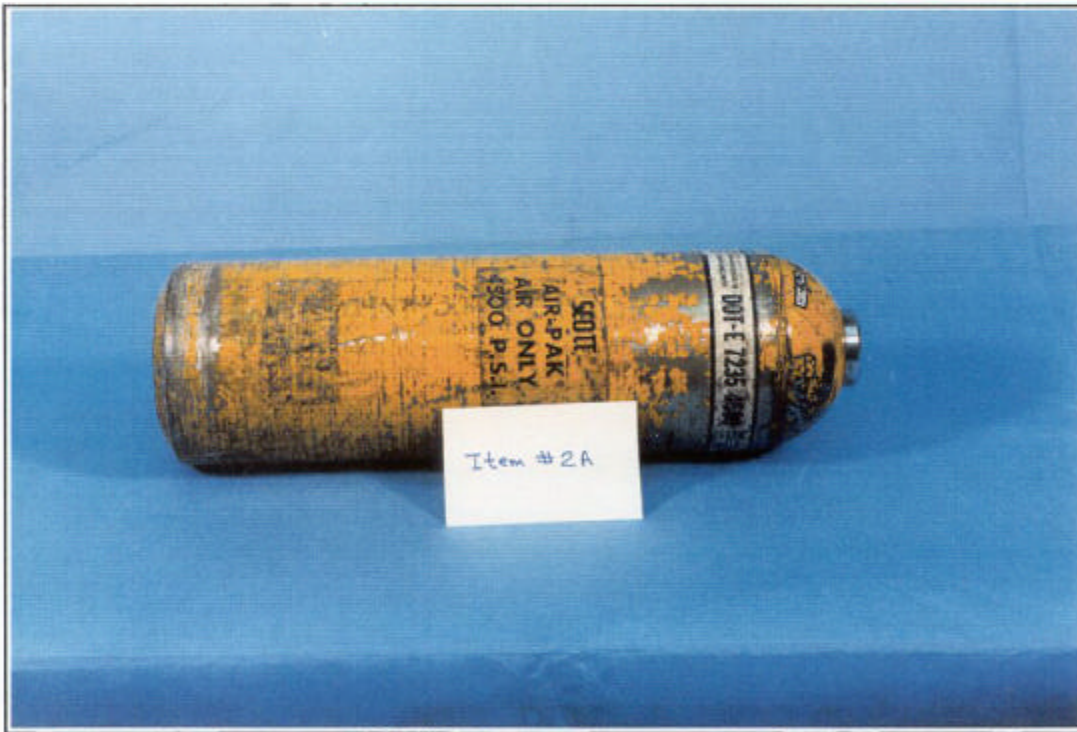
FIGURE 2 SCOTT AIR PAK CYLINDER (EXEMPLAR) -- ITEM 2A

DOCUMENTATION OF THE EXAMPLE CYLINDERS: In addition to the ruptured cylinder, two example cylinders (Items 2A and 10A) manufactured under DOT exemption E-7235 were also submitted to NIST by the U. S. Department of Transportation (DOT) Office of Hazardous Materials Technology. These example cylinders were reported to be from the same source as the ruptured cylinder. One of the example cylinders (Item 10A) is shown in Figure 18. For comparison with the ruptured cylinder, the example cylinder shown in Figure 18 (Item 10A) is properly fitted with a steel neck ring as required by the DOT regulations (Ref. 2). Figure 18 also shows that in addition to the neck ring a label entitled "RETROFITTED" is attached to the cylinder at the time the neck ring was fitted to the cylinder. This label was not required by the DOT regulations but was put on at the time the neck ring was fitted at the discretion of the manufacturer. Figure 18 shows that the neck ring is clearly visible on a cylinder that has been retrofitted with a neck ring and leaves no doubt that the ruptured cylinder never was fitted with a neck ring.

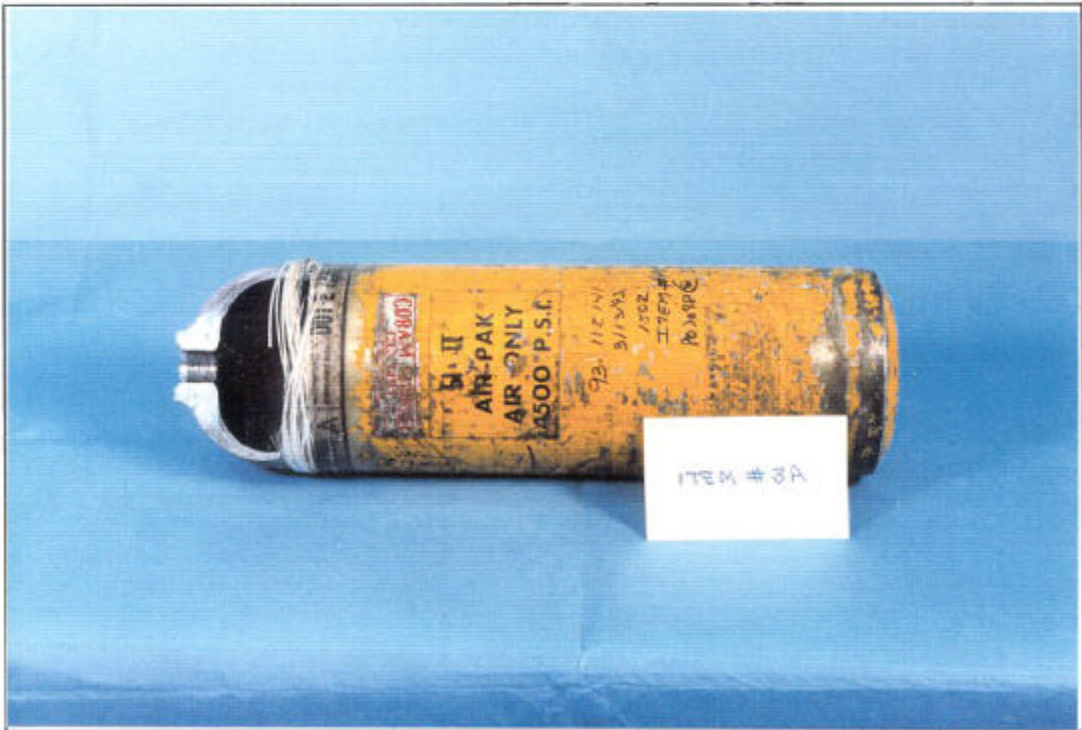
DOCUMENTATION OF THE Ruptured CYLINDER: The general condition of the ruptured cylinder received by NIST is shown in Figure 6 (Item 3A). The rupture of the cylinder resulted in the cylinder breaking into two pieces (Items 3A and 3B) as shown in Figures 6 and 7, respectively. A portion of the head of the cylinder (Item 3B) was removed as a result of the rupture. The rest of the

cylinder (Item 3A) remained intact (Fig. 6) with no significant secondary tearing or deformation of the cylinder.

DOT-E-7235 type cylinders are constructed of a seamless aluminum liner with hoop-wrapped fiberglass over-wrapping. The marked maximum service pressure of the cylinder that ruptured is 4500 psi. (Fig. 6).

FIGURE 6 SCOTT AIR PAK CYLINDER THAT RUPTURED AT NECK -- ITEM 3A

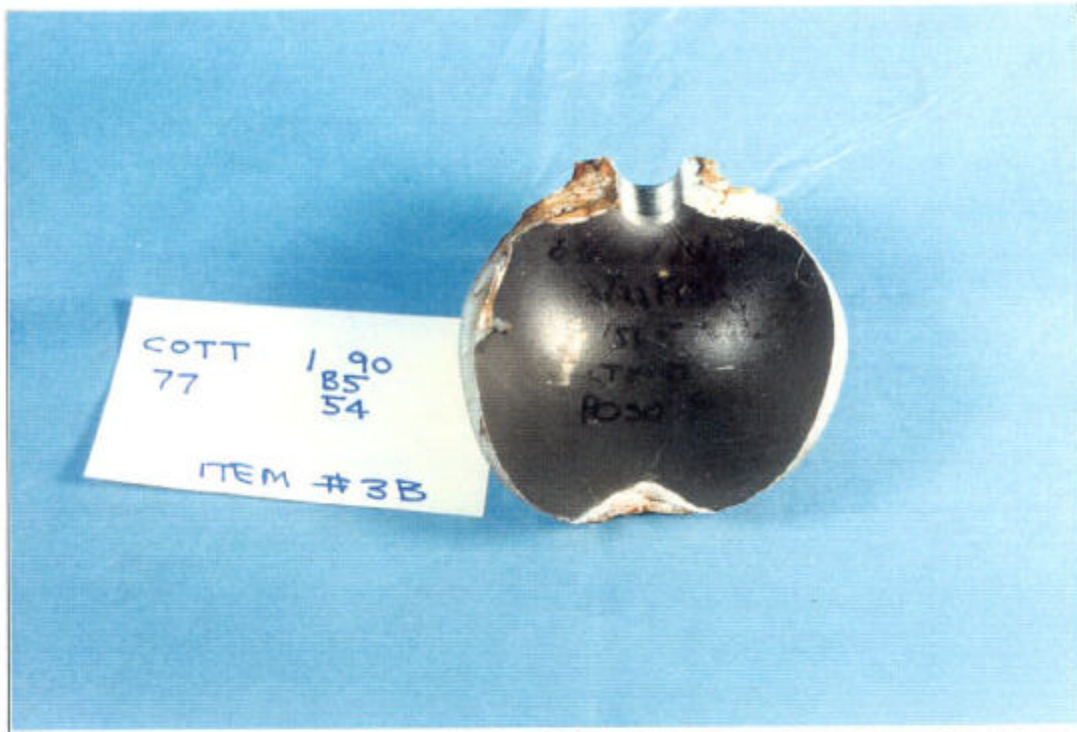
The rest of the markings on the head of the cylinder are shown on the section of the cylinder head that came off during the rupture (Item 3B) that is shown in Figure 17. The markings on this section of the head show the markings "COTT" which is the rest of the name of the ordinal purchaser, i.e., SCOTT and the year of manufacture, which is "77" for 1977. This section also shows the date of the last retest which is 1990.

FIGURE 7 FRAGMENT OF SCOTT AIR PAK CYLINDER THAT RUPTURED --
ITEM 3A
