Faaa-SF-R-96-06-16

Investigation of the Failure of an SCBA Cylinder

EFI Corporation
5357 Randall Place
Fremont, California 94538

July 2, 1996

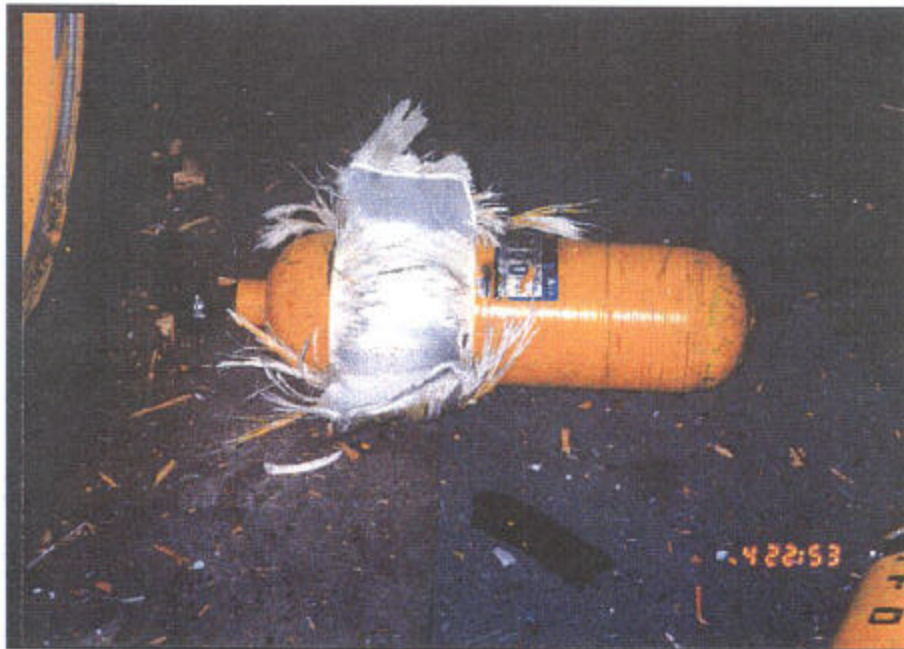
Figure 3. Close-up View of Failed Cylinder after Accident

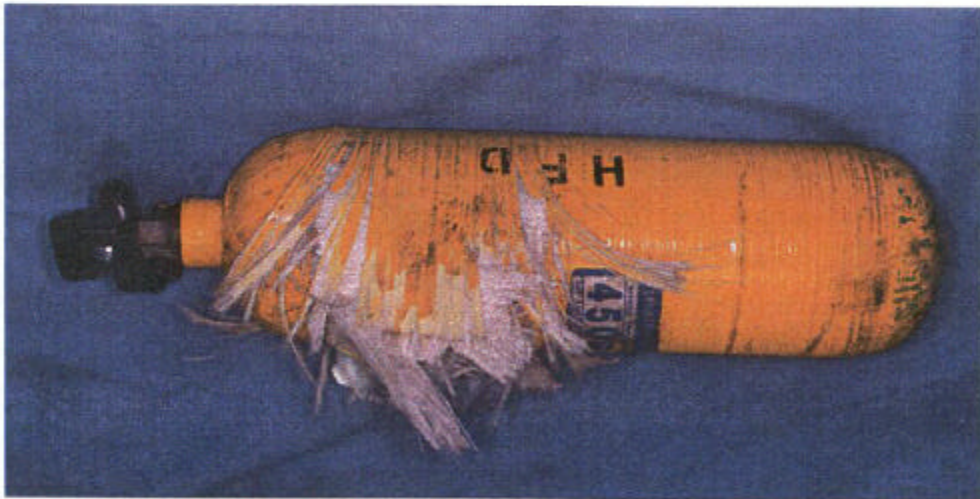
The overall fracture has an "H" shape, as shown in Figure 6, with the horizontal bar of the "H" oriented in the longitudinal direction of the SCBA cylinder and the vertical bars of the "H" oriented in the circumferential direction. Failure of the SCBA cylinder appears to have initiated in the circumferential fibers, near the right hand edge of the label, as viewed with the cylinder vertical and the valve at the top (see Figures 7 and 8).

Figure 8. Initial Failure Region of Accident SCBA Cylinder
