NATIONAL TRANSPORTATION SAFETY BOARD

HIGHWAY ACCIDENT REPORT

COLLISION BETWEEN METROLINK TRAIN 901 AND
MERCURY TRANSPORTATION, INC., TRACTOR-COMBINATION
VEHICLE AT HIGHWAY-RAILROAD GRADE CROSSING
IN GLENDALE, CALIFORNIA
ON JANUARY 28, 2000

**NTSB/HAR-01/02
PB2001-916202
Notation 7410
Adopted November 27, 2001**

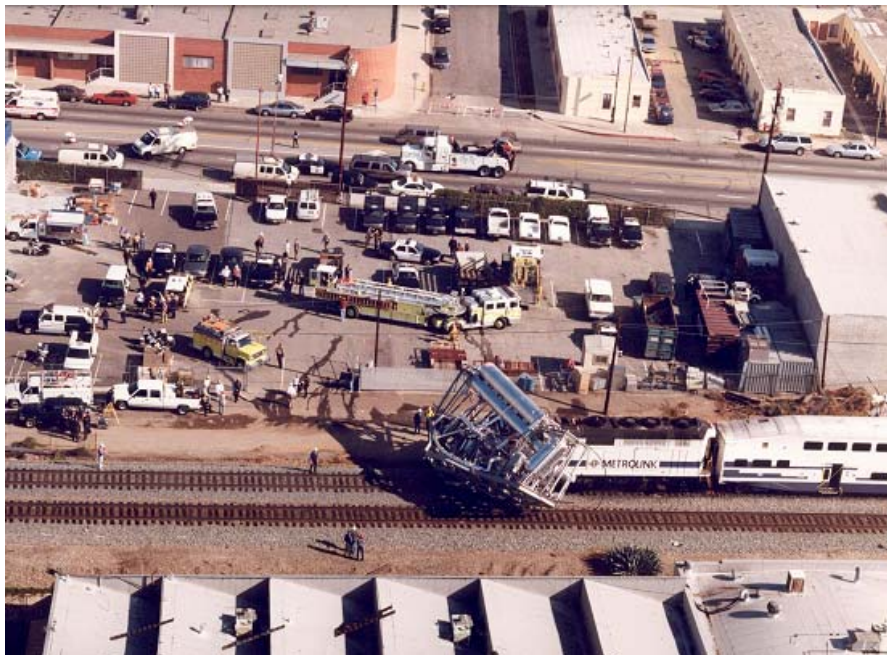
Figure 1. Final rest positions of train and vehicle. (Photograph source: Glendale, California, Police Department.)

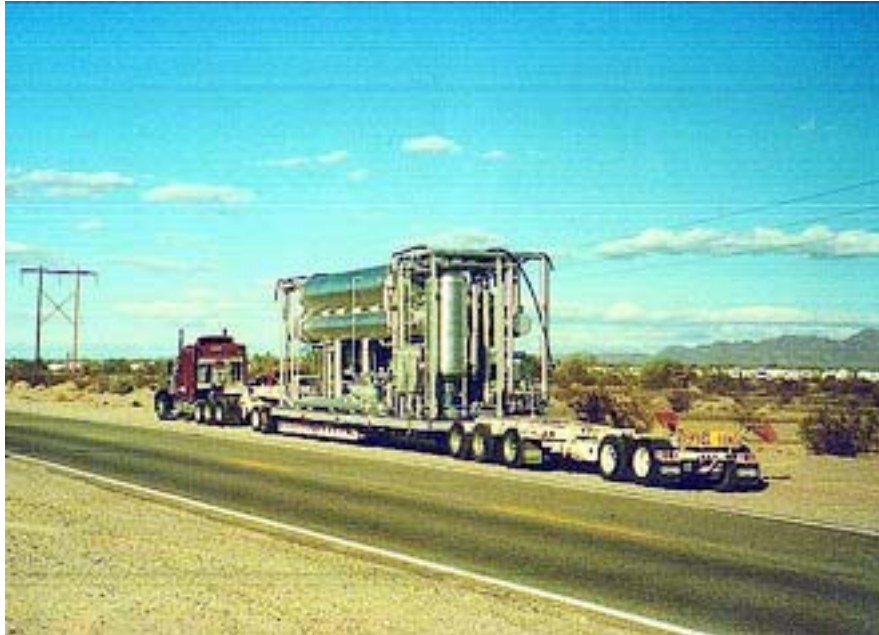
The tractor-combination vehicle measured 135 feet long, 15 feet wide, and 18 feet 6 inches high with a ground clearance of approximately 6 inches (see figure 2); the gross vehicle weight was 226,000 pounds.¹ (See appendix B for terms relating to oversize/overweight loads.) The load, valued at \$1.5 million, was being transported from

Figure 2. Photograph of the tractor-combination vehicle before the accident. *(Photograph source: Mercury Transportation, Inc.)*

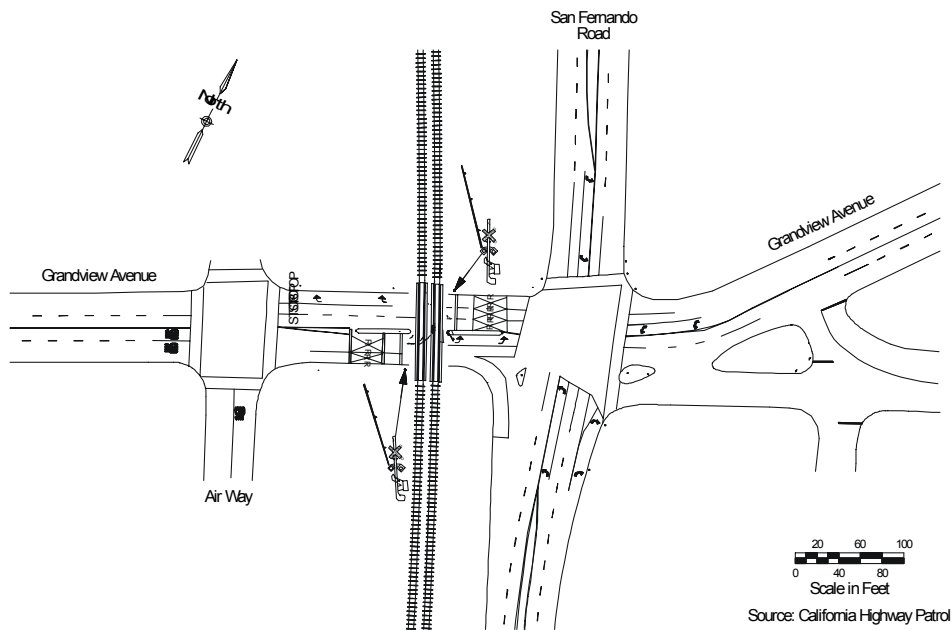
The railroad warning devices started to activate. Witnesses estimated that from the time the vehicle was initially stuck (stopped) on the tracks to the activation of the warning devices was less than 60 seconds. When the warning devices activated, several events happened at once. One CHP officer began to call on the CB radio for the truckdriver to get the truck off the tracks, believing the driver was still in the tractor. She did this several times until she saw the truckdriver running back toward the tractor from somewhere on the left side of the vehicle. The CHP officer-in-charge began to yell for the truckdriver to move the truck off the tracks. The rear pilot car driver began to call for the truckdriver to get the vehicle off the tracks. (See figure 9.)

Figure 9. Diagram of accident site.

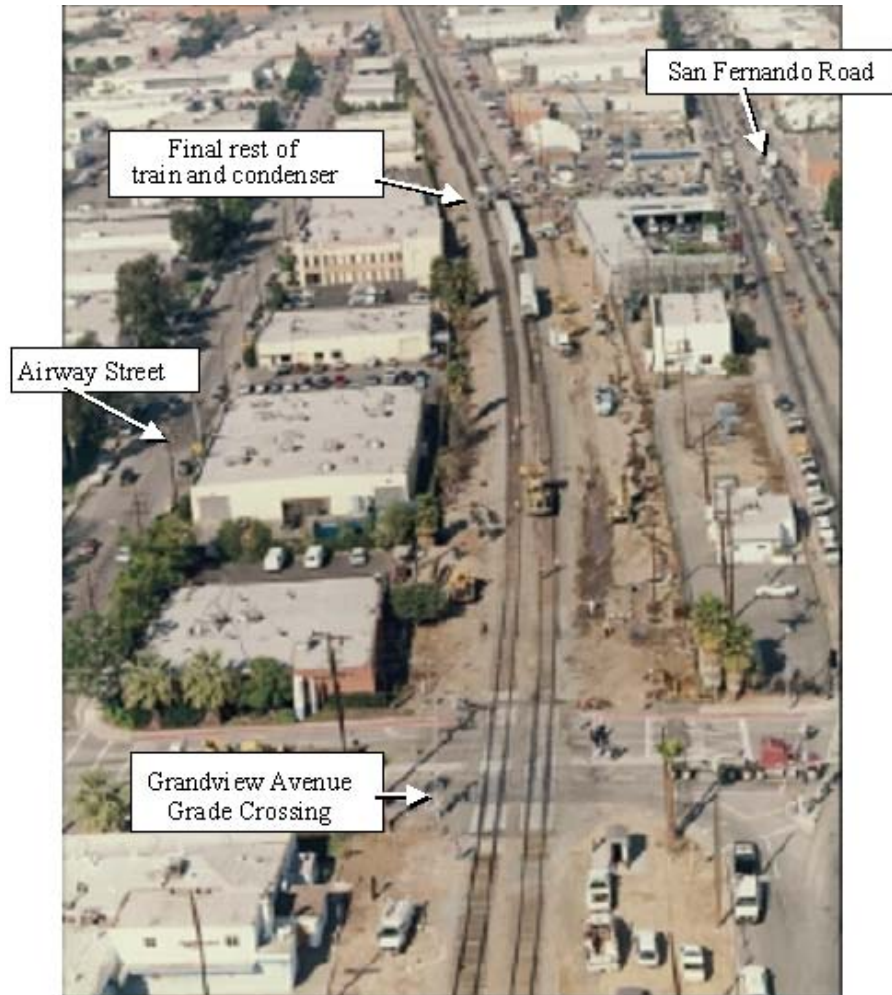
the tracks before coming to a stop on the tracks. (See figure 10.) Witnesses estimated the total time from the truck stopping on the tracks to impact was less than 90 seconds.

Figure 10. Aerial view of accident site. (Photograph source: Glendale, California, Police Department.)

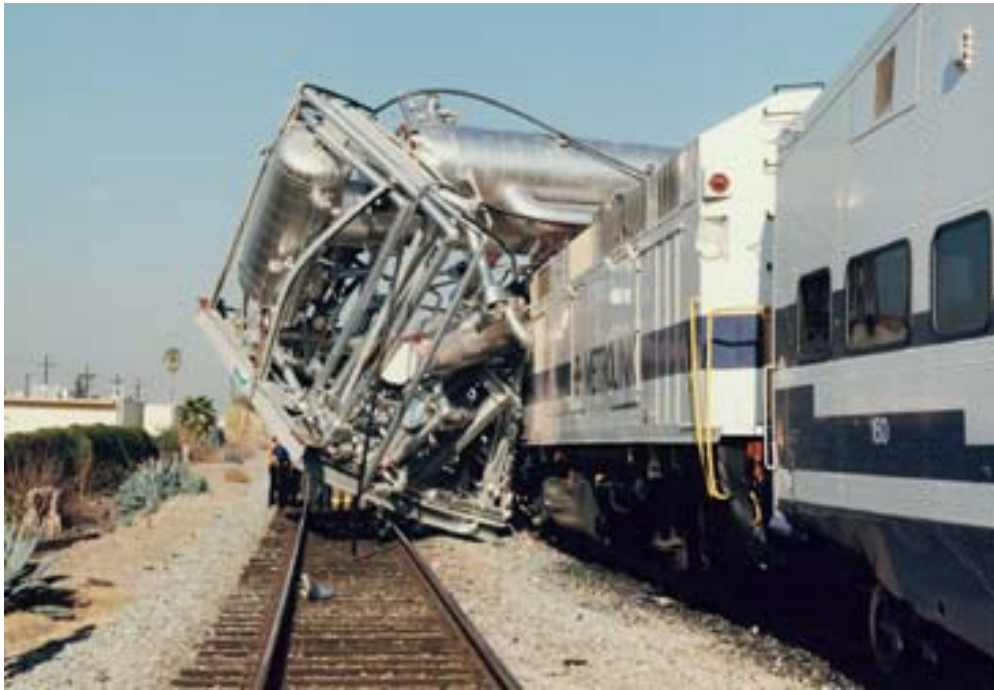
Figure 11. Postcollision view of condenser and train. (Photograph source: Glendale, California, Police Department.)

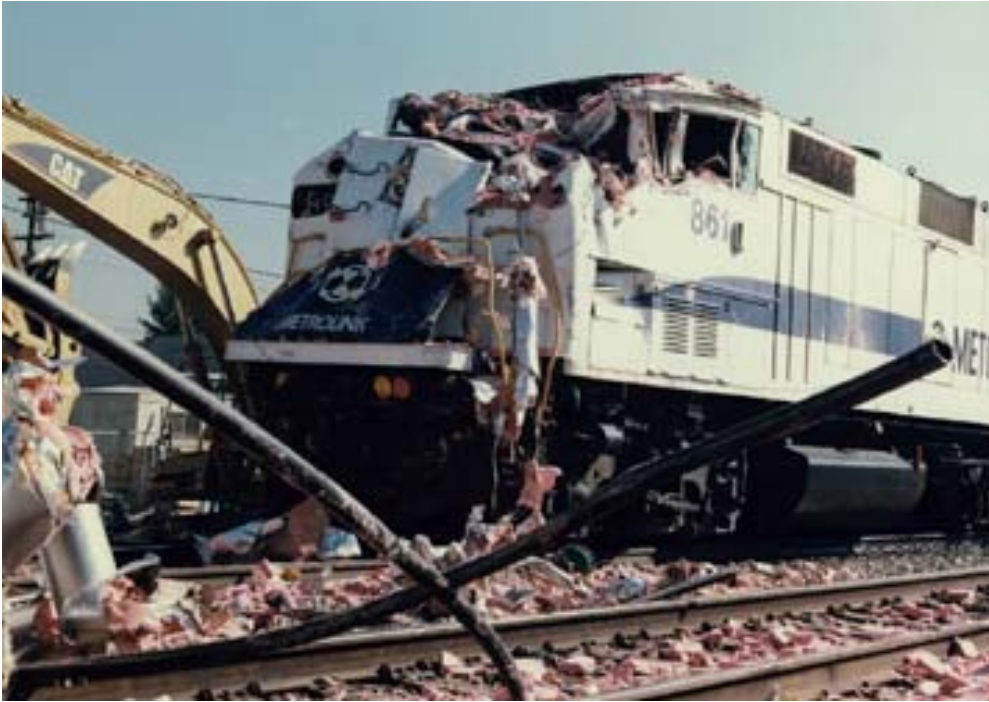
The collision resulted in severe damage to the locomotive (see figure 12) and minor exterior sheet metal damage to two coaches. The signal mast, lights, bells, and gate on the north side of the crossing were removed in the collision. No significant track damage occurred. The tractor was not damaged. The vehicle separated into three parts, and the oil refinery condenser was destroyed. (See table 2.)

Figure 12. Postcollision view of locomotive. (Photograph source: Glendale, California, Police Department.)

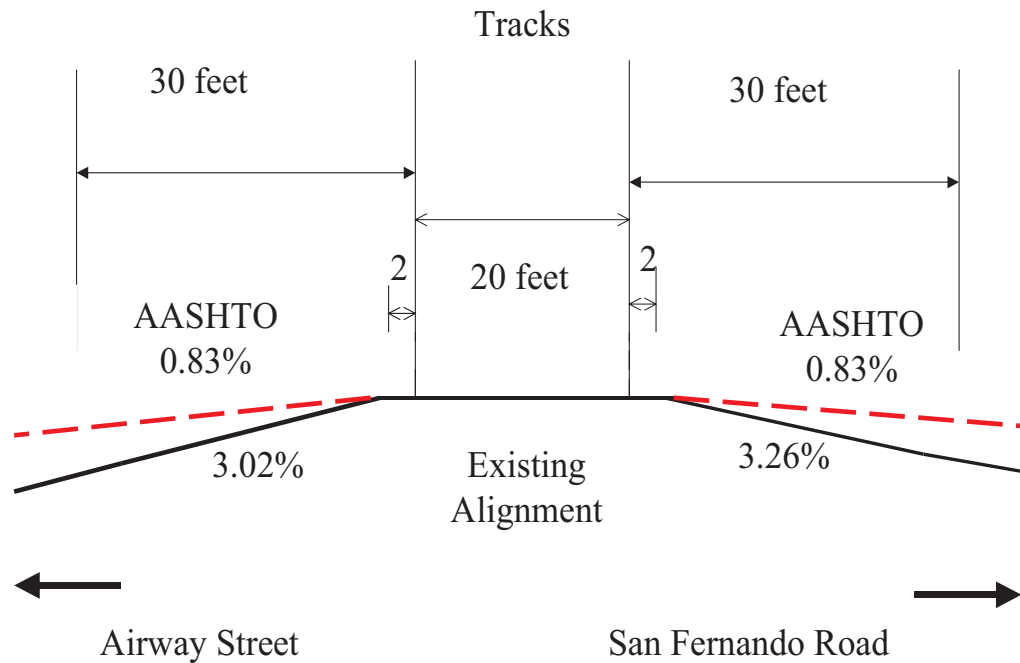
Figure 15. Diagram of Grandview Avenue grade crossing alignment.

Adopt the proposed changes that are published in the notice of proposed amendments to the *Manual on Uniform Traffic Control Devices* regarding warning signs for substandard vertical profiles at railroad grade crossings.
