RAILROAD ACCIDENT REPORT

REAR-END COLLISION OF NATIONAL RAILROAD
PASSENGER CORPORATION (AMTRAK) TRAIN P286
WITH CSXT FREIGHT TRAIN Q620 ON THE CSX
RAILROAD AT SYRACUSE, NEWYORK
FEBRUARY 5, 2001

**NTSB/RAR-01/04
PB2001-916304
Notation 7411
Adopted November 27, 2001**

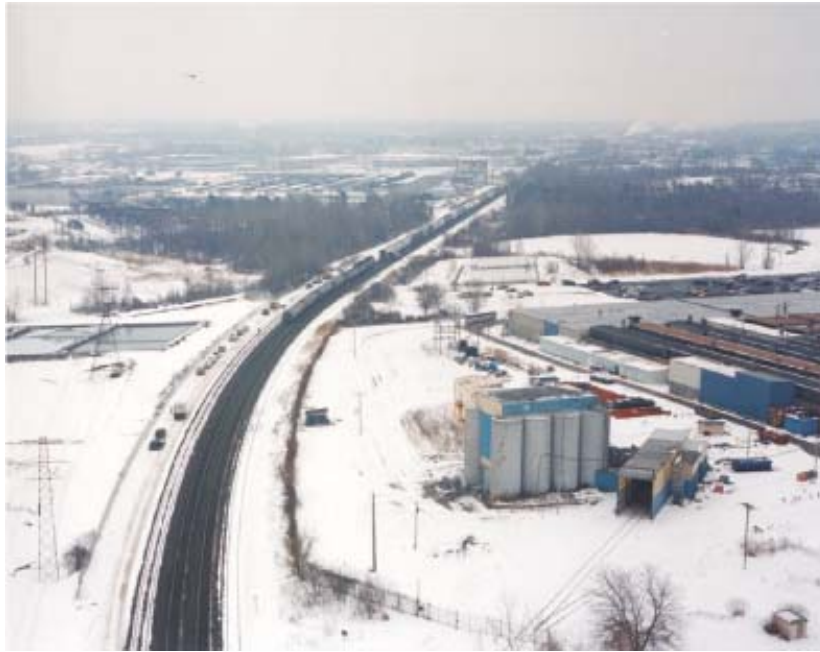
According to locomotive event recorder data, Amtrak train 286 went into emergency braking at about 57 mph about 840 feet from the rear of train Q620. At impact, the Amtrak train was traveling 35 mph. The freight train, which had proceeded again after stopping, was then moving eastbound at 7 mph, resulting in an effective impact speed of about 28 mph. The accident occurred about 11:40 a.m. (See figures 3 and 4.)

Figure 3. Looking east shortly after the collision, with the Syracuse China plant and parking lot on the right.

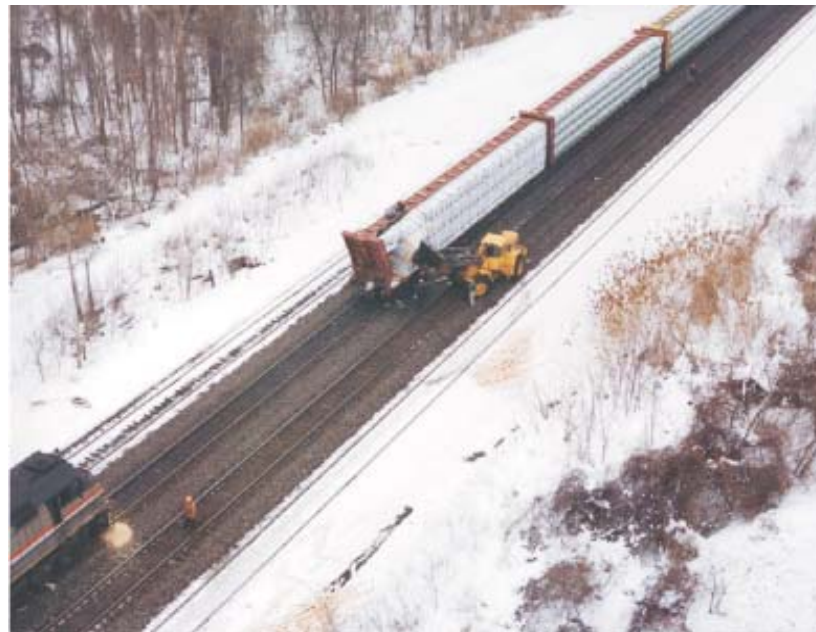
Figure 4. Postaccident positions of the end of the CSXT freight train and the lead Amtrak locomotive unit.

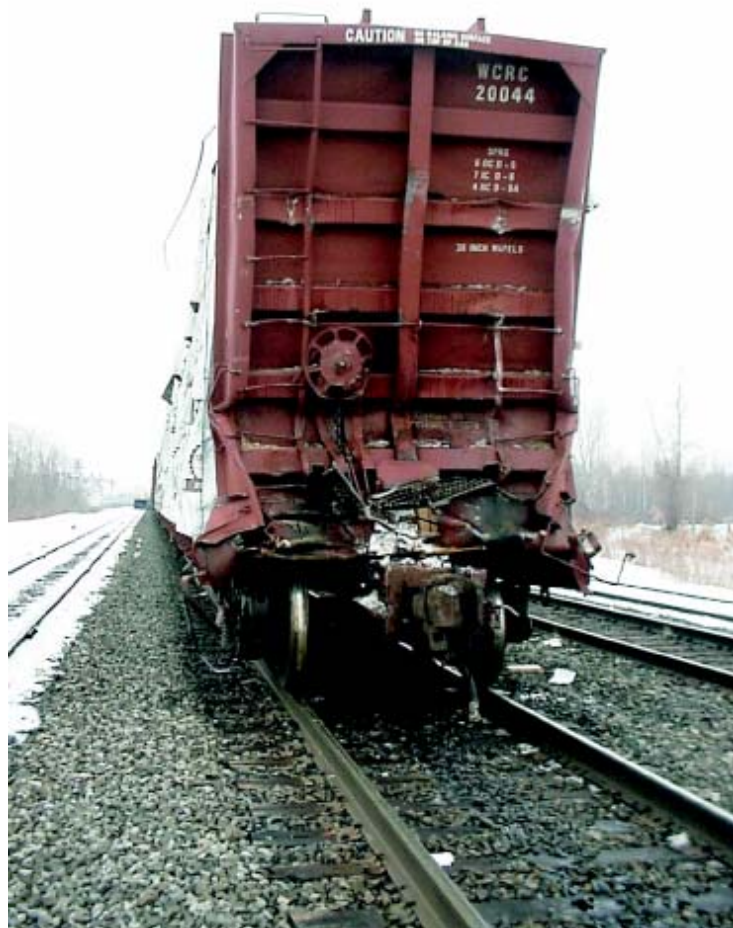
Figure 5. Damaged rear freight car of CSXT freight train Q620.

Upon impact, the CSXT freight train end-of-train device was destroyed. The brake pipe on the last car was also severed, which caused the CSXT train brakes to apply in emergency. The rear truck of the last freight car derailed. The last freight car lost a portion of its load of lumber. (See figure 5.) Total CSXT damage was \$7,581 for cars and lading. Except for a section of track that had rolled onto its side under the derailed rear freight car, the track structure remained relatively undisturbed with no significant change in track structure or geometry. Cost of repositioning and re-spiking the rolled rail was estimated at about \$600.

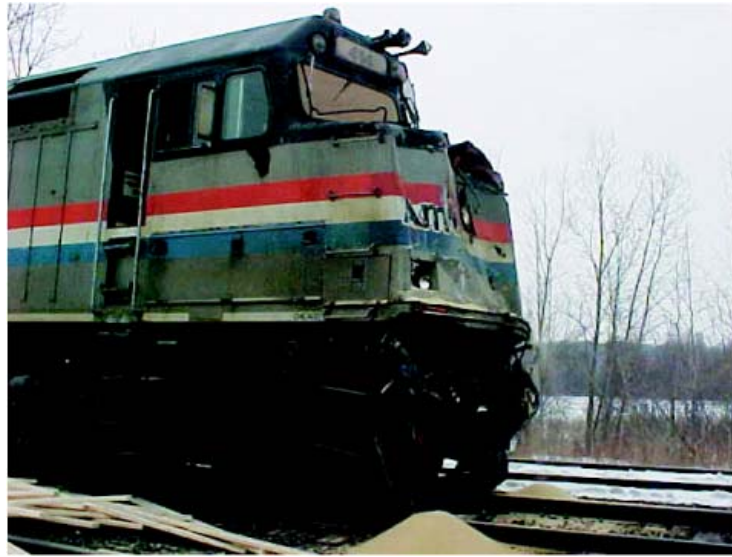
Figure 6. Damaged lead locomotive of Amtrak train 286.

The Amtrak lead locomotive, Amtrak 414 (figure 6), suffered damage to the nose, pilot, plow, front coupler, draft gear, coupler pocket, front collision post at deck level, electrical wiring and associated conduits, front trucks and derailed right and left No. 2 wheels, and No. 1 traction motor. Total damage was estimated to be \$200,000.

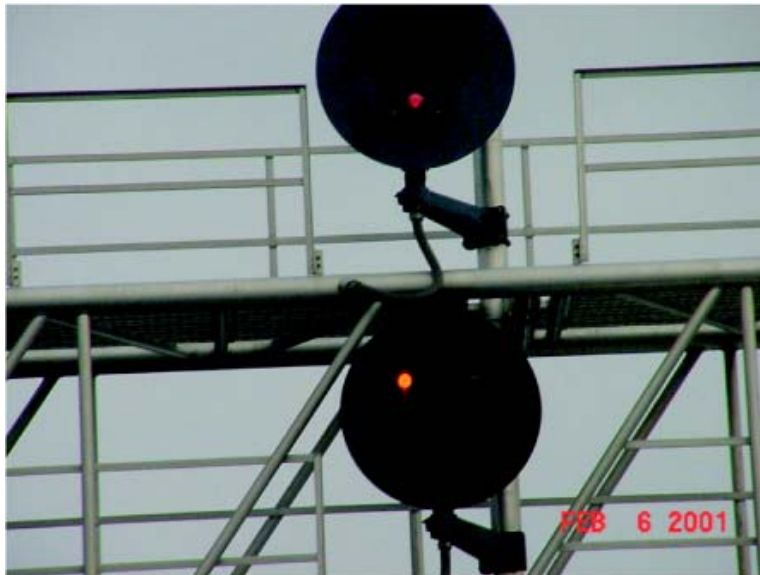
Figure 7. Close-up view of signal 6E. (Signal intensity not representative of actual appearance.)

The signal designated “6E” at the entrance to CP 290 used two US&S model CR-2 triangular color light signal heads mounted one above the other. (See figure 7.) Each of the two signal heads was mounted on a 36-inch-diameter circular background. The signal heads themselves consisted of a square housing with three 8 3/8-inch-diameter clear Lexan lenses in a triangular configuration. Behind each clear lens was a 5-inch-diameter colored lens of red, yellow, or green. Behind each of the three colored lenses was a GE SC-11 light bulb of a nominal 10 volts d.c. and 18 watts.

After the accident, the bulb for the red display on the top signal head of signal 6E (which was lighted at the time Amtrak train 286 passed the signal) was measured at 9.6 volts d.c. The bulb for the yellow display of the bottom signal head (lighted for train 286) was measured at 9.4 volts d.c. The flasher relay that causes a signal bulb to flash for certain signal aspects was found to be working as designed.
