**Derailment of CSX Transportation Coal Train V986-26
at Bloomington, Maryland, January 30, 2000**

RAILROAD ACCIDENT REPORT
NTSB/RAR-02/02 (PB2002-916302)

**NTSB/RAR-02/02
PB2002-916302
Notation 7445
Adopted March 5, 2002**

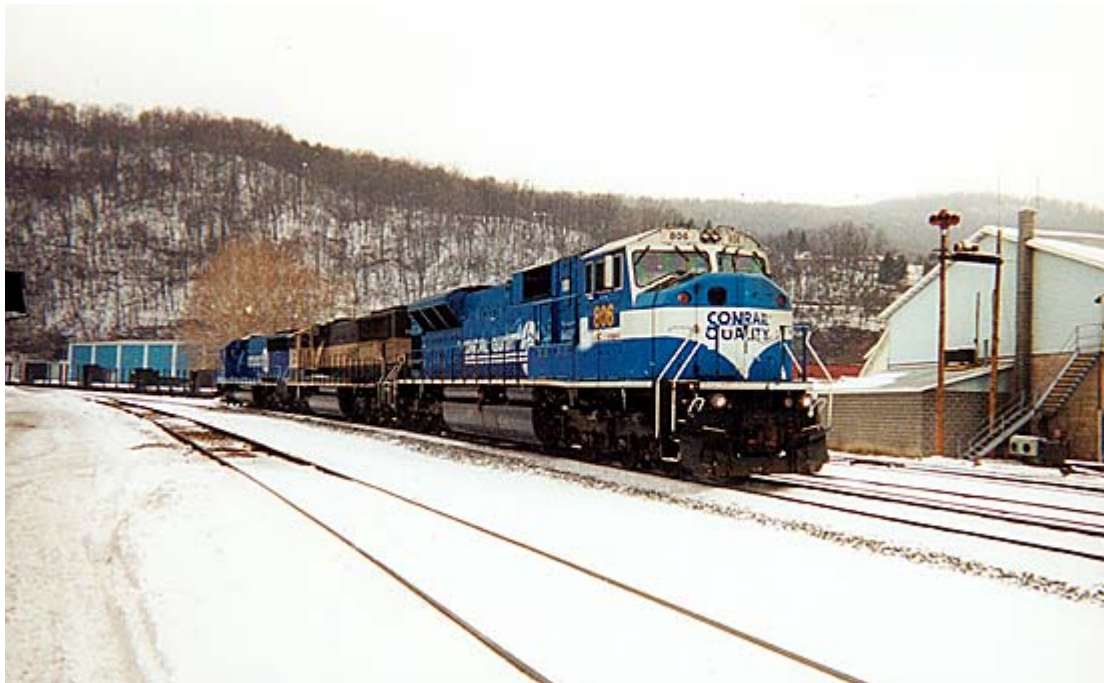
Figure 2. Accident locomotive consist.

Mechanical personnel from the Cumberland locomotive shop tested the dynamic braking system about 1:30 p.m. on January 31 at Westernport, Maryland. The testing was under the auspices of FRA inspectors. The No. 24 pin socket of the multiple-unit cable between the first and second locomotive units was defective. The defect prevented the dynamic brake excitation voltage of the lead unit from reaching the two trailing units. Thus, only the lead unit produced dynamic braking. Testers replaced the defective multiple-unit cable and performed both a static and running test of the dynamic brake system of the locomotive consist. The system then worked properly.

Dynamic braking on the two trailing locomotive units, while available, could not be activated because of the defective multiple-unit cable between the first and second locomotive units. Because he did not have the benefit of full dynamic braking, the engineer had to increase the air brake application beyond what normally would have been expected in order to control speed. By so doing, he unwittingly overheated the tread-brake system. Further, the maximum authorized speed for the accident grade had been established based on the assumed availability and use of dynamic braking. Judging from the CSXT's experience of successfully negotiating 17-mile grade at the maximum authorized speed, the combination of dynamic and air braking was, in fact, adequate to hold a train at or under the established maximum authorized speed as the train progressed down the grade. The Safety Board concludes that if all the available dynamic braking could have been activated on the accident train, the derailment probably would not have occurred.

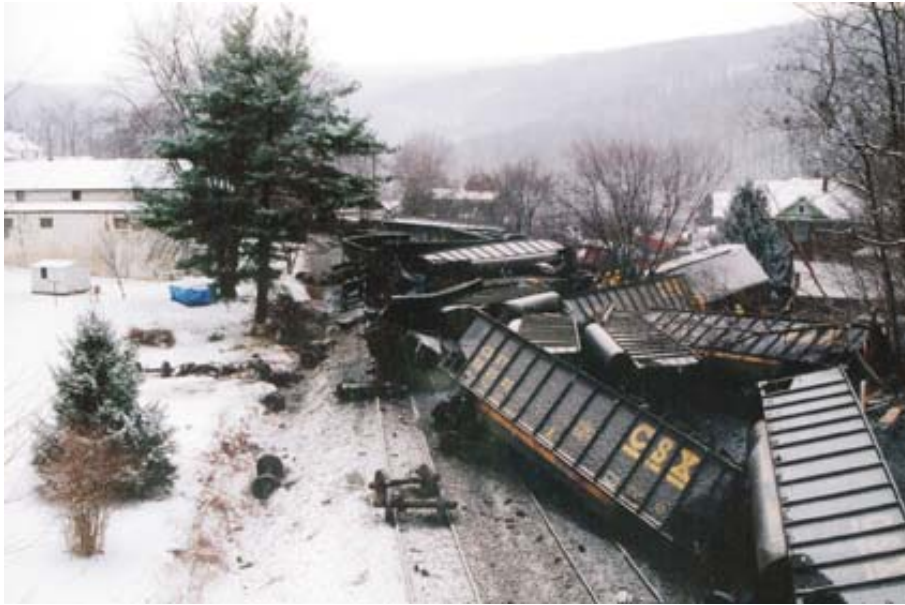
the 42 derailed in a general pileup. (See figure 3.) Some of the 41 derailed cars struck a nearby occupied residence, destroying the house and killing a 15-year-old boy and seriously injuring his mother. (See figure 4.) Three other occupants of the house escaped with minor or no injuries. Some of the 41 cars also broke a gas pipeline inside a transfer building near the track; as a result, about 101 customers of Columbia Gas of Maryland temporarily lost natural gas service.

Figure 3. Pileup of derailed coal cars.

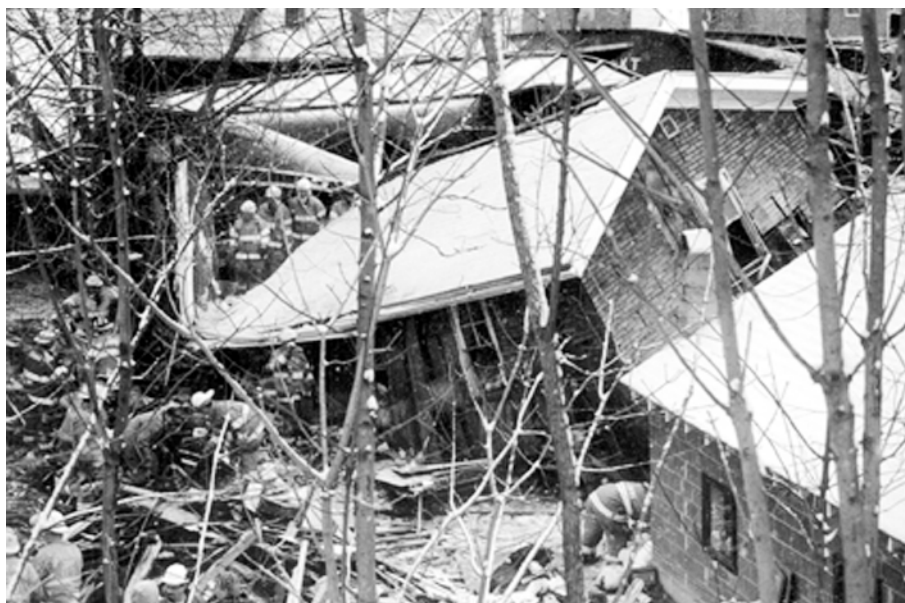
Figure 4. Destroyed residence where one fatal and one serious injury occurred.
