Derailment of Amtrak Auto Train P052-18 on the CSXT Railroad Near Crescent City, Florida April 18, 2002

Railroad Accident Report **NTSB/RAR-03/02**

**NTSB/RAR-03/02
PB2003-916302
Notation 7487A
Adopted August 5, 2003**

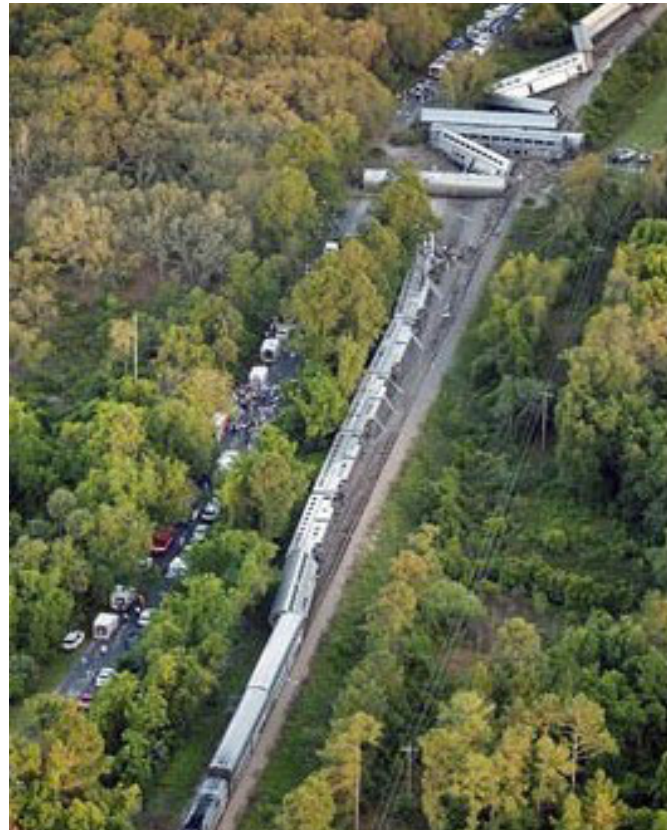
Figure 2. Aerial view of accident site.

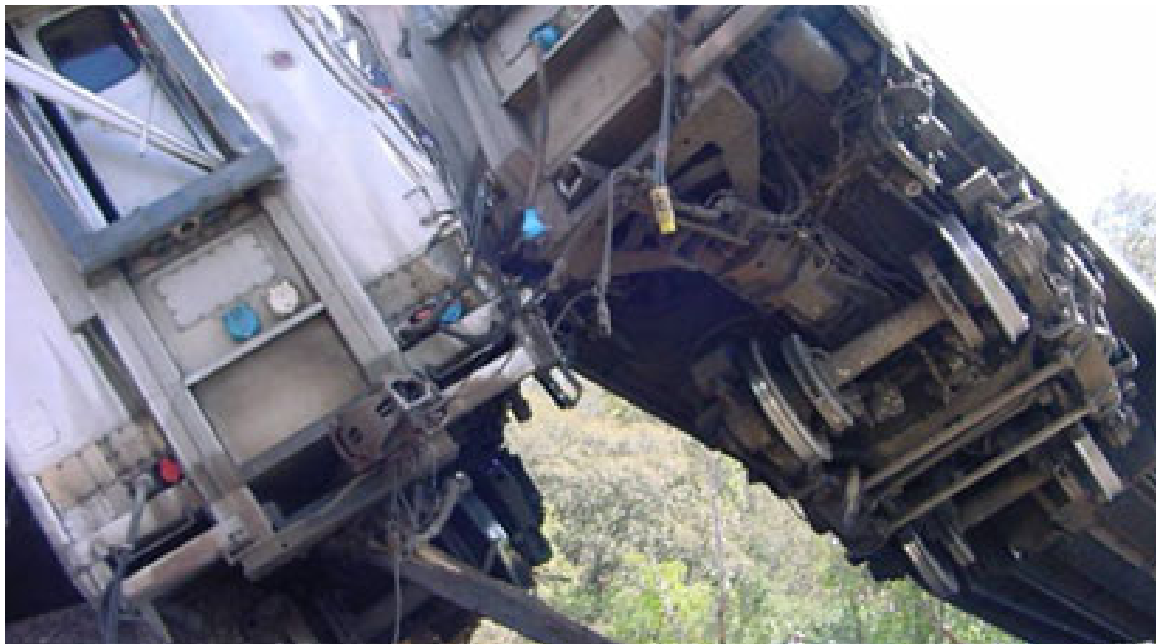
Figure 3. View of two cars after the accident.

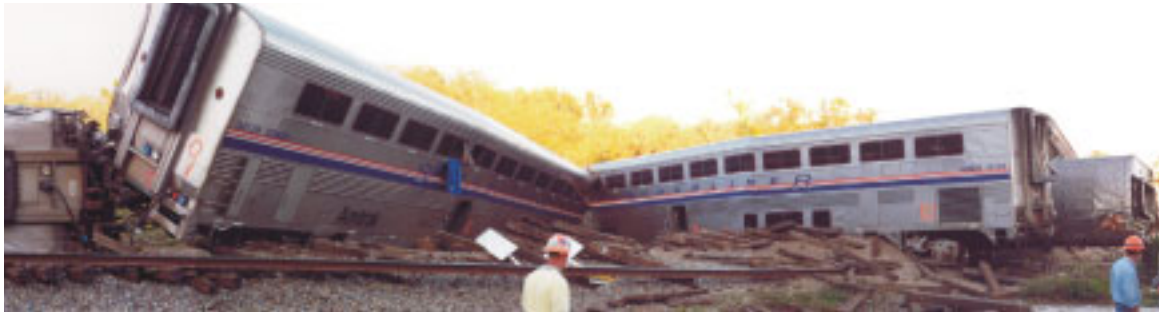
Figure 4. Figure 4. Panoramic/composite image view of derailed cars. (Photo source: Putnam County Sheriff's Department. Panoramic/composite view developed by the Safety Board.)

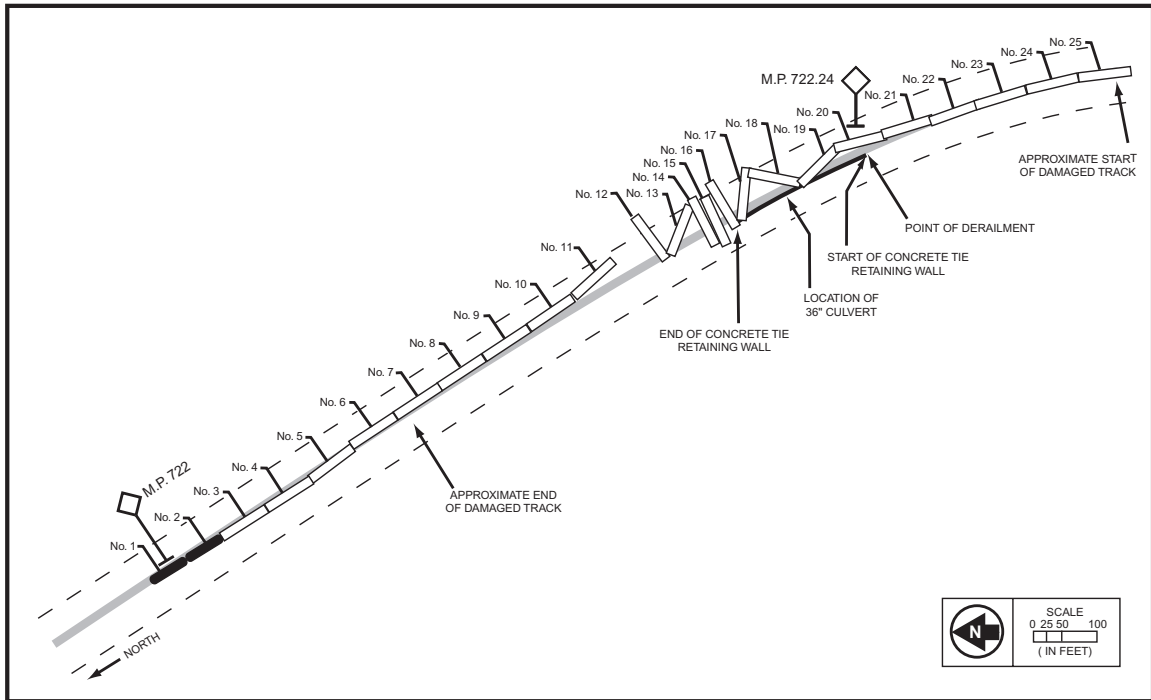
The 3rd through 23rd cars derailed during the accident. The first 16 cars in the train behind the locomotive units were Amtrak Superliner passenger cars; these were followed by 24 autorack cars. After the derailment, the locomotive units and first two passenger cars remained on the rails. The next 14 passenger cars and the 7 succeeding autorack cars derailed. The 7 derailed autorack cars remained generally in-line. The remaining 17 autorack cars stayed on the rails. (See figure 5 and table 2 for the postaccident disposition of the 2 locomotive units and the first 23 cars of the train.)

Figure 5. Postaccident disposition of 2 locomotive units and first 23 cars in accident train. (See table 2 for specific information concerning each locomotive unit and car.)

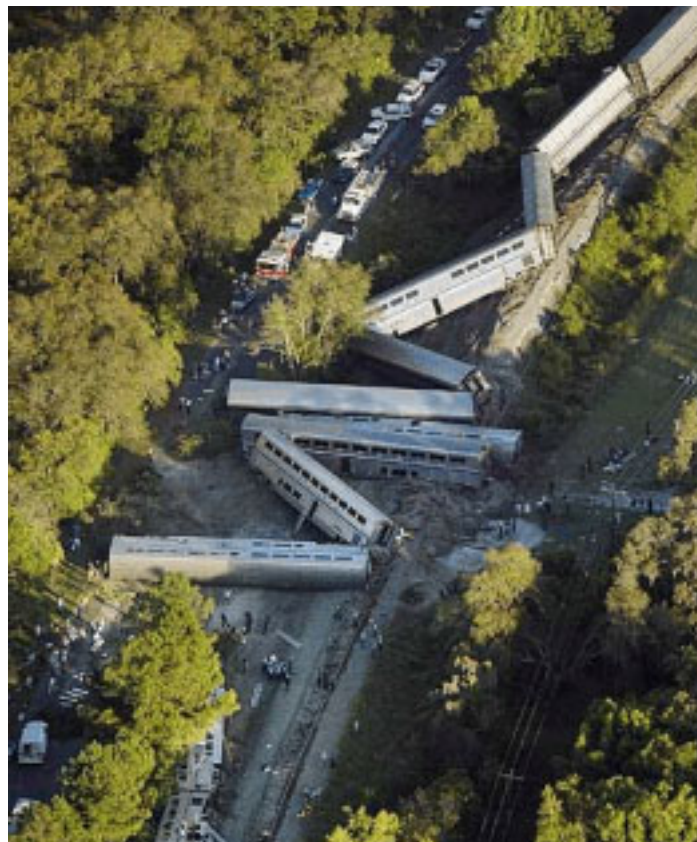
The disposition of the derailed cars, particularly the passenger cars, reflected the accordion effect of railcars when they derail, alternately folding together in parallel fashion, perpendicular to the track. (See figure 6.)

Figure 6. Aerial view of derailment showing accordion effect of derailed cars.

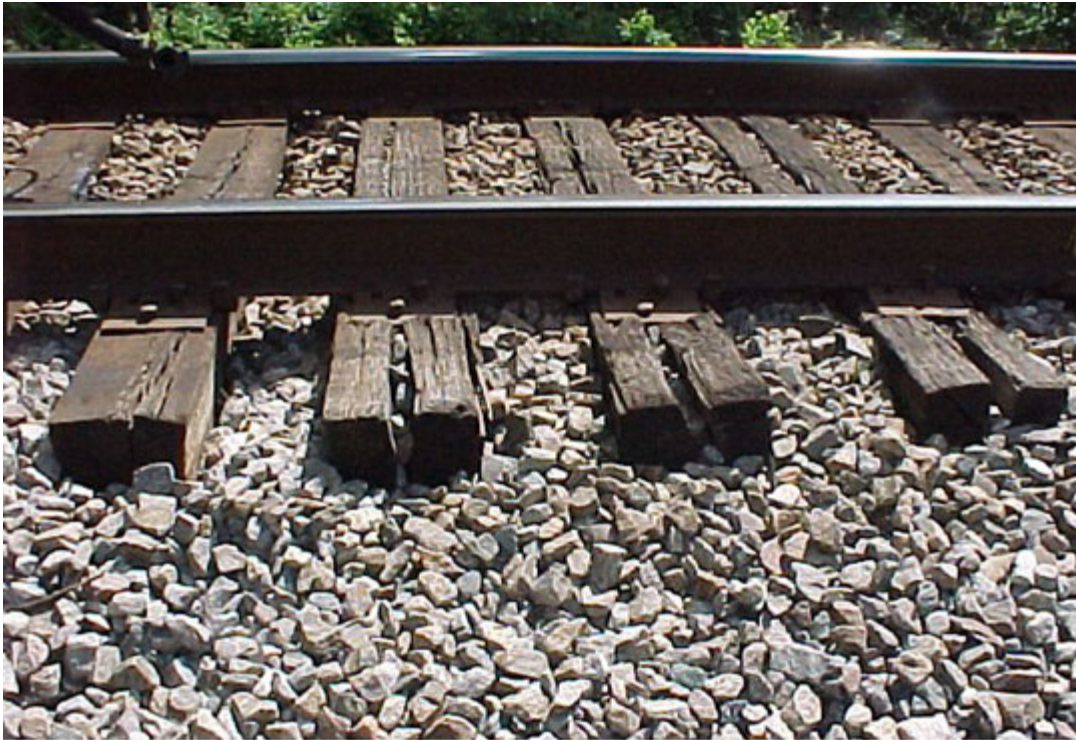
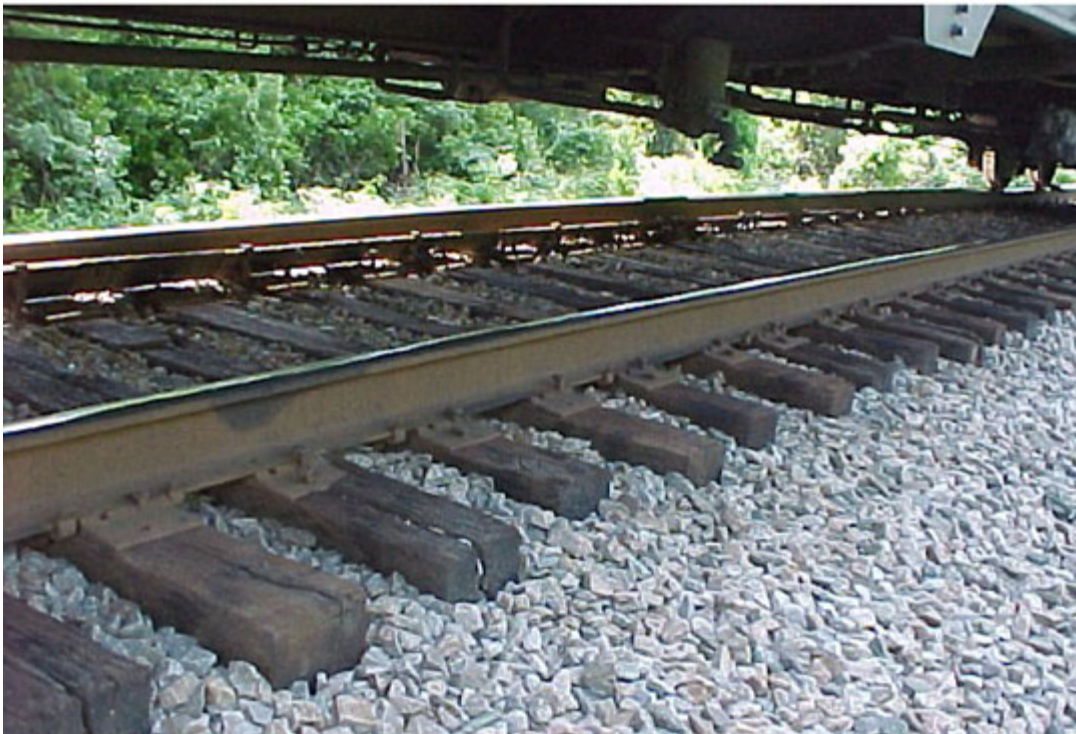
Figure 8. Ballast conditions in accident curve.

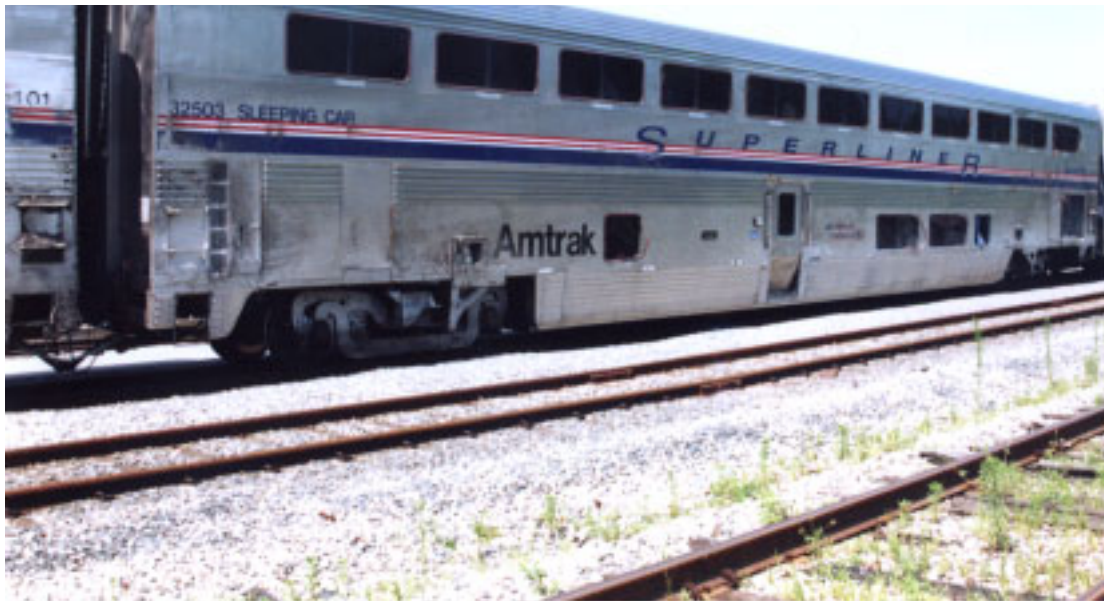
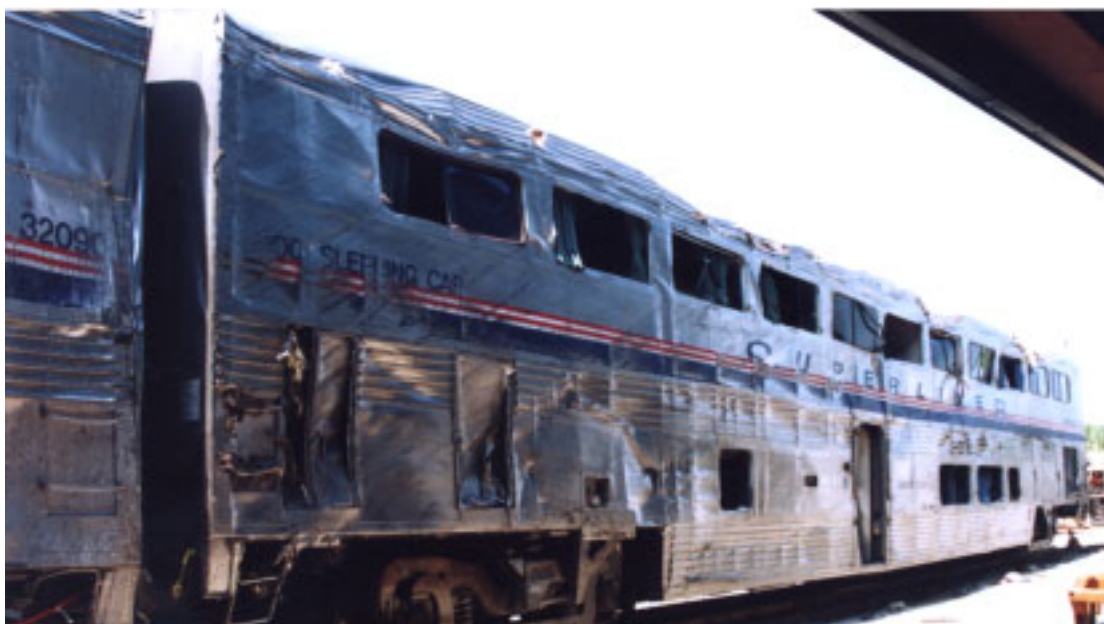
The exterior right-side sidewall panels of Superliner railcars #32074, #32503, #33101, #38052, #32501, and #32100 exhibited denting, abrasive markings, and battering damage. They also displayed obvious rounded indentions in the roofline between the transverse structural members of the roof. Such damage, which was most prominent in Superliner railcars #32501 and #32100, was consistent with a car body sidewall and roofline that had come into contact with objects along the railroad right-of-way and/or the terrain and/or damaged trackage right-of-way (track ballast, crossties, and/or running rail) during a derailment and subsequent rollover of the railcar. Examination of the damage indicated that the sidewall and roofline elements had become severely warped and displaced from their normal configurations, in a manner consistent with the action that could have contributed to the dislocation of the window grommets and the dislodgment of the window framing structures. Small tufts of vegetation and remnants of splintered trees (severed branches and clusters of leaves) of a character similar to the trees along the perimeter of the track right-of-way were also found embedded in crevices of the mangled window frame elements of several of the damaged Superliner railcars. Remnants of dislodged and splintered trees were found along the track right-of-way near where the Superliner railcars came to rest.

Amtrak technical staff represented to Safety Board investigators that the damage sustained by the Superliner exterior sidewall window assemblies and their component elements in this accident was to a degree that was far beyond original intended design criteria. (See figure 11 for postaccident views of railcars with compromised windows.)

Figure 11. Postaccident Superliner sleeper cars. Top photo shows car 32503 with damaged lower level sidewall windows and largely undamaged upper level windows. Bottom photo shows car 32100 with compromised sidewall windows on both levels.

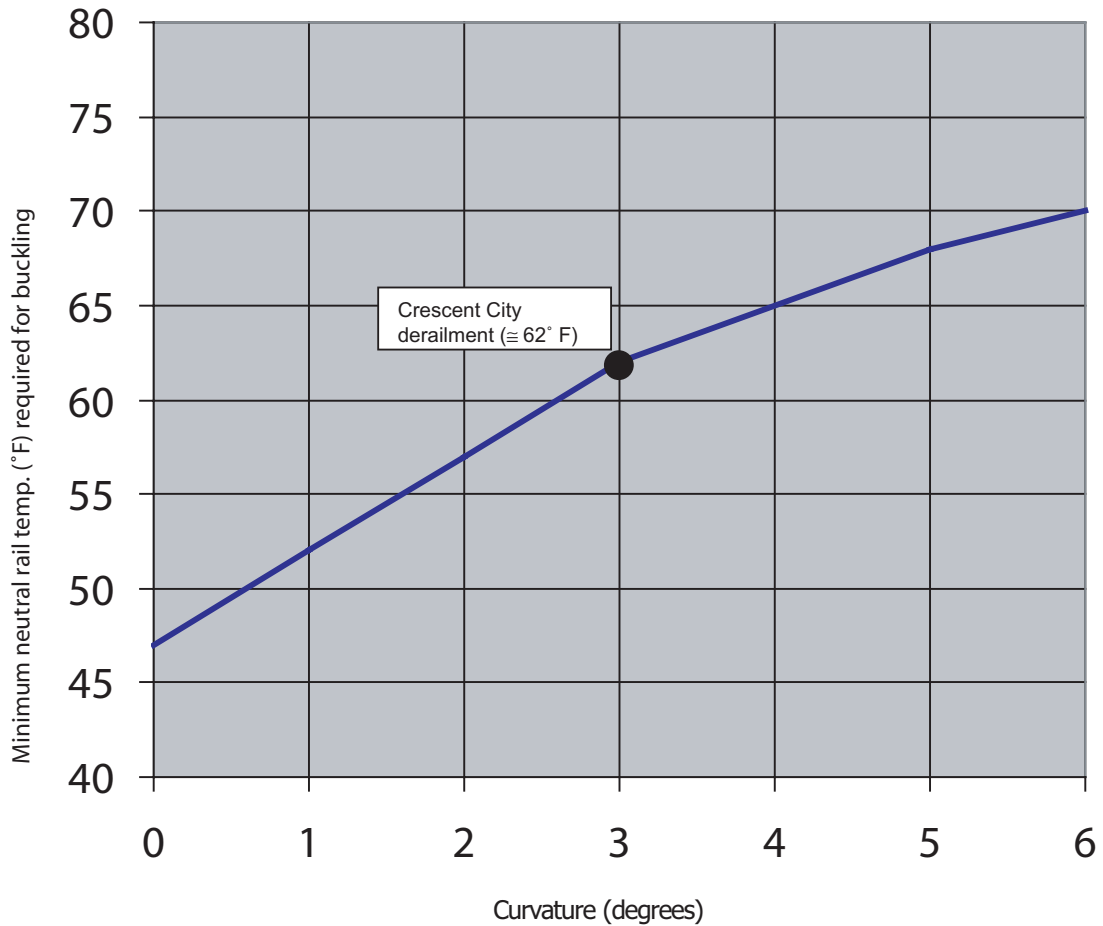
Analysis was also performed for different conditions and parameters. Had the actual rail temperature at the time of the derailment been higher, at 120° F, then the neutral

Minimum neutral rail temperature requirements for buckling prevention (Rail temperature = 115° F; Class 3 line defect)
