National Transportation Safety Board

Railroad Accident Brief

Accident No.: DCA-04-FR-007
Location: Queens, New York
Date of Accident: March 10, 2004
Time: 2:18 p.m. eastern standard time¹
Railroads: Long Island Rail Road and New York & Atlantic Railway
Accident Type: Multiple highway/railroad grade crossing collisions
Injuries: 4
Damages: \$83,000

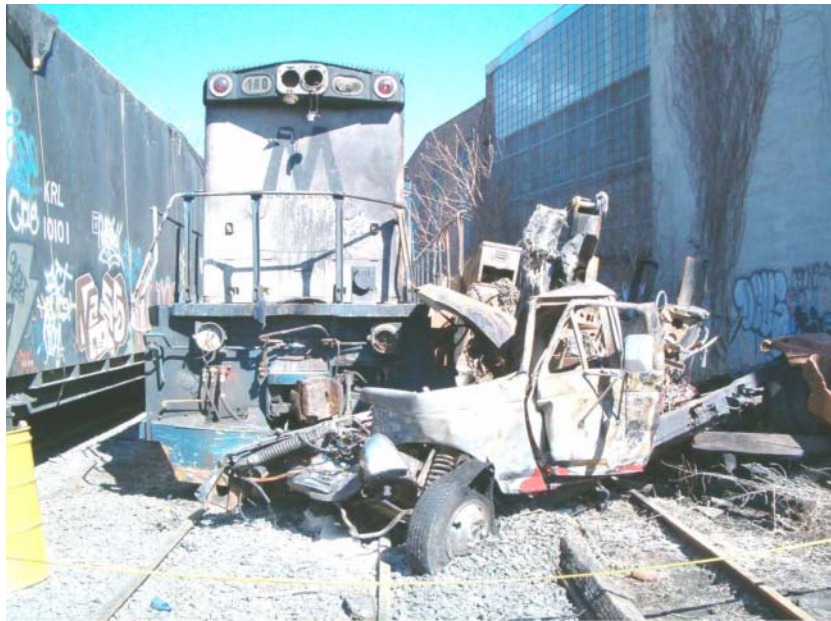
As LIRR 160 collided with the automobiles and trucks, the struck vehicles were propelled in different directions and struck other vehicles. As a result, the accident damaged five other vehicles and a backhoe.¹⁰ (See figure 1.)

Figure 1. Locomotive after collisions.

LIRR 160 did not derail. The fire following the collision with the two trucks damaged the front of the locomotive.
