National Transportation Safety Board  
Washington, D.C. 20594

Railroad Accident Brief

Accident No: DCA-04-FR-012  
Railroad: Alton and Southern Railway Company  
Train: Remote Control Train YAS313  
Location: East St. Louis, Illinois  
Accident date: September 21, 2004  
Accident time: 3:15 a.m. central daylight time<sup>1</sup>  
Type of Accident: Remote control collision in hump classification yard and hazardous materials release  
Fatalities/Injuries: None  
Property Damage: \$607,365

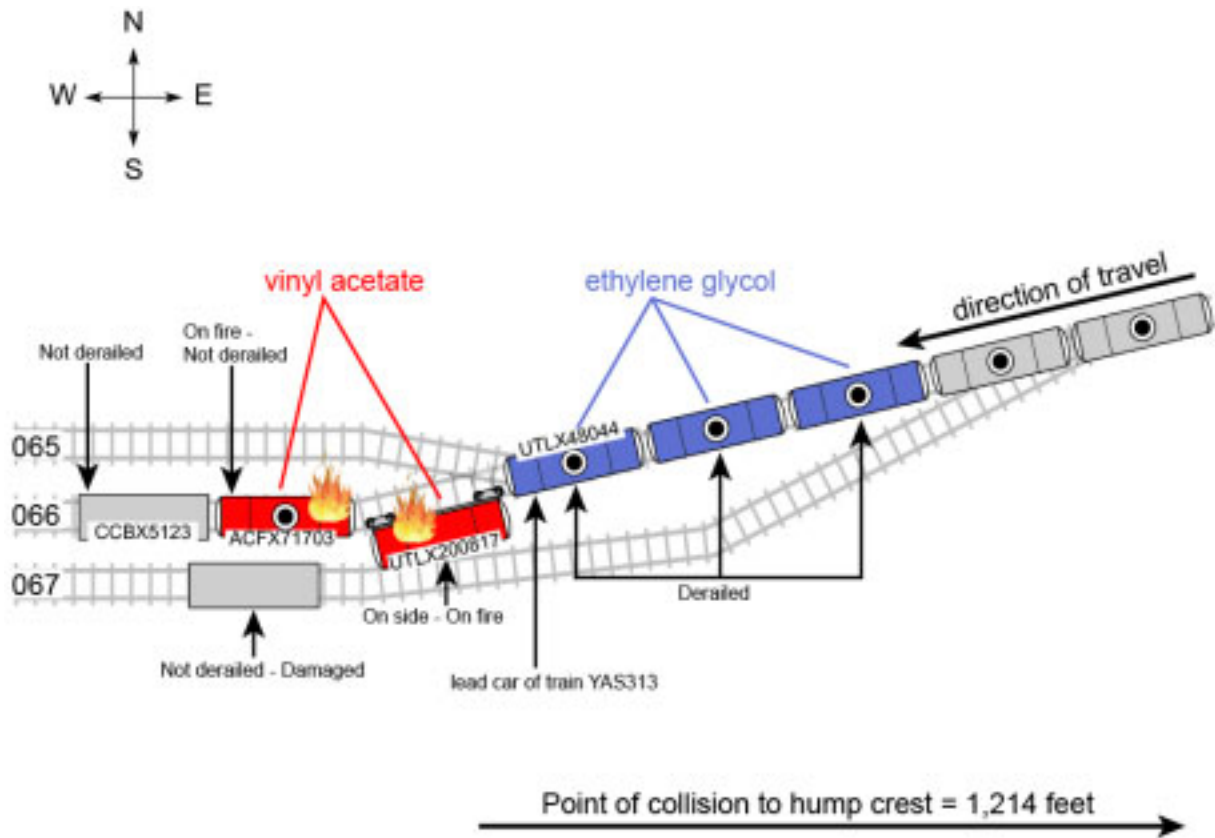
The 20-car train struck the first of the three stopped cars on track 066. (See figure 1 for a diagram of the collision and subsequent derailment.) The lead wheels of the first car in the train (tank car UTLX 048044) lifted as the car struck the first stopped car (tank car UTLX 200817), which contained vinyl acetate. UTLX 200817 was near, but not coupled to, the second stopped car (tank car ACFX 71703), which also contained vinyl acetate. When the train struck UTLX 200817, the two vinyl acetate tank cars (UTLX 200817 and ACFX 71703) missed coupling and their shelf couplers breached each other’s tanks, and UTLX 200817 rolled onto its side. Subsequently, the cargo from both cars—26,000 gallons of vinyl acetate each—caught on fire. In addition, the lead three cars of the train, all of which were tank cars containing ethylene glycol, derailed. These tank cars derailed in line and were not punctured or involved in the fire.

**Figure 1.** Diagram of collision and subsequent derailment.
