**Derailment of Amtrak Train No. 58,  
*City of New Orleans*, Near Flora, Mississippi  
April 6, 2004**

**Railroad Accident Report**  
**NTSB/RAR-05/02**

**NTSB/RAR-05/02  
PB2005-916302  
Notation 7642A  
Adopted July 26, 2005**

**Abstract:** About 6:33 p.m. central daylight time on April 6, 2004, northbound National Railroad Passenger Corporation (Amtrak) train No. 58 (*City of New Orleans*), derailed on Canadian National Railway Company railroad track near Flora, Mississippi. The entire train, consisting of one locomotive, one baggage car, and eight passenger cars, derailed near milepost 196.5 while traveling about 78 mph. The train was carrying 61 passengers and 12 Amtrak employees. The derailment resulted in 1 fatality, 3 serious injuries, and 43 minor injuries. The equipment costs associated with the accident totaled about \$7 million.

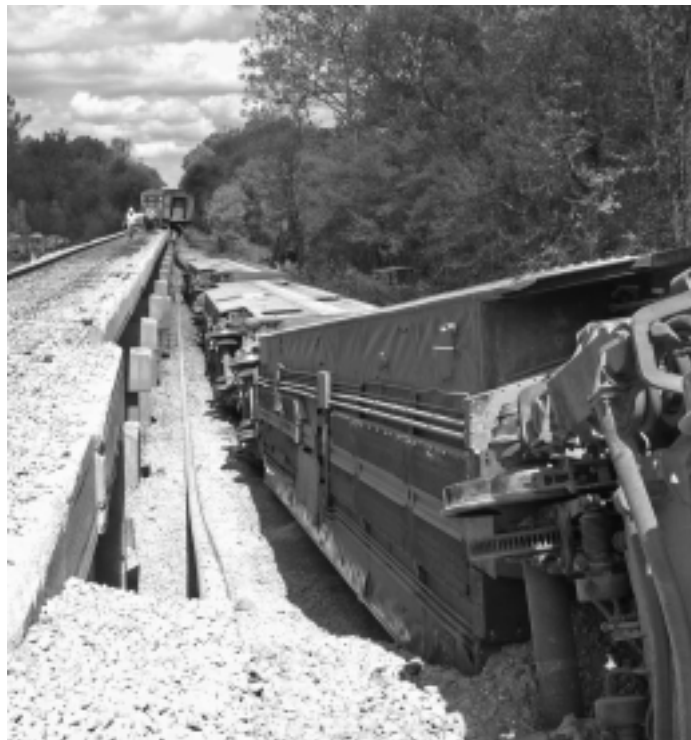
The entire train derailed beginning on the filled levee about halfway between the two bridges over the Big Black River. The locomotive and the baggage car reached the second bridge and came to rest upright, although the rear of the baggage car hung over the right side of the bridge. The remaining eight cars derailed to the right of the track. (See figure 2 for a photograph of the derailed train and figure 3 for a diagram of the accident aftermath.) The first passenger car, a transition sleeper car,<sup>4</sup> separated from the baggage car and went off the fill to the right of the track before it reached the second bridge. The transition sleeper and the seven cars following it remained coupled. The transition sleeper, the dining car, the lounge, and the first coach car rolled to the right 90° and came to rest on their sides on the flood plain below the bridge. The last four cars in the train did not reach the second bridge and were on the filled area of the track between the bridges when they derailed. The first of these cars rolled on its side on the downward slope of the raised fill and came to rest at about a 110° angle from upright. The second car tipped over 90°, the third car leaned at about a 45° angle, and the last car came to rest near the tracks in an upright position.

**Figure 2.** Wreckage of derailed train.

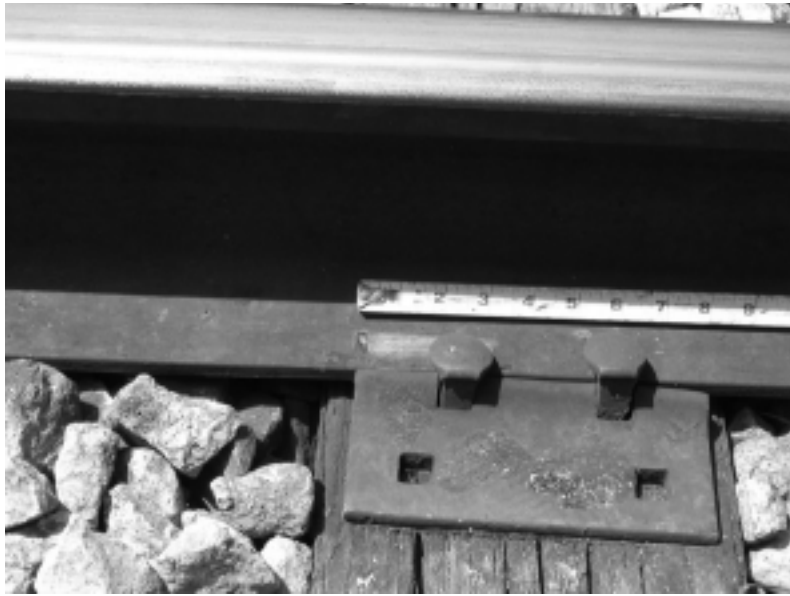
Just south of the derailment site, the rail was box anchored<sup>16</sup> at every tie on the 200-foot approach to the Big Black River Bridge. The rail on the open deck portion of the Big Black River Bridge was anchored on every tie with elastic metal clip fasteners.<sup>17</sup> (See figure 6.) The anchor applies pressure on the top of the base of the rail. If a rail moves longitudinally, shiny areas appear where the anchor contacts the rail. No shiny areas were found on the open deck portion of the bridge.

**Figure 5.** Abrasion marks on west rail.

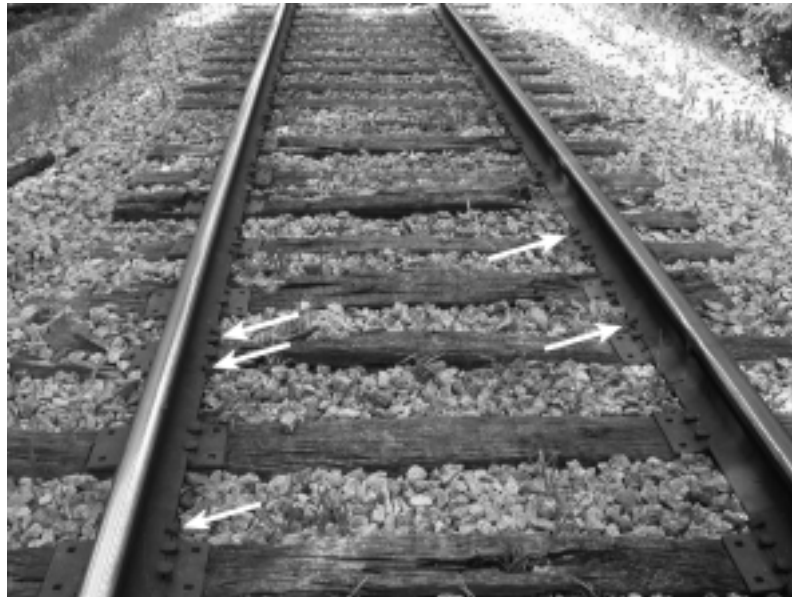
North of the 200-foot approach to the Big Black River Bridge, in the direction of the derailment site, was evidence that rail anchors had been applied to every other tie from the gage side. (See figure 7.) Investigators found 281 crossties in the area and 295 anchors placed against the sides of the ties. If the ties were box anchored on every other tie, that is, two anchors on each rail on every other tie, there would have been 281 anchors on each rail. The west rail had 144 anchors (51.25 percent), and the east rail had 151 anchors (53.74 percent). Additional anchors were lying on the ballast near by or away from the sides of the crossties.

**Figure 7.** Ties with few anchors, indicated by arrows.

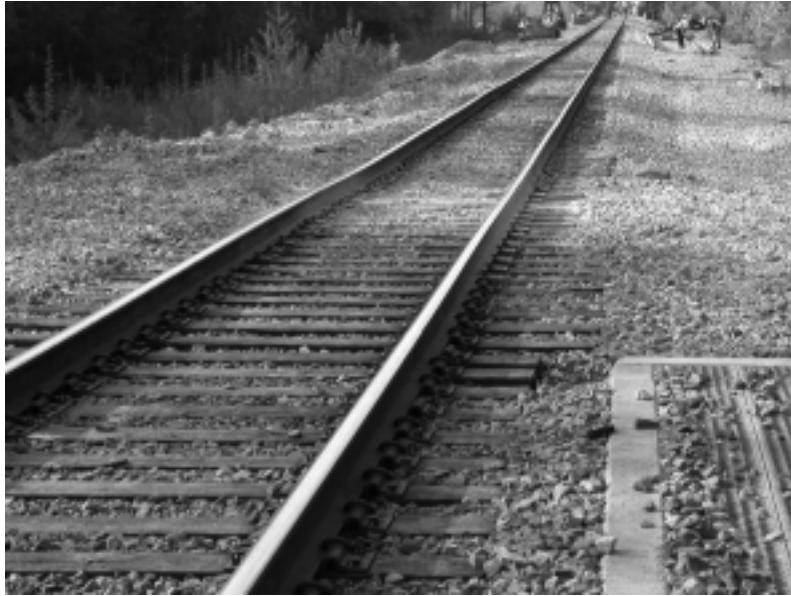
**Ballast.** The crossties were surrounded by limestone ballast approximately 24 inches deep and 12 inches wide on the outside for shoulder support. The areas between the ties (the tie cribs) were filled with ballast. Near MP 196.6 at the north approach to the Big Black River Bridge were signs of improper drainage from fouled ballast.<sup>18</sup> (See figure 8.) Title 49 CFR 213.103, the FRA regulation regarding ballast, states that

**Figure 8.** Fouled ballast.

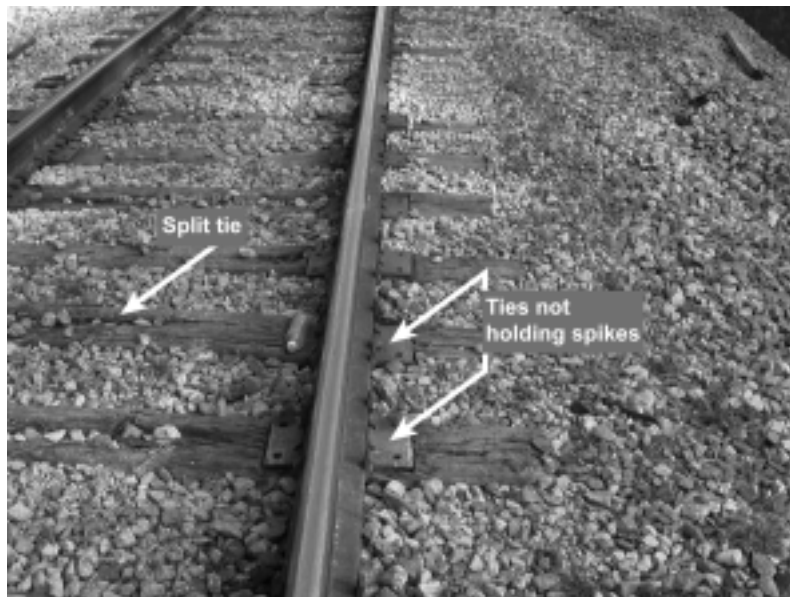
Several crossties near the point of derailment were broken through and split and showed signs of not holding the spikes. (See figure 9.) Neither the number nor the pattern of defective ties exceeded those allowed by the regulations. The crossties and track surface had been rehabilitated in 1998. CN had planned to do the next rehabilitation project for this area in the first quarter of 2005, but after the Flora accident, it accelerated the schedule. (See *Postaccident Actions* in the *Other Information* section of this report.)

**Figure 9.** Ties that are broken and not holding spikes.

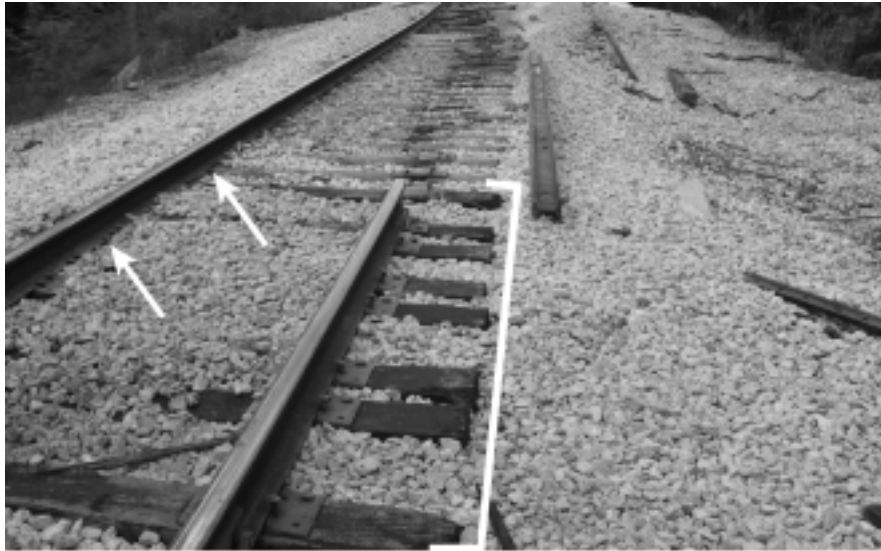
A few days later, the track foreman returned to the area to replace ties. Inserting the ties in two locations reinforced the correction of the gage problem and repaired the profile problem at the north end of the bridge. According to testimony by the track foreman, he “put the [existing] anchors back on” the area where the plug was inserted. As shown in figure 10, the new ties were not box anchored on every other tie. He maintained the speed restriction set earlier by the track inspector.

**Figure 10.** New ties with few anchors. Bracket indicates new ties. Arrows indicate anchors.

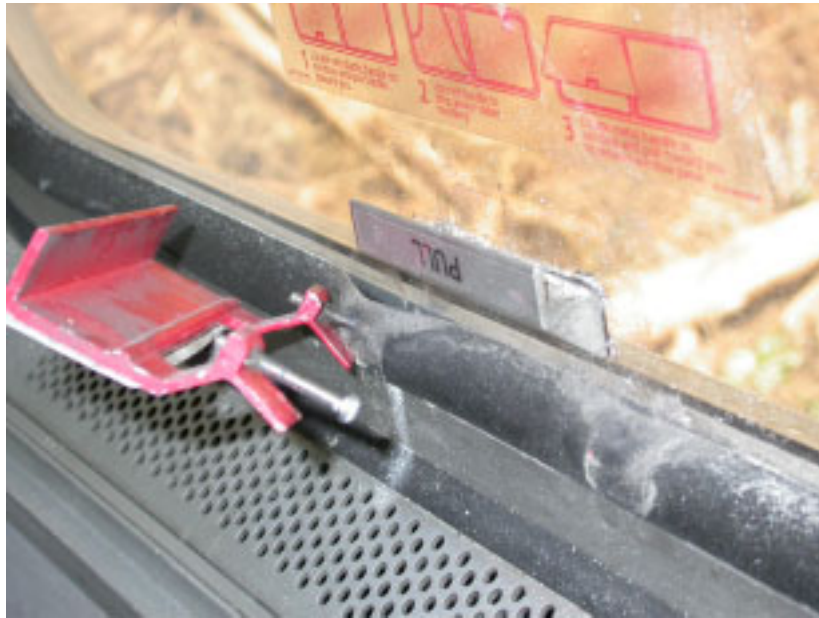
**Figure 11.** Emergency window handle that partially pulled free from rubber grommet.

9. The handle on an emergency window on the sleeper car was found to have failed.

Since the accident, Amtrak has informed Safety Board investigators that it will increase to four the minimum number of emergency windows tested per car during each 3-month cycle for all Superliner, Surfliner, and Viewliner passenger cars. If a failure is detected during the inspection, the same number of additional windows will be tested to ensure compliance and operability.
