National Transportation Safety Board Washington, D.C. 20594

Railroad Accident Brief

Accident No.: DCA-04-FR-004
Location: San Antonio, Texas
Date of Accident: December 7, 2003
Time: 12:12 a.m. central standard time¹
Railroad: Union Pacific Railroad
Accident Type: Railroad switching foreman struck by locomotives
Fatalities: 1
Injuries: 0
Damages: \$0

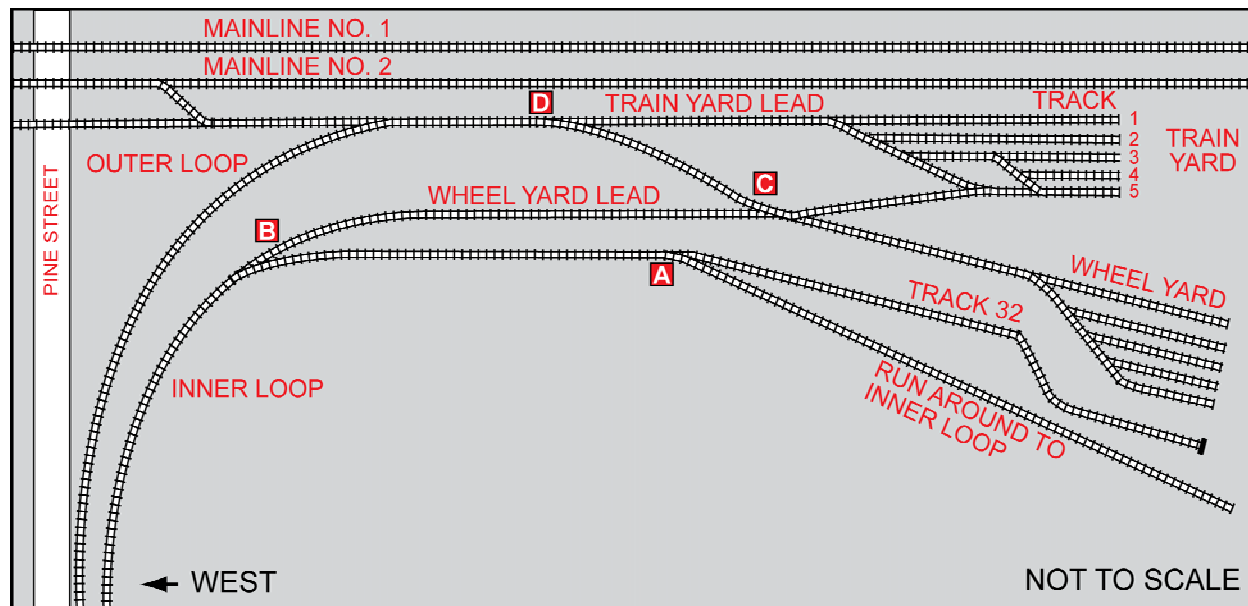
Figure 1. Track layout of west end of East Yard. (Letters A, B, C, and D indicate switches.)

through the first switch (labeled A in figures 1, 2, and 3) and four relatively short back-and-forth movements across three other switches (labeled B, C, and D in figures 1, 2, and 3).

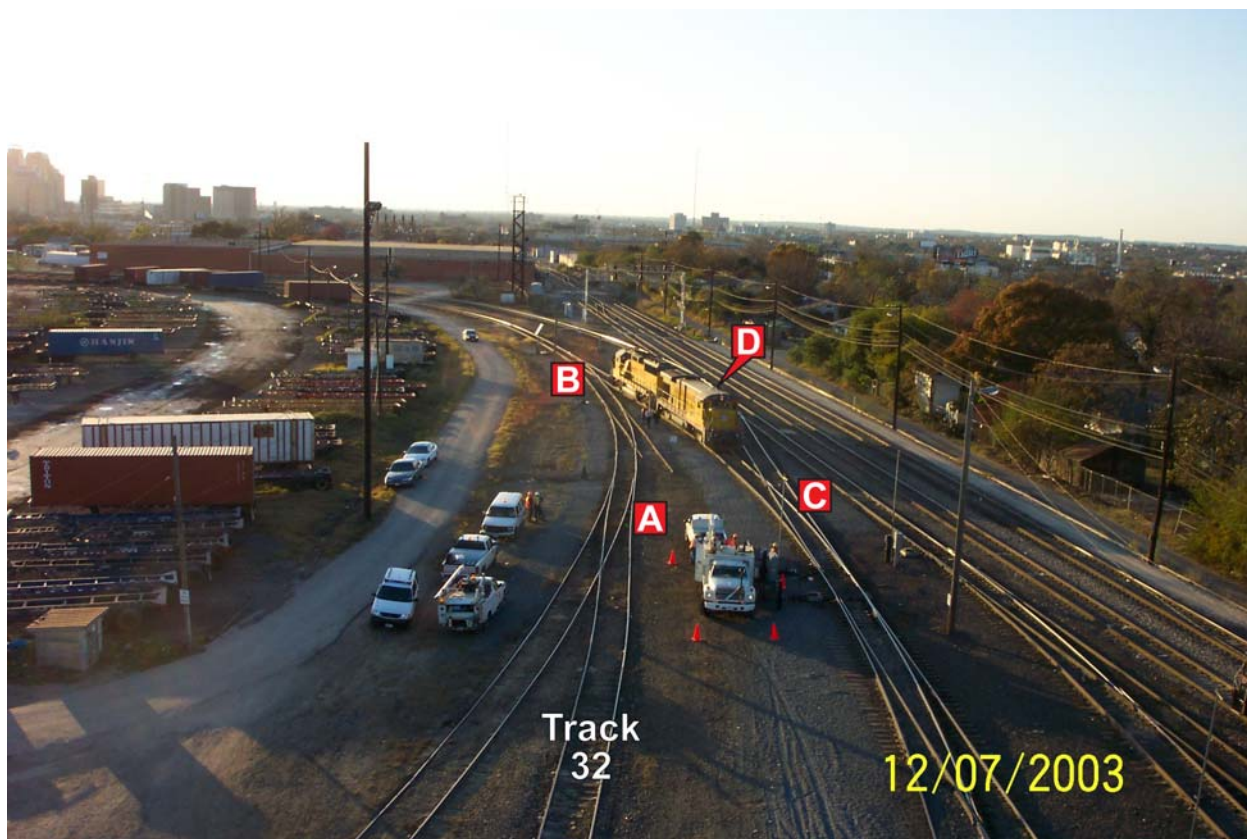
The event recorder data indicate that the locomotives responded to a remote control transmitter command, moved westward about 12:09 a.m. through switches A and B, and then stopped. Next, switch B was aligned by a radio control command, the locomotives were moved eastward back through switches B and C, and then the locomotives stopped. The locomotives were then moved westward back over the same track toward switch B, instead of moving over the intended track and switch D. About 12:12 a.m., a stop command from the remote control transmitter was recorded about the time the third-shift foreman was struck. The locomotives were found later standing on the wheel yard lead track with the west end of the leading locomotive about 237 feet from the switch points of the last switch traversed, switch C. (See figure 2.)

The wheel yard lead to the train yard lead east crossover switch (C) was found aligned toward the inner loop. For the locomotives to reach the train yard lead and the train yard track 3, switch C should have been aligned in the other direction.

Figure 2. Exemplar locomotives are shown near postaccident point-of-rest location. (Letters A, B, C, and D indicate switches.)

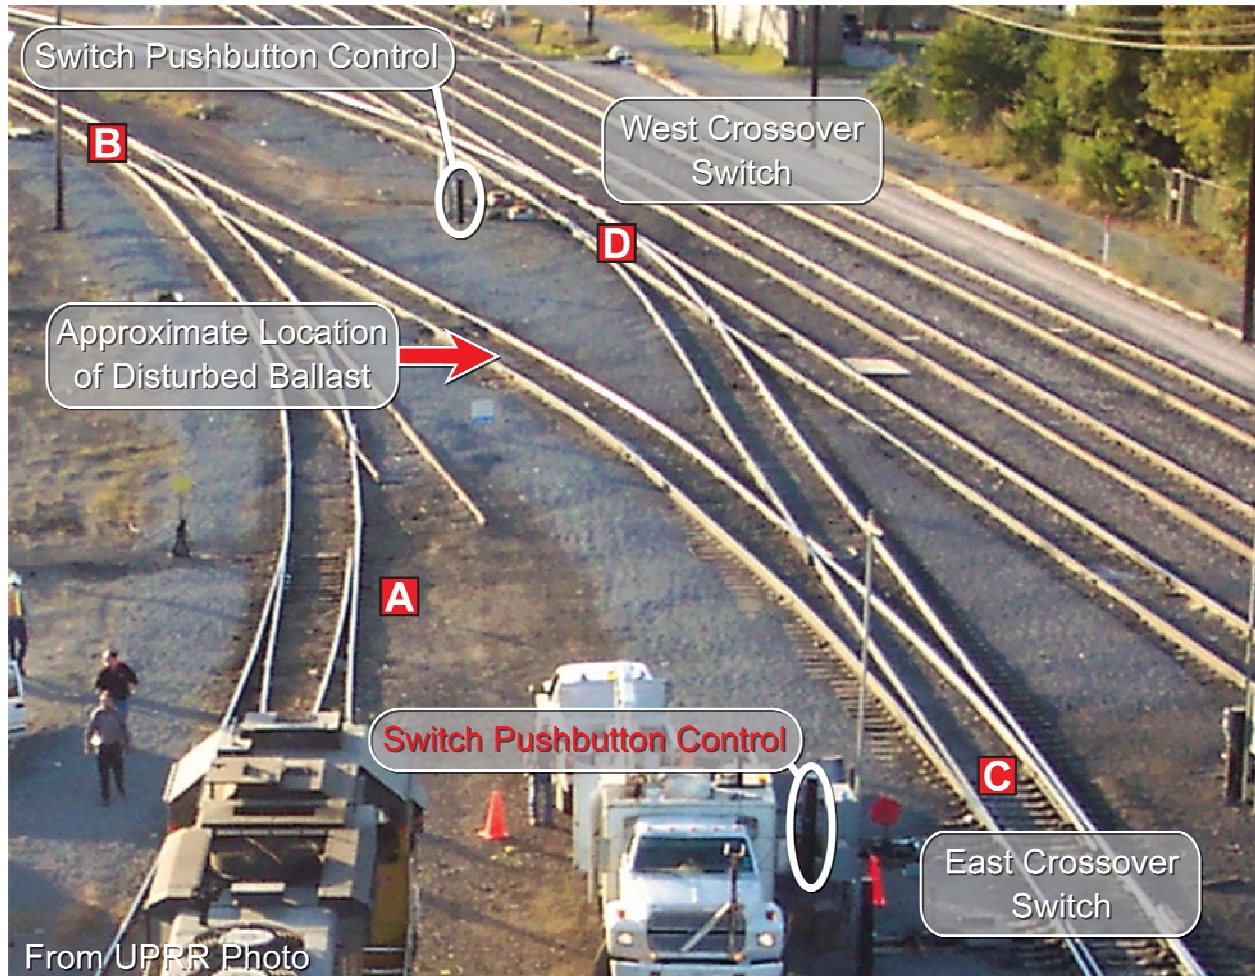
The locomotive event recorder data showed that the foreman initiated his last movement after the locomotives cleared the east crossover switch (switch C). The location of the disturbed ballast indicated that the locomotives struck the foreman about 122 feet west of the switch points, where the westward crossover track diverged from the wheel yard lead. This ballast site was located on a straight line between the pushbutton control boxes of the east (C) and west (D) switches.

locomotives. Despite the UP procedure that required a visual confirmation of switch point and target position, he likely did not wait at the switch machine to confirm visually that the points had moved to the correct position, but instead he relied on the audible motor and pump noise as indications that the points had moved. (See figure 3.)

Figure 3. Location of switches, pushbutton controls, and disturbed ballast. (Letters A, B, C, and D indicate switches.)
