**Crash During Landing
Executive Airlines (doing business as
American Eagle) Flight 5401
Avions de Transport Regional 72-212, N438AT
San Juan, Puerto Rico
May 9, 2004**

NTSB/AAR-05/02

**NTSB/AAR-05/02
PB2005-910402
Notation 7650A
Adopted September 7, 2005**

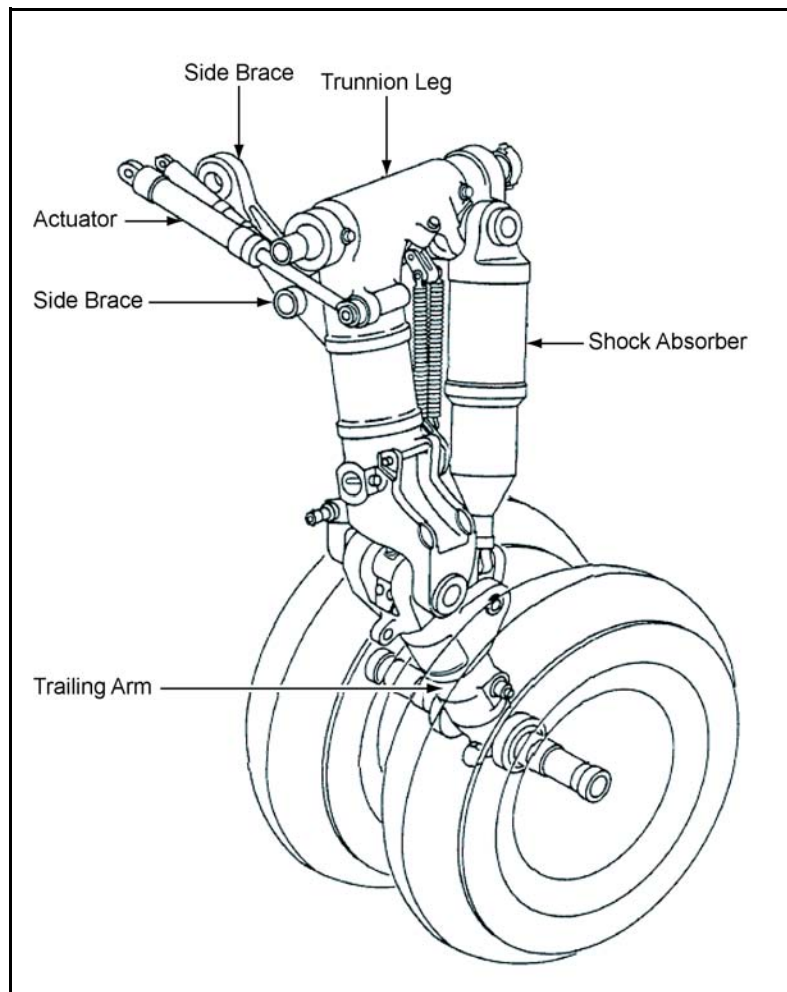
Figure 2. Main landing gear assembly.

The left MLG was fractured circumferentially at its vertical trunnion leg just below the actuator attach point. The upper portion of the vertical trunnion leg, which remained attached to the horizontal trunnion leg, was 4 inches long. The horizontal trunnion leg remained attached to the fuselage by the trunnion attach points, and no evidence of any damage to these components was found. The lower portion of the vertical trunnion leg, which remained attached to the wheel assembly, was 24 inches long.

Sections of the vertical trunnion that contained the fractures were removed from the airplane and sent to the Safety Board's Materials Laboratory for further examination. The examination revealed that the fracture surfaces were consistent with overstress separation. No evidence of fatigue was found.

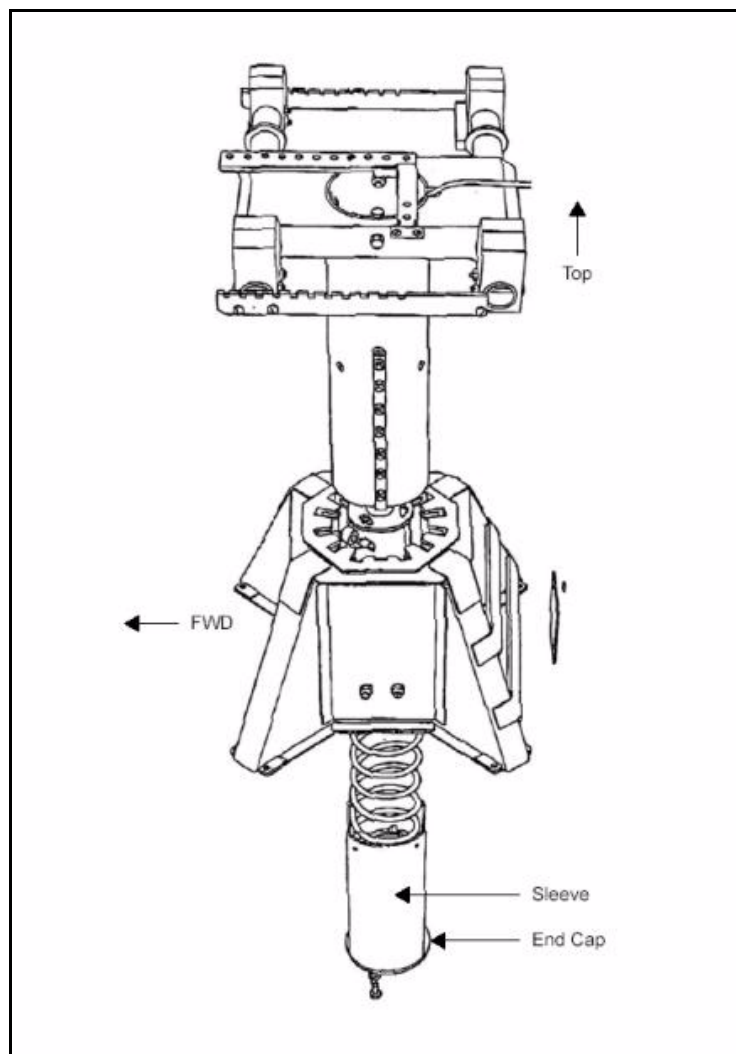
Figure 5. Schematic of the cockpit seat assembly.

Visual examinations of the captain seat revealed that the weld that attached the end cap to the sleeve was fractured at both welded joints, releasing the end cap from the sleeve. Visual examinations of the fractured welded joints revealed the presence of dark, oxidized, preexisting regions that were consistent with weld discontinuities at the inner diameter side of both joints. On the forward sidewall fracture, intermittent weld discontinuities extended along most of the 4.2-inch circumferential length of the joint to a depth of about 0.03 to 0.06 inch.³⁹ On the aft sidewall fracture, the weld discontinuity was continuous and extended along the entire circumferential length of the joint to a depth of about 0.03 to 0.06 inch.

A Safety Board materials engineer estimated that the weld discontinuities extended through about 25 percent of the cross-sectional area on the forward side and about 40 percent of the cross-sectional area on the aft side. The discontinuities contained repeating columnar patterns with curved features at an angle to the surface, which was consistent with a lack of fusion that resulted from molten regions not bonding during the welding process. High-magnification optical and scanning electron microscope examinations of the aft sidewall fracture showed the presence of small fatigue cracks that had propagated from the weld discontinuity region toward the outer diameter, which slightly increased the total penetration of the preexisting defect region.

Visual examinations of the intact welded joints on the first officer seat revealed that gaps existed between the mating surfaces of both welded joints, which was consistent with incomplete weld penetration. The forward sidewall region had about a 2.9-inch-long gap (the total joint length was 4.2 inches). The aft sidewall region had two slightly overlapping gaps that extended about 3 inches. A section of the forward sidewall welded joint was excised and fractured open, revealing that the gaps at the inner diameter of the welded joint had features similar to the preexisting weld discontinuity (lack of fusion) regions on the inner diameter of the welded joints on the captain seat. The maximum penetration of the weld discontinuity was about 0.045 inch in the section that was fractured open for examination.
