NTSB/AAR-06/04
PB2007-910401

**Runway Overrun and Collision
Platinum Jet Management, LLC
Bombardier Challenger CL-600-1A11, N370V,
Teterboro, New Jersey
February 2, 2005**

**NTSB/AAR-06/04
PB2007-910401
Notation 7715C
Adopted October 31, 2006**

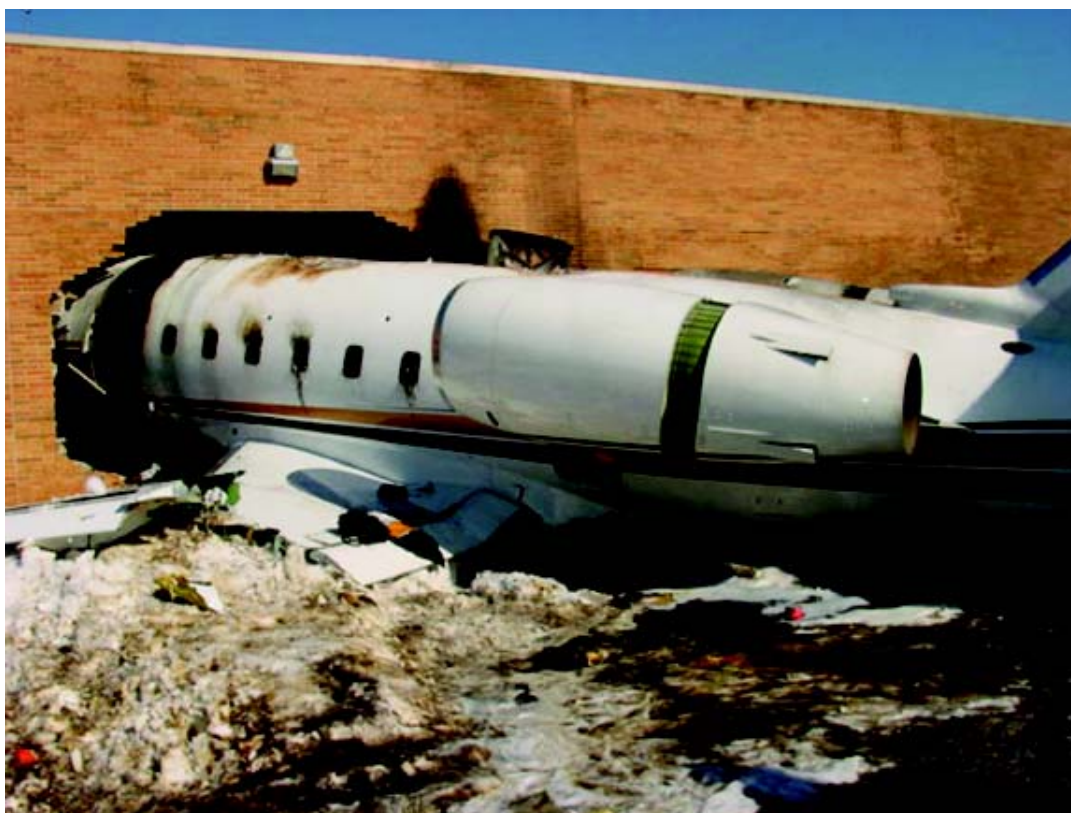
Figure 1. The airplane wreckage partially embedded in the building after the postimpact fire was extinguished.

Postaccident examination revealed that, although some small pieces of airplane structure and other debris were found between the end of the runway and the building, all of the major pieces of the airplane were located at the main wreckage site. The fuselage, empennage, and left inboard wing remained intact. The outboard portion of the left wing separated from the inboard portion near the outboard end of the inboard flap, and there was red paint transfer and impact damage in the area of the left wing separation and on a red car adjacent to the separated portion of the wing.

All of the longitudinal flight control surfaces were found intact and attached to associated mounting structures,⁵⁵ and the engines remained attached to the aft fuselage. The right wing was separated from the fuselage at the wing root area but remained somewhat intact adjacent to the fuselage. The right winglet was separated from the right wing and was located near a small building at the edge of the parking lot.

There was crushing damage and moderate-to-heavy fire damage to the forward fuselage and the right-wing leading edge where they impacted the building and burned. The cockpit was extensively fire damaged, and a layer of soot covered all of the interior

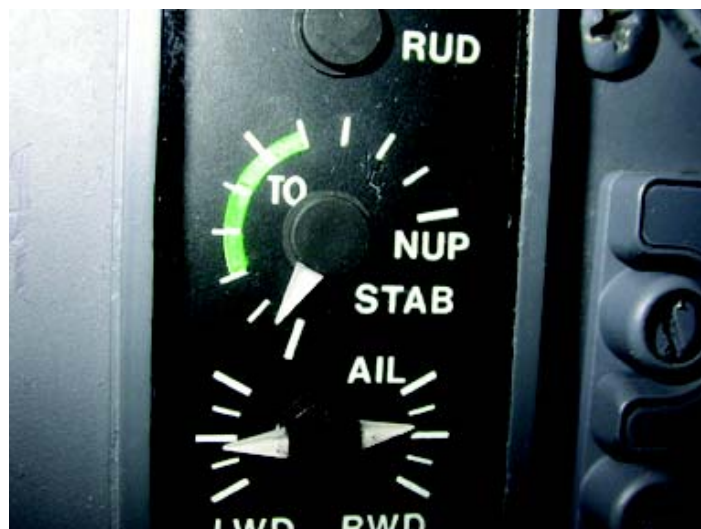
Figure 3. Photograph of a CL-600 pitch trim position indicator similar to that in the accident airplane.

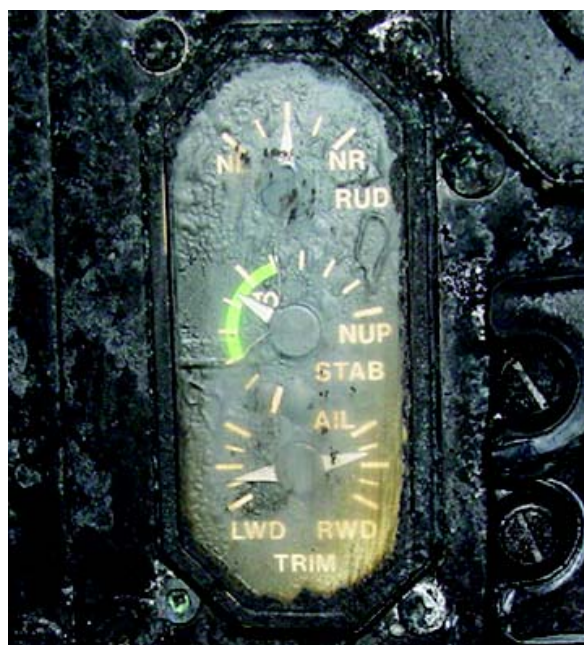
Postaccident examination of the accident airplane's trim position indicator showed that the needle on the stabilizer trim display was located near the middle of the green band, below the takeoff (TO) and nose-up (NUP) indicators.⁴⁵ Figure 4 shows the accident airplane's pitch trim position indicator display, as documented postaccident.

Figure 4. The accident airplane's pitch trim position indicator display, as documented postaccident.

⁴⁵ As noted in table 3, the CL-600 AFM indicates that, for forward CGs within CG limits, the pitch trim should be set in the top of the display range (NUP).

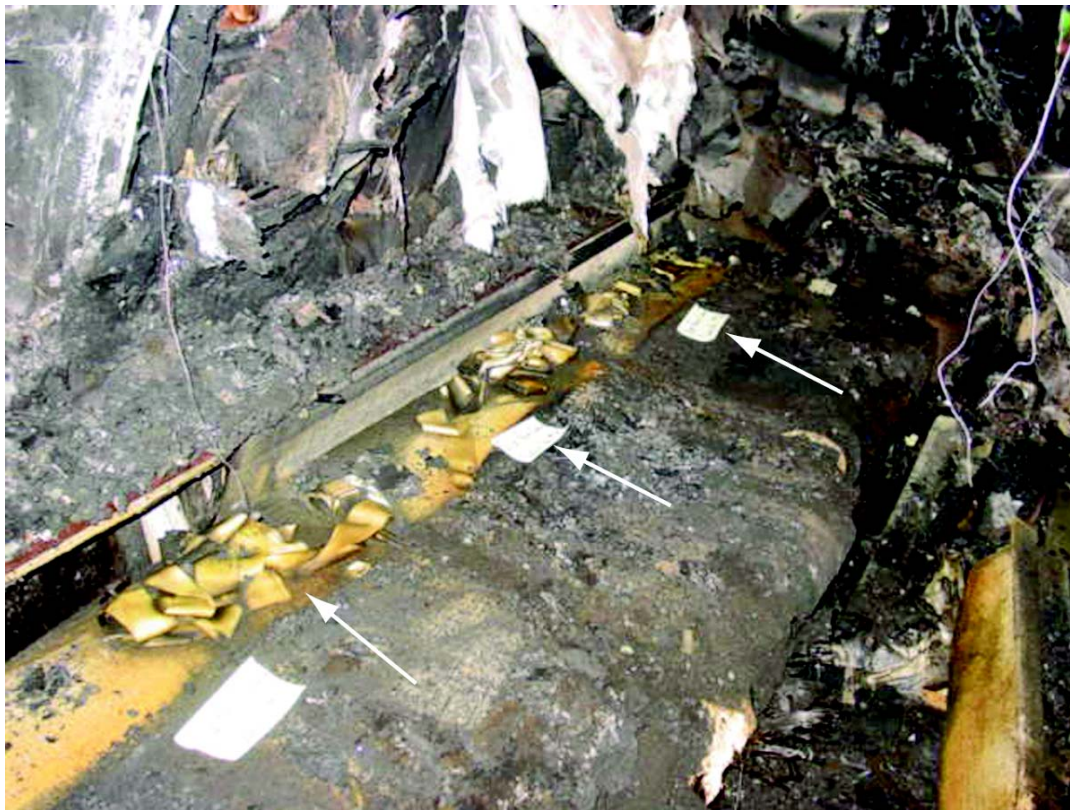
Postaccident examination of another PJM CL-600 revealed that its divan seatbelts had been placed beneath or behind the divan seatback cushions. Further, during postaccident interviews, a corporate flight attendant instructor told investigators that, "in many cases," she had seen airplanes in which the divan seatbelts had been intentionally folded and stowed beneath the seatback cushions. She stated that some corporate airplane operators had told her that they preferred to fold and stow seatbelts beneath the seatback cushions, likely for a tidier appearance. Investigators noted that passengers would have to locate the seatbelts between the seat cushions tactilely or remove the divan seatback cushions to locate seatbelts stowed in this position. Figure 5 shows the side-facing, three-passenger divan with the burned seat cushions removed.

Figure 5. The side-facing, three-passenger divan from the accident airplane with the burned seat cushions removed. Note: the arrows indicate the row of folded seatbelts that were found beneath the seatback cushions.

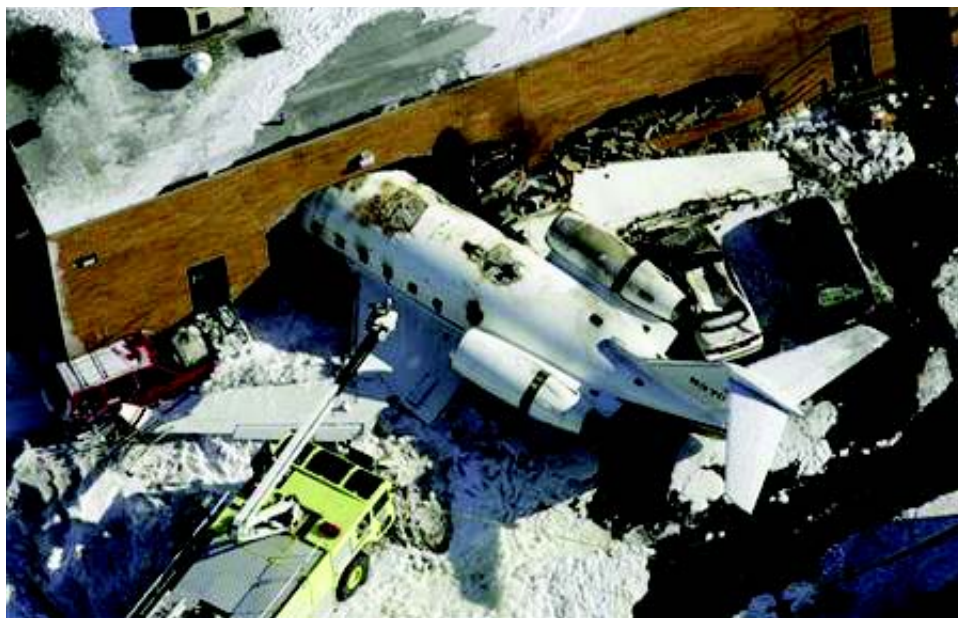
Several passengers and witnesses indicated that ARFF vehicles arrived just after the occupants exited the airplane and immediately initiated efforts to extinguish the exterior airplane fires. All the airplane occupants evacuated and moved away from the airplane to await medical evaluation. Firefighting personnel from neighboring communities⁵⁸ also arrived promptly to assist in the firefighting effort; however, the interior fire was not extinguished until a high-reach extendable turret (HRET) vehicle equipped with a skin-penetrating nozzle arrived from the Newark International Airport (EWR), Newark, New Jersey.⁵⁹ The HRET/skin-penetrating-nozzle-equipped vehicle arrived about 0851, and the interior fire was extinguished within minutes thereafter (see figure 6).

Figure 6. The accident airplane, the impacted building and several impacted vehicles, and the HRET/skin-penetrating nozzle-equipped firefighting vehicle.
