NATIONAL TRANSPORTATION SAFETY BOARD

PIPELINE ACCIDENT SUMMARY REPORT

NATURAL GAS PIPELINE RUPTURE AND FIRE
DURING DREDGING OF TIGER PASS, LOUISIANA
OCTOBER 23, 1996

**NTSB/PAR-98/01/SUM
PB98-916501
Notation 6809A
Adopted: September 28, 1998**

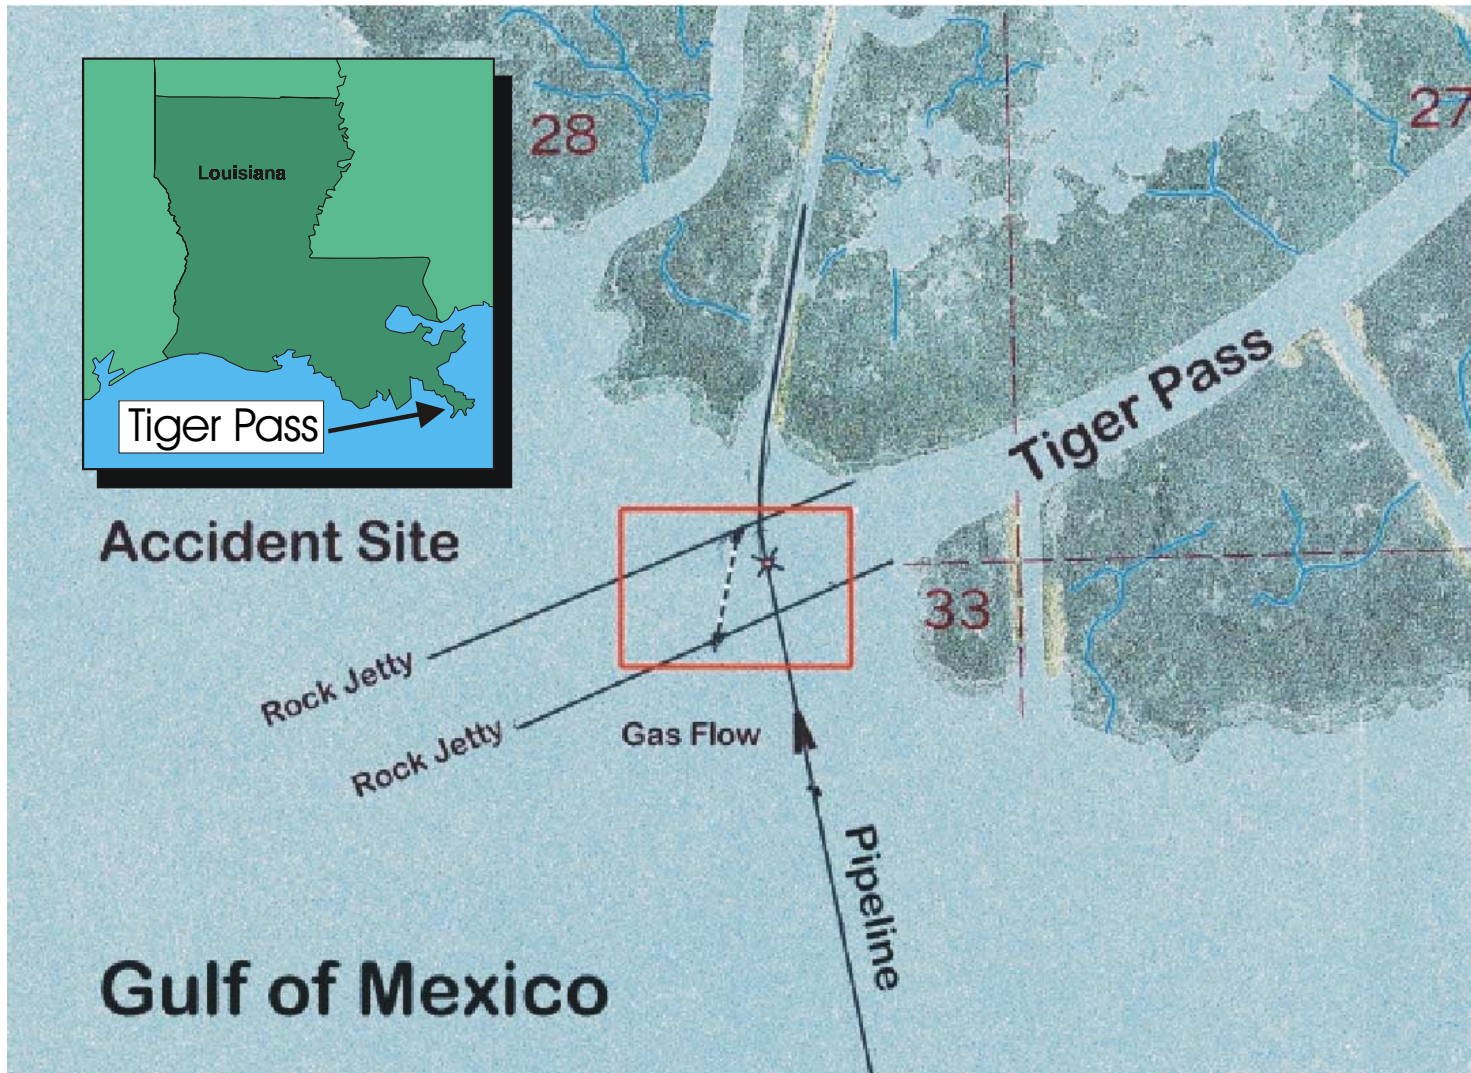
Figure 1. Overview of accident site. Dotted line marks location of pipeline as identified by pipeline operator. (Rectangular area shown in greater detail in figure 2.)

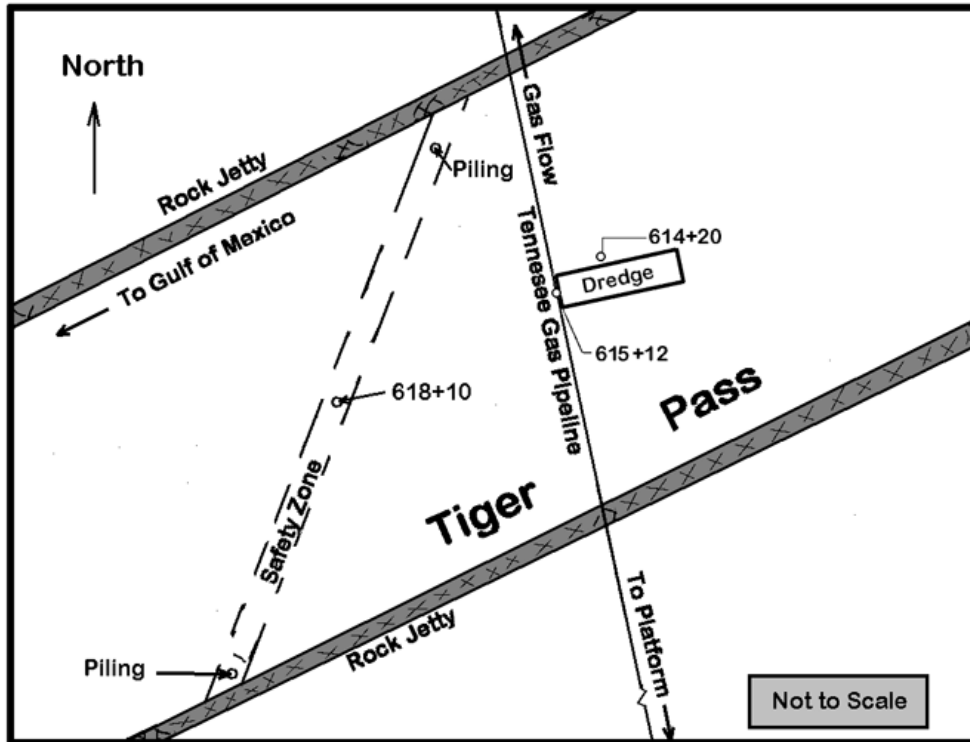
About 2 p.m., on October 19, a Tennessee Gas inspector boarded the dredge and, using information and a sketch provided by her supervisor, established a 100-foot safety zone in the area of the two pilings. (See figure 2.) In order to avoid damage to the pipeline, dredging in that area was to be done with the suction pumps only, without using the cutting head. Bean’s daily quality control reports showed that the pipeline location identified by Tennessee Gas personnel did not match the location shown on the Corps of Engineers drawings.

Figure 2. Detailed view of accident area. Corps of Engineers drawings showed location of pipeline at 614+20; pipeline owner identified location as 618+10; actual location was 615+12.

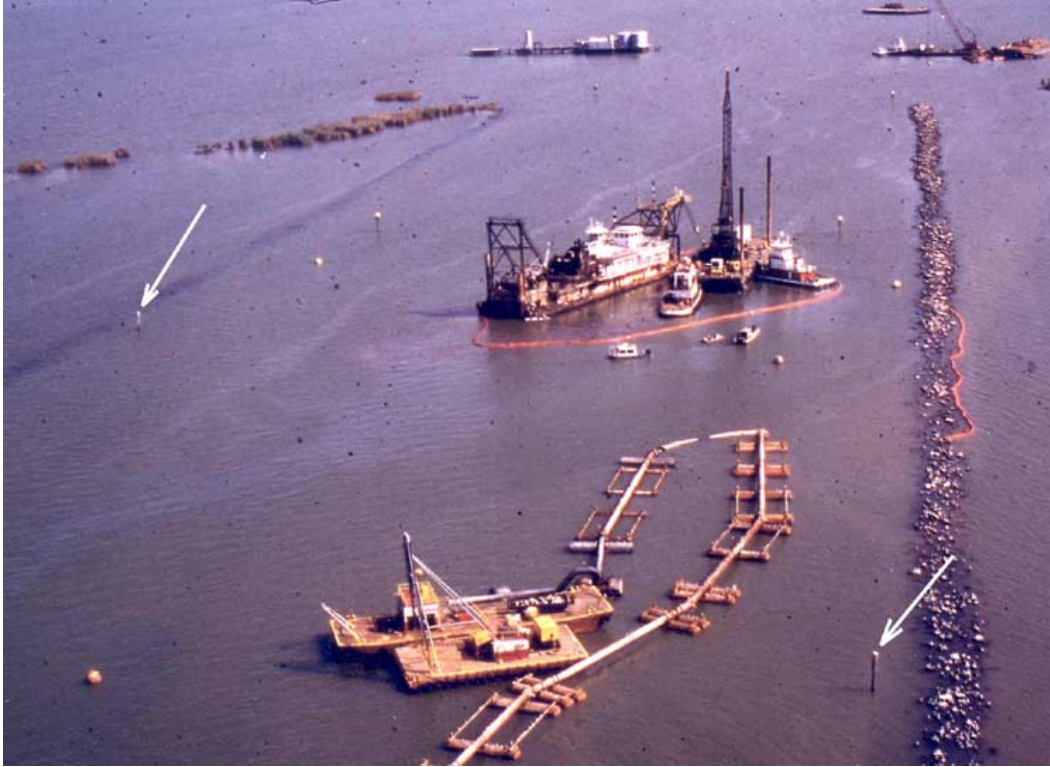
On October 23, at 4:50 a.m., after stopping the dredging to clean the cutting head and reset the swing anchors, the crew dropped a stern spud into the river at about station 615+12 and directly into the Tennessee Gas pipeline, rupturing the pipeline and releasing pressurized natural gas. (See figure 3.)

Figure 3. Aerial view of the stern of dredge *Dave Blackburn* (large white vessel near the center) and the pilings (marked by arrows) that were believed to locate the pipeline. The rectangular framework on the stern of the dredge is directly over the ruptured pipeline.
