**Investigation of Fatality
Mississippi Canyon Block 167
OCS-G 08801
September 8, 2000**

**Gulf of Mexico
Off the Louisiana Coast**

**Investigation of Riser Fatality
Mississippi Canyon Block 167
OCS-G 08801
September 8, 2000**

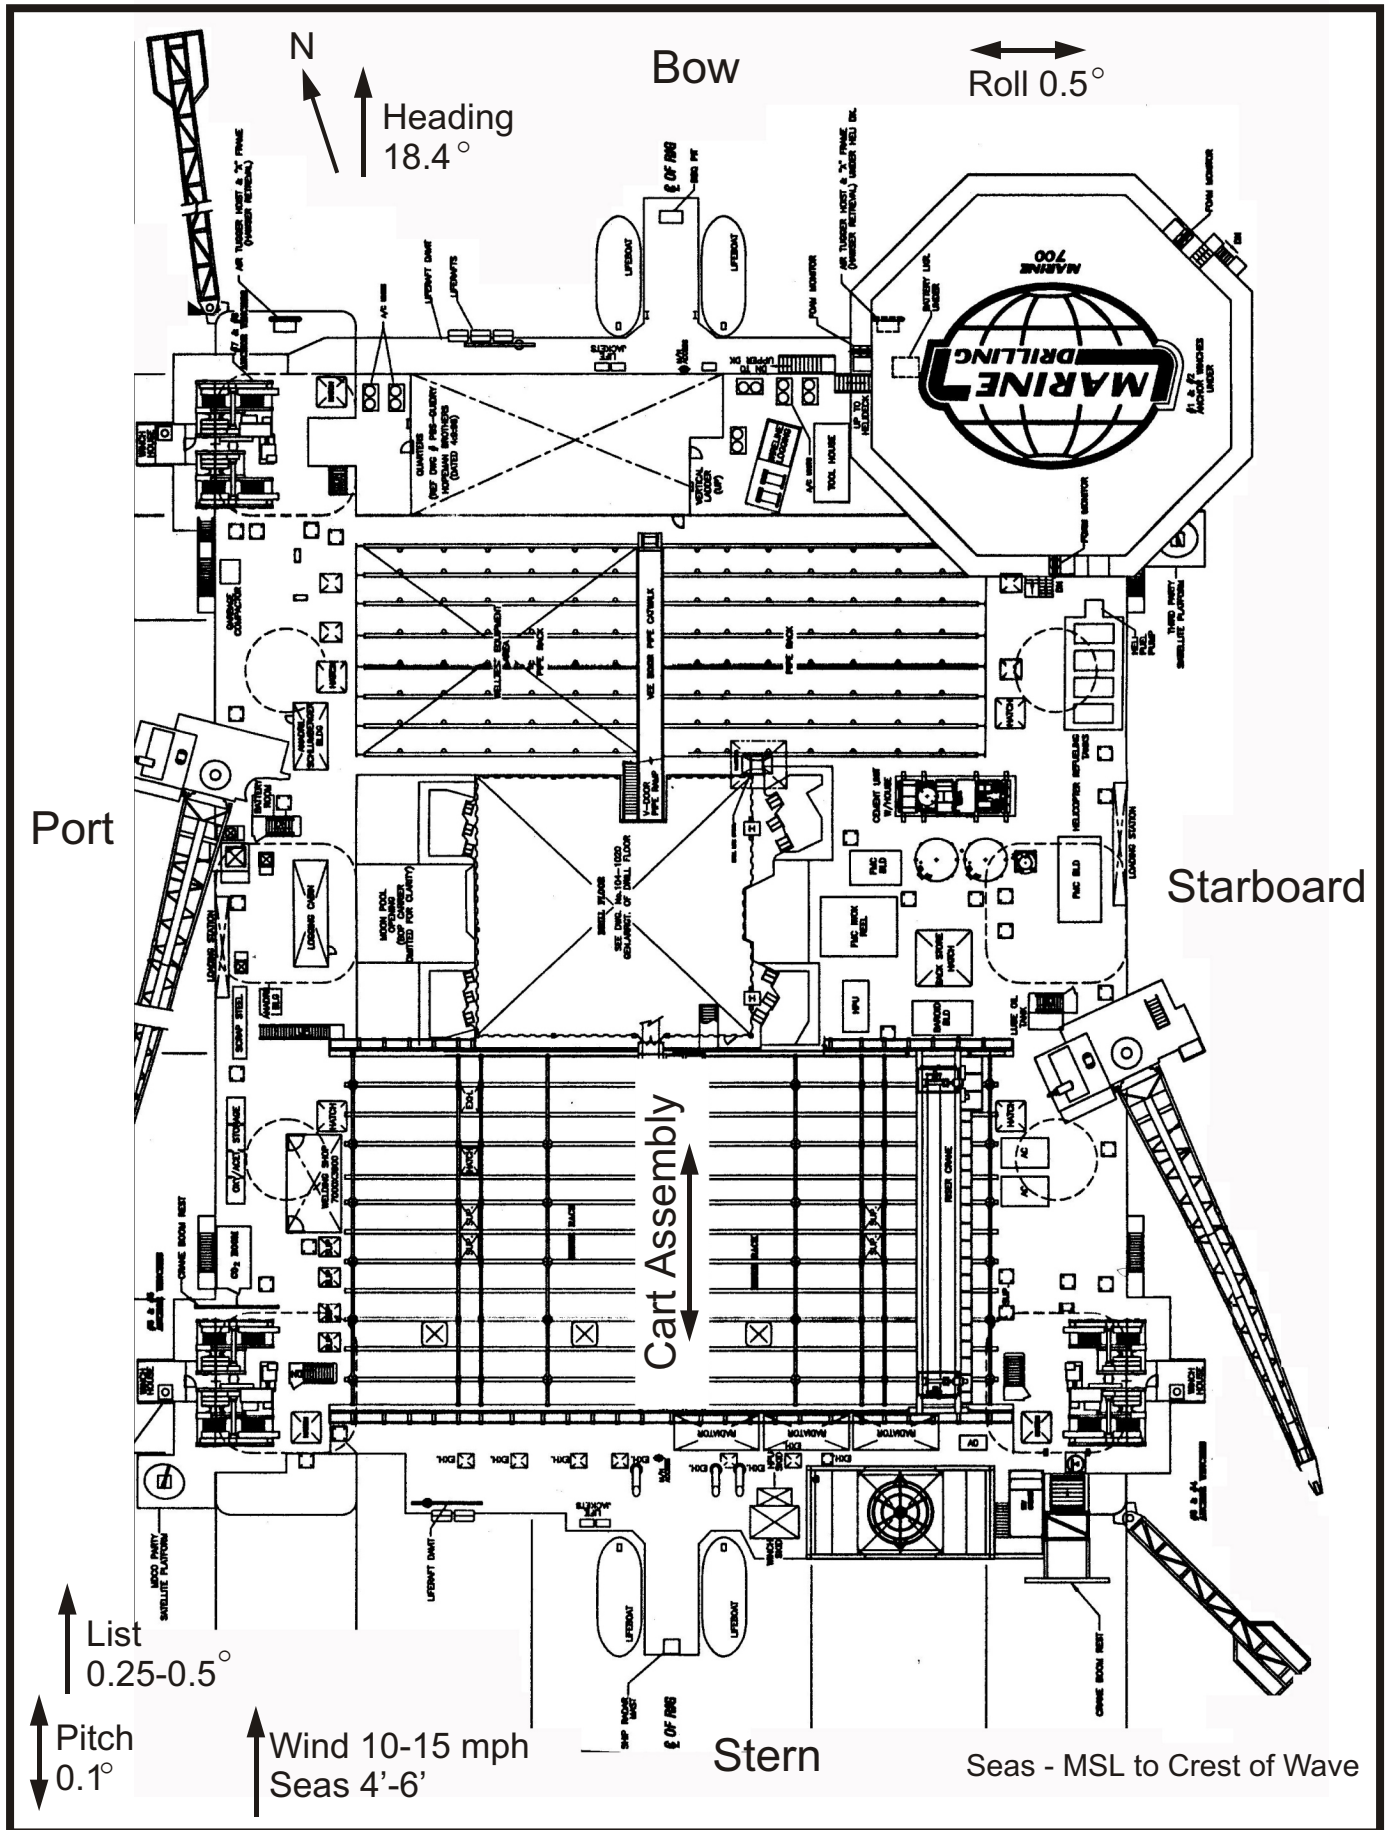
Weather and Sea Effects on Marine 700

At the time of the incident, the air temperature was 82 degrees Fahrenheit and the barometric pressure was 30.19 inches. The wind direction and speed were south-southwest (approximately 200°) at approximately 10-15 knots. The seas were running out of the south-southwest (approximately 200° heading) with a wave height of 4-6 feet. The wave period at the time of the incident was six seconds. Wave height is the measurement from mean sea level (MSL) to either the crest (top) of the wave or trough (bottom) of the wave. Under these weather conditions, the rig was experiencing a pitch of 0.1 degrees and a roll of 0.5 degrees. Pitch is the pivotal movement up and down of the rig along the centerline axis from the bow to the stern. (When the bow goes up, the stern goes down.) Roll is the pivotal movement up and down of the rig along the centerline axis from port to starboard sides. When the port side is up, the starboard side is down. The rig also had a heave of approximately 1inch. Heave is the vertical movement up or down of the rig along the surface of the water. Rig personnel stated during the initial MMS visit that the rig also had a list of 0.25 – 0.5 degrees to the bow. List is the relative leaning position of the rig with respect to the sea surface. *For weather and sea effects on Marine 700, see Attachment 2.*

The movement of the rig was caused by the sea conditions at the time of the accident and the relative position of the rig. The sea conditions created enough pitch and heave, coupled with the list of the rig, to cause the cart to move from its stationary position toward the rig floor. This movement continued until the cart assembly fatally struck the Marine employee and pinned him against the iron roughneck. Therefore, the sea conditions and their effect on the rig at the time of the accident are considered to be contributing causes of the accident.

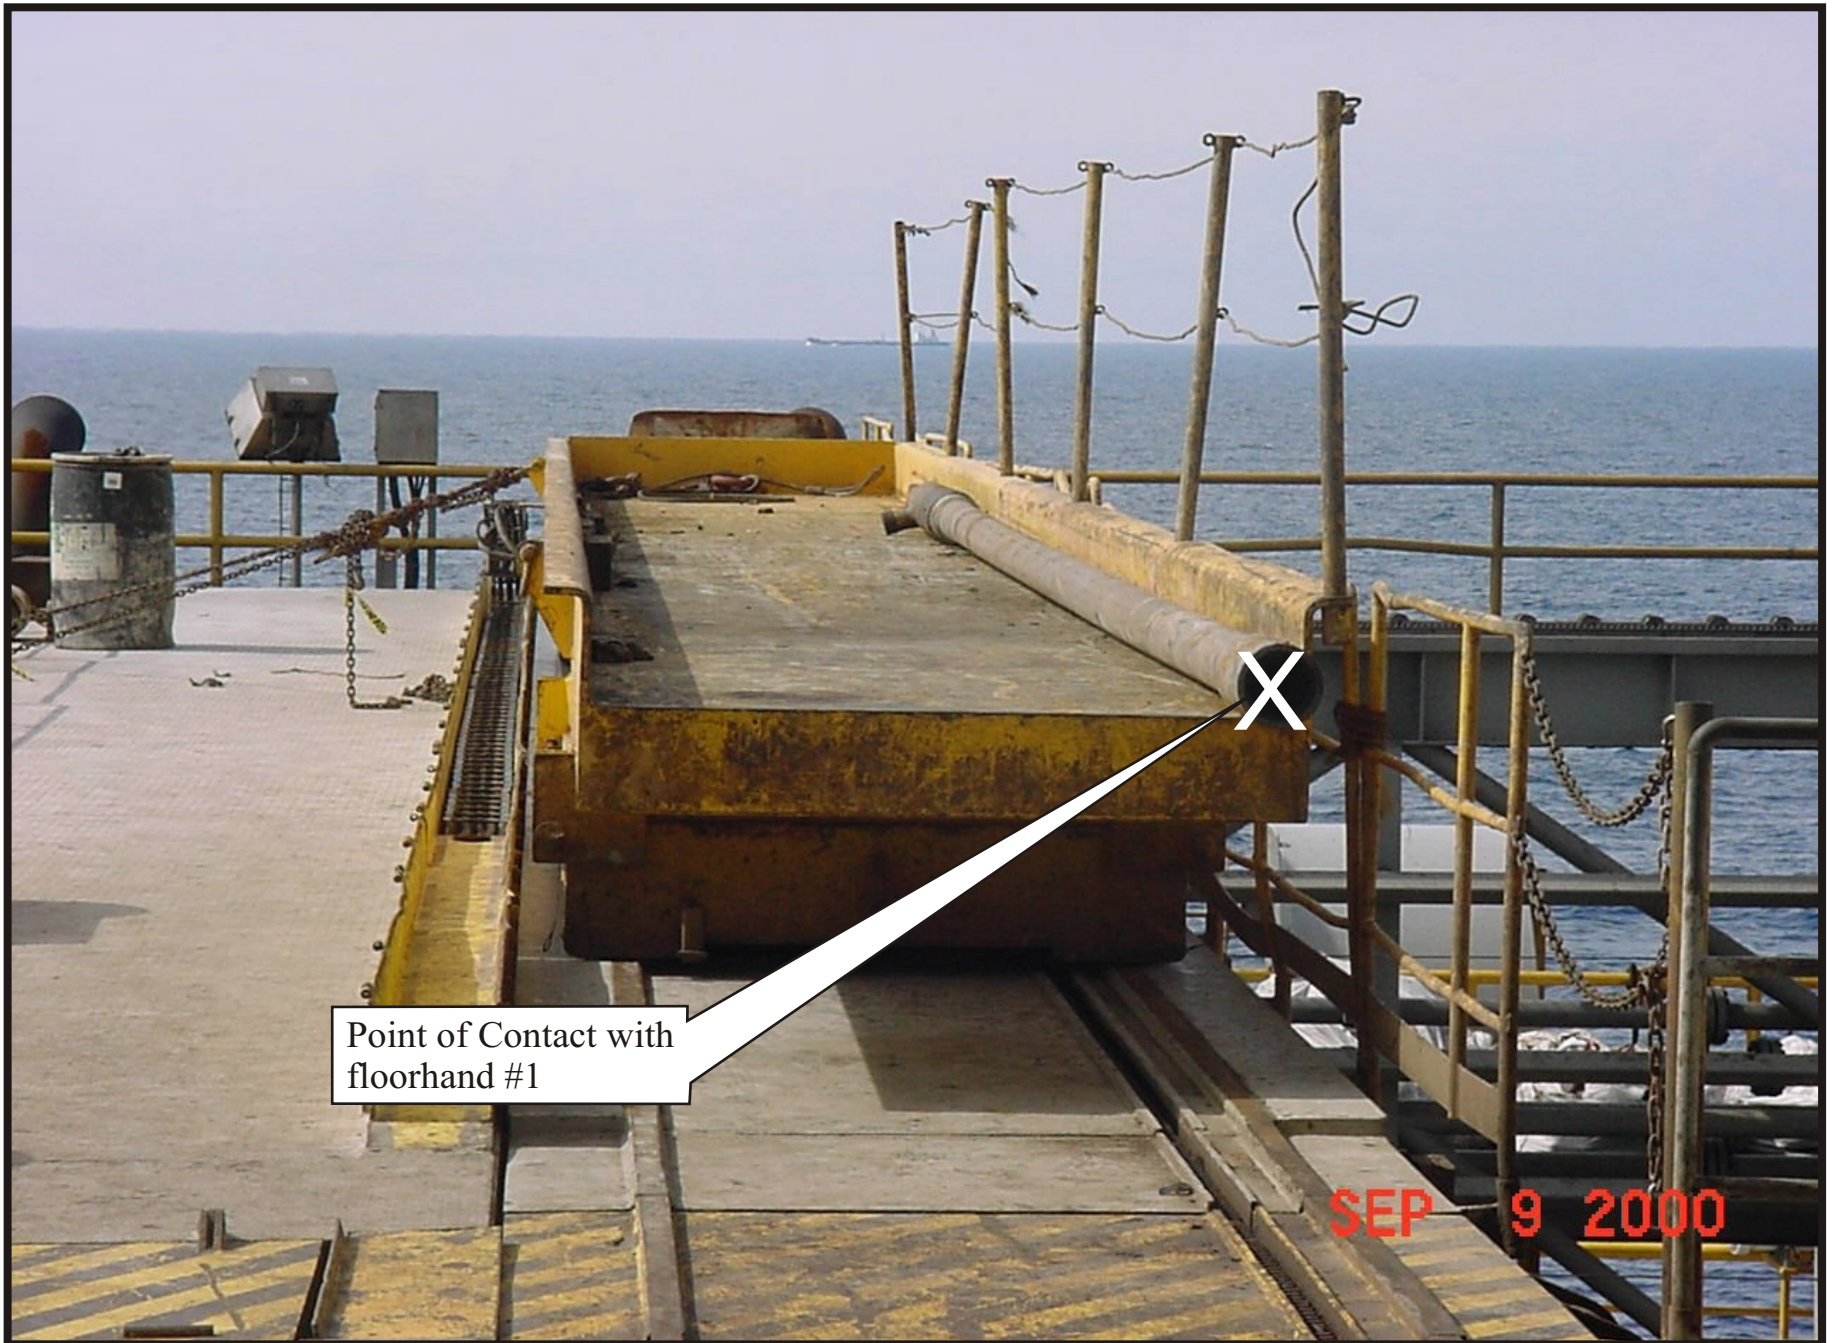
Picture of Cart Assembly Point of Contact

During routine drilling operations on the MODU Marine 700, the riser cart/carriage assembly moved forward, pinning a drilling floorhand between the riser cart/carriage assembly and the iron roughneck on the drillfloor. The floorhand received fatal injuries as a result of this accident.

At 0425 hours on September 08, 2000, the drill crew was in the process of connecting the last string of drill pipe with the aid of an iron roughneck. There were two floorhands operating the iron roughneck. Floorhand #1 was watching the torque gauge on the iron roughneck when the toolpusher and floorhand #2 noticed the casing cart rolling towards floorhand #1. The cart hit him, pinning floorhand #1 between the cart and the iron roughneck. *For pictures of the points of contact, see Attachments 3 & 4.* The cart rolled back a few feet and floorhand #1 fell to the floor. The toolpusher went to the cart control panel and attempted to move the cart away from floorhand #1. The cart would not move, so the toolpusher told the driller to turn on the cart hydraulics and then the toolpusher moved the cart away from floorhand #1. The medic arrived on the drill floor at 0430 hours and started tending to floorhand #1. At 0445 hours, floorhand #1 was taken to the rig hospital, where he died at 0500 hours. *For a diagram of the accident scene, see Attachment 5.*

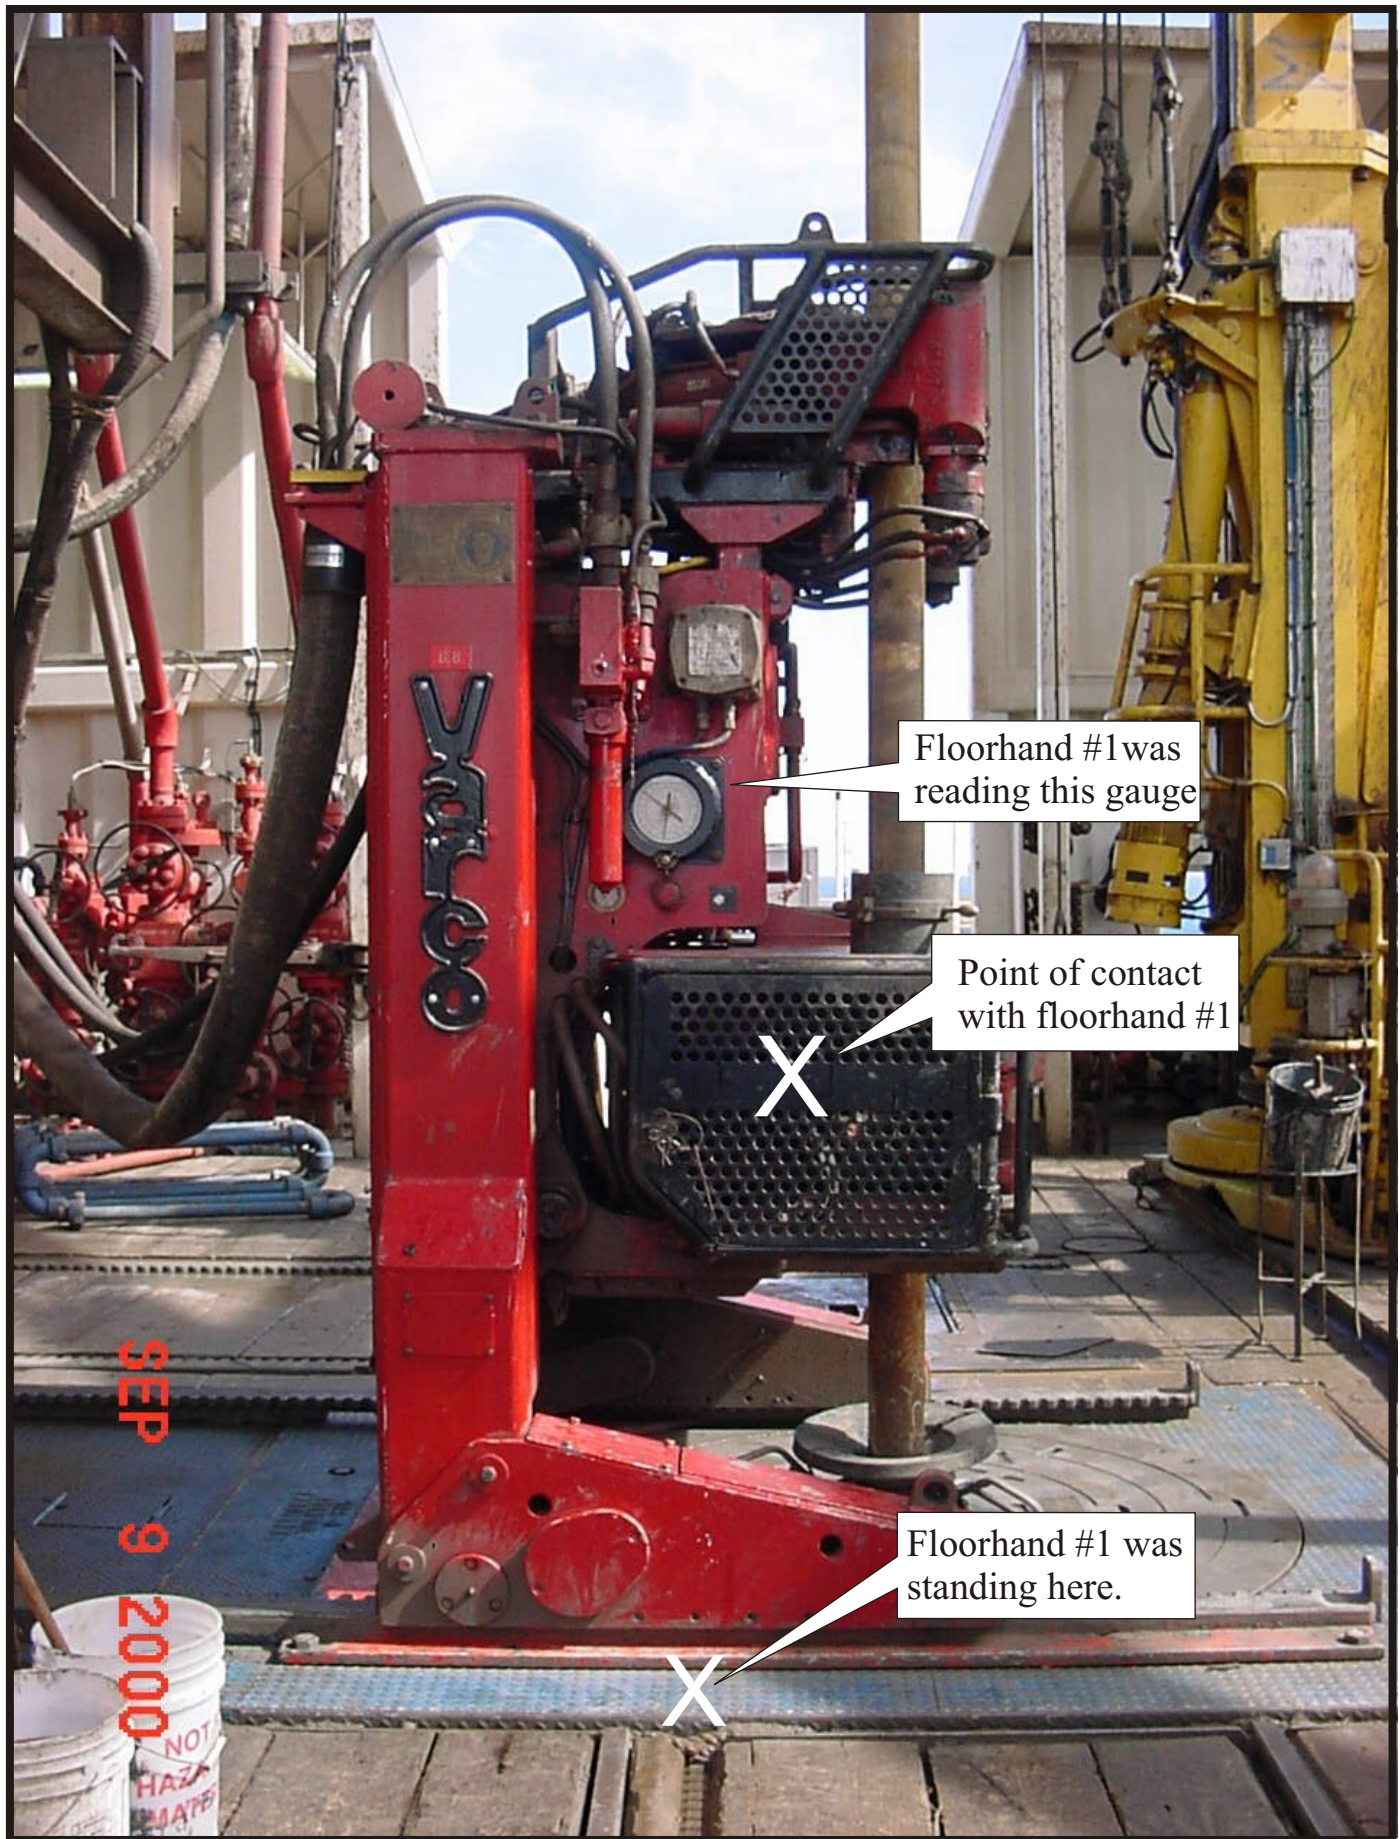
Picture of Iron Roughneck Point of Contact

Floorhand #1 was reading this gauge

Point of contact with floorhand #1

Floorhand #1 was standing here.

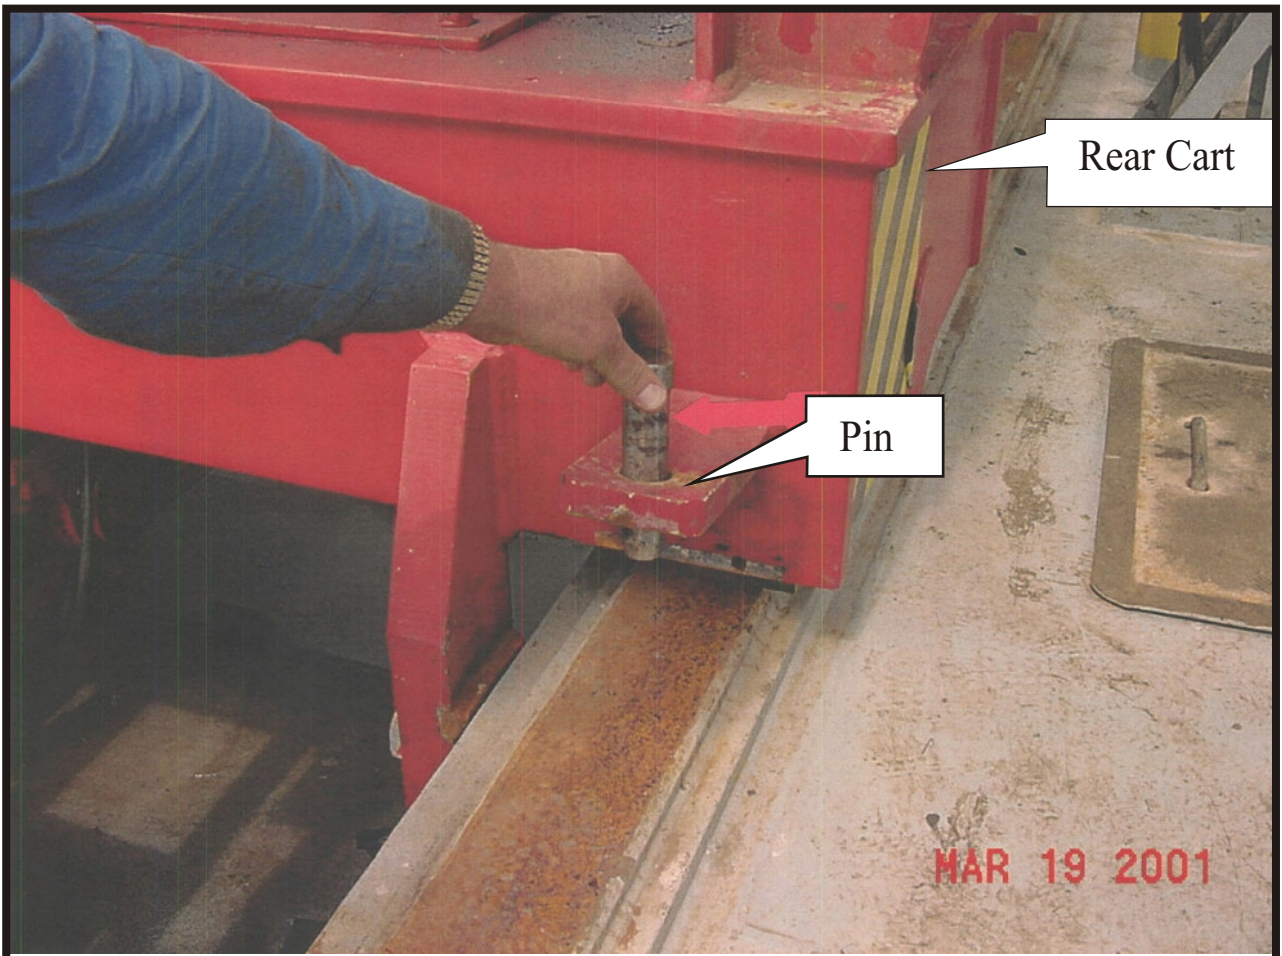
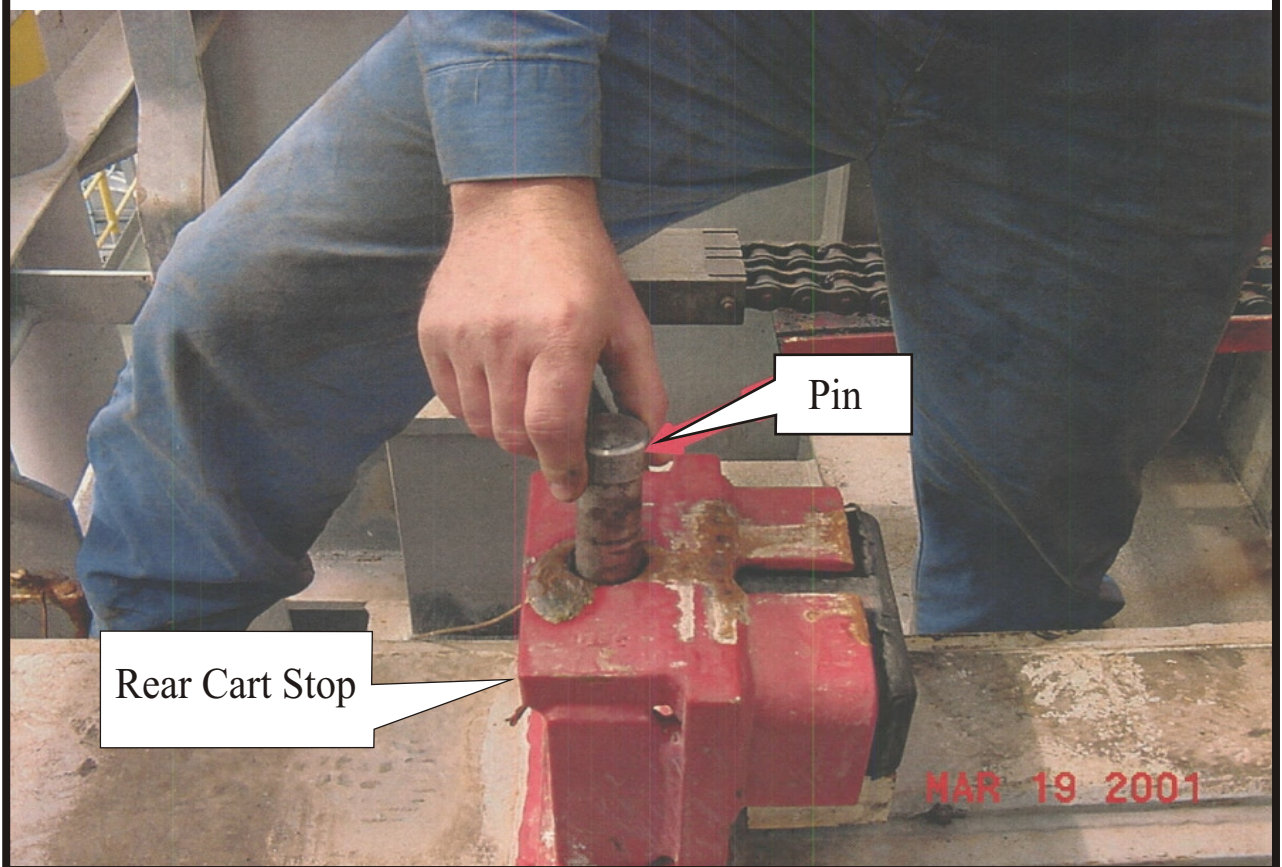
Example of Pin Type Positive Locking System

The aft cart is not equipped with any type of positive locking device such as a pin (dog) to prevent unwanted movement. *For an example of a pin-type positive locking system, see Attachment 7.*

The failure of VMW to provide a secondary lockout device or a secondary procedure (as a backup to the brakes) to prevent unwanted movement of the casing cart assembly is considered to be a contributing factor. If a positive locking device such as a pin had been provided, it might have been used to prevent unwanted movement of the cart, thereby preventing the accident. However, the availability of a positive locking device does not guarantee its use.

- Clearly defined procedures for the use of and storage of the riser and casing cart assemblies.
- Detailed inspection and maintenance procedures for all critical operating components.
- Detailed documentation of inspection findings and corrective measures taken.
- The use of a pin-type, positive-locking device or other method to prevent unwanted movement when the cart assembly is not in use.

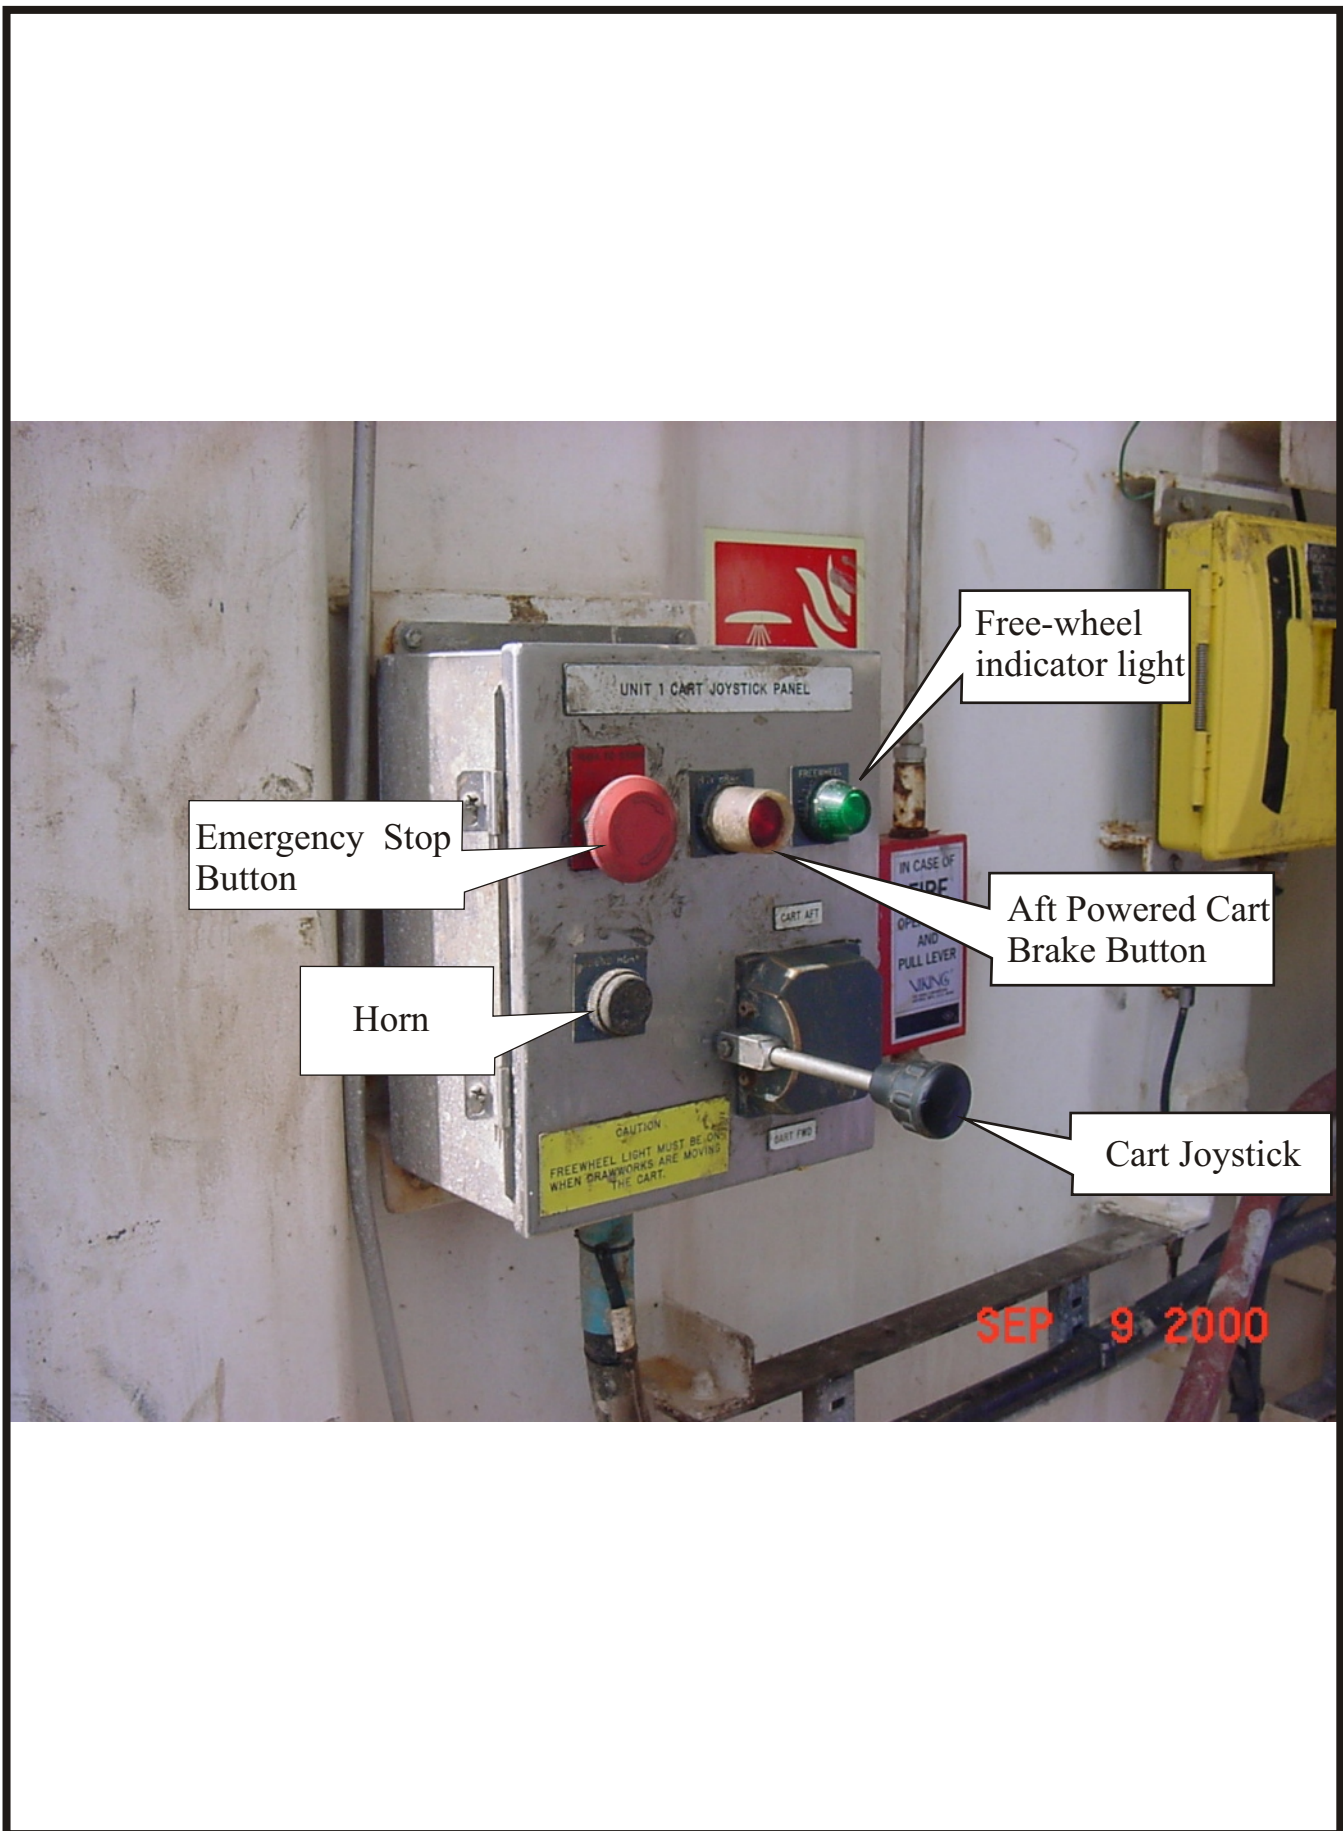
Picture of Cart Joystick Panel

The joystick panel for the aft cart is located on the drill floor inside the drill floor wall. The joystick panel consists of one joystick, three pushbuttons, and one signal light. The joystick controls the motion of the aft cart. The top left button is the emergency stop button. The set brake button, located in the center of the joystick panel, sets the brake on the aft cart. The button is lighted to indicate the brake is set. The green signal light on the right side of the joystick panel is lighted when the aft cart is freewheeling. *For picture of cart joystick panel, see Attachment 8.*
