INVESTIGATION REPORT

VENT COLLECTION SYSTEM EXPLOSION

TECHNIC INC.

REPORT NO. 2003-08-I-RI

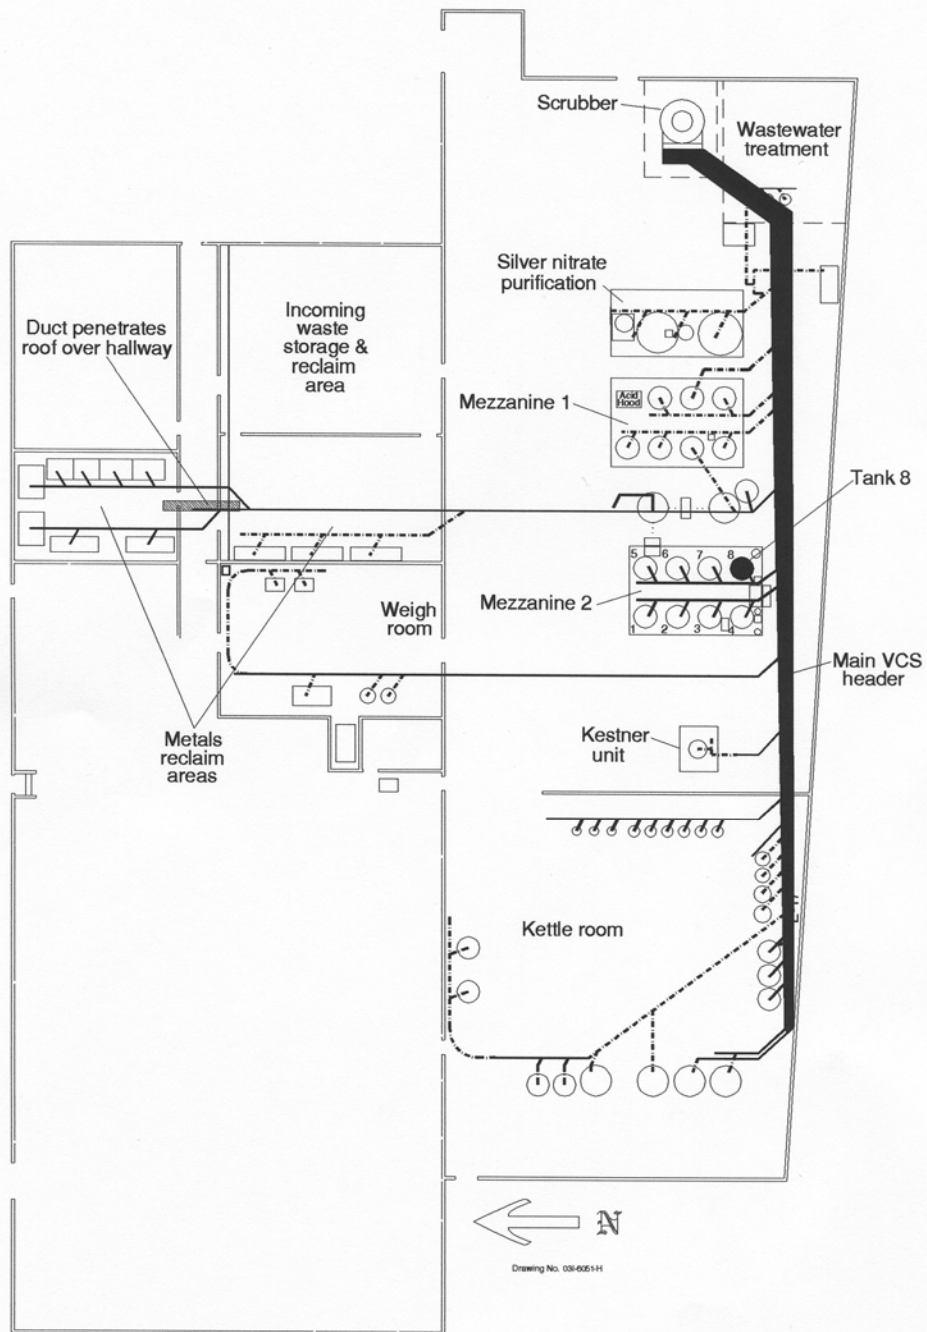
Figure 3. Vent collection system as of February 7, 2003 (modifications to original design are shown by dashed lines).

From April 2001 until the date of the explosion, additional kettles were added in the kettle room, and the baghouse in the weigh room was disconnected in an attempt to increase the duct capture efficiency of the packaging equipment. Discussions with the loss prevention carrier revealed that none of these modifications were submitted to the carrier for review.

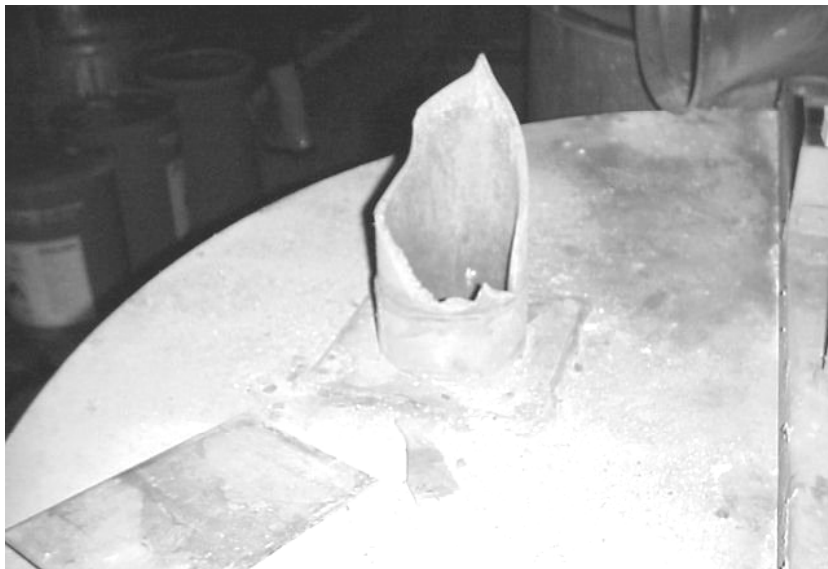
The explosion likely originated at the vertical exhaust duct connected to tank 8 on mezzanine 2 (Figures 1 and 3). This section of duct was shattered into small fragments that dispersed in all directions. Figures 4 through 8 show the extent of the explosion and fire damage to the vent collection system and its connected equipment. Table 1 outlines the sequence of events in the explosion and fire.

Figure 4. Sharp fracture of 4-inch exhaust duct above tank 8.

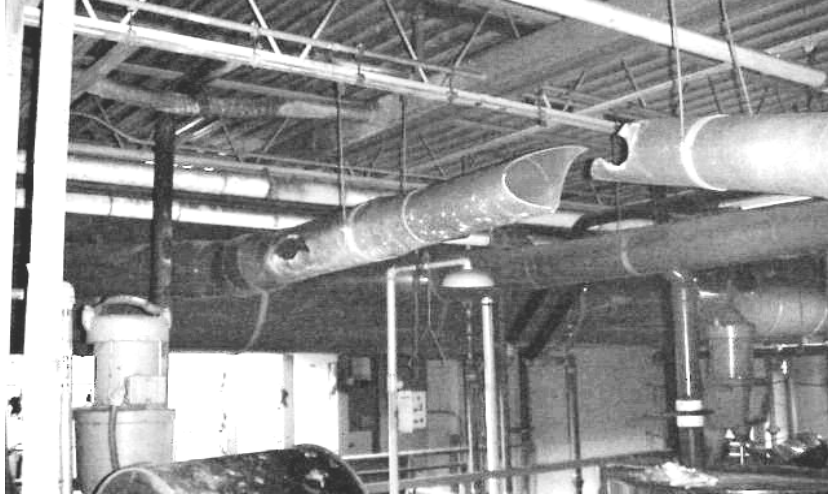
Figure 5. Large fracture of 10-inch branch duct above mezzanine 2 production area.

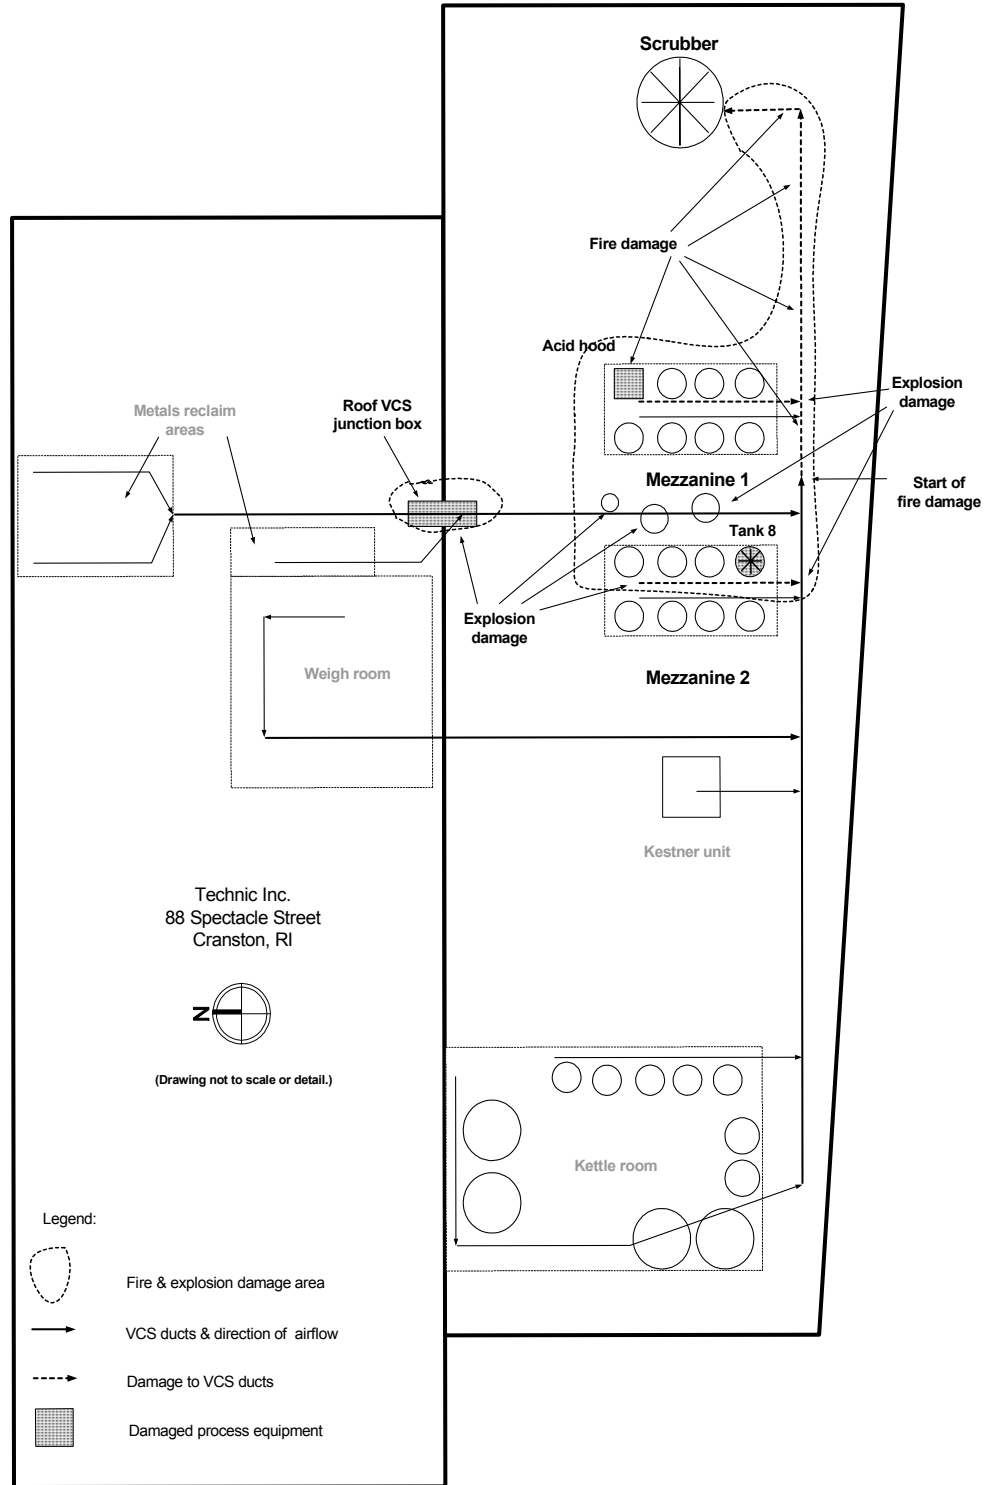
Figure 6. Depiction of explosion and fire damage, February 7, 2003.

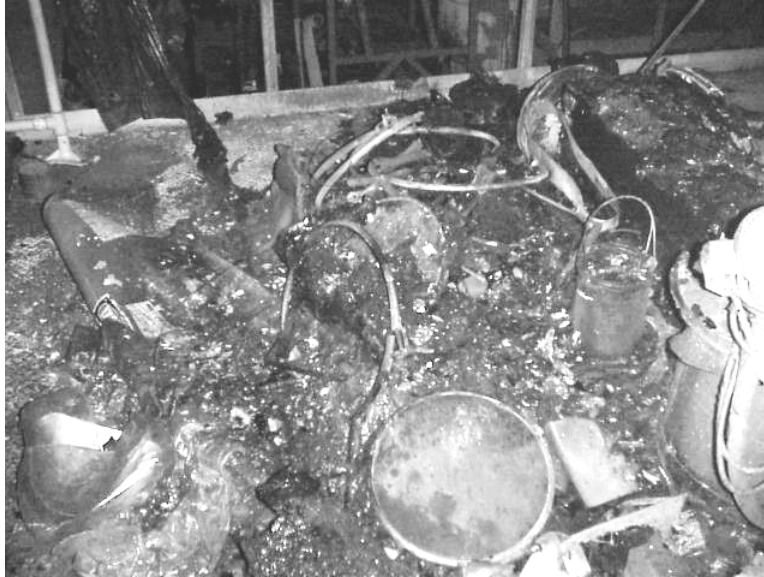
Figure 7. Remains of acid hood on mezzanine 1.

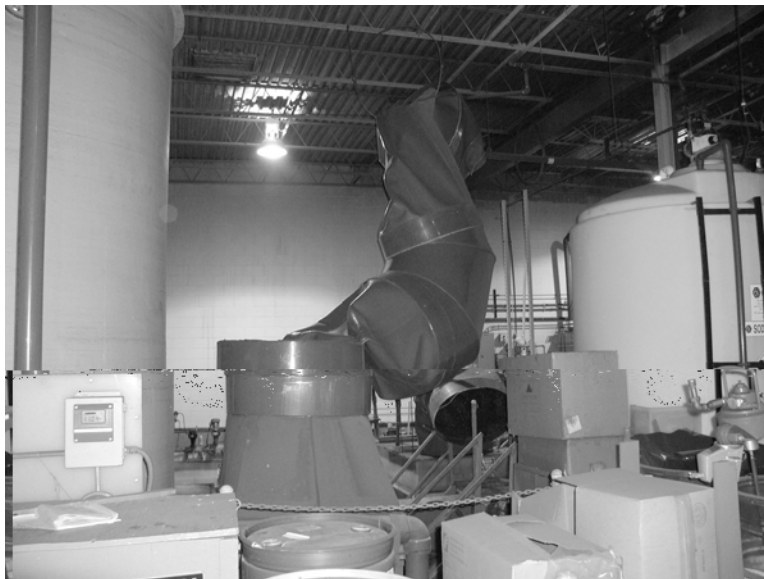
Figure 8. Collapsed 36-inch-diameter main header at scrubber along east wall.

Above northernmost end of mezzanine 1	Firefighters opened this section of roof to extinguish fire	Radiant heat from burning acid hood charred building roof
Main header from mezzanine 1 to scrubber	50 feet of duct melted and collapsed (Figure 8); hazmat team opened section of duct to extinguish smoldering fire	Duct contained large amount of deposited combustible material that continued to smolder and flare

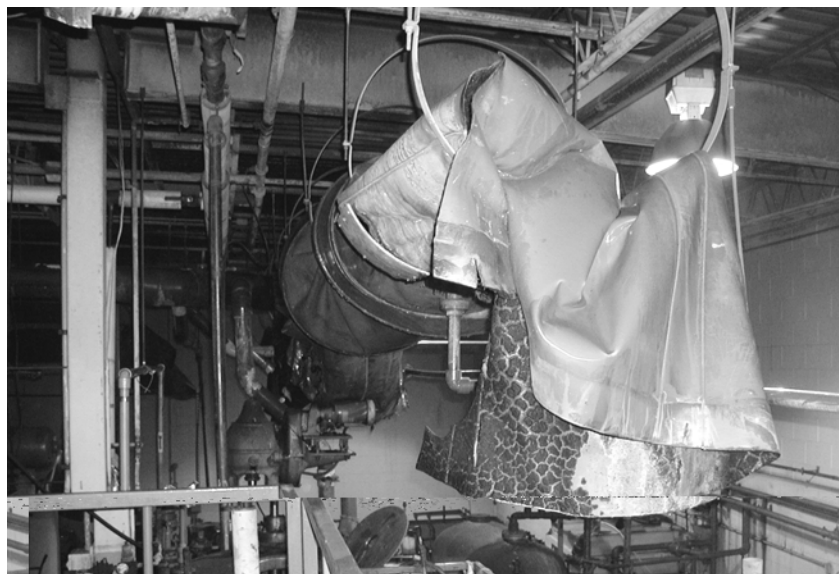
The initial explosion likely ignited fuel (e.g., dusts or accumulated residue) inside the main header. The resulting flame moved downstream toward the scrubber, causing at least one additional explosion. The presence of shiny, blistered char inside the duct indicates that the fire burned intensely for an extended time (Figure 9).⁷

Figure 9. Blistered char inside 36-inch-diameter main header adjacent to mezzanine 1.

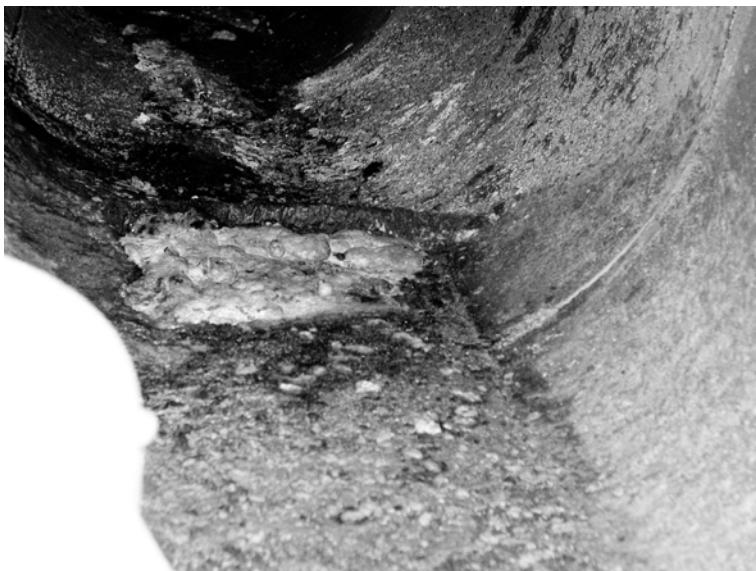
CSB examined all of the process areas connected to the vent collection system and the chemicals used in each area. Through years of accumulation of solids (Figure 10) and mixing, many materials could have resulted in violent reactions such as the one that caused this incident. CSB evaluated only a sample of

Figure 10. Solid deposits in main header duct.

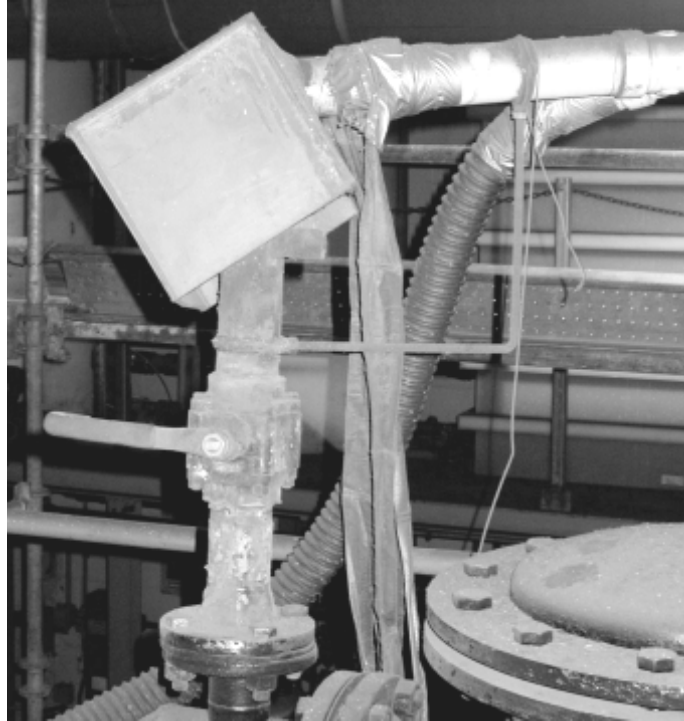
- Kestner unit: Interviews with employees revealed that during occasional process upsets, fumes from this distillation vessel overwhelmed the vent collection system and vented into the plant. In-house maintenance personnel connected the Kestner unit to the vent collection system as shown in Figure A-1. This unit was in full operation on the day of the explosion.
- Mezzanine 1: Employees stated that on occasion dark red smoke overwhelmed the vent collection system and escaped through the loose-fitting tank access door into the plant (Figure A-2). On the day of the explosion, three batches of silver nitrate were being held on mezzanine 1 for future use, but none were being processed.

Figure A-1. Kestner unit exhaust ventilation.

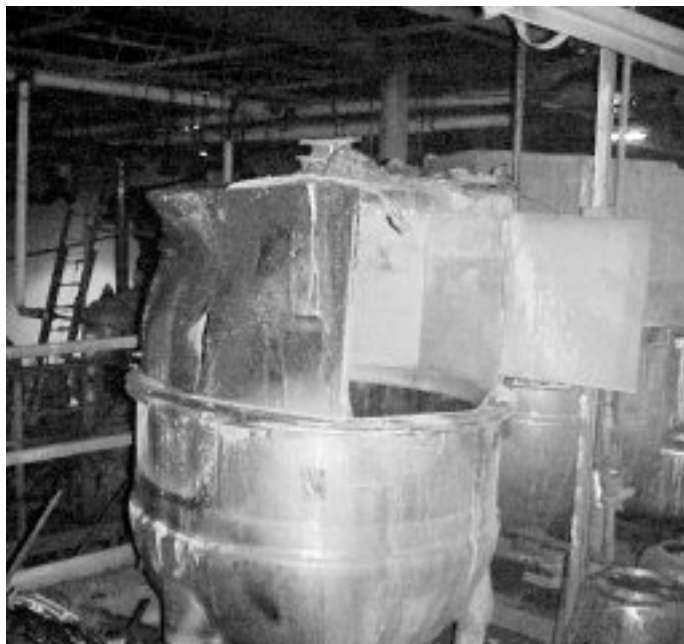
Figure A-2. Silver nitrate reactor on mezzanine 1 with open tank door (following explosion and fire).
