NBS TECHNICAL NOTE 558

LUBBOCK TORNADO: A Survey of Building Damage in an Urban Area

N. F. Somes, R. D. Dikkers, and T. H. Boone

Building Research Division
Institute for Applied Technology
National Bureau of Standards
Washington, D.C. 20234

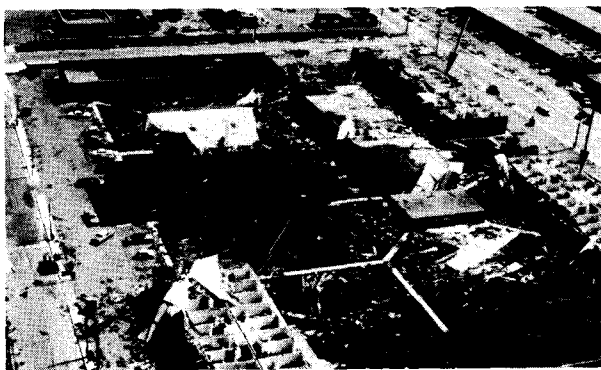
Photograph 1 shows roof decks completely ripped from low-rise apartment buildings. Photograph 2 shows how wind struck the corners of the buildings, attacked the edge flashing, ripped the flashing apart,

Photograph 1—Apartment complex with considerable loss of structural roof deck. View looking south. (Location 1)

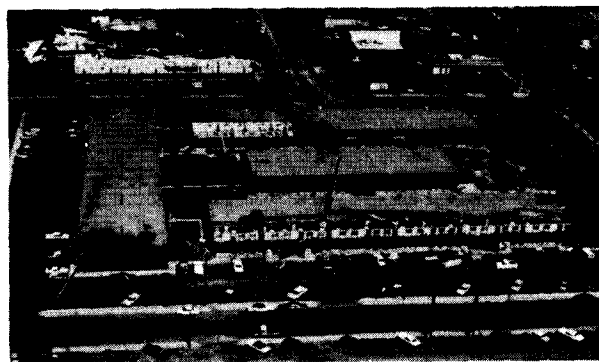
Photograph 2—Apartment complex with “peel-back” of roof membrane and loss of roof overhanging a balcony. View looking east. (Location 2)

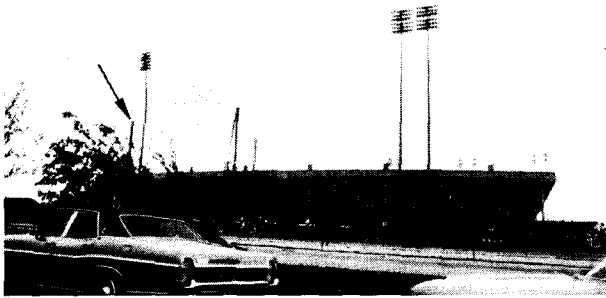
Photograph 3—Jones Stadium of Texas Technological University with bent and collapsed floodlight standards. View looking west. (Location 2)

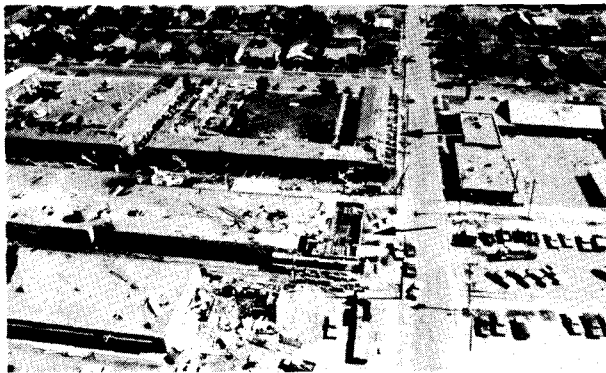
Photograph 4—Roof and wall damage to building of Hygeia-Ozarka Water Company located in center foreground. View looking south. (Location 3)

pany suffered damage to roofs and walls. In the center of the photograph, an apartment complex lost a considerable portion of its roof.

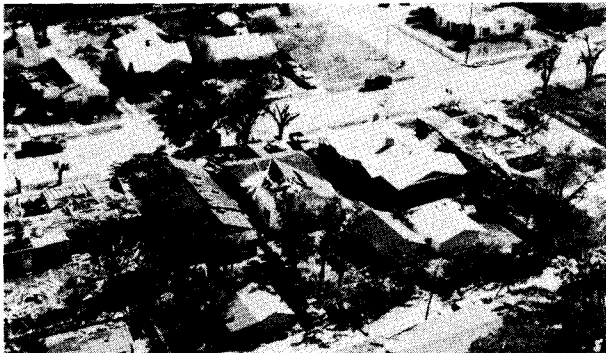
Photograph 5—Random damage to gable roofs of wood framed houses. View looking south. (Location 4)

The erratic distribution of damage to the gable frame roofs of in-city houses is illustrated in photo-

graph 5. Some houses sustained complete destruction of the structural roof while others had only slight damage to the tabs of asphalt shingles. Such variations were discussed at the beginning of this chapter. Many non-reinforced masonry chimneys on older houses in this same area had toppled over causing considerable damage to the roofs.

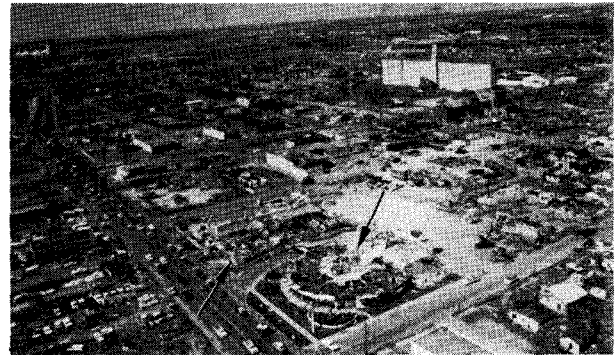
Newsom's Living Center is shown in the foreground of photograph 6 and comprises a circular one-story building and an adjoining two-story building, rectangular in plan. The tornado is believed to have passed directly over these structures before changing its direction of travel to the northeast. The one-story building was destroyed while the second floor of the two-story building was badly damaged. Considerable distortion of the steel frame occurred in both structures.

Photograph 6—View looking northeast from center of city. Note destruction of Newsom's Living Center and neighboring buildings in the foreground. (Location 5)

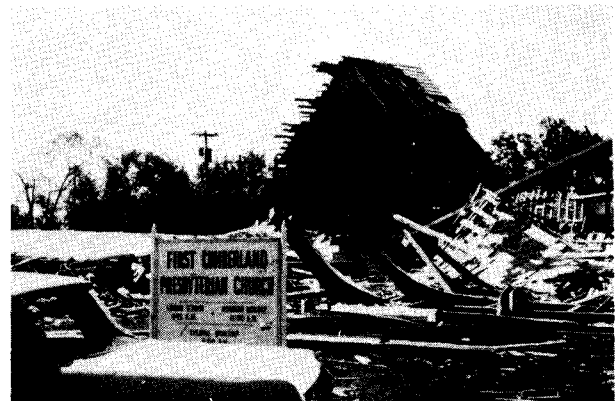
Photograph 7—Church of timber construction. View looking northwest. (Location 6)

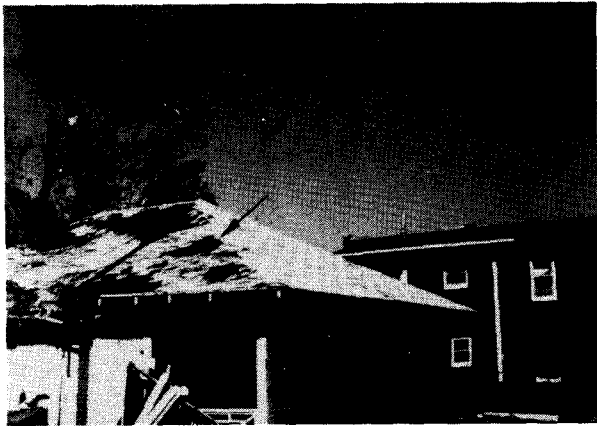
Photograph 8—Partial loss of asphalt shingles on south slope of roof. (Location 6)

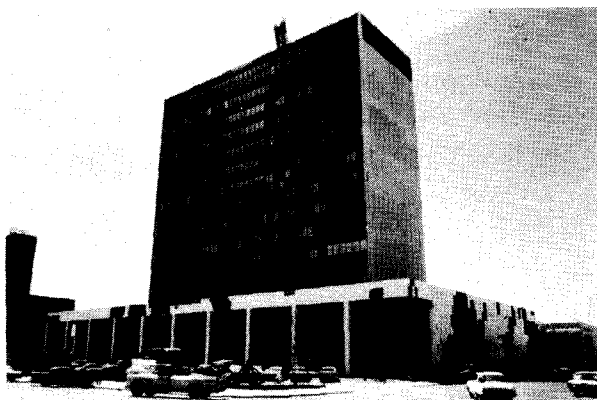
Damage to the 15-story First National-Pioneer Building was estimated at \$1 million.³ This reinforced-concrete frame building was completed in January, 1969, and consists of a large two-story base and a 13-story tower. As shown in photograph 9, exterior marble veneer was stripped from portions of the two-story base. Some loss of marble veneer was observed on all four elevations of the building. Extensive damage to the glazing and the glass spandrels of the 13-story tower can also be seen in photograph 9. Interior building damage was reported to be severe and included damage to suspended ceilings.

Photograph 9—View of First National-Pioneer Building looking southeast. Glazing, spandrel glass veneer and marble veneer severely damaged. (Location 7)

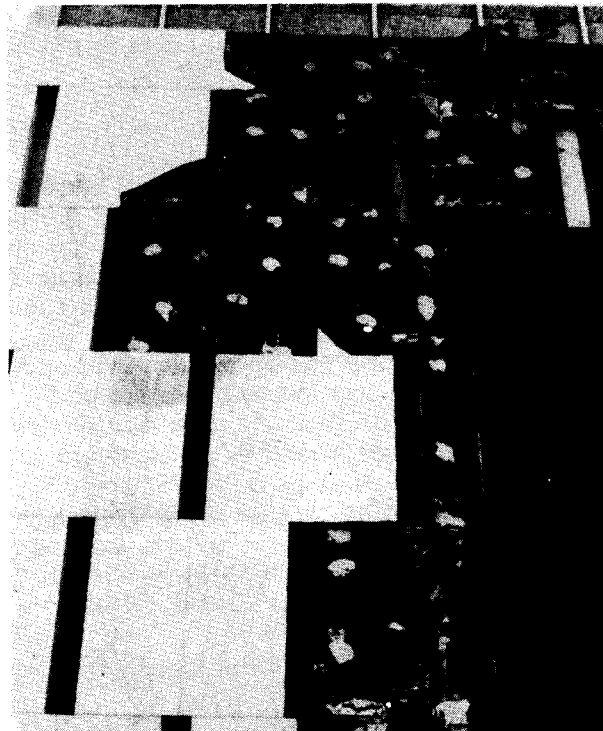
Close-up views of the marble veneer damage on the east elevation of the building are provided by photographs 10 and 11. Typical pieces of marble

Photograph 10—Close-up of marble veneer on east elevation of First National-Pioneer Building. (Location 7)

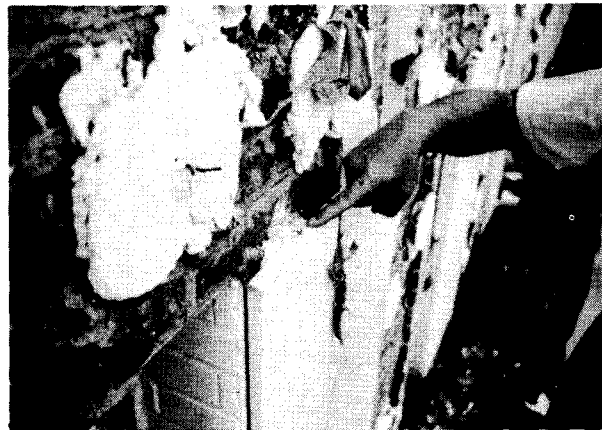
Photograph 11—Marble veneer anchorage failure; First National-Pioneer Building. (Location 7)

veneer are approximately 8 sq. ft. (2 ft. by 4 ft.) in area and $\frac{7}{8}$ -in. thick. This veneer was tied by copper wire anchors to masonry or concrete backup. In most places the loss of marble veneer was due to the wire anchors pulling out of the holes in the edge of the veneer. Splitting of the marble veneer at the anchor holes was also observed; note photograph 11.

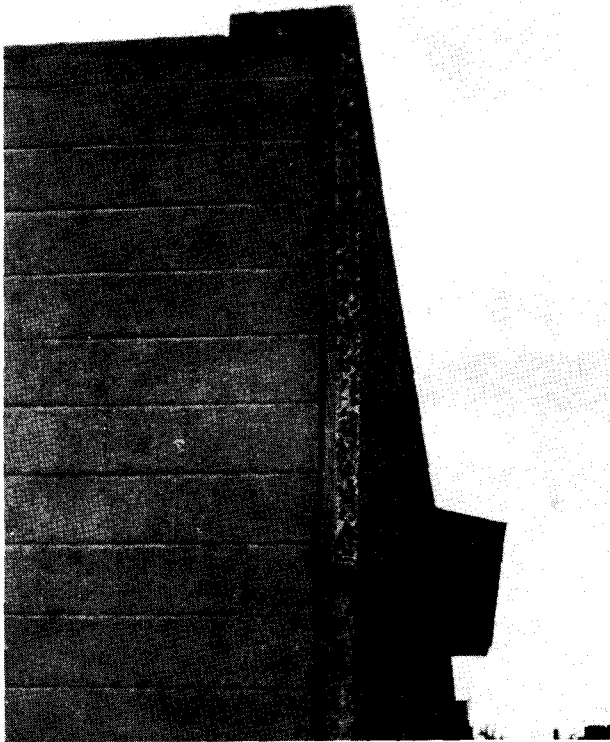
A dislodged precast concrete panel was noted at one exterior corner of the Sanders Funeral Home (photograph 12). In the front part of this building, the overhanging roof had been lifted and damaged. In the interior of the building, cracking along the wall/roof intersection was also noted.

Photograph 12—Dislodged precast concrete panel at northwest corner of Sanders Funeral Home. (Location 8)

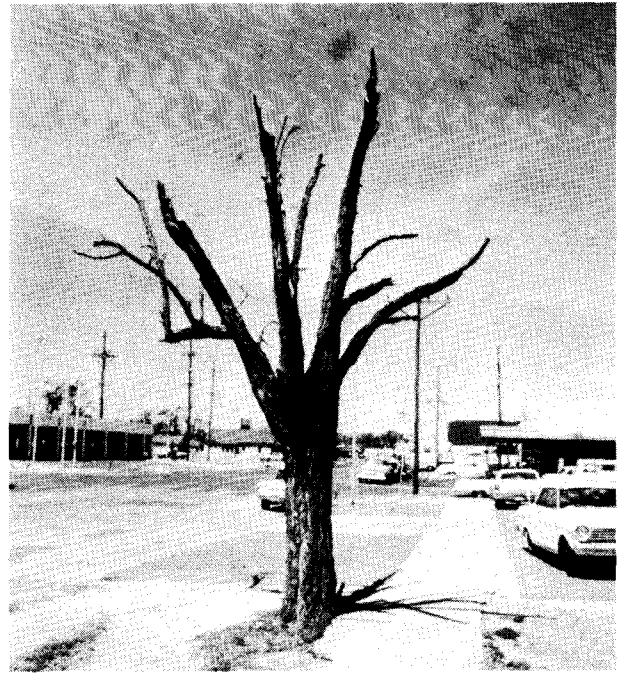
Photograph 13—Typical tree damage. View looking west. (Location 8)

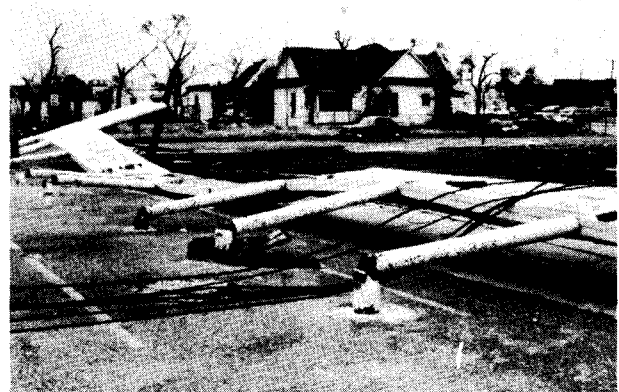
Although heavily damaged, the steel sign in photograph 14 was anchored sufficiently to prevent it from being blown away; failures at the base of the steel posts occurred at weld locations (photograph 15).

Photograph 14—Damage to sign with tubular steel posts. View looking north. (Location 9)

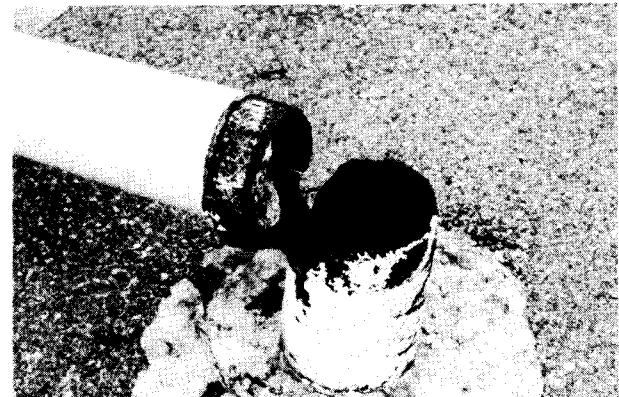
Photograph 15—Weld-fracture at base of sign posts shown in Figure 14. (Location 9)

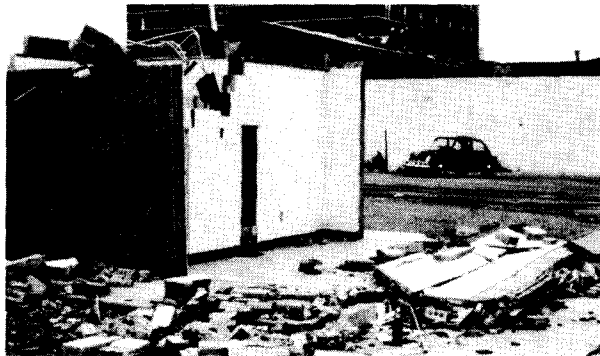
Photograph 16—Small office building for dealer in used automobiles. Roof structure completely removed and non-reinforced masonry walls badly damaged. (Location 9)

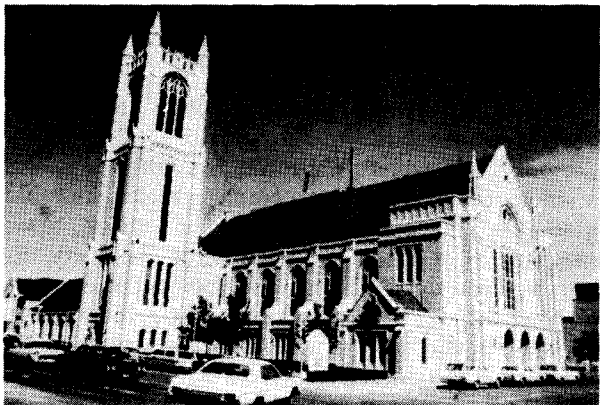
Photograph 17—View of First Methodist Church looking northwest. This masonry structure sustained only minor damage to clay roof tiles and to glazing. (Location 10)

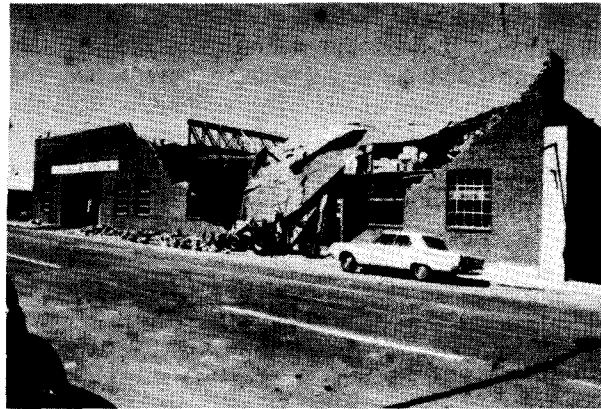
Photograph 18 shows the Texas, New Mexico and Oklahoma Coach Company maintenance shops and damage to the east wall and roof structure of this one-story building which is almost square in plan. At the south end of the west elevation, an 18-foot-wide overhead door was pushed into the building. The combination of wind pressure inside the building and wind force on the approximately four-foot-high parapet caused the outward collapse of the lightly-loaded masonry east wall shown in the photograph. The wood roof collapsed with the loss of support from the wall. The masonry wall was 12 inches thick and consisted of a 4-inch brick facing and 8-inch clay tile backup.

Photograph 18—Maintenance shops of Texas, New Mexico and Oklahoma Coach Company. View looking southwest. (Location 11)

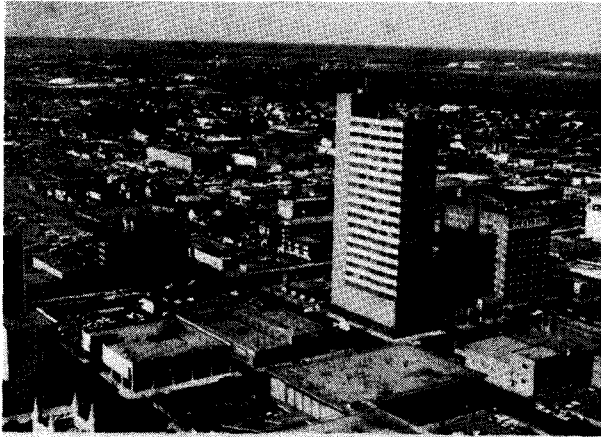
Approximately 50 percent of the glazing was pushed into the building on both the south and west elevations as shown in photograph 20. This effect is concentrated near the southwest corner as shown in photographs 20 and 21. On the east elevation,

Photograph 20—Center of City with 20-story Great Plains Life Building in foreground. View looking northeast. (Location 13)

however, the probable combination of pressure buildup inside the building and suction outside the building caused glazing to be forced out and to fall in the street below. Some 20 percent of the glazing was lost from the east elevation.

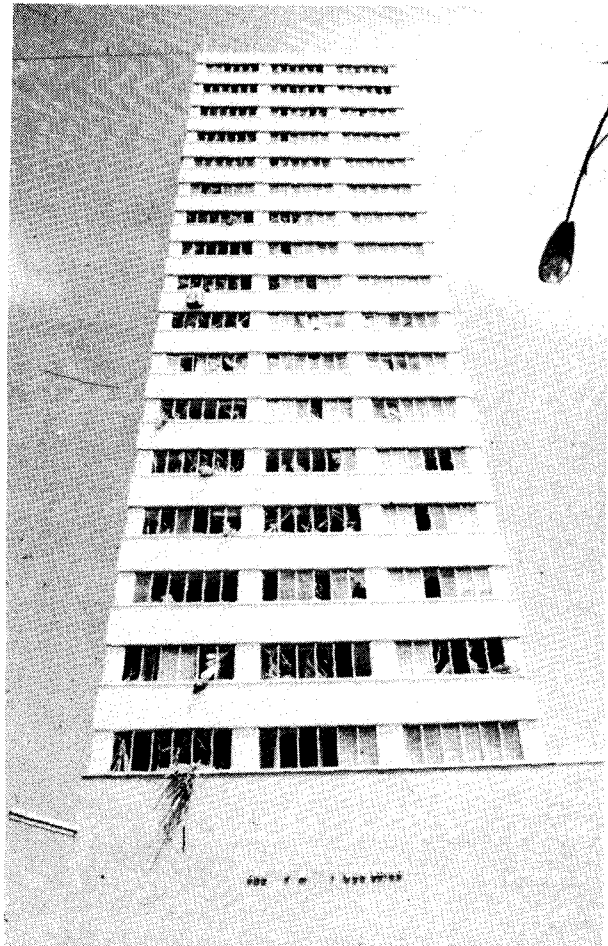
Photograph 21—South elevation of Great Plains Life Building. Glazing damage was particularly severe on southwest corner of building. (Location 13)

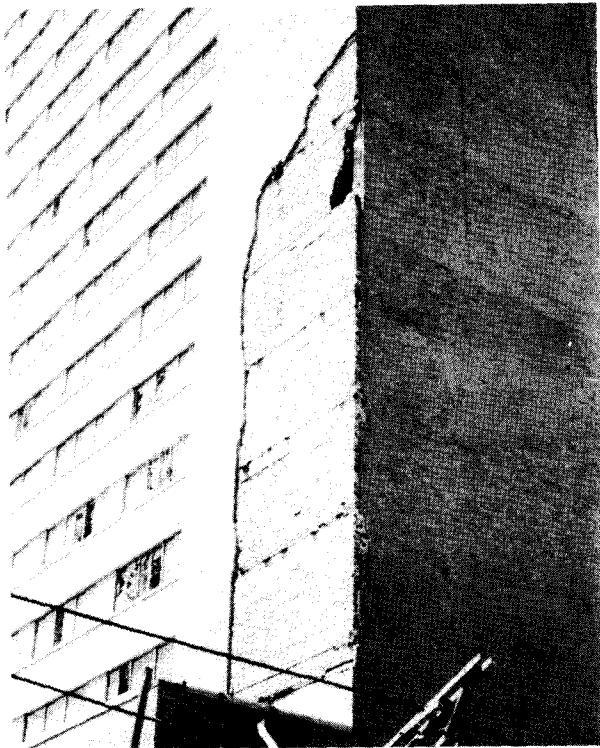
On the north edge of the east elevation the combination of the air flow around the building and the twisting of the building caused the loss of brick veneer over a clay tile infill wall panel enveloping the utility tower. This area extended vertically over seven stories with a maximum width of 20 feet; note photograph 22. From ground level it appeared that the brick was bonded by brick headers to the clay tile backup.

Photograph 22—Northeast corner of Great Plains Life Building with loss of brick veneer over clay tile infill wall panels enveloping the utility tower. (Location 13)

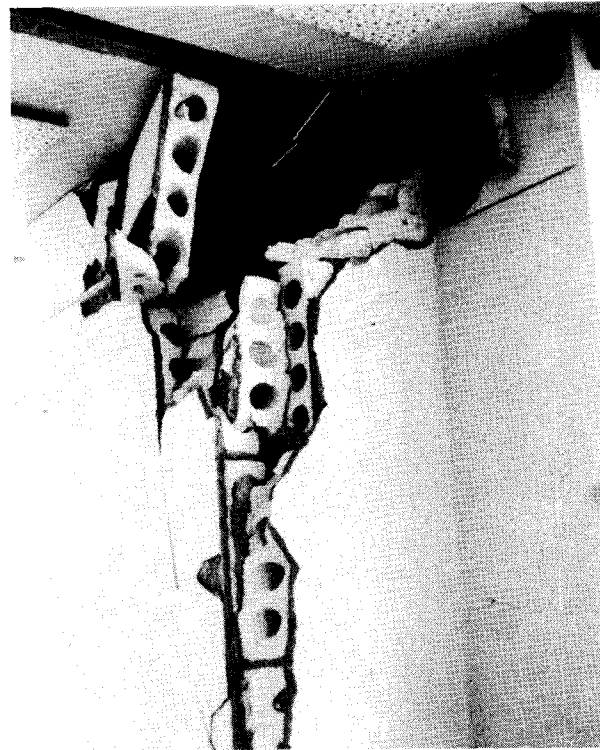
Other evidence of this torsional rotation was provided by similar cracking of fire protection to steel columns adjacent to the utility tower. In these columns the cracks were at 45 degrees to the horizontal. Photograph 23 shows that the movement of one steel column on the sixth floor was large enough to cause disruption of gypsum tile.

Photograph 23—Disruption of gypsum-tile fire protection to steel column in the Great Plains Life Building. (Location 13)

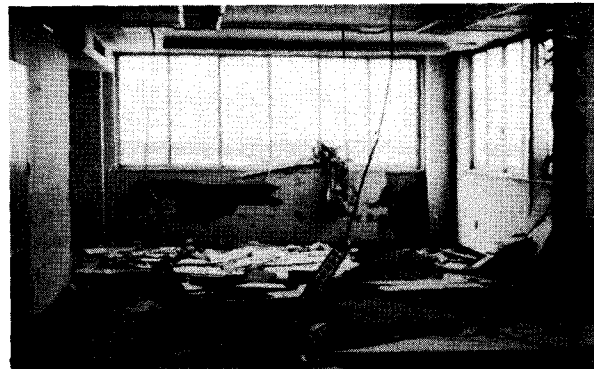
Photograph 24—Southwest corner on the sixth floor of Great Plains Life Building. The 3-inch gypsum tile non-loadbearing walls were shattered by wind pressure. (Location 13)

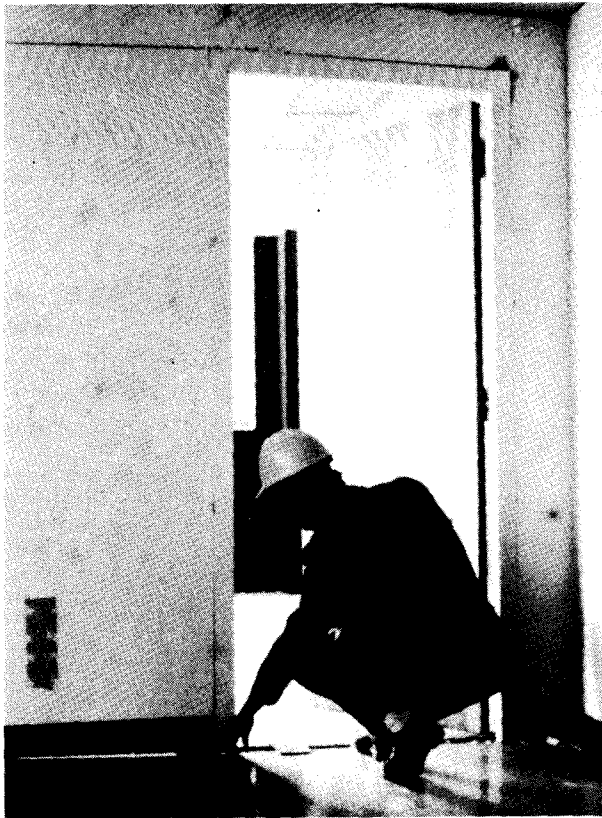
Photograph 25 shows a one-inch vertical movement of the gypsum tile partition at the southeast corner of the sixth floor. In this case the ceiling and wall remained in contact and the resulting movement racked a door frame.

Photograph 25—One inch vertical movement of gypsum tile partition at southeast corner of sixth floor of Great Plains Life Building. Note racking of door frame. (Location 13)

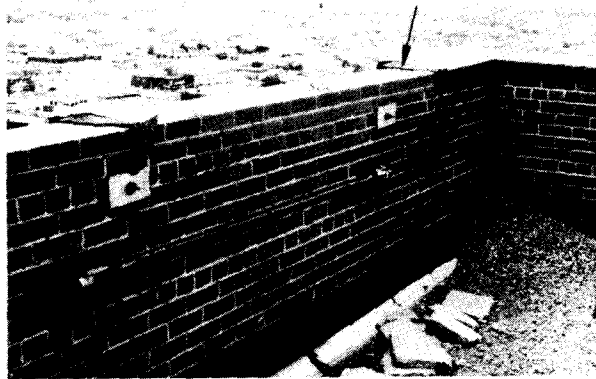
Photograph 26—Eight-foot lengths of stainless steel coping were completely stripped from east parapet wall on the roof of the Great Plains Life Building. (Location 13)

There was considerable damage at both the roof level and at the top of the utility tower which rises 40 feet higher. In one area where an exhaust vent passed through the roof, a 4 foot square area of built-up roofing around the vent was lifted. The brick parapet wall on each side of the roof was capped by stainless steel coping in 8-foot lengths.

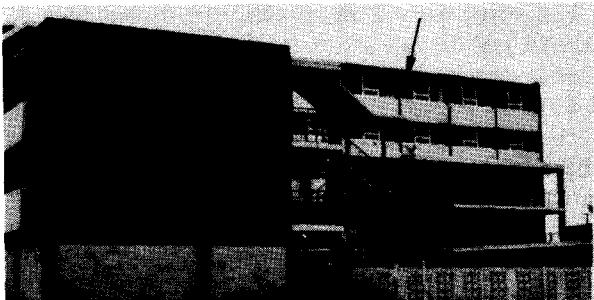
Photograph 27—South elevation of five-story motel with damage to glazing in upper floors. (Location 14)

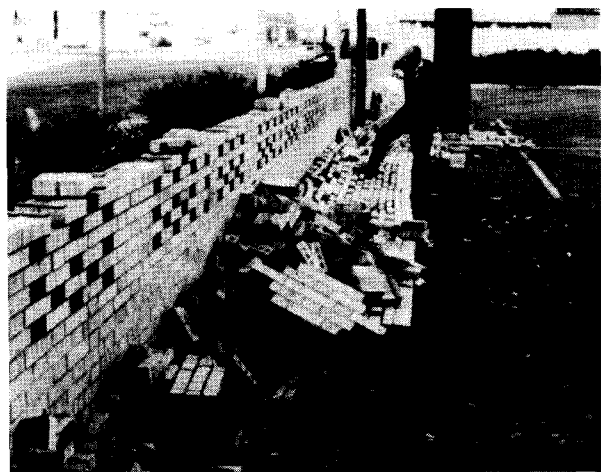
Photograph 28—East-west brick wall with the upper 40-inch height overturned. (Location 14)

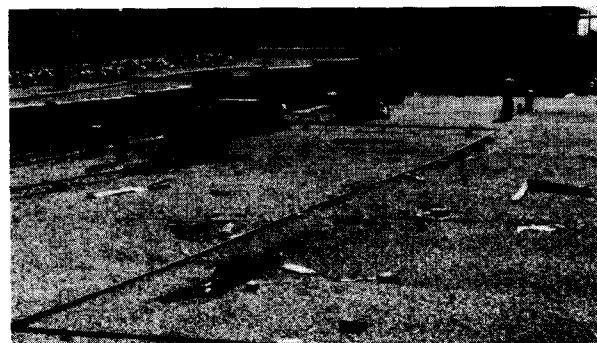
Photograph 31—View looking northeast showing roof of Recruiting Station for U.S. Military Services. Note punctured roof in foreground and overturned parapet wall to the rear. (Location 16)

As shown in photograph 31, the damage to the

one-story U.S. Military Recruiting Station was a large puncture through the roof membrane and deck. It is believed that this damage was caused by flying debris from another building.

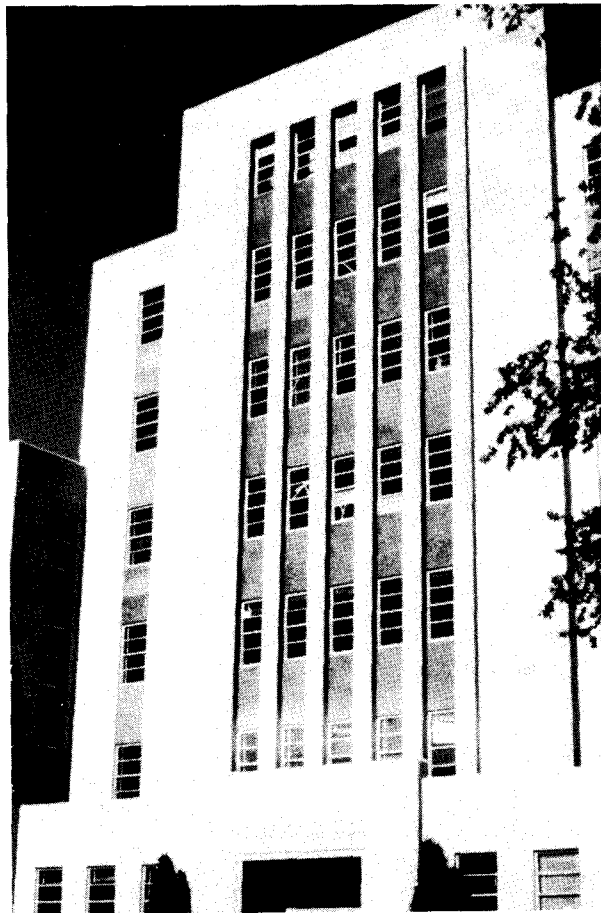
Photograph 33—West elevation of County Court Building suffered only slight glazing damage. (Location 18)

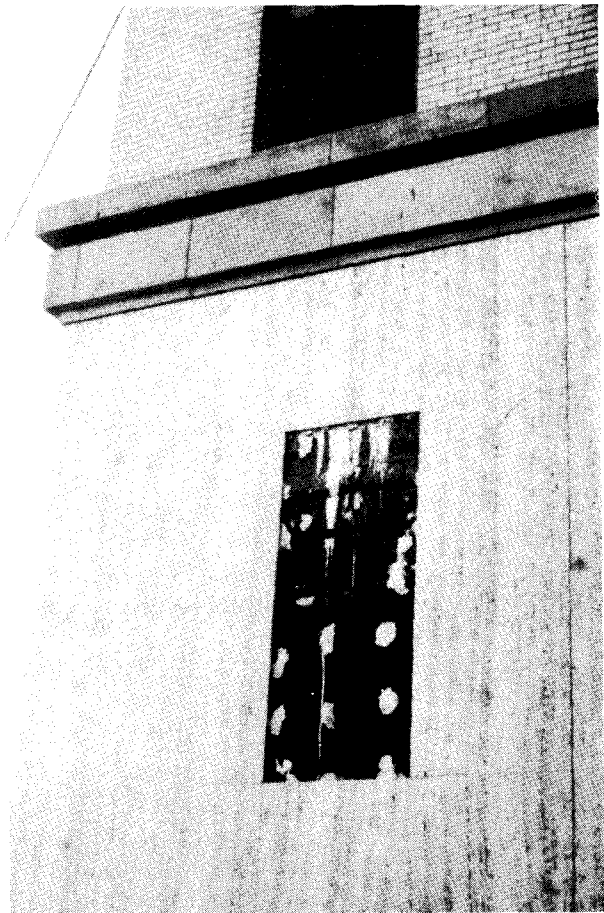
Photograph 34—Marble veneer dislodged from east elevation near southeast corner of Lubbock National Bank. (Location 19)

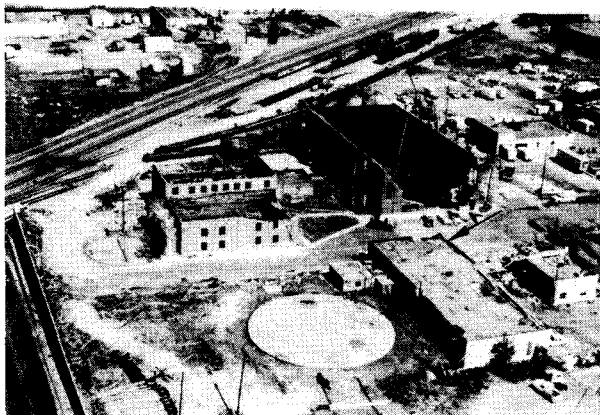
Photograph 35—Wall and roof damage to light industrial buildings. View looking east. (Location 20)

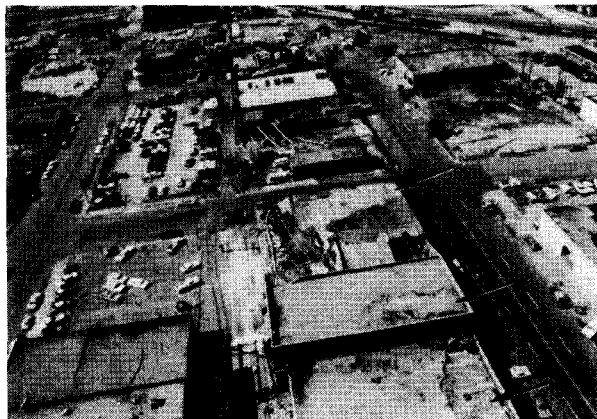
Photograph 36—Roof damage to light industrial buildings. View looking north. (Location 20)

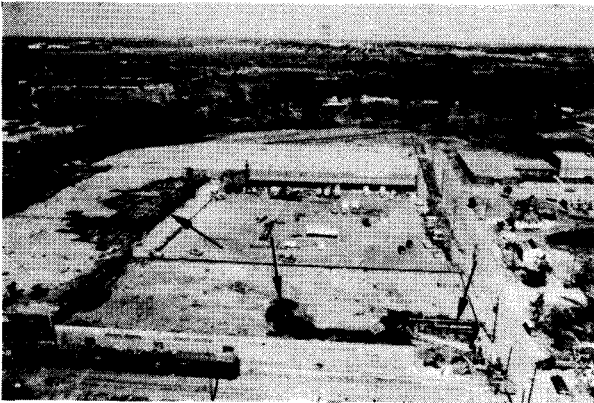
Photograph 37—K. T. Ibell Wholesale Grocery Warehouse with roof and wall damage. View looking west. (Location 21)

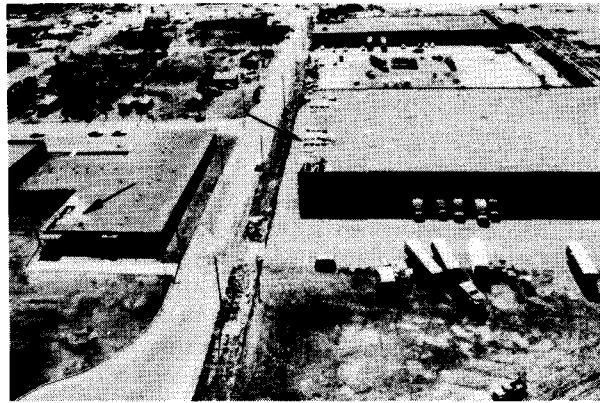
Photograph 38—K. T. Ibell Wholesale Grocery Warehouse with damage at edge of roof. View looking west. (Location 21)

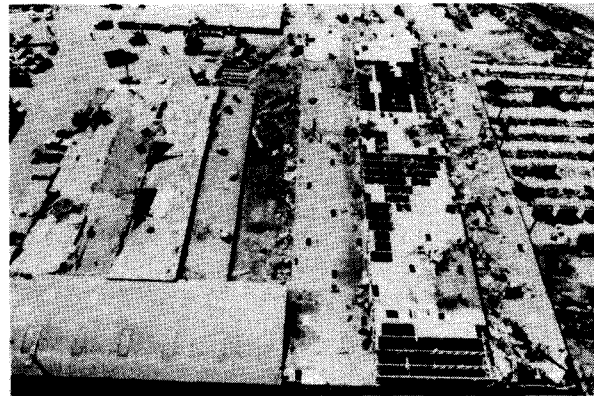
Photograph 39—Damage to roofs of light industrial buildings of the Hancock Division of Clark Equipment Company. View looking west. (Location 22)

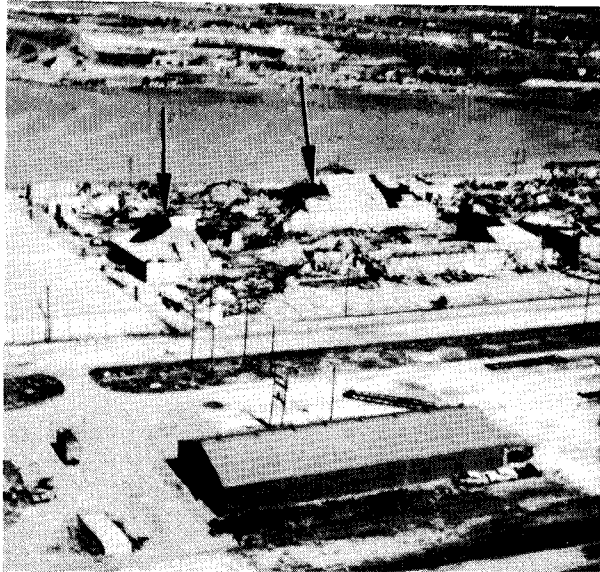
Photograph 40—Destruction of cotton process buildings. View looking east. (Location 23)

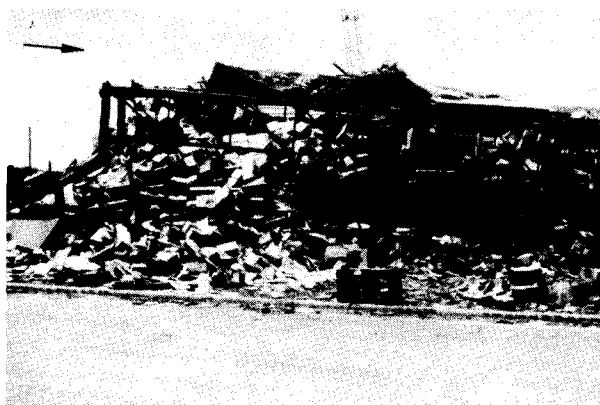
Photograph 41—Destruction of a soft-drink warehouse. View looking west. (Location 24)

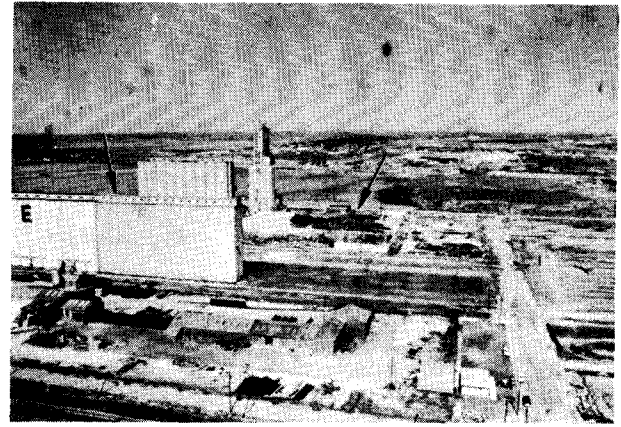
Photograph 42—Damage to roof structure of light industrial building. View looking east. (Location 25)

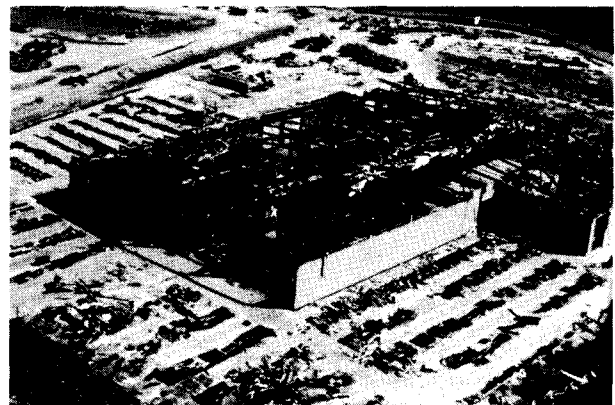
Photograph 43—Clark Equipment Company workshop with stripping of corrugated metal roofing and distortion of the structural steel frame. View looking south. (Location 26)

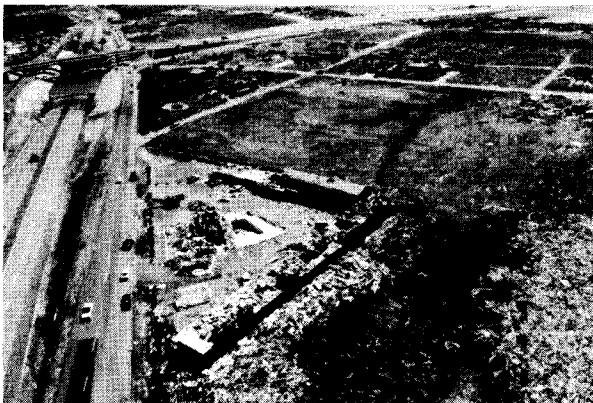
Photograph 44—View looking south over the destroyed two-story Ramada Inn Motel. (Location 27)

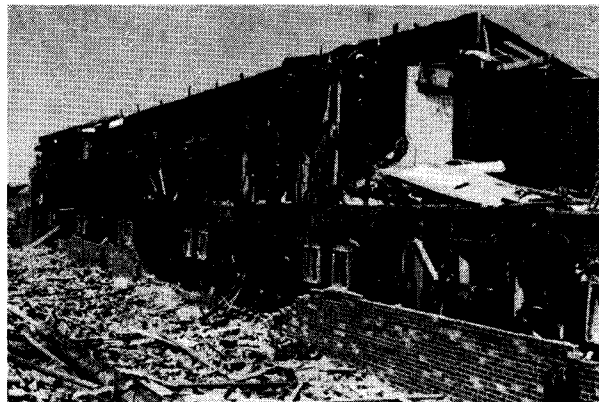
Photograph 45—Southwest elevation of Ramada Inn with effect of intense bombardment by debris. (Location 27)

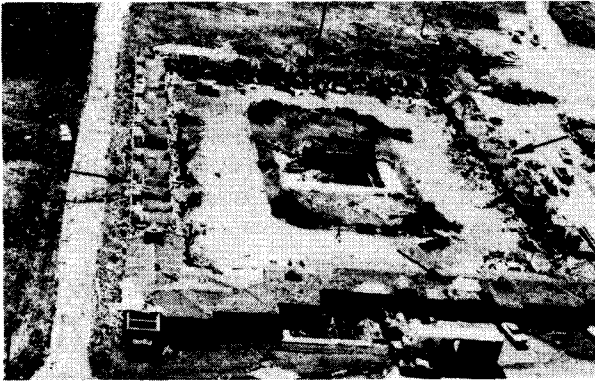
Photograph 47—Motel with loss of complete roof structure on south, west and north sides and loss of some roof covering on east side. View looking west. (Location 27)

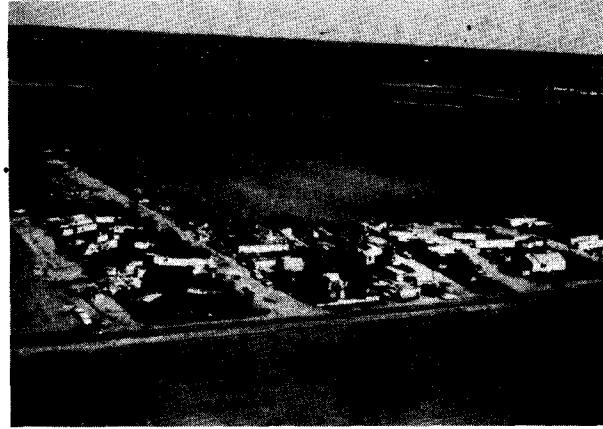
Photograph 50—Mobile home park at Quirt Road, looking east. (Location 30)

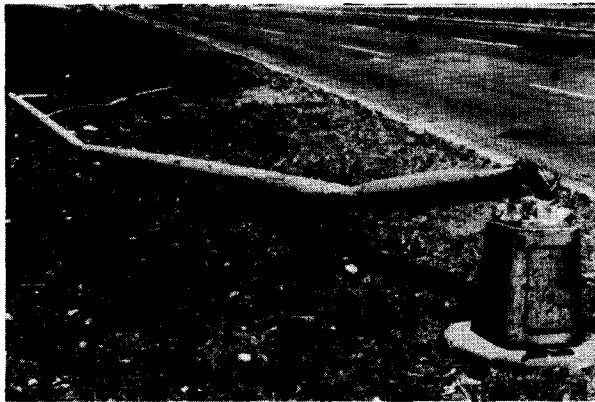
Photograph 48—Collapsed steel lighting standard on U.S. Route 87. View looking north. (Location 28)

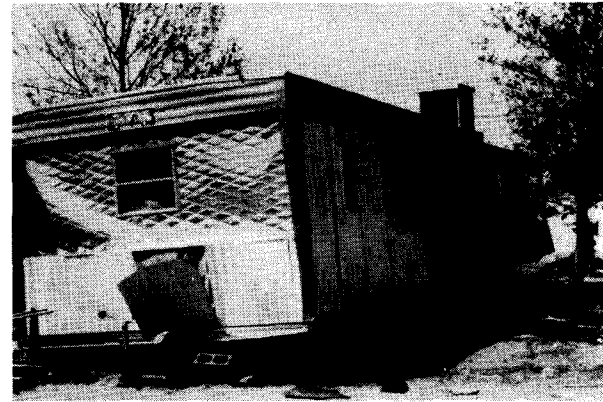
Photograph 51—Typical damage to light aluminum skins of mobile homes at Quirt Road. (Location 30)

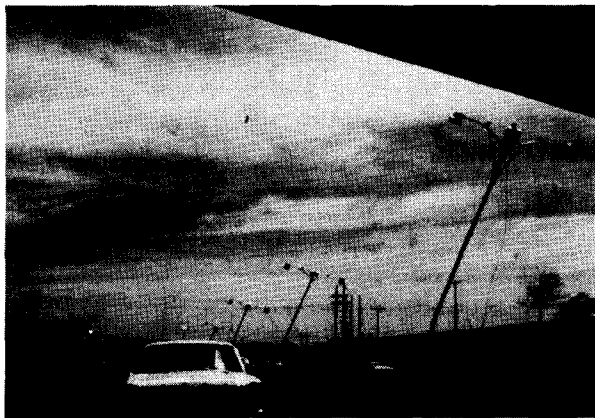
Photograph 49—Median strip lighting standards leaning to the north on U.S. Route 87. (Location 29)

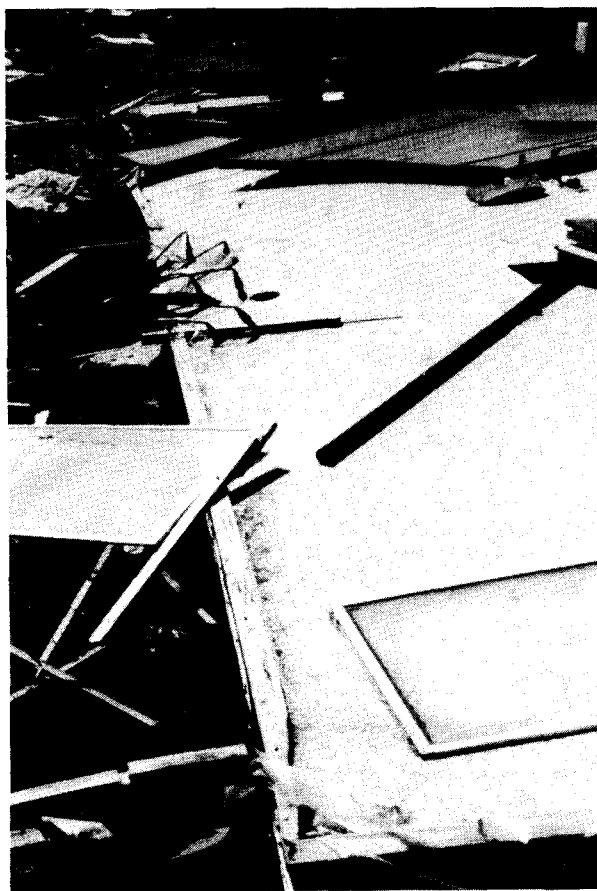
Photograph 53—Base of mobile home from which complete superstructure has been stripped. (Location 30)

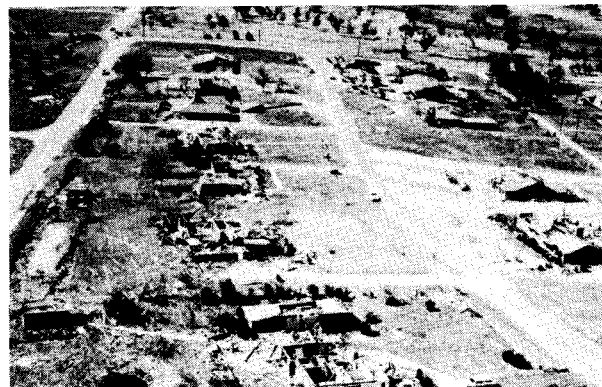
Photograph 54—View looking north on destruction of expensive housing which was in the direct path of the tornado. Note that one house (upper left) in this line escaped damage. (Location 31)

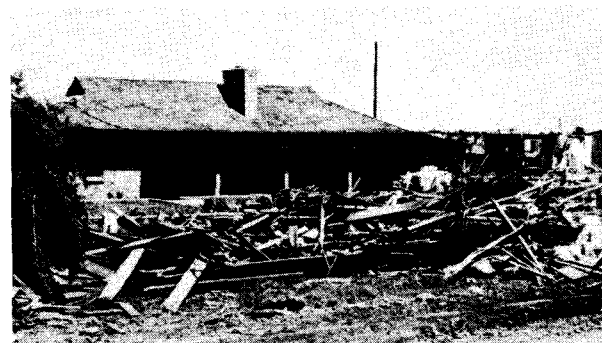
Photograph 55—While houses immediately north and south of this house were severely damaged, this home remained unscathed. (Location 31)

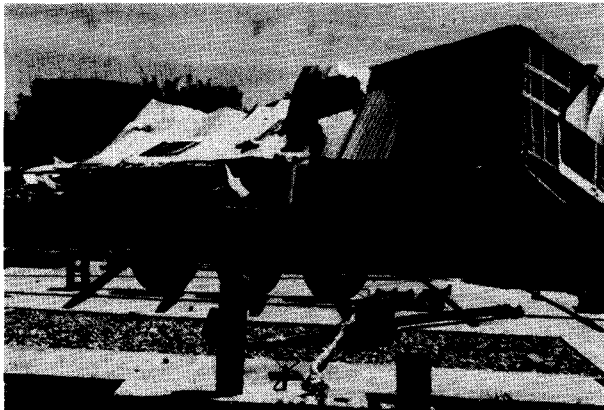
Photograph 58—Mobile home park at Purdue Street with one unit dislodged from its chassis and partly overturned. (Location 32)

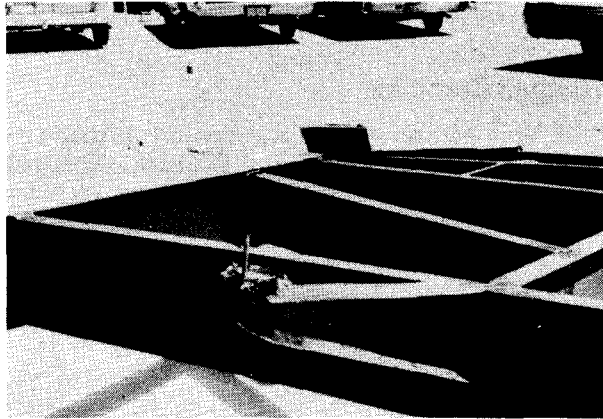
Photograph 59—Typical holdingdown screw which failed to prevent separation of mobile home from its chassis. (Location 32)

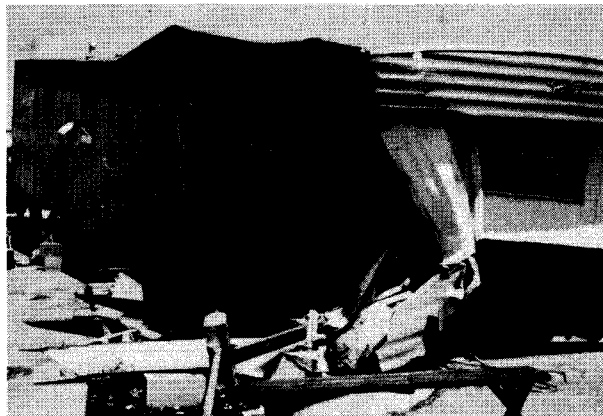
Photograph 60—This mobile home probably collided with a neighboring unit. (Location 32)

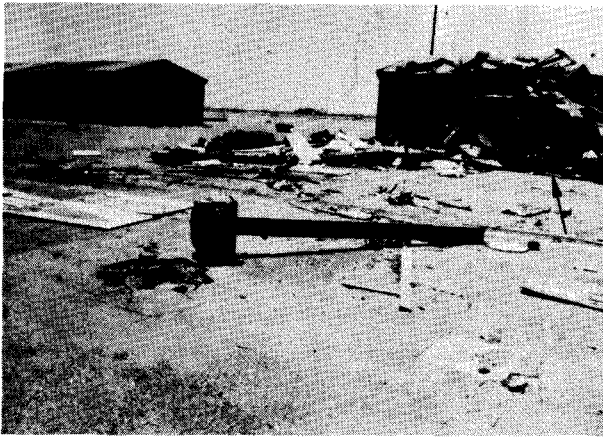
Photograph 61—An overturned steel column is all that remains of several private airplane hangars on the east side of Lubbock Municipal Airport. (Location 33)

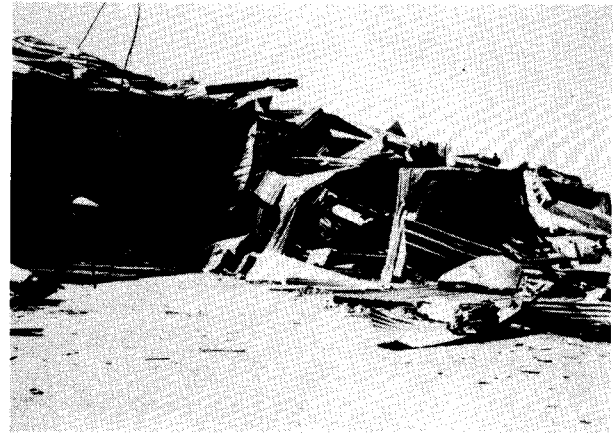
Photograph 62—Considerable damage was caused to private planes both inside and outside hangars. (Location 33)

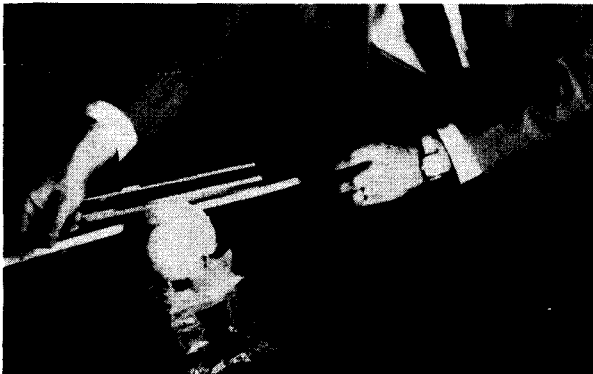
Photograph 63—View of three-inch hailstone preserved by local resident in area five miles south of Lubbock. (Location 34)

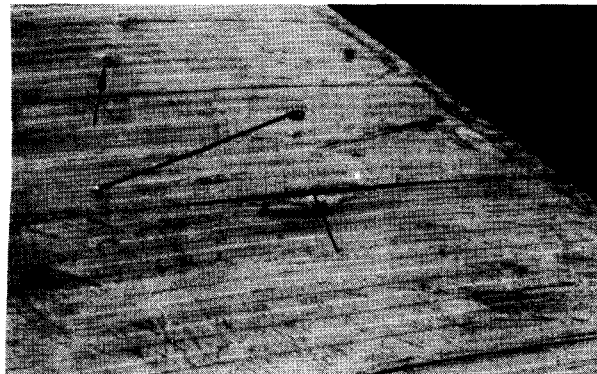
Photograph 64—Mobile home aluminum roof shows denting and splitting of seams caused by hailstone impact. (Location 34)

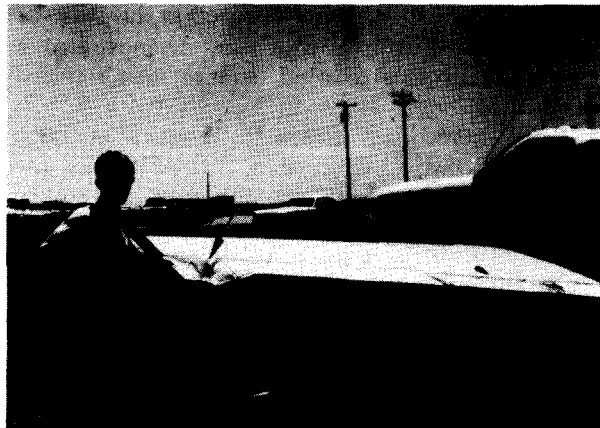
Photograph 65—Hailstone damage to the wing of a light aircraft at the Town and Country Airport, five miles south of Lubbock. (Location 34)
